## **Site Review and Update Roost Appraisal**

**Selsfield Place Farm Buildings, Selsfield Common,  
East Grinstead, West Sussex RH19 4LW**

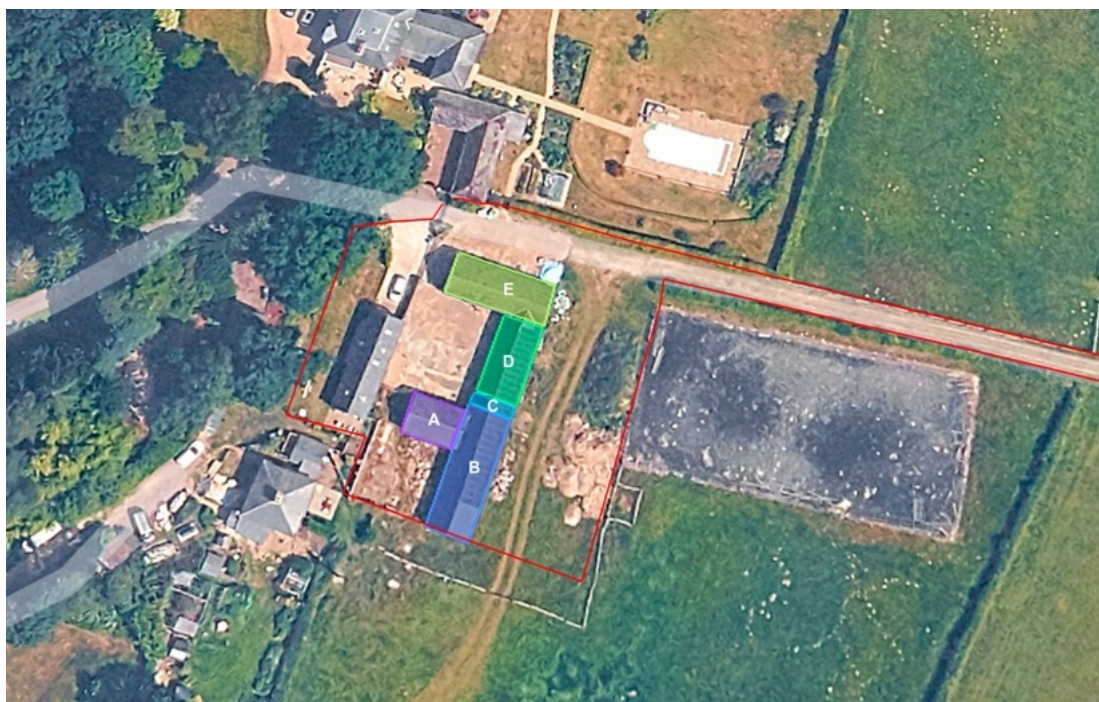
*Figure 3: The remaining barns which are to be converted under the application*

1.4 The proposals are for the redevelopment of the barn buildings. The barn on the western aspect has already been converted under a bat licence. The remaining barns, on the eastern aspect of the site, are all subject to this report. With the barns subject to conversion shown in Figure 3 below.

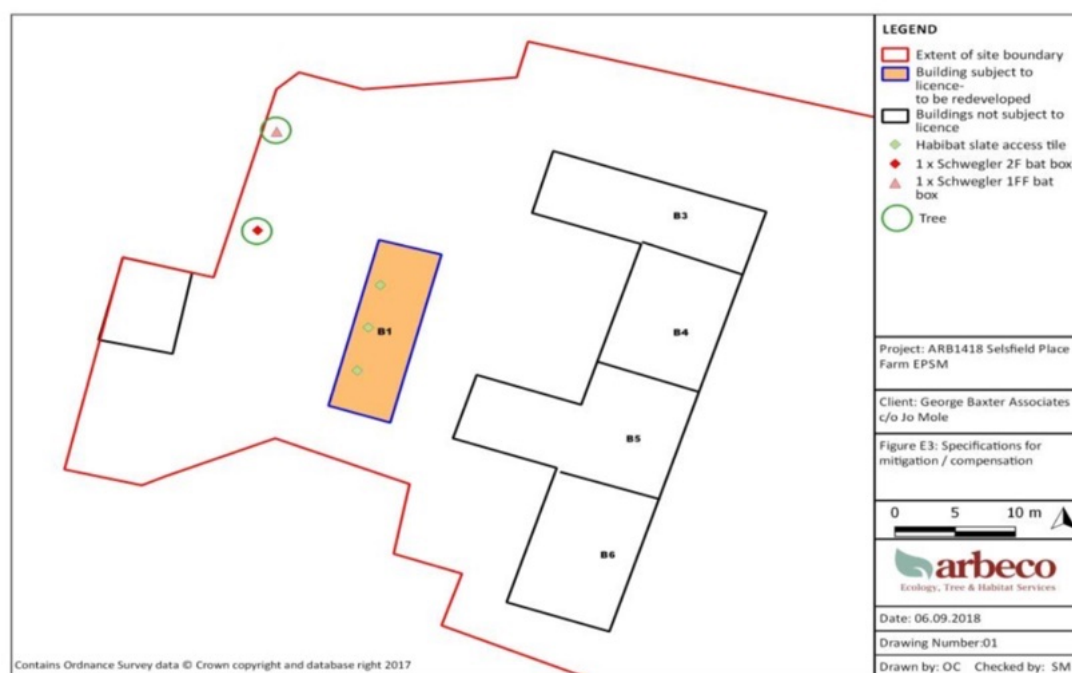
- 2.12 The licence 2018-37539-EPS-MIT covered the period November 2018 – November 2028 inclusive. Actions undertaken between October 2018 and July 2022 did not result in the capture or disturbance of BLE, common pipistrelle or serotine bats. Three Habibat Slate Access Tiles integrated into the roof of B1, one Schwegler 2F bat box and one Schwegler 1FF bat box were located on mature trees within the ownership boundary. The location of these compensation measures are shown in Figure 6 below.

**Figure 6 Location of Compensation Measures**

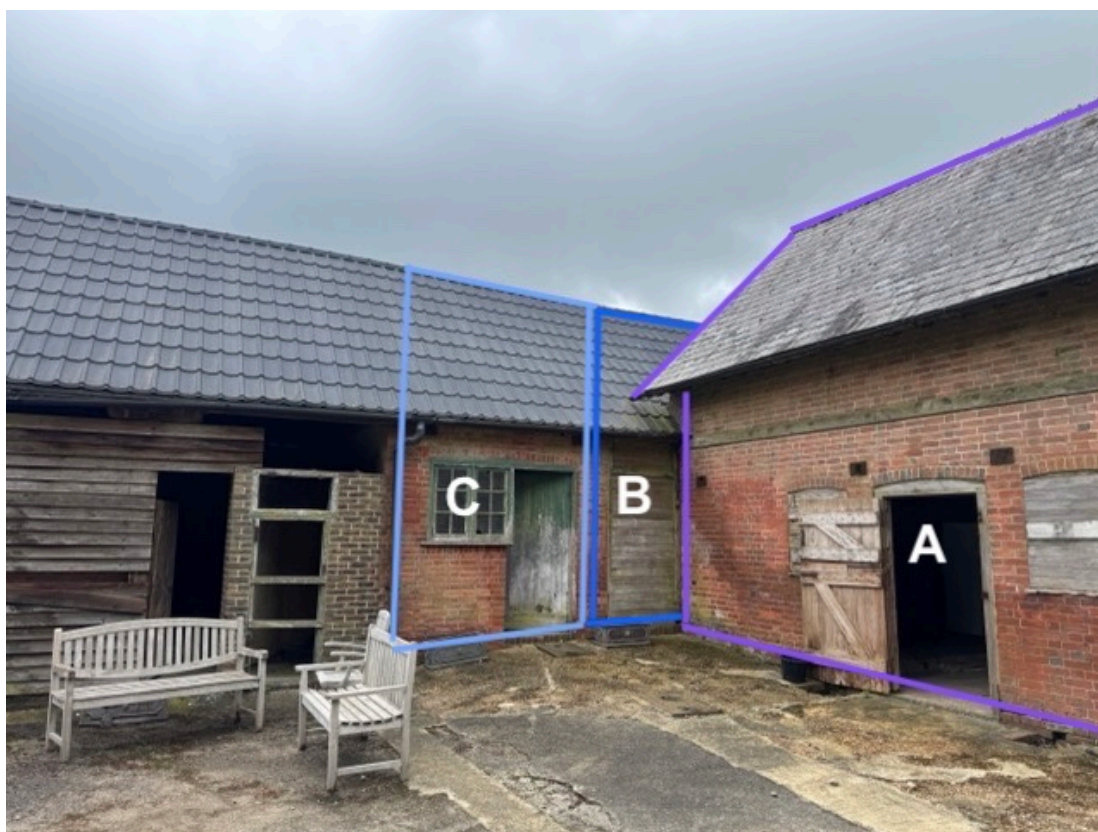
*Figure 10: Building sections A, B and C from the courtyard view*

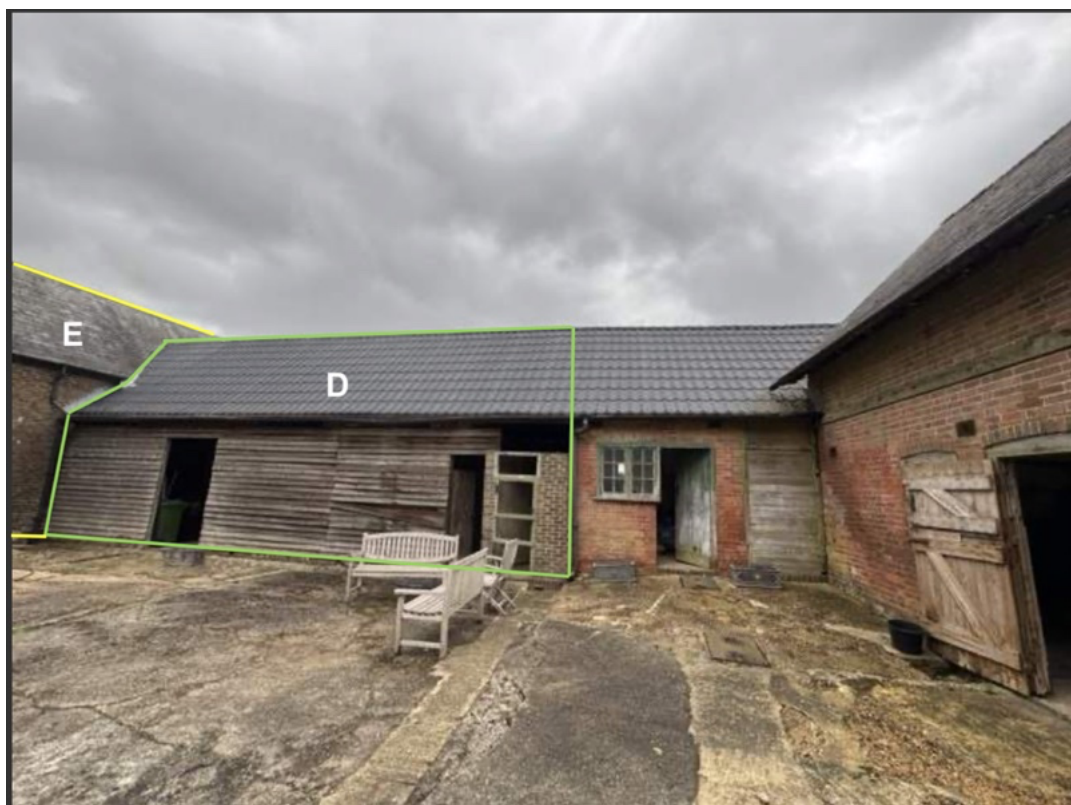
- 4.17 The buildings Building D and Building E are shown in Figure 11 below.

*Figure 11: Building sections D and E from the courtyard view*

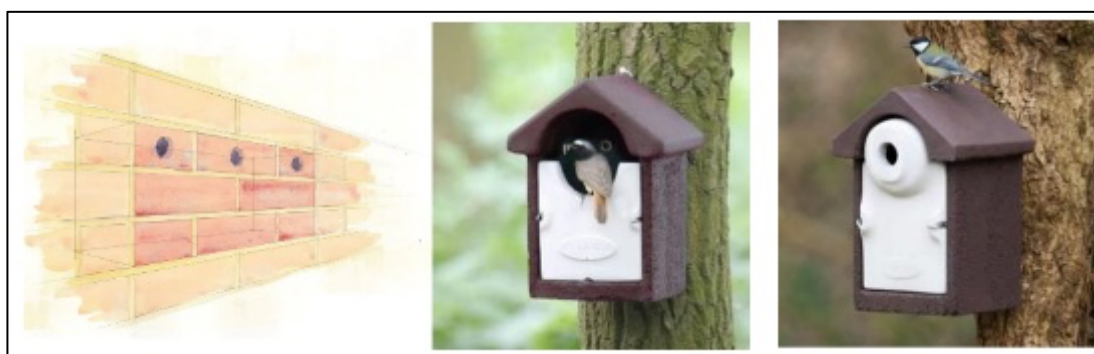
*Figure 12: Examples of suitable bird boxes which could be installed on site – NHBS terraced sparrow box with custom brick facing (left), Vivara Pro Barcelona WoodStone Open Nest Box (centre) and Vivara Pro Seville 32mm WoodStone Nest Box (right)*

- 5.12 The site has a lot of opportunities to improve on the current biodiversity and ecological features in which it retains. A number of enhancements can be incorporated within the development scheme to help reduce potential ecological impacts to support ambitions under the NPPF and the Environment Act.
- 5.13 Additional bird nesting opportunities can be provided onsite; hardwearing woodcrete boxes, or similar, are recommended. These could either be installed into the brickwork of the buildings / barns. Some suitable models are shown in Figure 12 below. The boxes should be positioned on a north or east facing aspect and at least 2.5m above the ground if possible. These would cater for species such as house sparrows and wagtails.

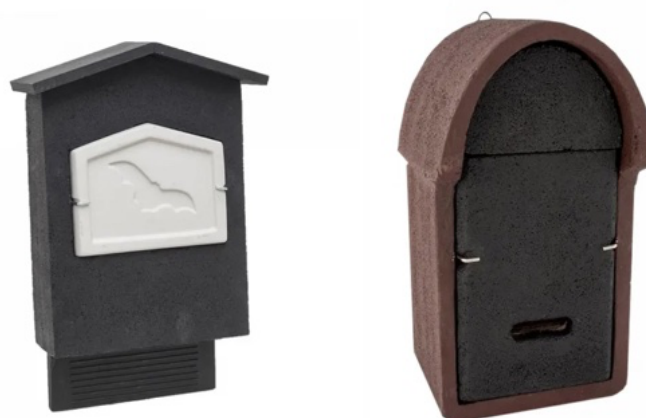
- Large Multi Chamber WoodStone Bat Box – This is a multipurpose box designed for larger colonies and a range of bat species including pipistrelles, noctules and brown long-eared bats.
- Low Profile WoodStone Bat Box- This box is designed to attach to the external walls of existing building and is designed for species such as common pipistrelles.

*Figure 13: Low Profile WoodStone Bat Box (left) and Large Multi Chamber WoodStone Bat Box (right)*

- 5.14 It is recommended that a large chamber bat box should be installed within the site boundary, in order to provide a temporary roost for any bats found during works, as

well as replacement roost to mitigate for the disturbance to the existing roost. As crevice dwelling species such as common pipistrelles and void dwelling species such as brown long-eared bats were roosting within the barns within the complex. A total of two bat boxes are recommended. Boxes should ideally be exposed to the sun for most of the day, so southern and western aspects are preferable, and should be hung as high as possible (around 5m above ground) to encourage bats and avoid predation from cats. Recommended boxes or similar include (Figure 13):

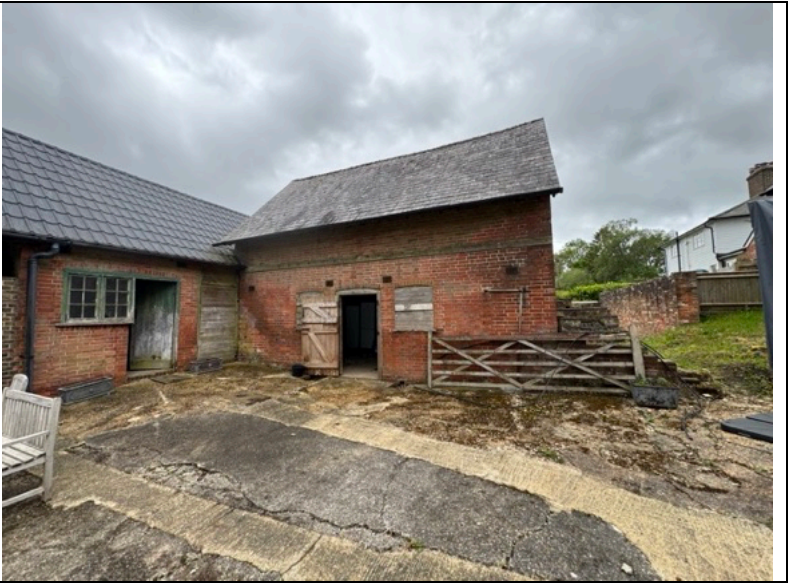
- 4.8 Building A is a brick built structure and tiled roof. The entrance is within the courtyard and a single window in the courtyard is covered. The western aspect there is a large door with a wooden covering. A small section of this door was open at the top. A sealed wooden door was located on the southern aspect.

| <p><b>Photograph 1:</b> Barn section A</p> | A photograph of a two-story brick barn with a grey tiled roof. The building has several windows and doors, some of which are boarded up. A wooden fence is visible in the foreground, and a paved area leads to the entrance. The sky is overcast. |

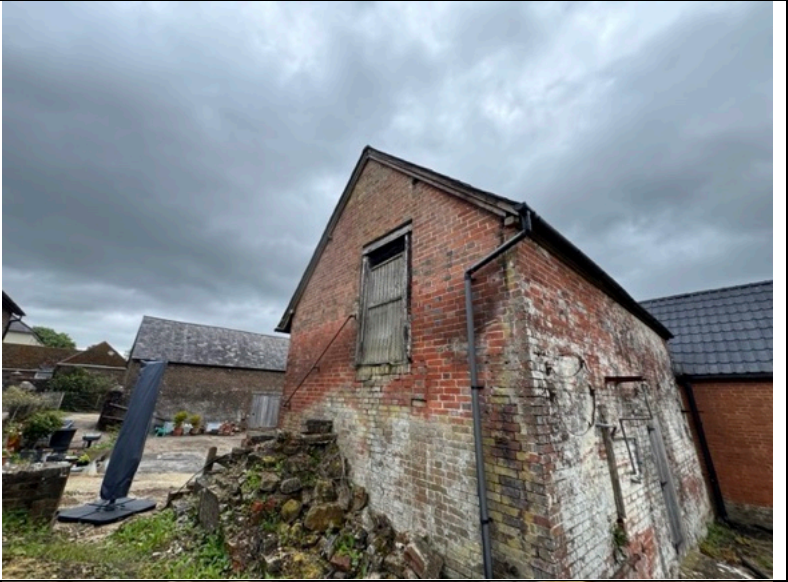
| <p><b>Photograph 2:</b> The western aspect of building section A</p> | A photograph showing the side of the brick barn. The wall is made of red brick with some white plaster or render. A window with a wooden shutter is visible. A dark blue tarp is leaning against the wall, and a pile of stones or debris is in the foreground. |

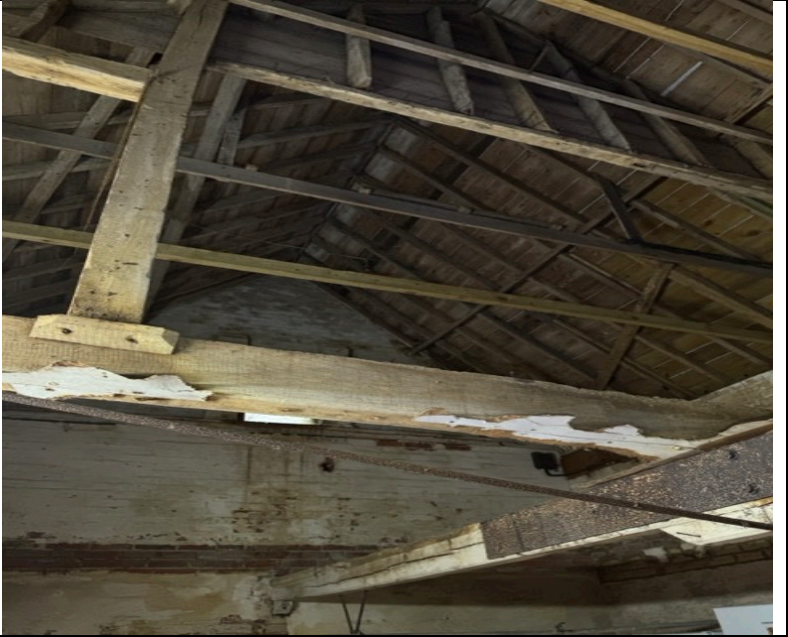
- 4.9 Internally the building was open to the roof apex. The roof structure is formed of wooden beams with wooden with wooden sarking under the tiles. The sarking boards appeared well fitted, with no obvious crevices or openings, albeit there are small gaps internally between the sarking and the brick work.

| <p><b>Photograph 3:</b> Internal roof structure in section A</p> | A photograph of the interior of the barn, looking up at the roof structure. The wooden beams and rafters are visible, showing signs of age and wear. The floor is made of concrete or stone. |

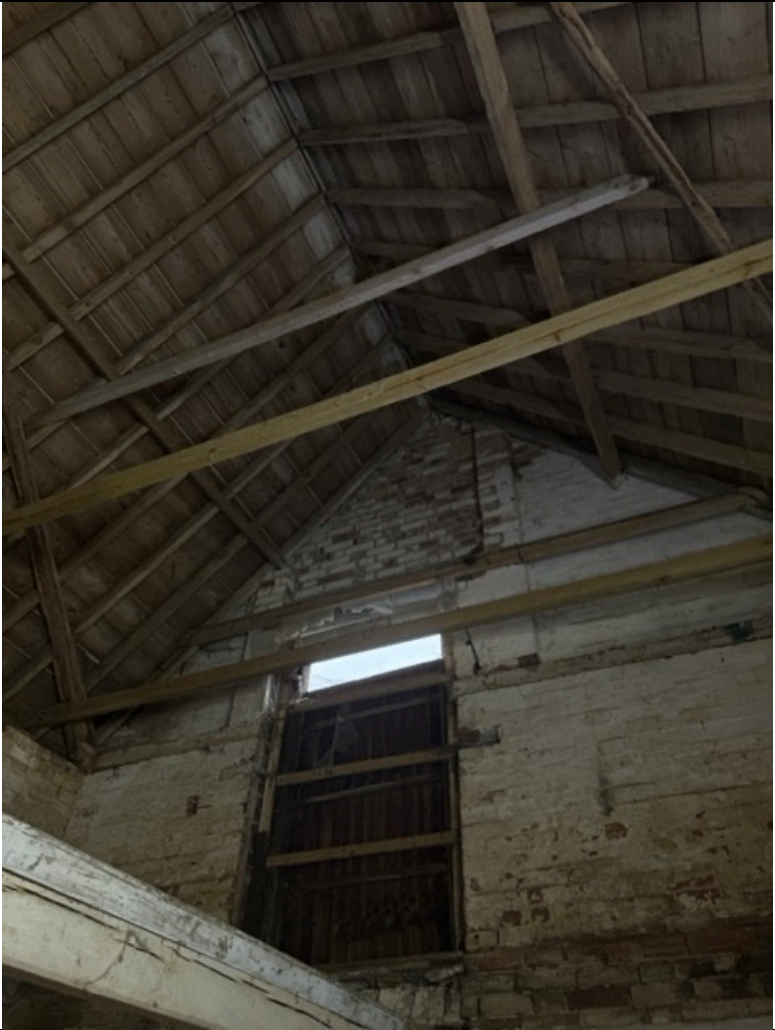
| <p><b>Photograph 4:</b> Internal view of the western edge of section A</p> | A photograph showing the interior of a building. The roof is made of dark wooden rafters and beams, with a lighter-colored wooden beam running diagonally across the frame. Below the roof, there is a stone wall with a window that has a dark wooden frame. The wall appears to be made of rough-hewn stone or brick. |

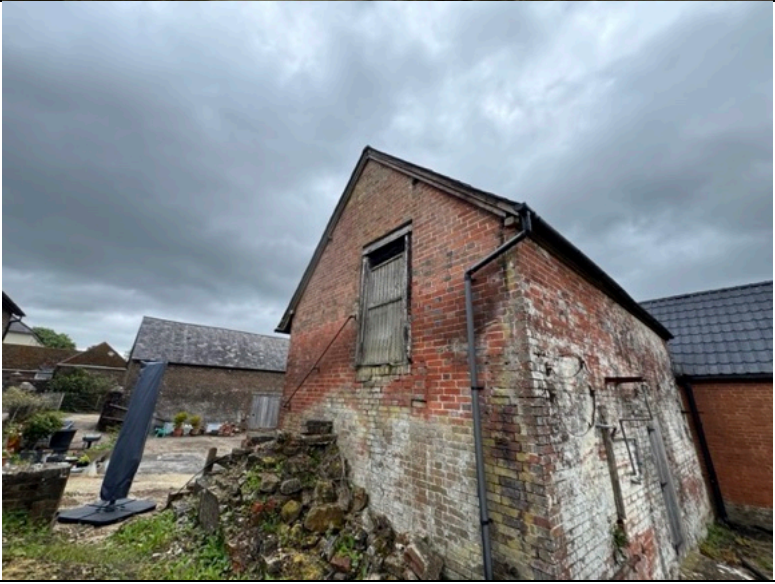
- 4.10 Externally the roof tiles were well fitted. The soffits on the western aspect have a slight gap along the drain pipe. Some additional gaps are present around the western doorway. These could provide some potential crevices where bats could access.

| <p><b>Photograph 5:</b><br/>External view of soffits and the gaps around the door on the western aspect in building A</p> | A photograph of the exterior of a building. The building is made of red brick and has a steep gabled roof. There is a window with a dark wooden frame. The ground in front of the building is covered with grass and some debris. The sky is overcast and grey. |

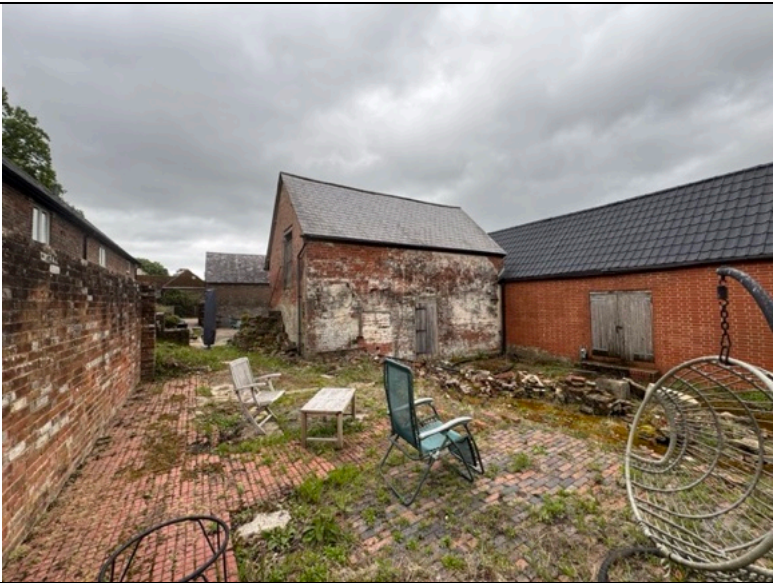
| <p><b>Photograph 6:</b> The rear, the east of the barn section B</p> | A photograph showing the rear of a brick barn. The ground is paved with red bricks and has some weeds growing. There are two green metal chairs and a small wooden table. A large metal wheel is visible on the right. The sky is overcast. |

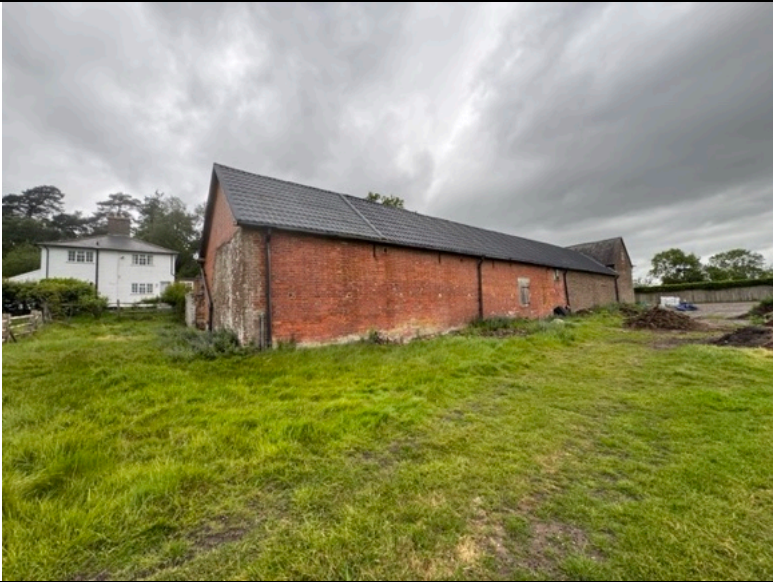
| <p><b>Photograph 7:</b> The eastern aspect of the building section barn B</p> | A photograph showing the eastern aspect of the brick barn. The building is long and made of red brick with a dark roof. It is surrounded by green grass. A white building is visible in the background. The sky is overcast. |

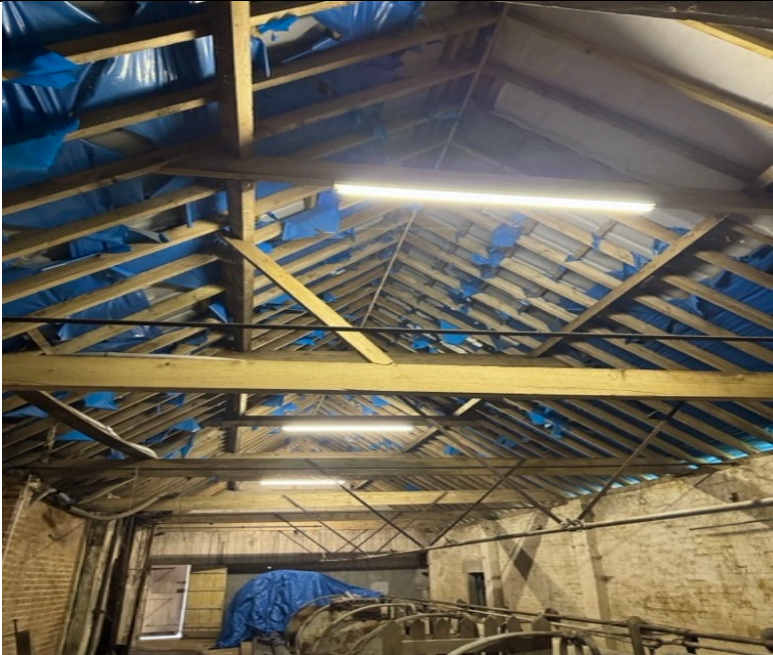
- 4.13 Internally, the building is the old dairy with some structures still present. The barn is open to the apex of the roof. The roof structure supports well fitted tiles with plastic internal lining. The wooden frame of the roof is clear. The southern gable supports brick work to the apex.

| <p><b>Photograph 8:</b> Internal structure building section B</p> | A photograph showing the internal structure of the barn. The roof is made of wooden beams and rafters, with blue plastic sheeting covering the roof. The walls are made of brick. There are some wooden structures and a blue tarp in the foreground. |

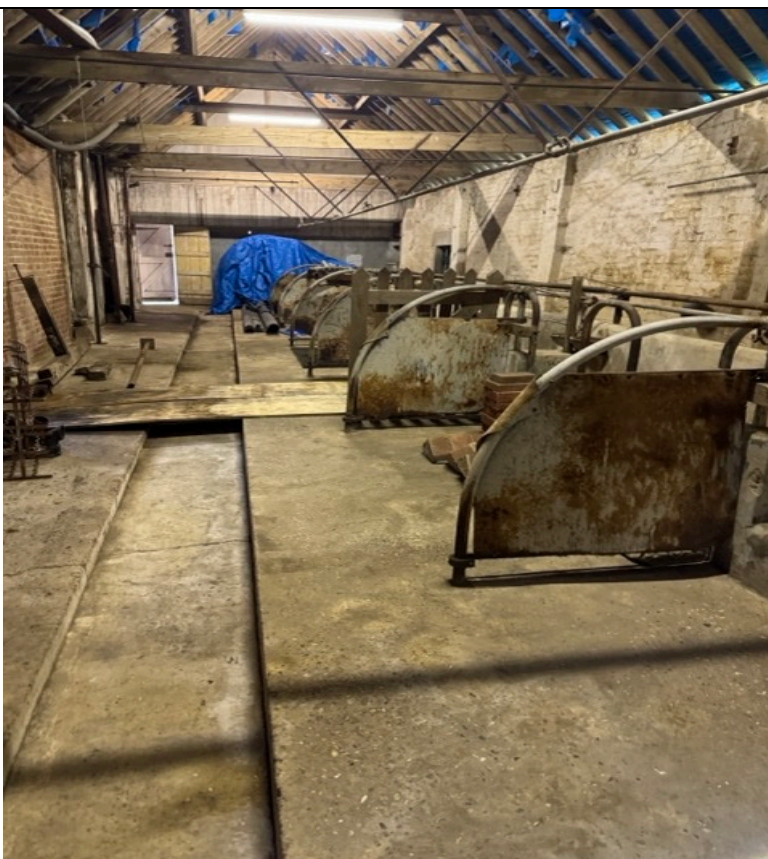
**Photograph 9:** The floor of the barn section B

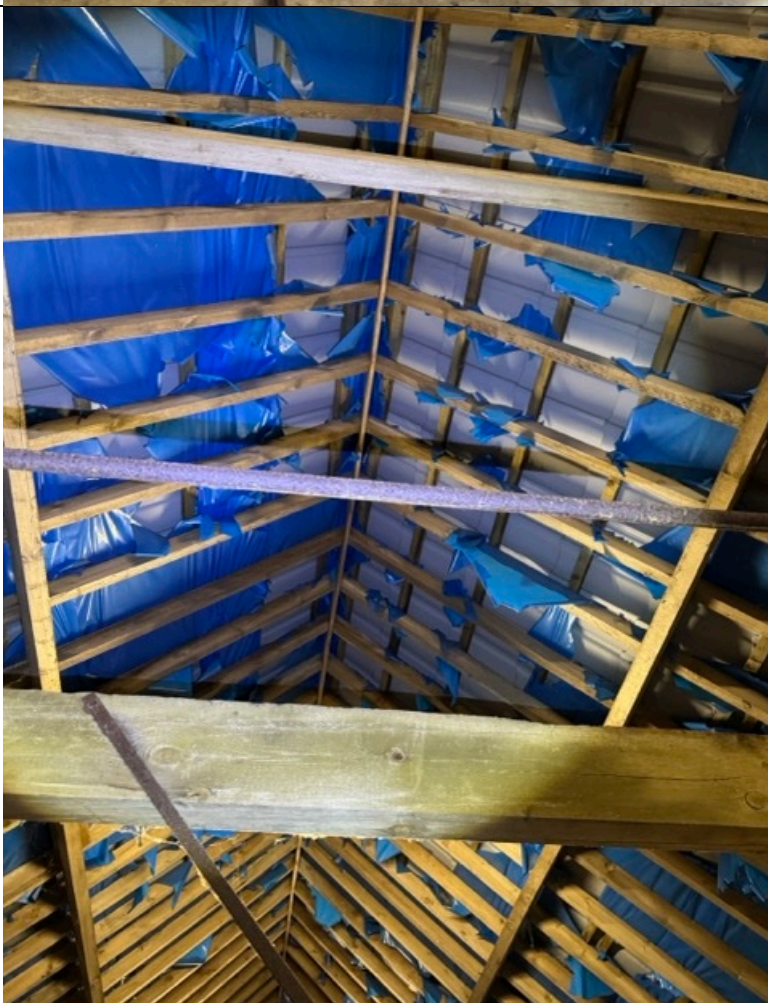
**Photograph 10:** The roof structure of the barn section B

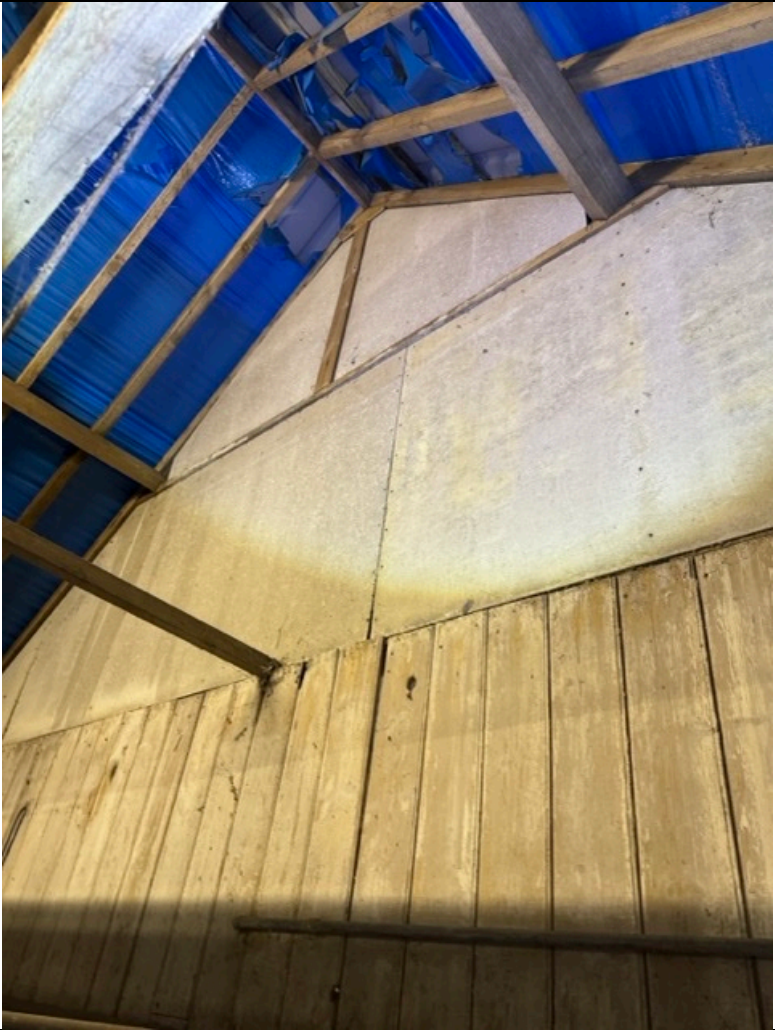
- 4.14 The northern gable supports wooden and concrete structures. Several bat droppings were taken from the wall of this section of the site. These were confirmed to be from brown long eared bats (appendix 2). No other evidence of bats was identified within this section of the site, with no other droppings or feeding remains located within the building.
- 4.15 Building C is a small enclosed section between the northern gable of Section B, with the doorway present into Section B coming from the door of Section C from the main courtyard.
- 4.16 Building C supports an enclosed roof structure and is brick built and supports two rooms. No evidence of roosting bats was recorded within this structure. It must be noted that the enclosed section of the building was not possible to access.

- 5.5 Brown long-eared bat droppings were identified in Building B, with low numbers of bat droppings stuck on the gable end of the wall. A single bat dropping was located within the barn which is used for storage, Building E. No other evidence of bats was found in any barns, with no evidence of feeding remains. No dead bats or live bats were identified during the survey.

| <p><b>Photograph 11:</b></p> <p>Several bat droppings were taken from this wall on the northern section of B</p> | |

- 7.3 All of the barns are subject to the redevelopment. Bat droppings were located within barn B and a single dropping in barn E. The barns will require three evening dusk surveys to determine how bats are utilising the buildings
- 7.4 It is recommended the development follows a sensitive lighting scheme so impacts on foraging and commuting bats will be avoided.
- 7.5 Nesting birds are fully protected through seasonal clearance or pre-works checks, ensuring compliance with legislation.
- 7.6 A number of ecological enhancements are recommended to be incorporated into the development scheme to improve the biodiversity on the site and the wider landscape.

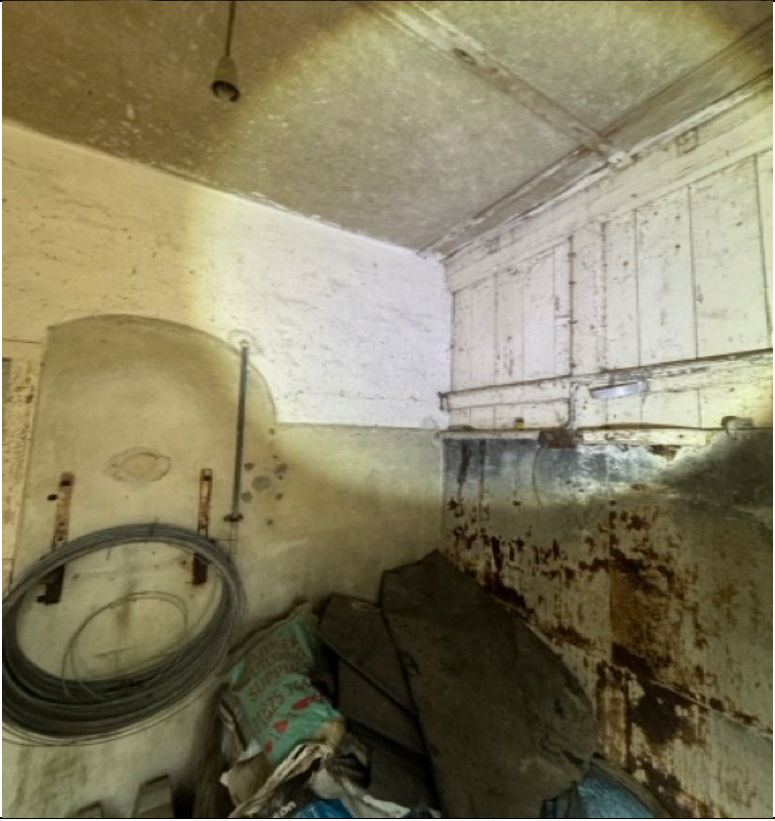
| <p><b>Photograph 12:</b></p> <p>Section C an enclosed section of the site</p> | |

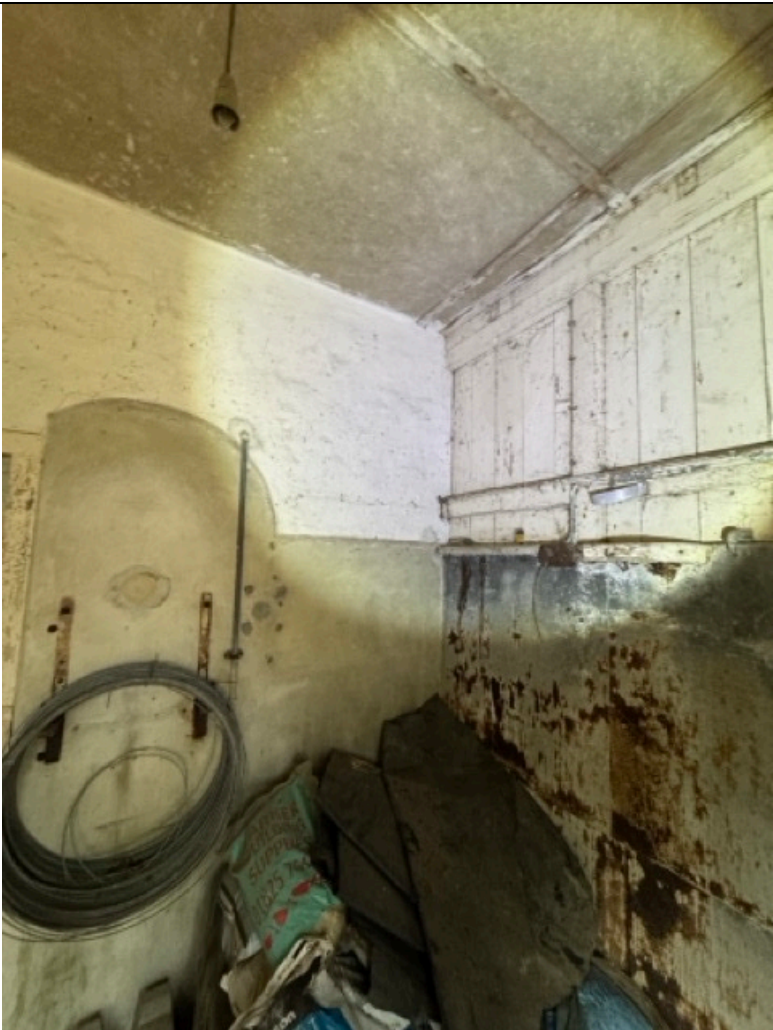
| <p><b>Photograph 13:</b></p> <p>Section C an enclosed section of the building.</p> | |

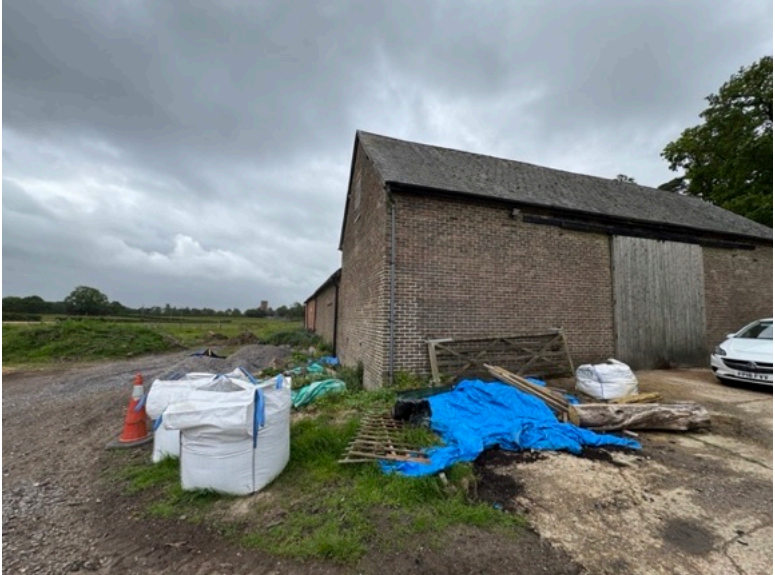
- 4.19 The final building, Building E, is the most northern structure supports stored machinery for the farm. This building supported well fitted slate tiles, with no loose of missing tiles and no opportunities for crevice dwelling species to exploit. The barn was open from the apex to the ridge. A single dropping was identified within the Building E, this was sent for DNA analysis and was confirmed to be from brown long eared bat (Appendix 2). No other droppings or any evidence of bats was recorded in the barn.

| <p><b>Photograph 15:</b></p> <p>Northern most barn,<br/>Building E</p> | A photograph of a large, old brick barn with a steep gabled roof. The barn is situated on a gravel area. In the foreground, there are several large white sacks, a blue tarp, and some wooden pallets. A white car is partially visible on the right side of the barn. The sky is overcast and grey. |

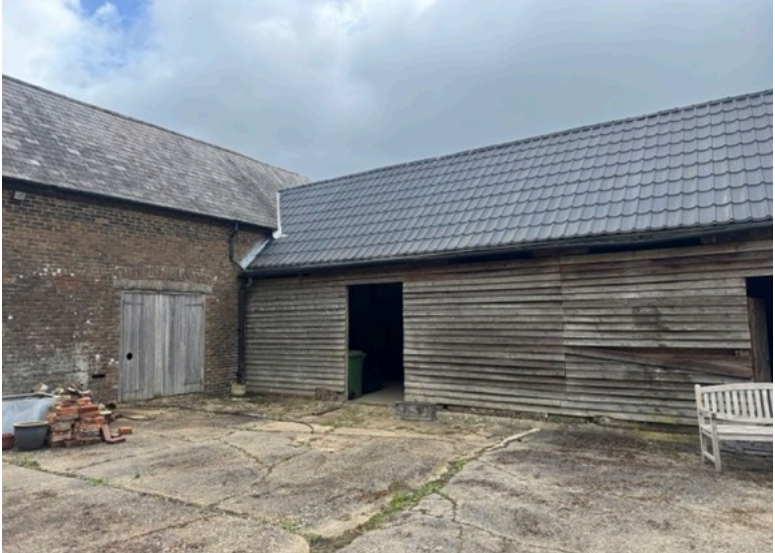
- 4.18 Building D is located along the eastern aspect, adjacent to C supports some loose weatherboarding. This could provide some potential for crevice dwelling species. Internally, the tiles were well sealed as found in sections B and C. No opportunities for crevice dwelling species were identified. Internally the building supports wooden frames and well fitted tiles with some plastic present under the tiles. No evidence of bats were identified.

| <p><b>Photograph 16:</b></p> <p>Warped<br/>weatherboarding of<br/>the central building D</p> | A photograph of a central building with a tiled roof and weathered wooden siding. The siding is warped and peeling. The building has a large open doorway. In the foreground, there is a concrete area with some debris and a white bench on the right. The sky is overcast. |

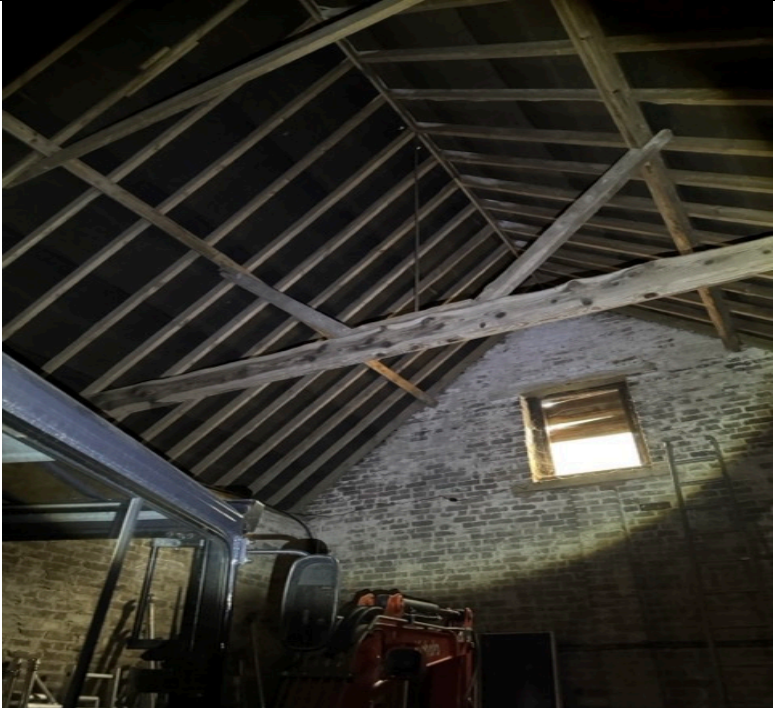
| <p><b>Photograph 17:</b> Inside<br/>the Building E</p> | A photograph of the interior of a barn. The roof is made of dark wooden beams. A small square window is visible on the right wall, letting in light. In the foreground, there is a red tractor and some other equipment. The walls are made of brick. |

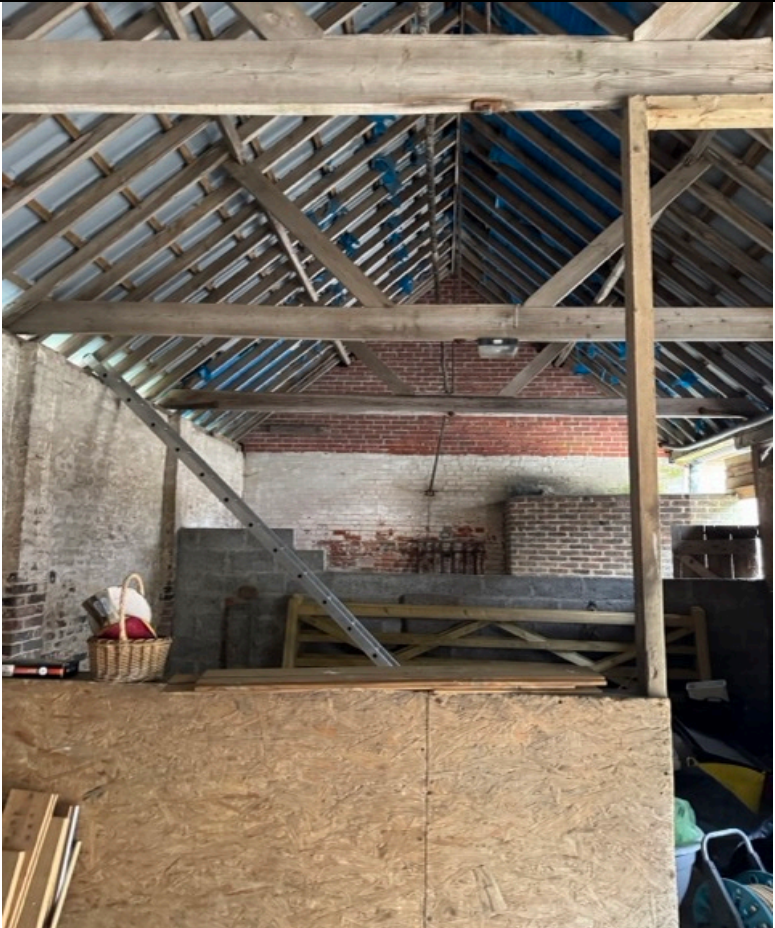
| <p><b>Photograph 18:</b> Inside building D</p> | A photograph showing the interior of a building. The roof is made of wooden beams and rafters, with blue corrugated metal sheeting visible. The walls are made of brick and concrete. A wooden partition or counter is in the foreground. A ladder is leaning against the wall on the left. A basket with red and white items is on the counter. |

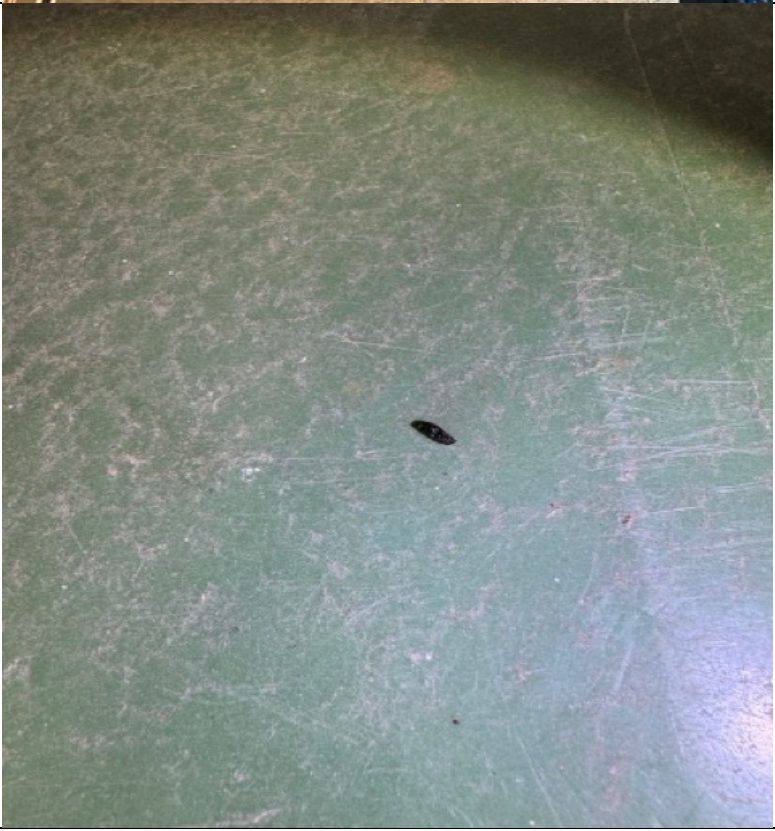
| <p><b>Photograph 19:</b> A single bat dropping found in Building E confirmed as brown long eared bat</p> | A photograph of a single bat dropping on a green floor. The bat is small and dark, with long ears. The floor is green and has some scratches and dust. |

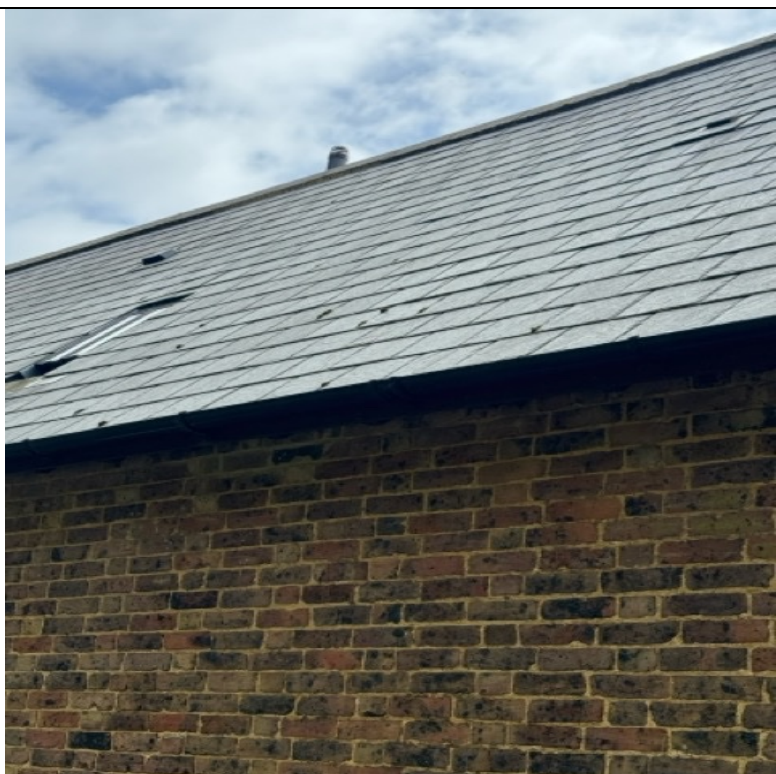
**Photograph 20:** The off site building which supported a bat roost and now converted. The tiles are present within the new roof structure
