## STATEMENT OF HERITAGE SIGNIFICANCE

**Property Address:** Marlow House  
107 High Street  
Lindfield  
West Sussex  
RH16 2HR

**Prepared by** Richard Pocock MSc MRICS

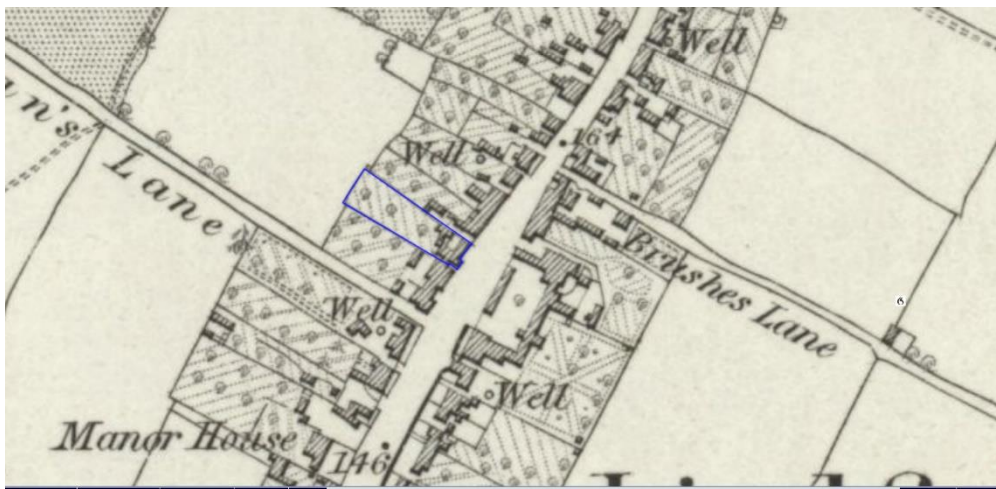
The building is shown in the 1874 map with what looks to be a particularly well observed and accurate layout. The shopfront element to the southeast has also been picked out. The bakehouse to the rear is also shown and depicted as detached at this point.

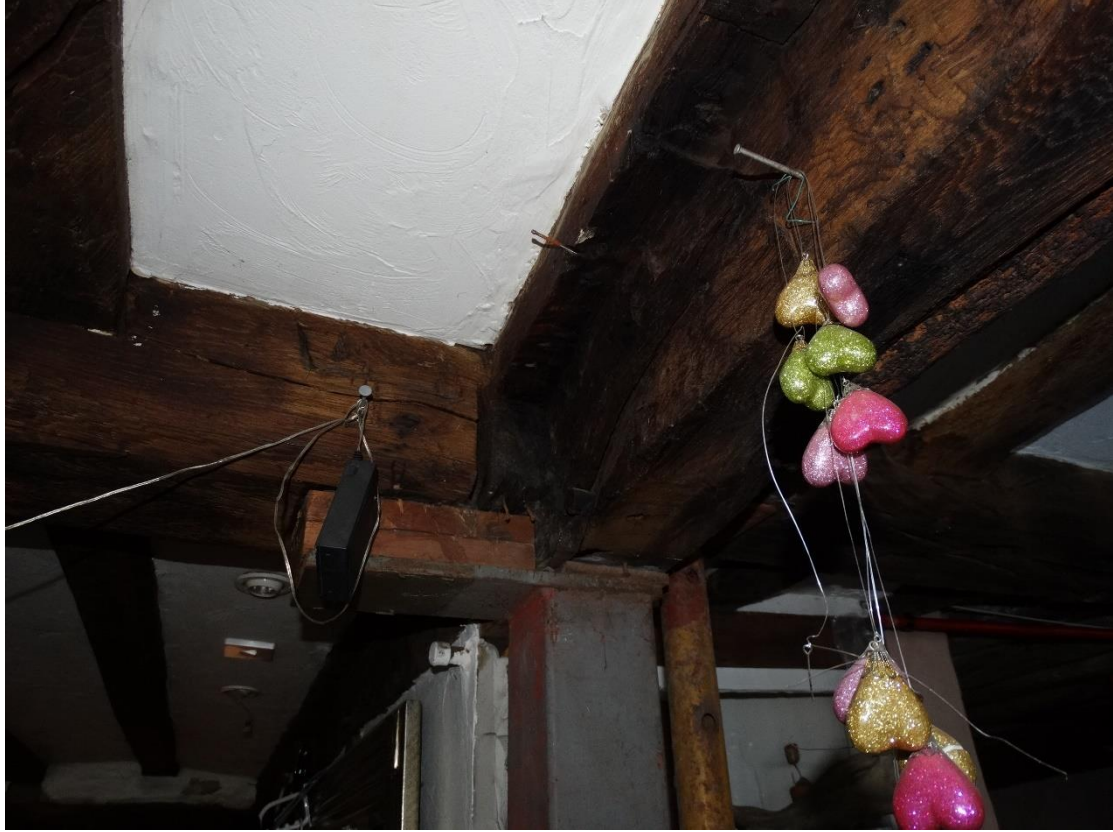
Another element that may suggest a more central open hall design is part of the structure for the continuous jetty along the frontage. The central girder beam axial on the ground floor in Bay 3 is not mortised. It looks to be recessed into the upper face of the lateral high end lower tie.

Whilst the stopping and chamfering and also the joist dimensions are broadly consistent between the areas, this method of mounting the axial beam is more usually seen with the insertion of a floor and Bay 3 is the only bay in which evidence of soot blackening has been located within the upper parts (upper rear wall plate below).

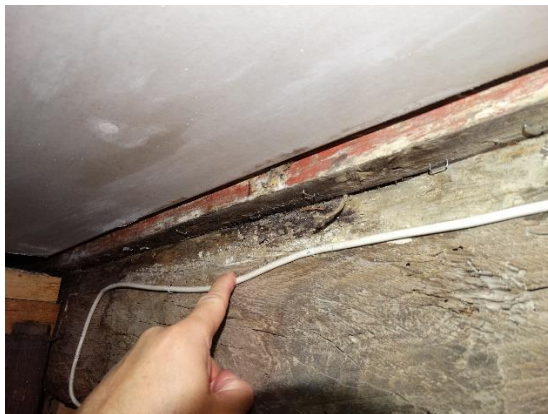
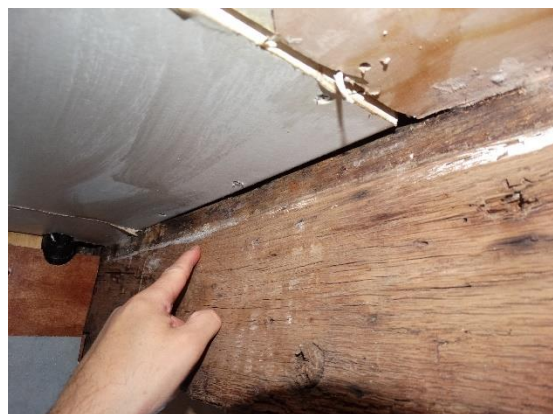
This soot crystalline residue is the only evidence that there has been an open hall element within the building, and it is fragmentary at best. The lower parts of the wall plate and so many other areas being systematically cleaned by previous owners. This sooting was saved by virtue of a ceiling line that was once in place against the wall

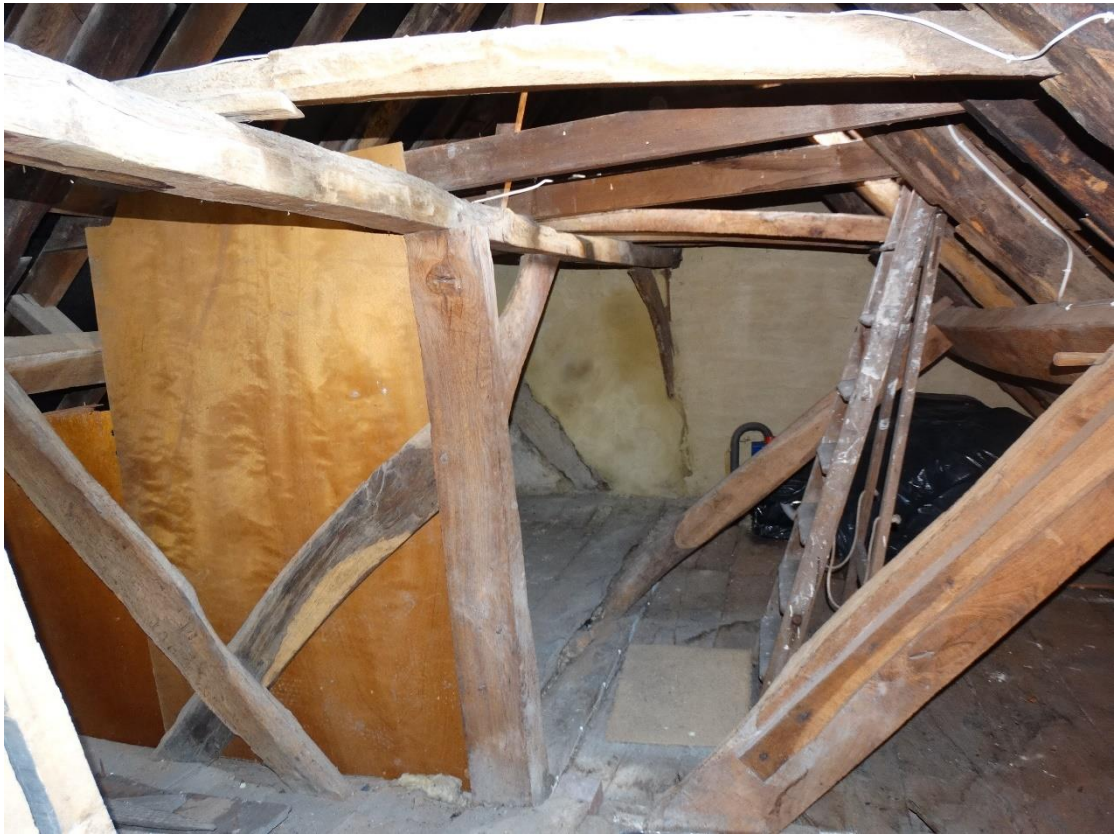
The main roof is presently a crown post design, but with rather evident side purlins supported from raking queen struts which belong to a later phase and are discussed below.

Rafters are conspicuously older in date than the crown post frame itself, some being soot blackened, and show no particular numerical order, nor is the positioning of collar notches consistent. Indeed, the rafter frame has undergone further post 1750s alteration to insert ridge boards in places (Phase 4). Therefore, the roof can be said to represent a number of phases of development.

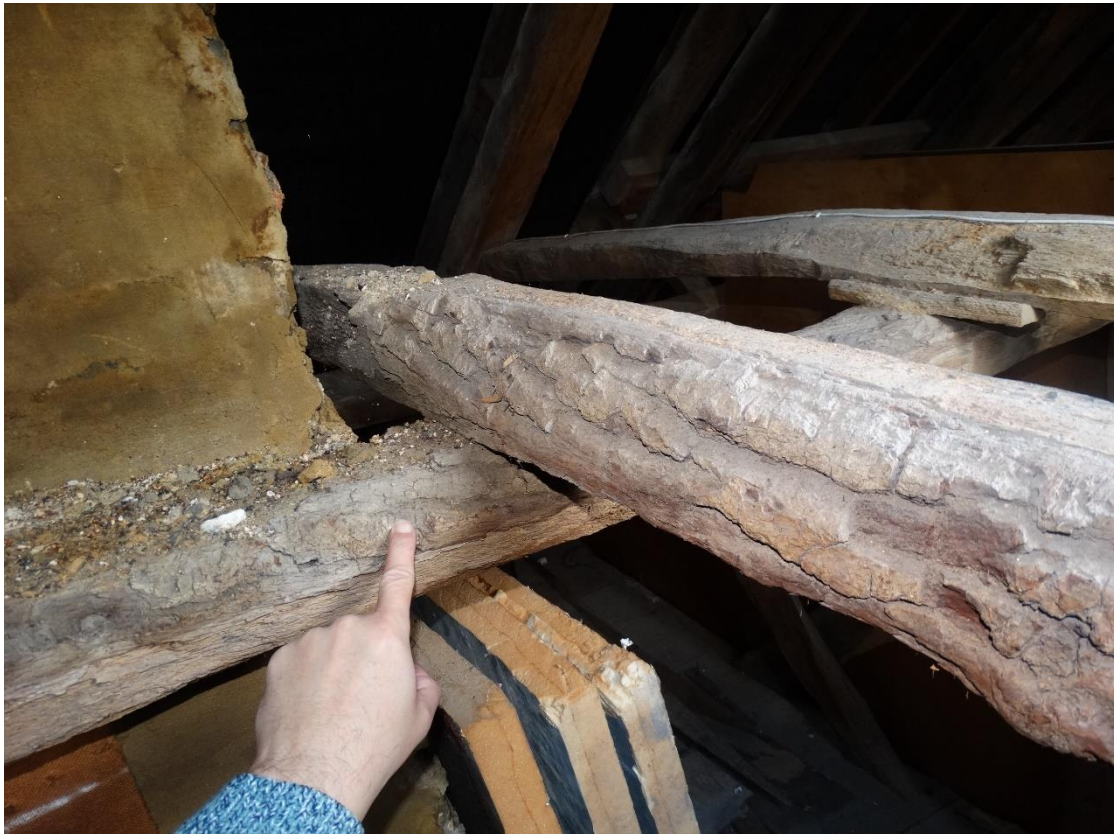
The timber used is also very poor quality when compared to the older, in situ elements of the main building frame. The various elements of the present crown post roof consist of immature oak, with excessive amounts of sap wood and bark evident.

The crown struts are undecorated and very sparsely braced. Indeed, bracing was only installed to one side of most struts, and this goes for both up and down bracing. What is interesting, is that the central down bracing is facing west, wrapping around the main stack, with corresponding up bracing, whereas within the other bays either side, the bracing extends in the opposite direction.

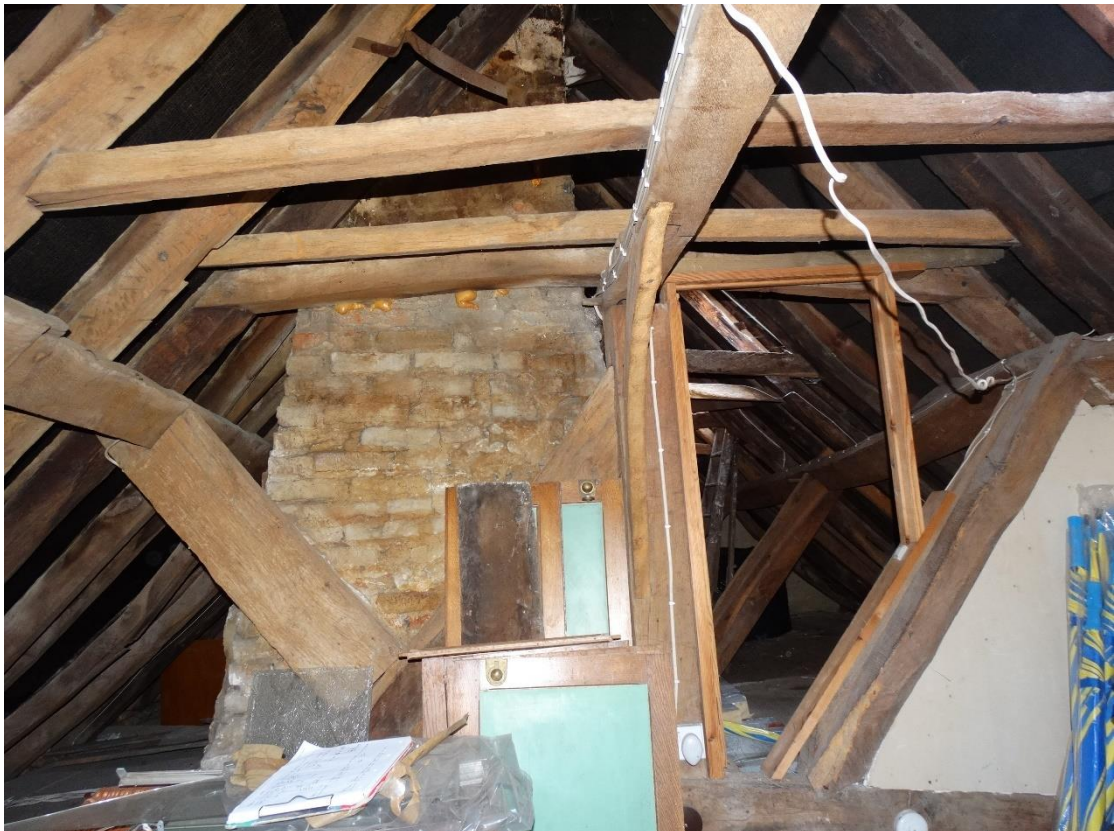
The position of the crown purlin is also not quite centred and is just a little offset around the stack.

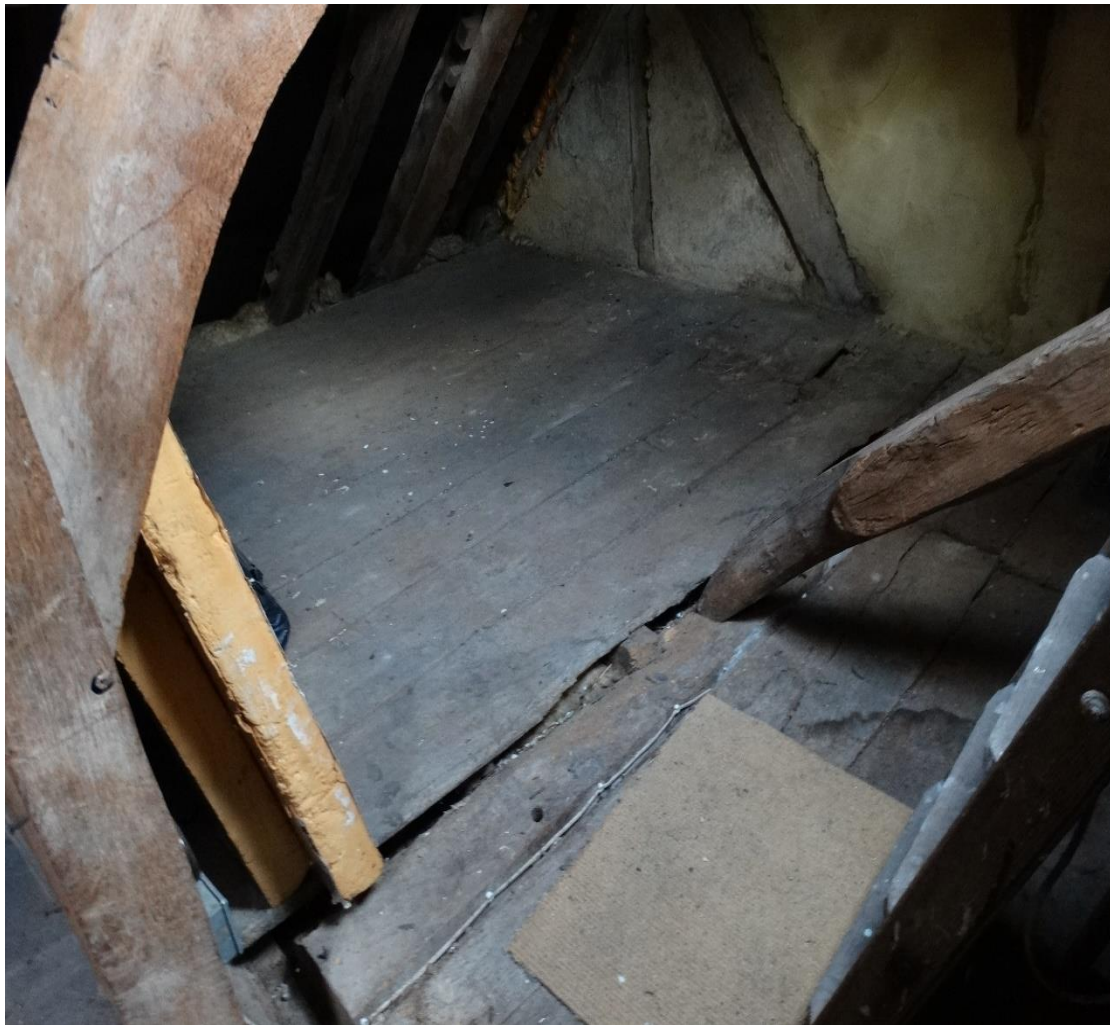
The area still retains a considerable amount of the wide plank flooring from the 17<sup>th</sup> century.

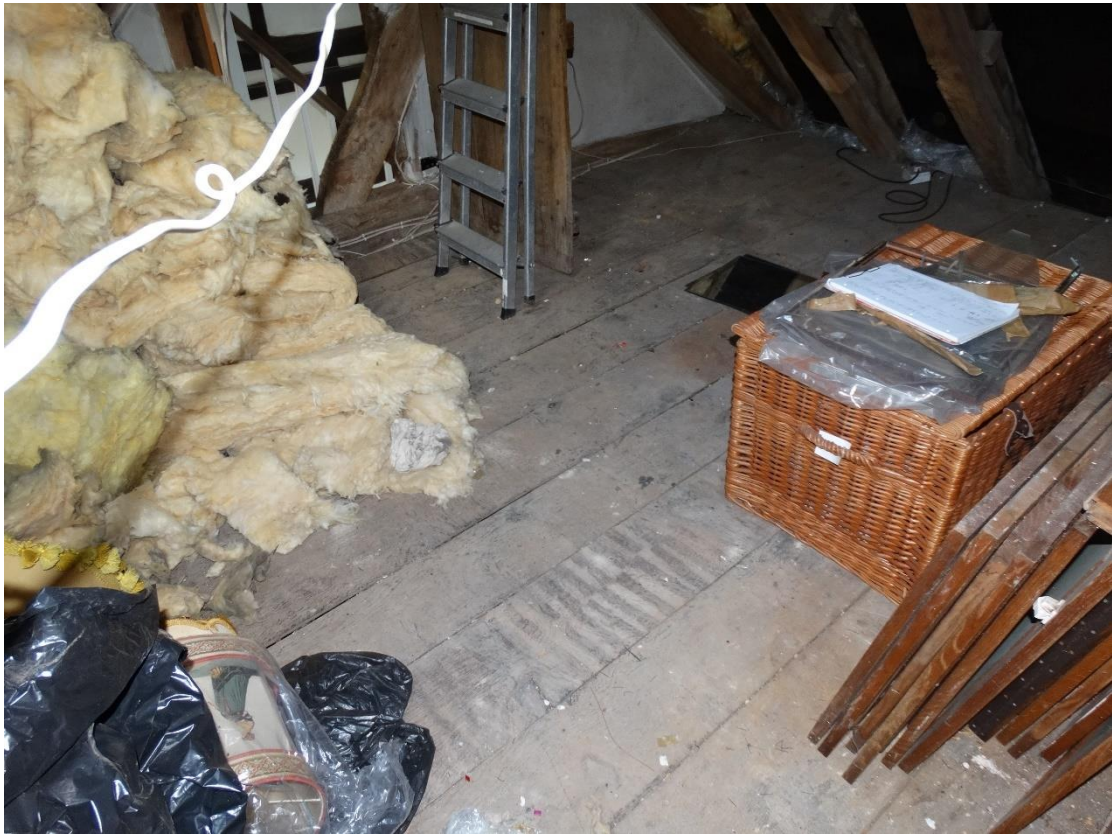
However, the area in the image below has been raised and reinstated to allow for strengthening work some years ago.

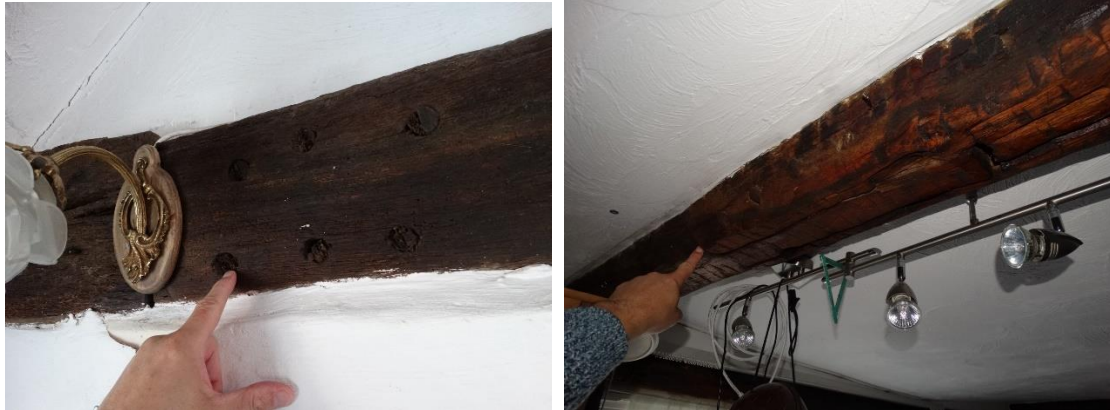
At some point, lateral ties across the building were altered and two look to have been replaced, with their bearing ends spliced with scarf jointed connections. The reasons for doing so are obscure and may relate to structural necessity through damage, or a change of design. Nonetheless, this was still early in the building's history.

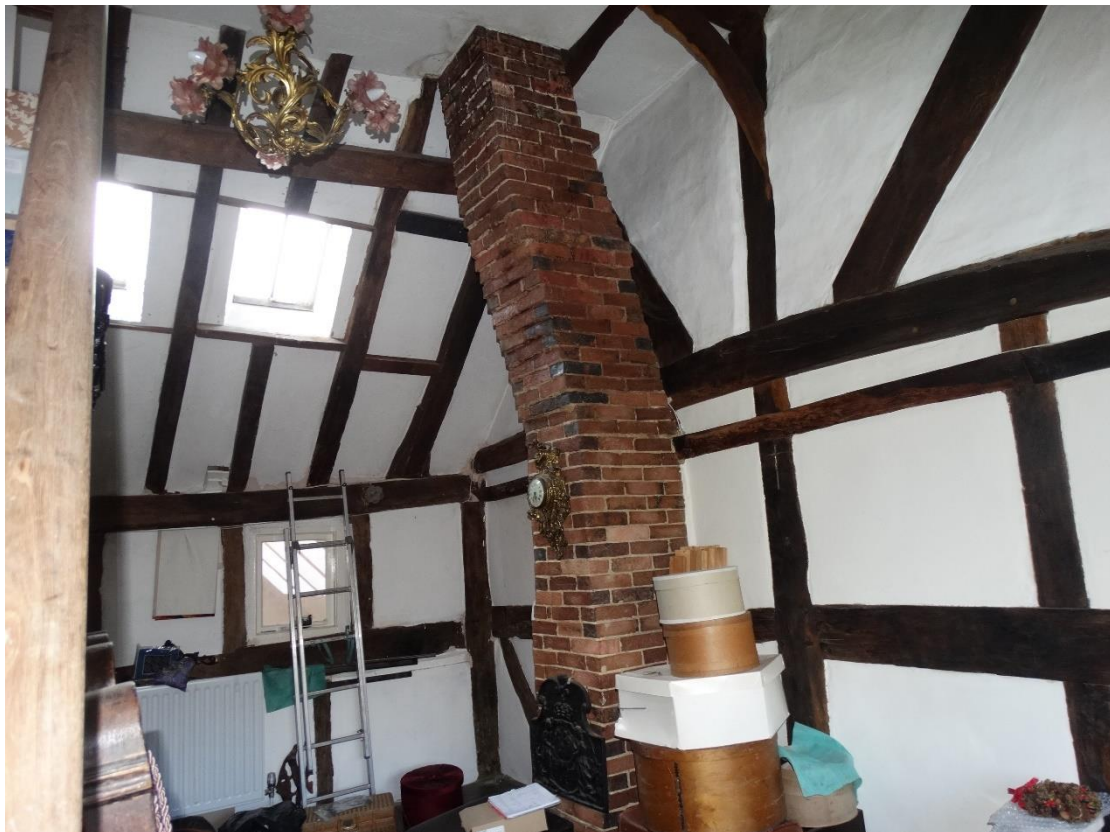
Other alteration comes in the form of the floor being removed from bay 4 to create a room open to the rafters (thereby actually returning of the room to an earlier arrangement). The floor support corbels nailed to the older frame are still in situ.

It is not known when this was carried out. However, this is presumably well after the early 19<sup>th</sup> century brick stack was inserted through the space.

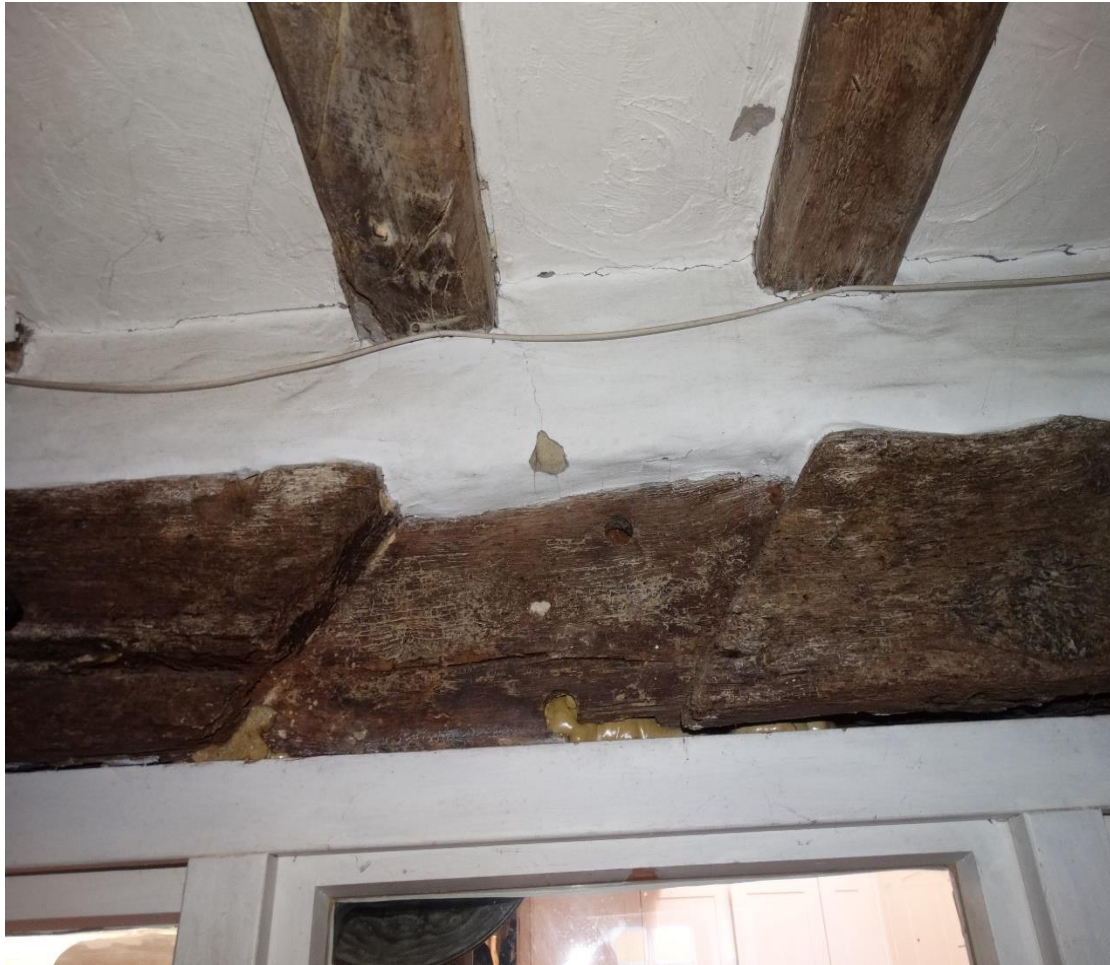
There is fragmentary evidence of a possible internal passing brace at the rear of the house, which would indicate relatively early origins for the lower frame elements, but the fragmentary nature cannot open up any definitive conclusions.

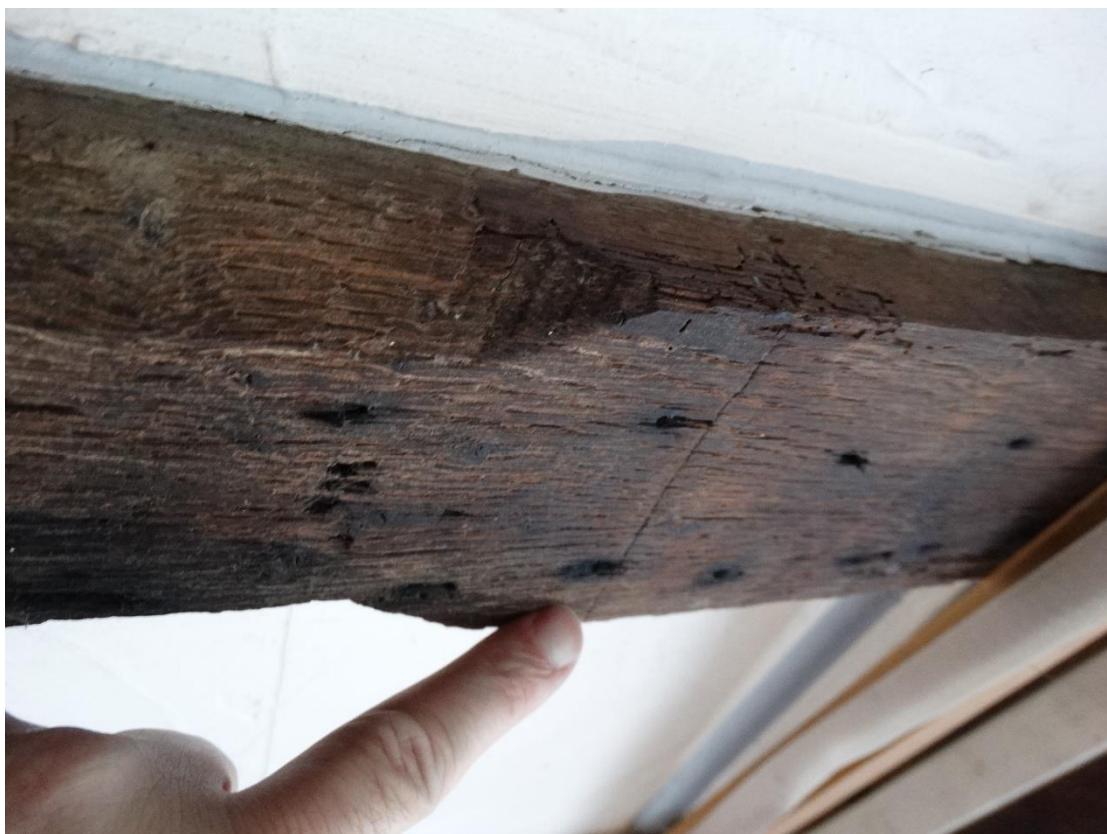
During the earlier 19<sup>th</sup> century, the building saw the removal of the frontage jetty plate. The joists suggest that the building was continuously jettied at the front and even with some reservation about some joists, the evidence suggests that the property is unlikely to have been of a Wealden type due to this continuous jetty arrangement. It does not appear to have been retrofitted later as part of the flooring of a full open hall, but evidence of this may be located once more of the structure as exposed on the first floor. Notwithstanding this, the position of the plate is clearly scored on the underside of the joists and the stops are positioned with a continuous jetty plate in mind.

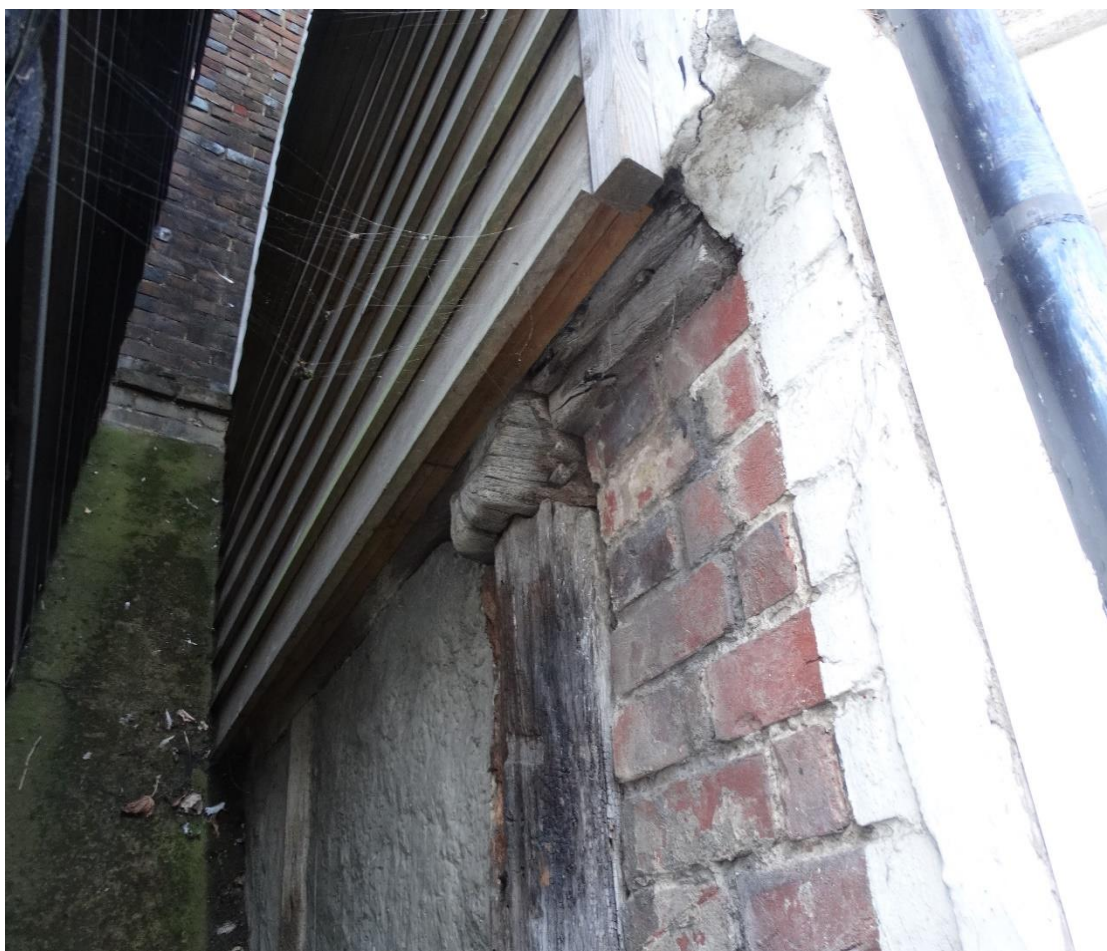
External evidence of jetty also remains in a fragmentary manner.

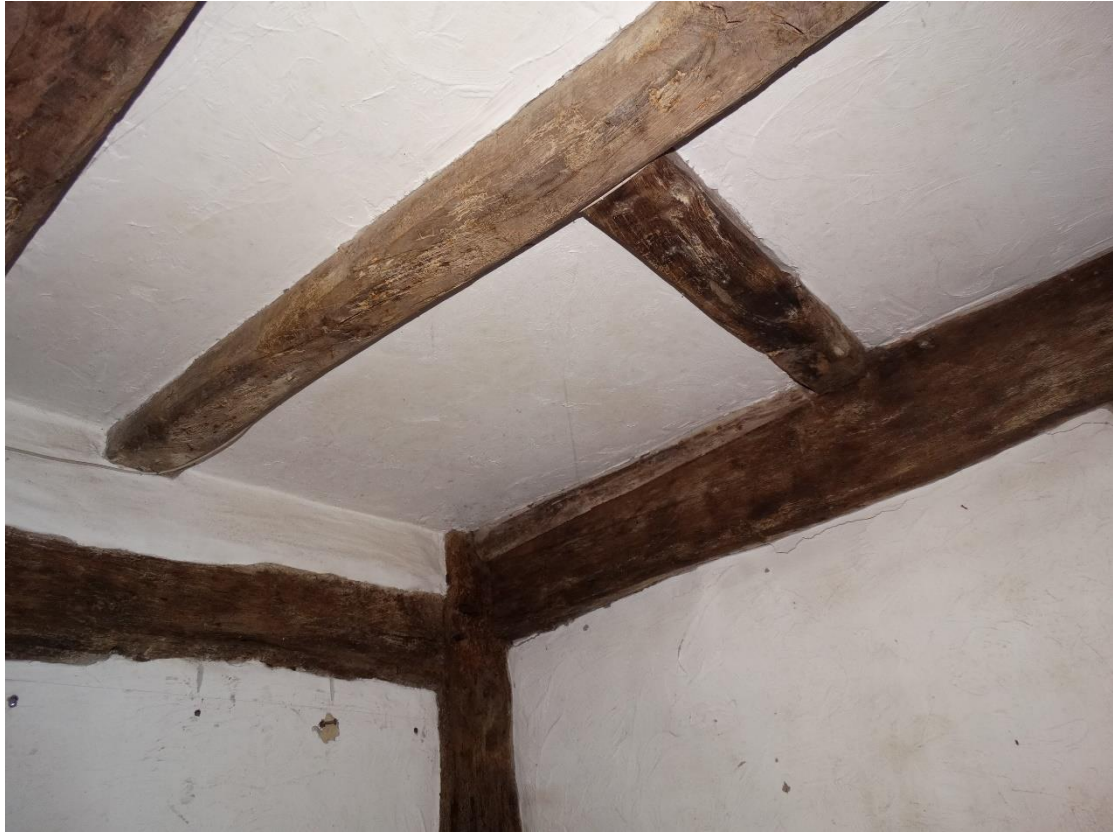
Within the north bay, however, there is corner trimming for a ladder stair hole in the northwest corner and this is considered to be original.

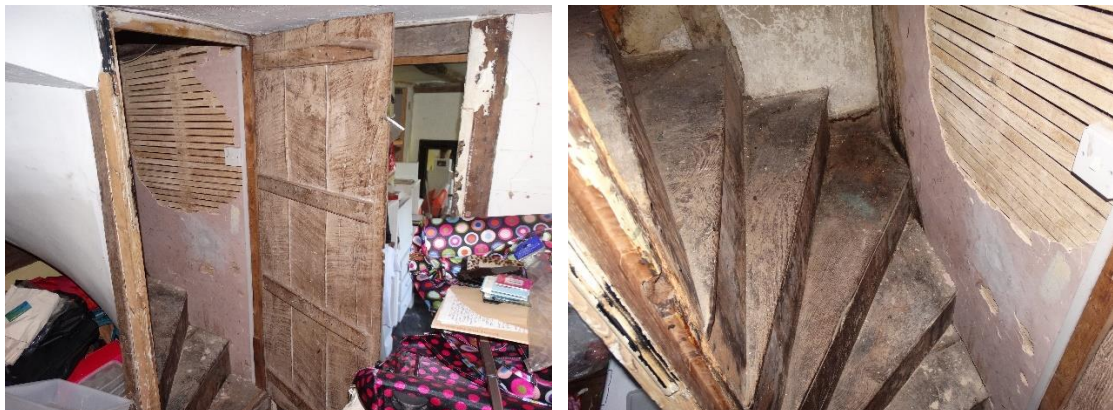
Later phases of stair have been added. The 17<sup>th</sup> century winding stair to the loft rooms are partially complete. The upper part from the landing to the second floor as shown in the images below is complete and shows no serious loss of material apart from wall plaster to the enclosure.

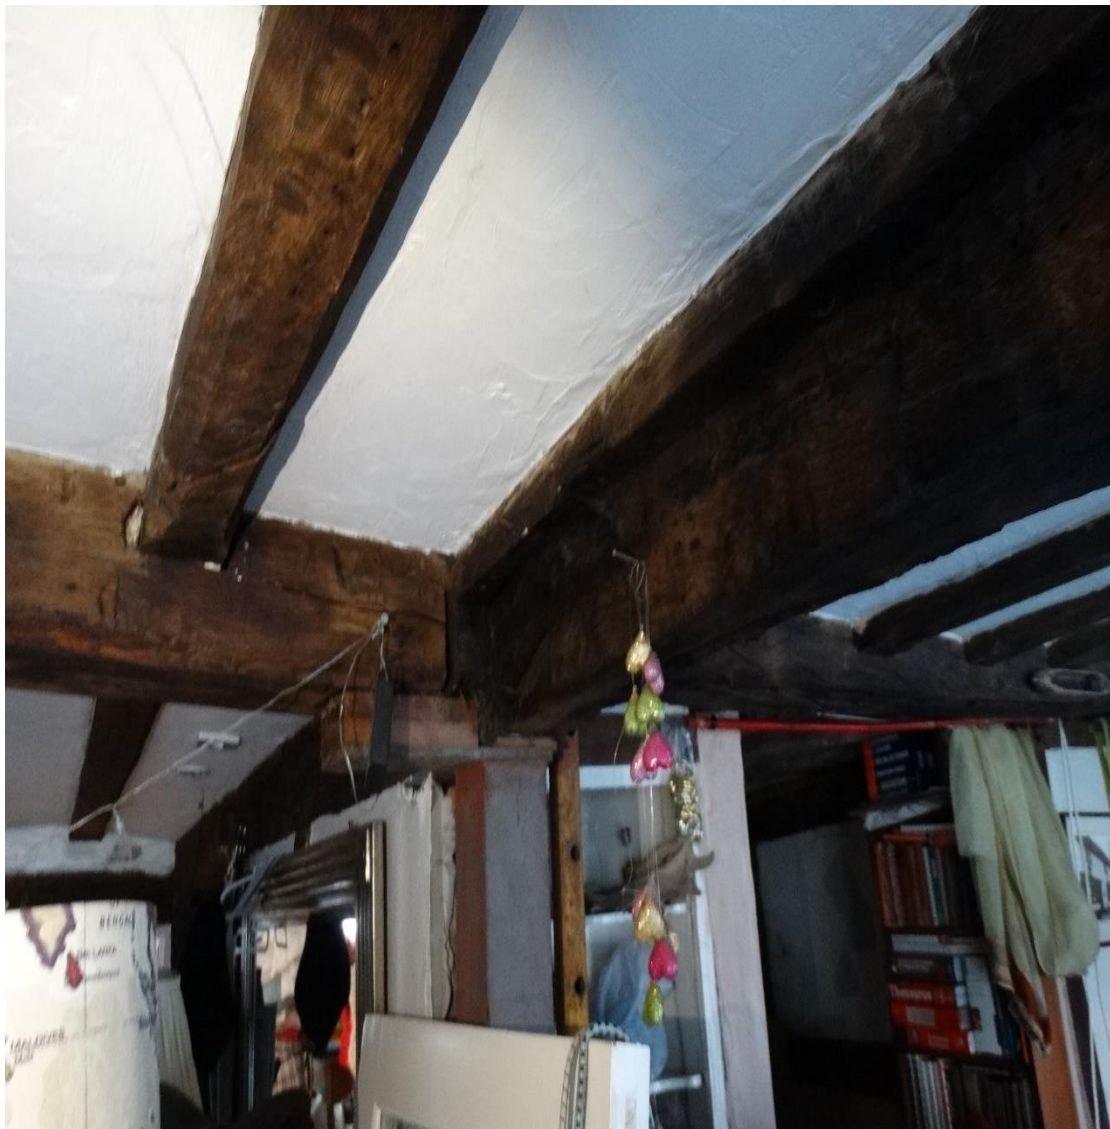
The ground floor central room has had much of the original timber lateral partitioning removed at some time in the past. Whilst there is some central support in masonry, the joint where the axial first floor support beam crossed the tie is weak and has had to be propped with modern steelwork.

However, the underside of the tie does reveal the design of the partition in this instance, and the doorway at the end into the snug area looks to be in its original position.

It is noted that the central living area lateral partition wall appears somewhat thin and the present masonry wall in this position looks to have been superseded by this wall (which may seek to reinstate something of the former timber infill wall) which would have originally been in this position. What is not clear is the means of support for the structures above, as the present timber framing tie in this area is structurally supported by a modern steel prop.

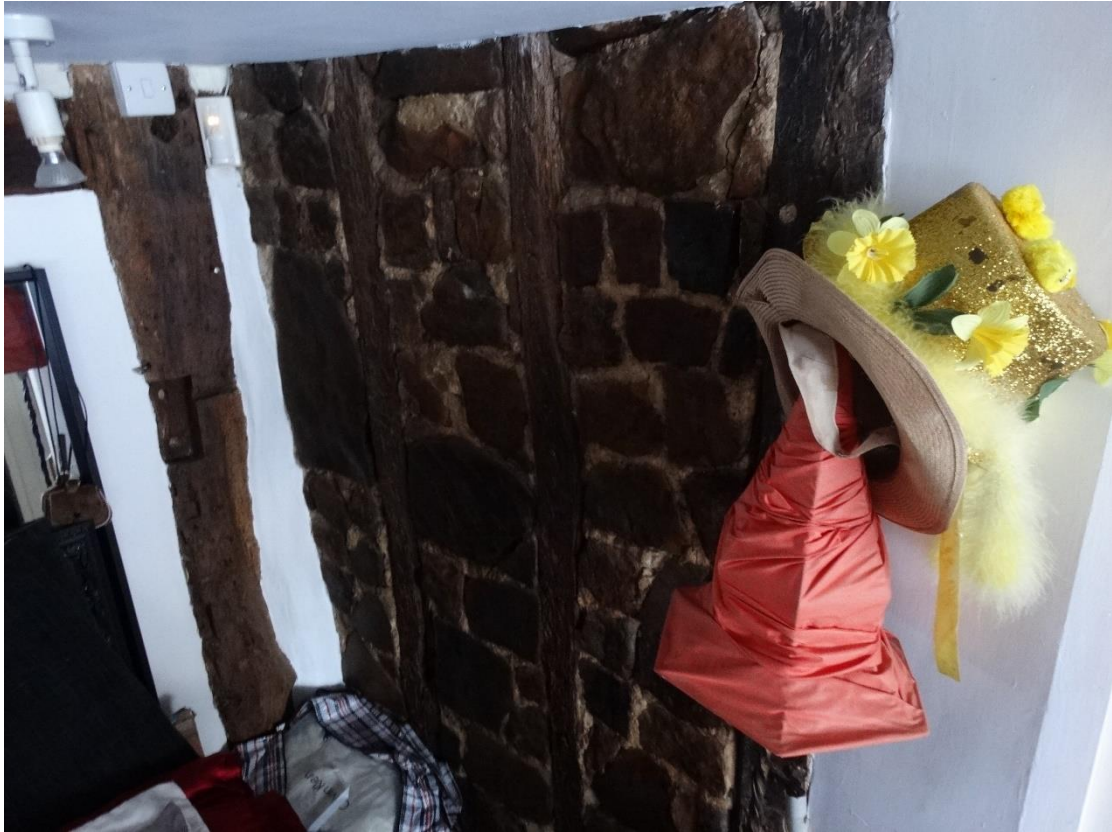
One dining room wall has been left exposed as a feature wall.

The studs are out of alignment with the main bay post of the lower end of the house and the wall looks to be a later infill at the end of the cross passage. The stone infilling and general design of the wall may coincide with the creation of the later cellar entrance adjacent to it in the hallway. The door positions to the lower end services are not visible and it may have been constructed to re-face the end of the passage and close off one of the service door positions. Being Sussex, it would be more common to see service end doors towards the outer bay positions rather than centrally placed, like is found the further east you go towards Kent.

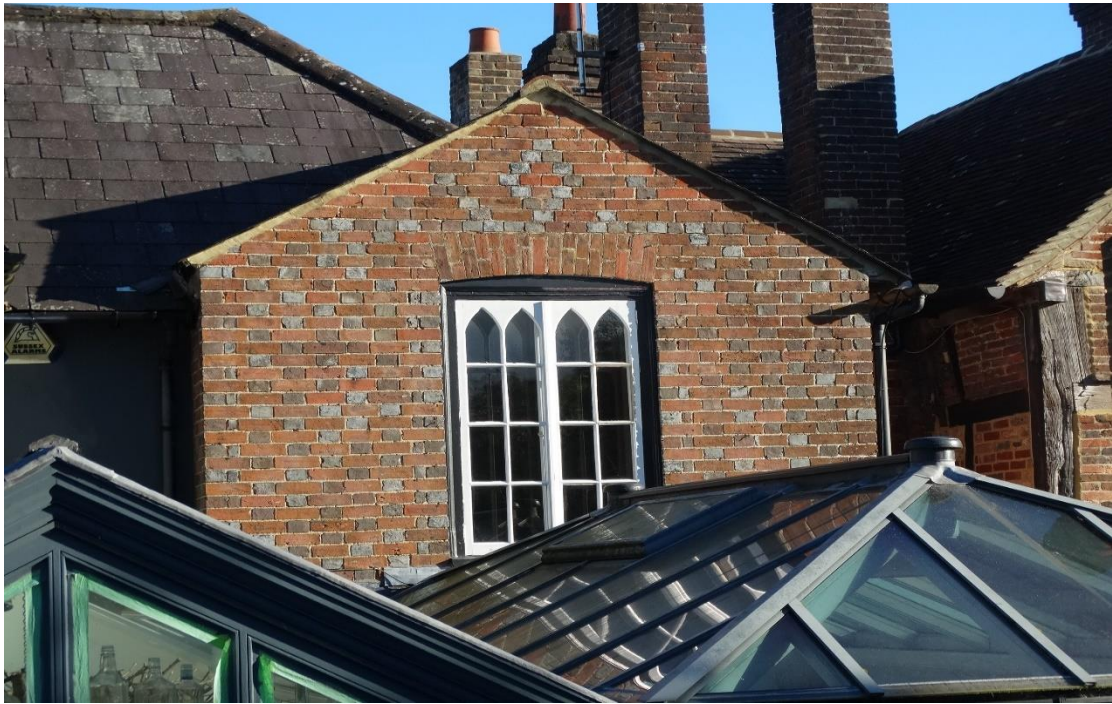
The rear projecting two storey extension was added circa 1830

It is fabricated in solid brick masonry in a Flemish bond, showing off blue glazed headers.

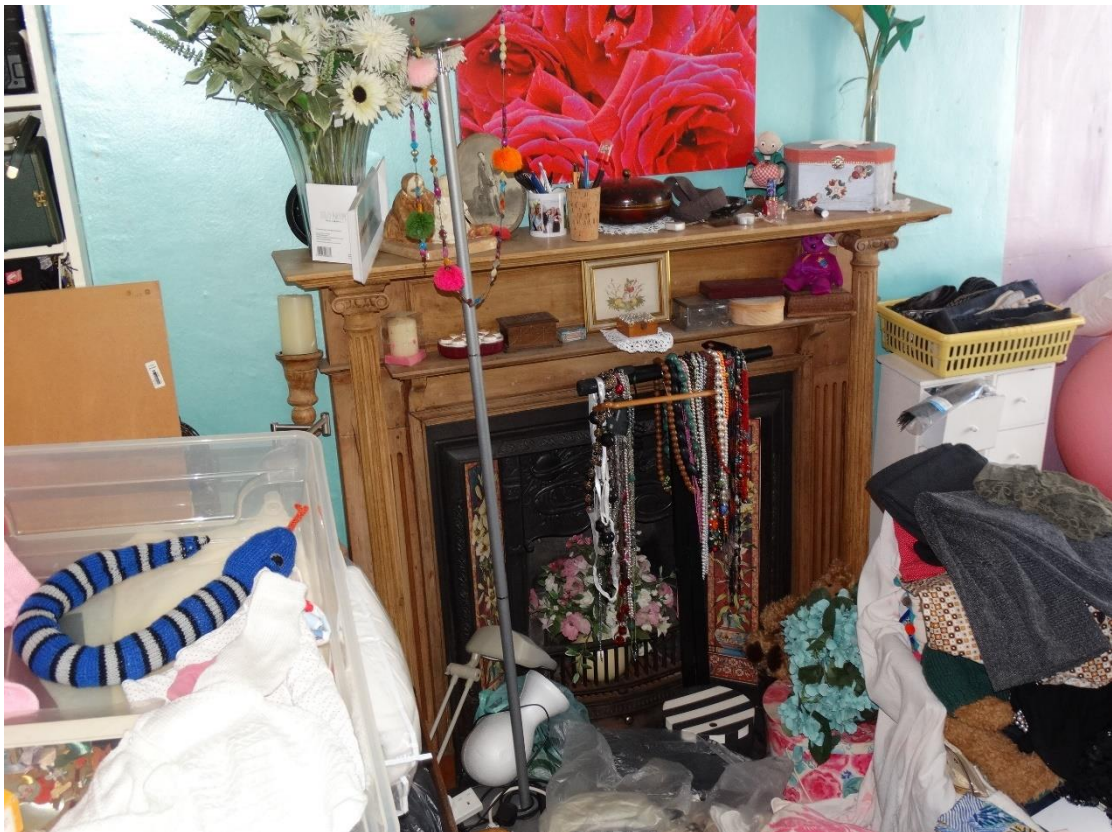
The fireplace within the first floor of this area is possibly early 20<sup>th</sup> century at the earliest. Closer access would confirm if a reproduction.

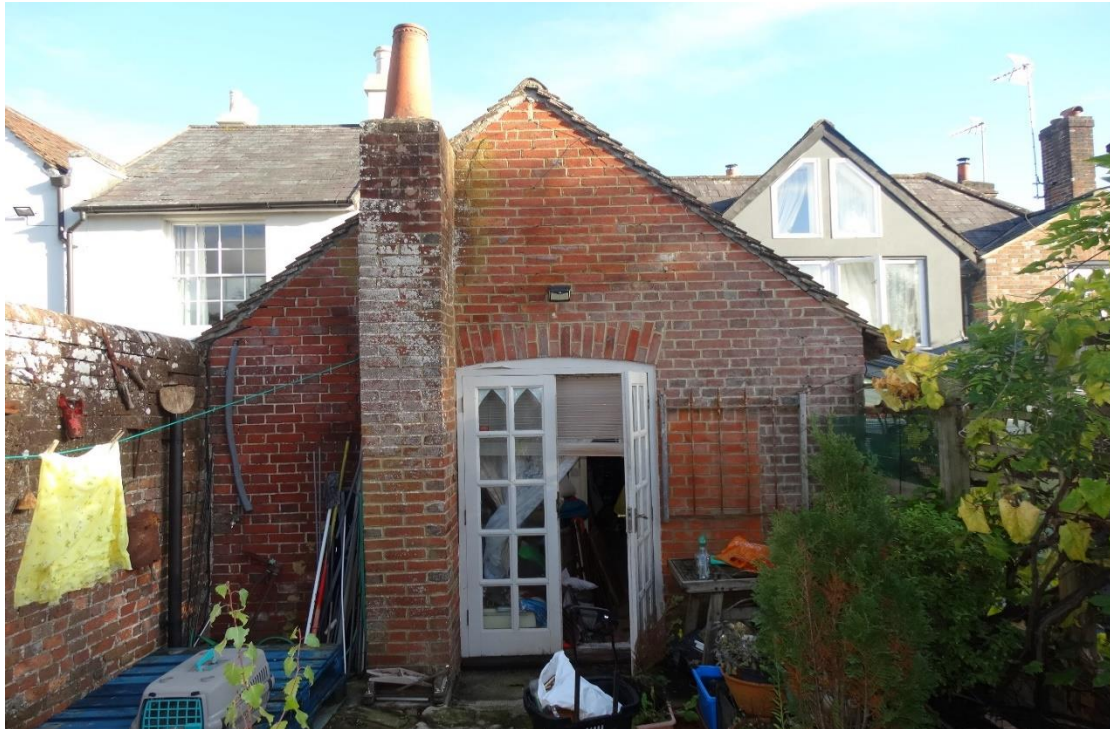
A bakehouse was also added to the rear, of which only the outer walls now remain in situ. No internal features remain, and the interior linings and fixtures are wholly modern.

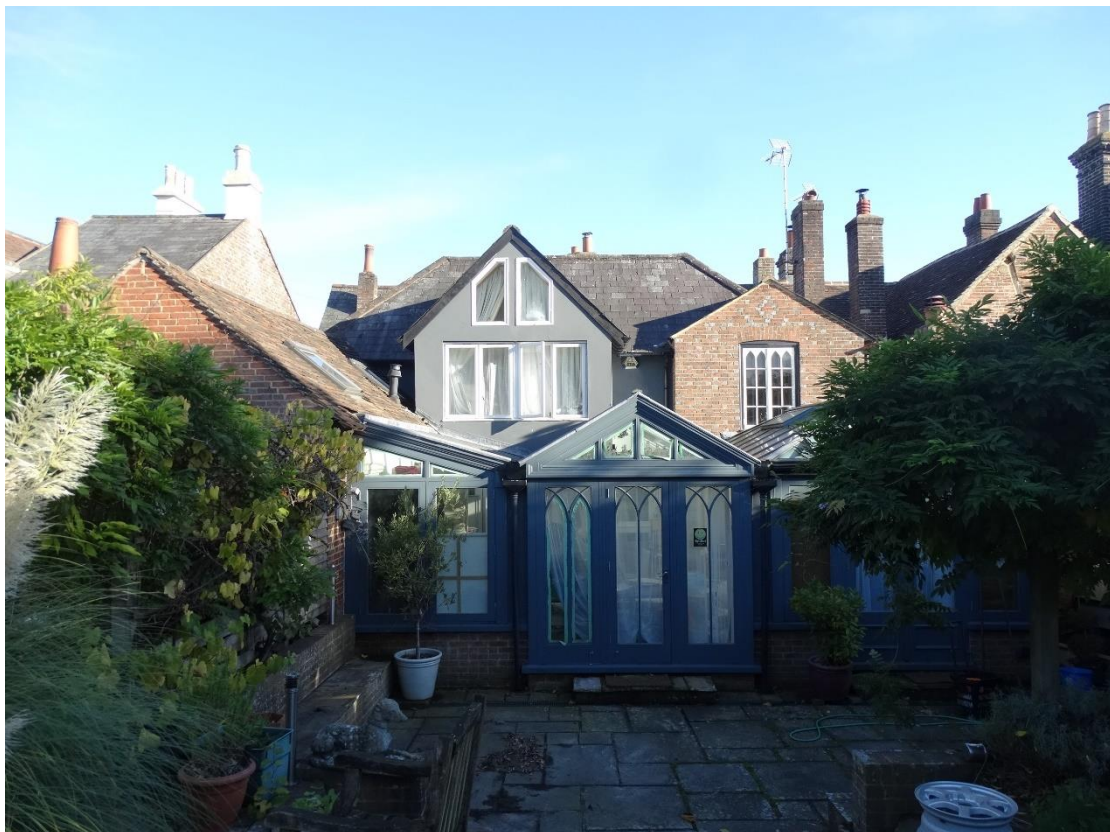
Rear fenestration is also modern in this part of the building. A substantial modern extension was added in the 2000s, comprising a rear projecting glazed cross wing and a substantial conservatory room crossing the majority of the rear of the building.

The modern extension cuts into the roofline of the older building but has been essentially built off from the roofing elements and has not evidently caused any loss of material.

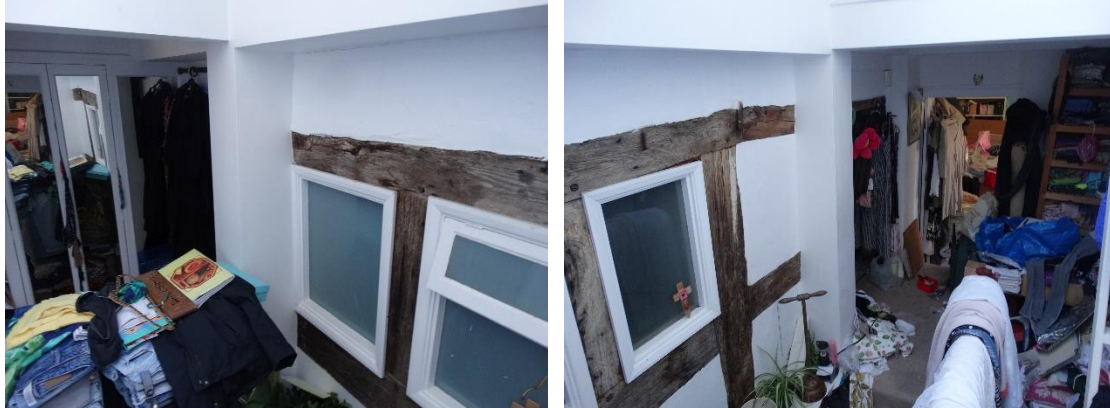
The structure of the extension is also entirely structurally separate from the older building, with the foundations allegedly partially piled and the structure built from a rigid steel frame positioned up against the back wall of the main house.

These boxed frame elements are to be seen clad within the upper landing. The modern extension could, therefore, in theory be removed without risk of material loss or damage to the existing building.
