# Land South of Floran Farm

## Existing Drainage Infrastructure Clarification Note

Planning Application: DM/26/0843

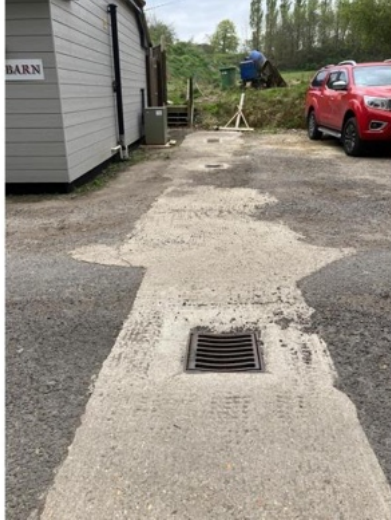
**Photo A1**  
**Upstream end of existing private drainage route / drainage infrastructure serving Floran Farm.**

Existing grated drainage inlet within the developed Floran Farm area. This provides photographic evidence of established drainage infrastructure serving the wider holding at the upstream end of the route shown on Drawing SK1000.

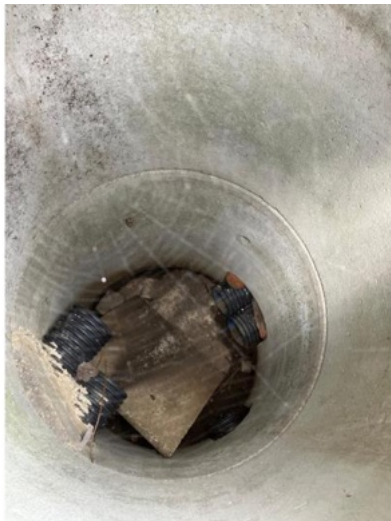
**Photo A2**  
**Existing piped drainage route at upstream end of the downstream corridor.**

View within an existing drainage chamber showing connected pipework. This records the physical below-ground drainage infrastructure forming part of the existing private drainage route.

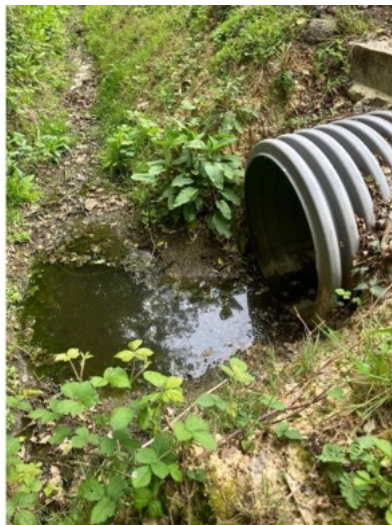
**Photo A3**  
**Downstream drainage infrastructure approaching the receiving watercourse.**

Existing large-diameter culverted drainage section close to the downstream end of the private drainage route. The photograph provides clear physical evidence of the established conveyance infrastructure approaching the receiving ordinary watercourse.

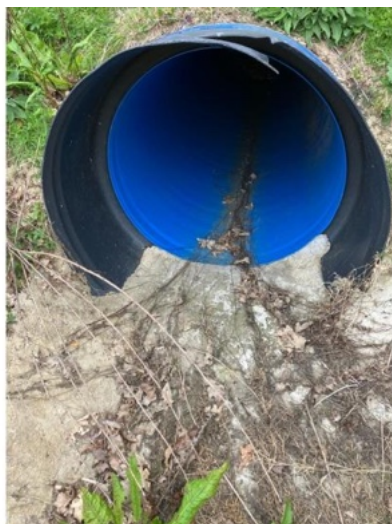
**Photo A4**  
**Existing private drainage infrastructure along downstream route.**

Existing large-diameter twinwall pipework within the downstream drainage corridor. This provides further evidence of the established private drainage infrastructure along the route identified on Drawing SK1000.

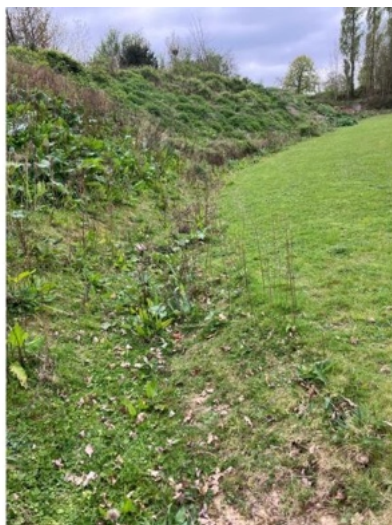
**Photo A5**  
**Existing private drainage route through the defined drainage corridor.**

Established linear open drainage feature within the defined downstream corridor. The feature is consistent with the route shown on Drawing SK1000 and the pronounced topographic drainage corridor identified by the LiDAR terrain data.

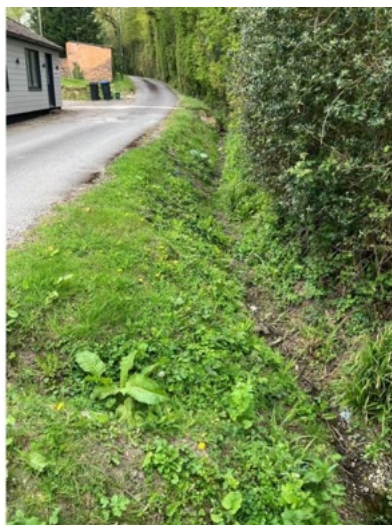
**Photo A6**  
**Existing private drainage system**  
**at/adjacent to connection with receiving**  
**ordinary watercourse.**

Established open drainage feature at the downstream end of the private drainage system, adjacent to its connection with the receiving ordinary watercourse. This photograph supports the identified transition from the private drainage route to the downstream open watercourse system.

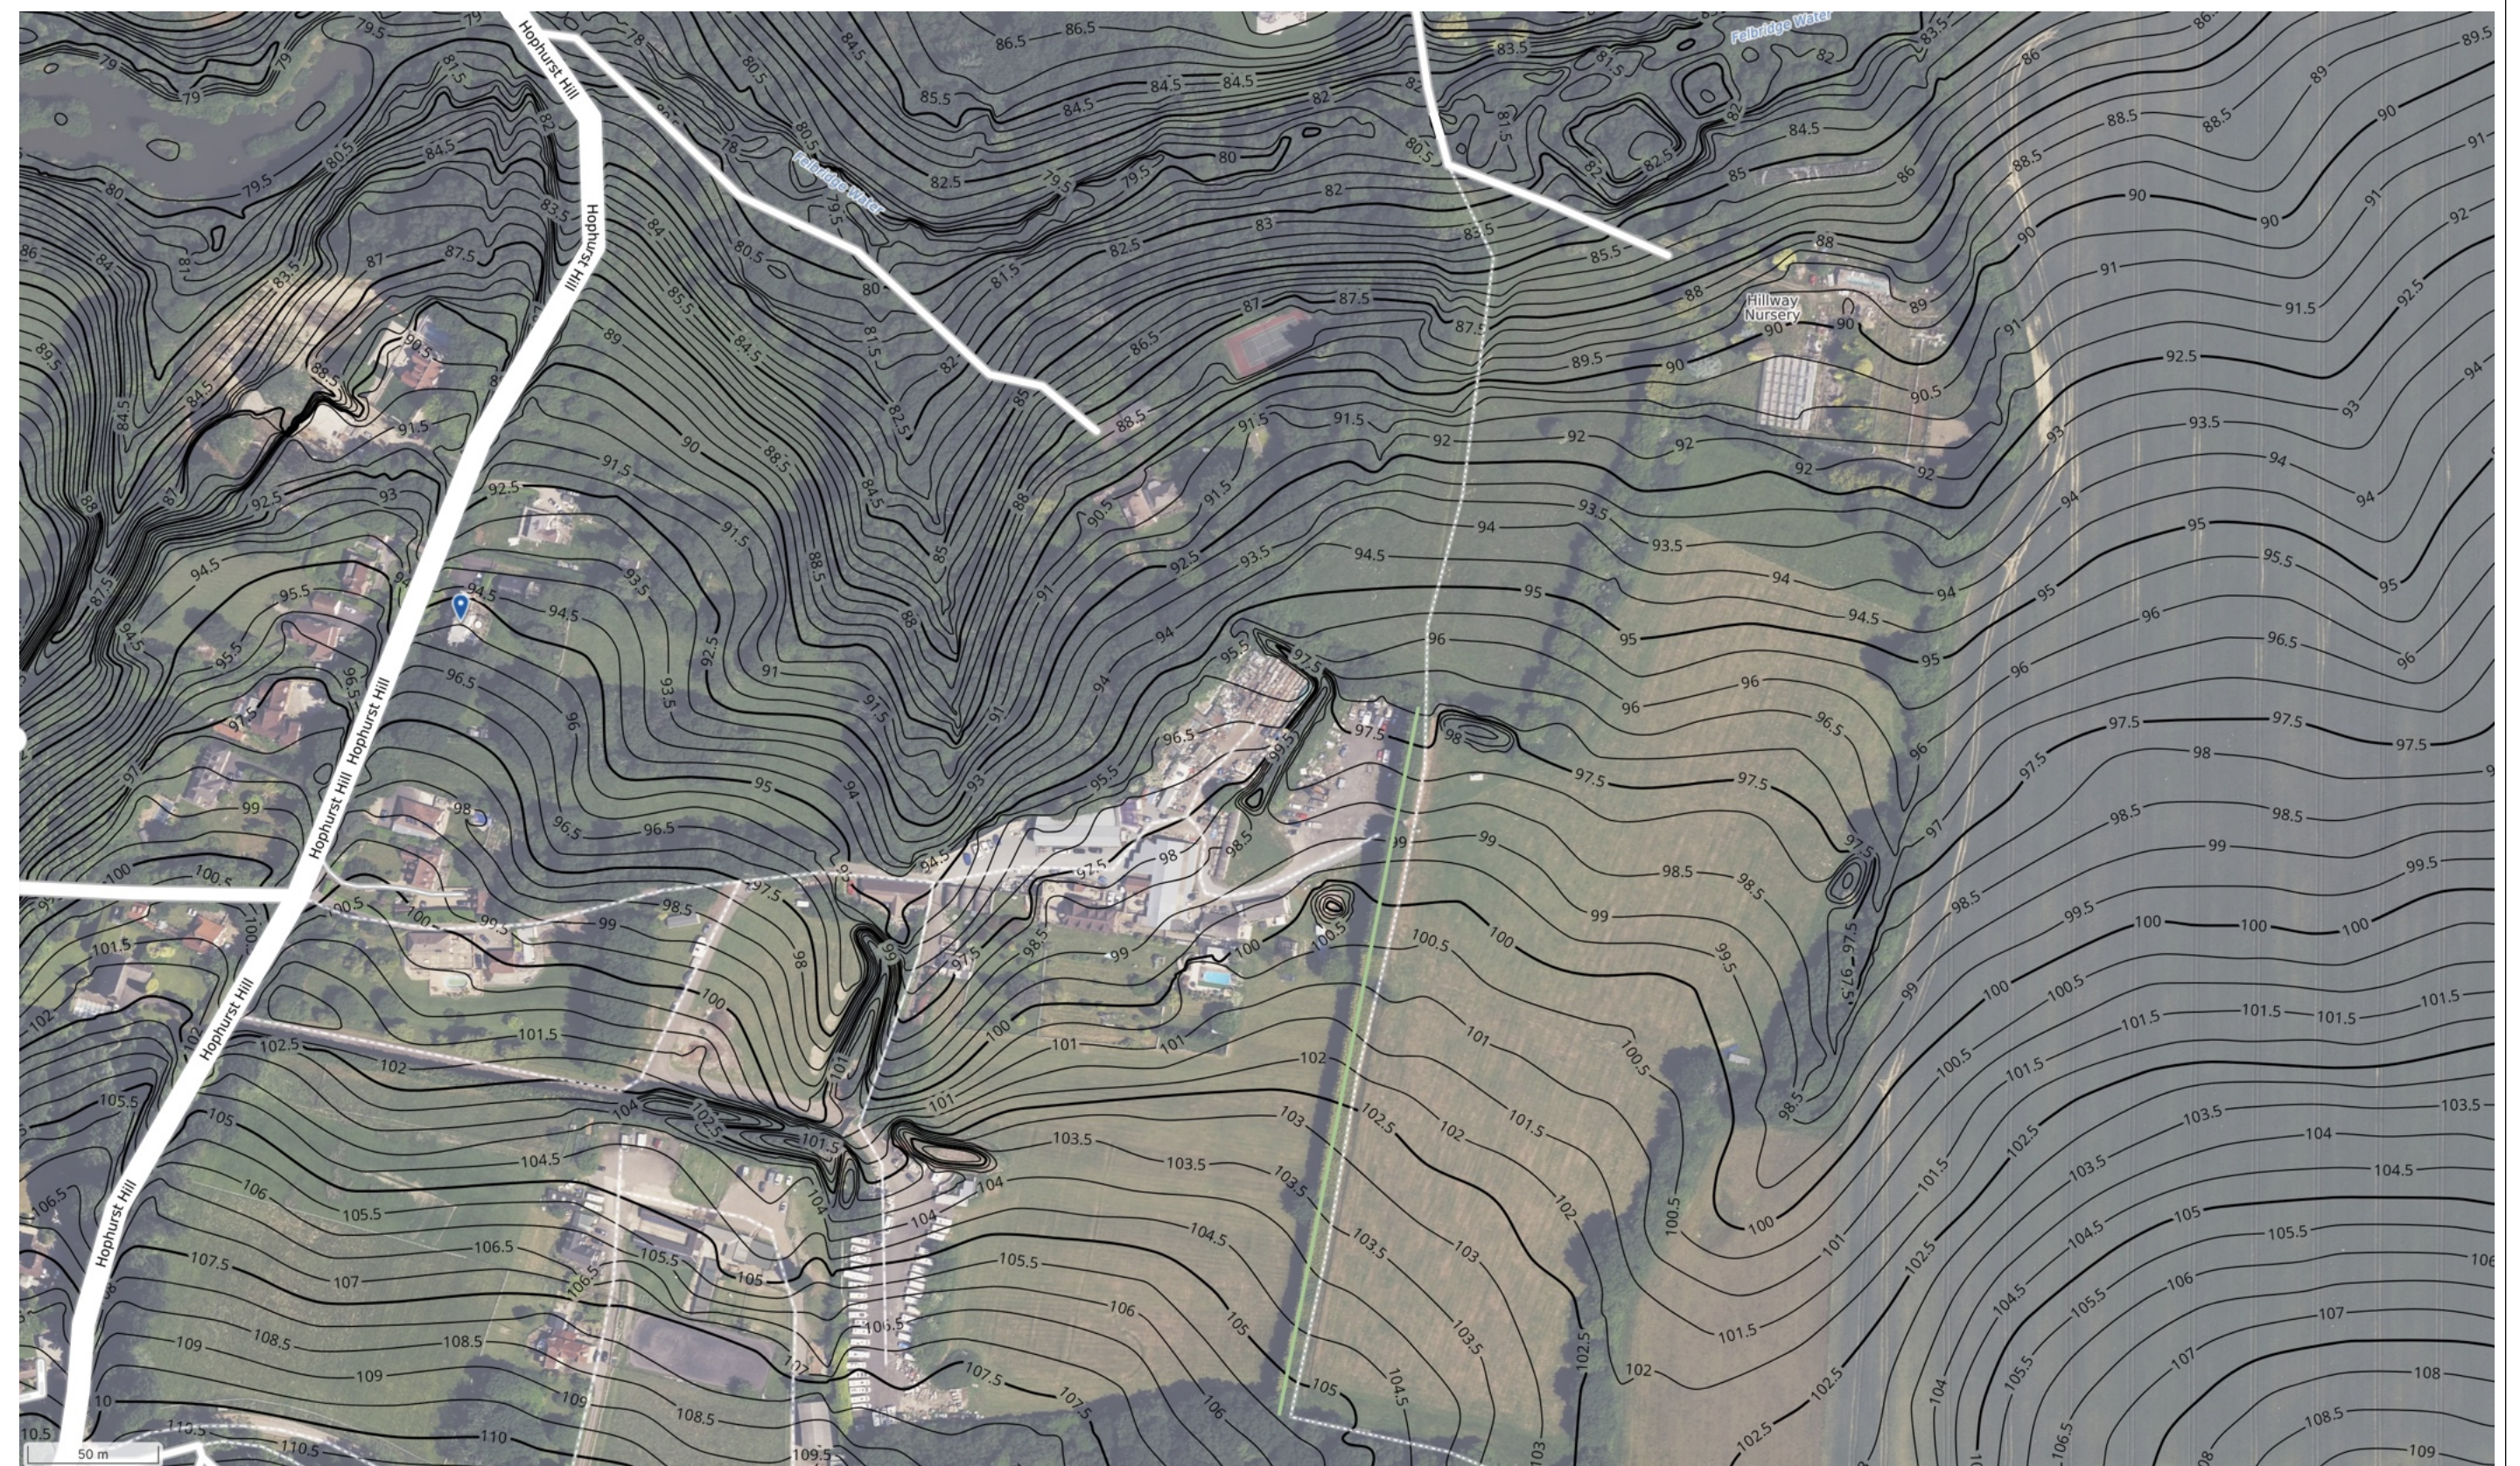
4.2 Drawing SK 1000 shows the receiving ordinary watercourse continuing downstream from the existing drainage connection towards Felbridge Water.

7.2 Drawing SK 1000 identifies the existing private drainage system serving the wider Floran Farm holding and its downstream route to the receiving ordinary watercourse. The route is supported by landowner information, photographic evidence, mapping and terrain information.
