## Ground Investigation Report

Proposed LED Floodlit Turf Pitches

Sackville School, East Grinstead

Document no.: STV6168-R01 Rev A

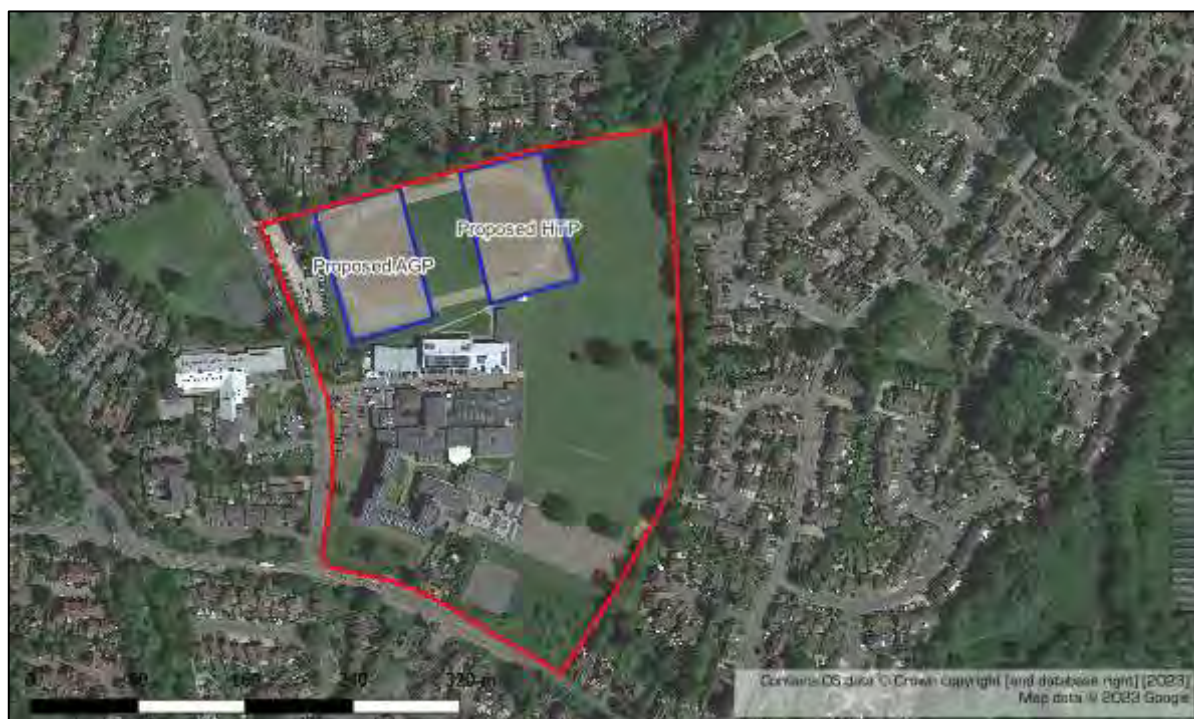
Figure 2-A: Aerial photograph of site boundary (red) and AGP/HTP footprint (blue)

2.2.1 An aerial image showing the approximate site boundary and approximate development footprint is presented below, followed by a table summarising the key site features and a series of site photographs. A site plan is provided within Appendix A.

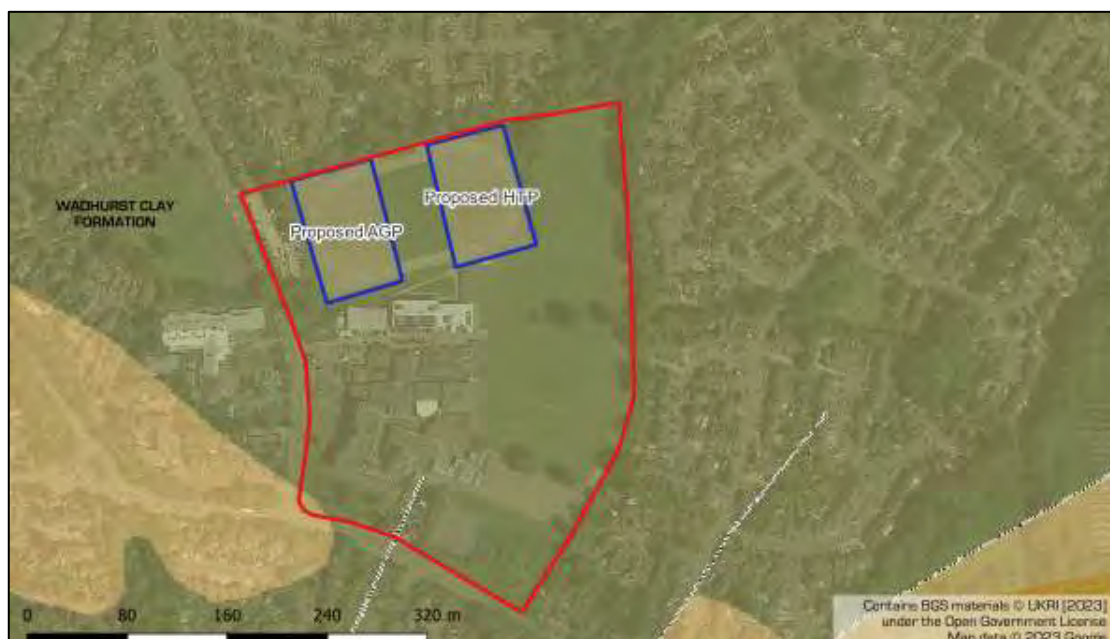
Figure 2-F: Bedrock geology

- 2.4.1 Based on a review of available records, the site is anticipated to be underlain by bedrock of the Wadhurst Clay Formation, with local boreholes suggesting weathered clay to approximately 3m before grading into mudstone. No superficial deposits are shown to be present in the area of the site.
- 2.4.2 In addition, due to the presence of suspected cutting slopes to the west and an embankment to the south (based on adjacent topography), it is likely some earthworks have been undertaken in order to form a level running track. Made Ground is therefore likely to be present on site, potentially deepening to the east (3-4m based on the topographical survey for the pitch areas).
- 2.4.3 Historical maps also record a pond and at least one stream crossing the site and therefore localised Alluvium is also anticipated.

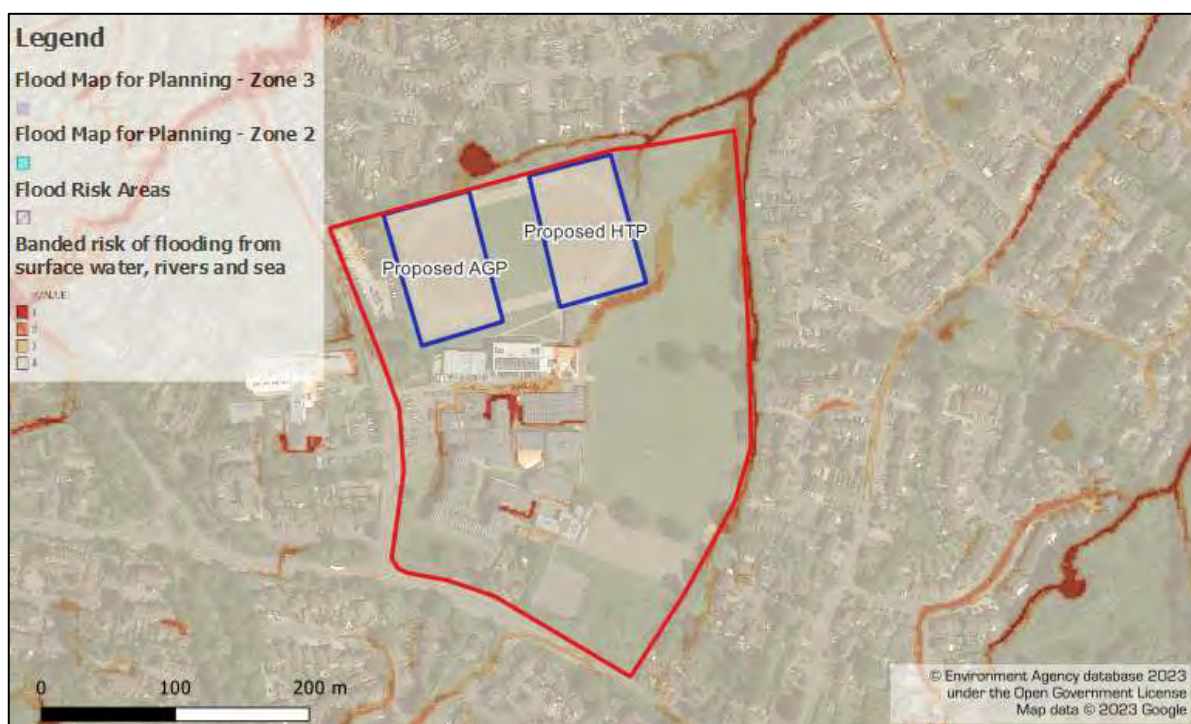
Figure 2-G: Extract of EA flood risk mapping for the site

- 2.5.1 The site falls within a Flood Zone 1 area. This designation indicates there is less than a 0.1% chance of flooding from rivers or the sea in any year.
- 2.5.2 There are areas at risk of flooding from surface waters within the site, predominantly along the northern and eastern boundaries and a linear area extending from the northeastern corner into the main school complex. None of these areas are within the locations of the proposed pitches.
- 2.5.3 It should be noted that this information does not constitute a site-specific Flood Risk Assessment and one may be required for the scheme.

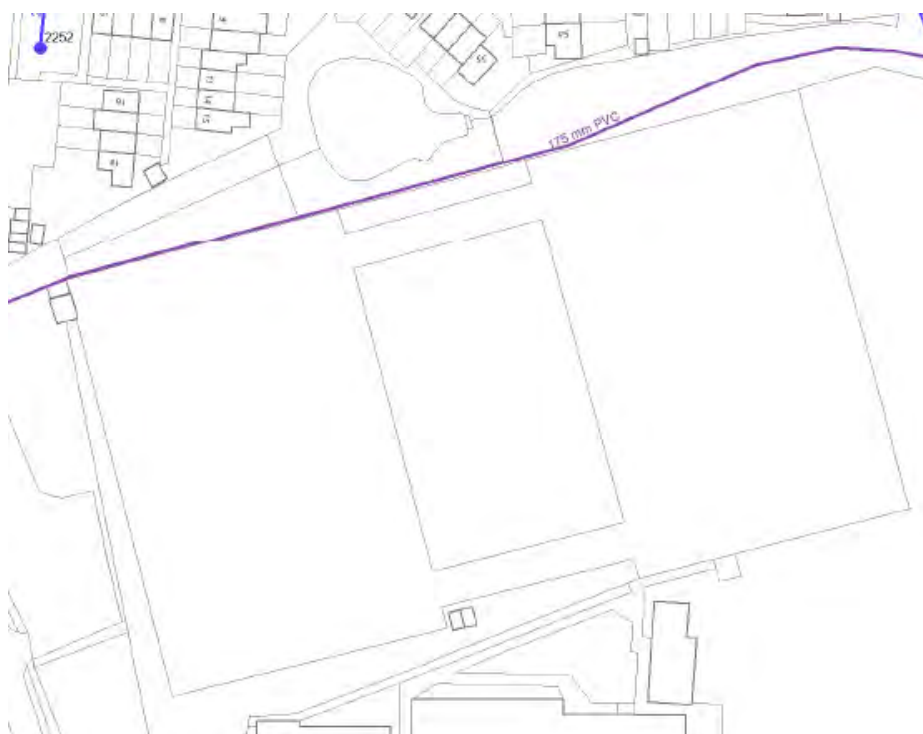
*Figure 2-H: Extract of Southern Water service plan showing rising main (purple line).*

- 2.8.1 Copies of all utility plans obtained are presented as Appendix G. The plans are provided for information only and should not be relied upon to be accurate. In addition, it is worth noting that the public utility plans provided by the asset owners typically exclude private service runs.
- 2.8.2 The plans do not show any mains services to cross the site, although a rising main is present adjacent to the northern boundary of the running track, as shown in the extract below.

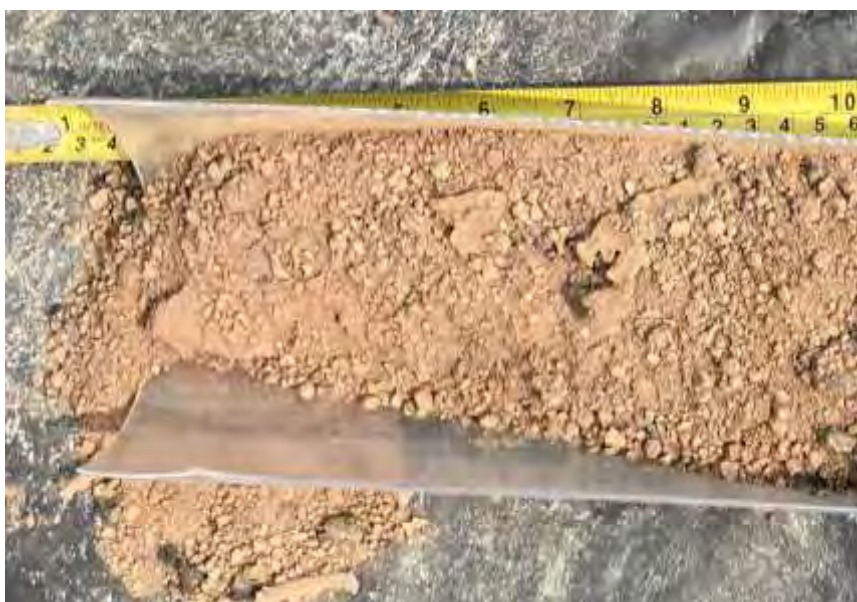
Figure 5-A: Redgra Surfacing encountered in WS01

- 5.2.1 Surfacing across the running track was encountered to depths between 0.05m and 0.20m in thickness and comprised very soft, reddish brown, very gravelly, clay. Gravel consisted of limestone.
- 5.2.2 A photograph of the typical surfacing encountered is presented below.

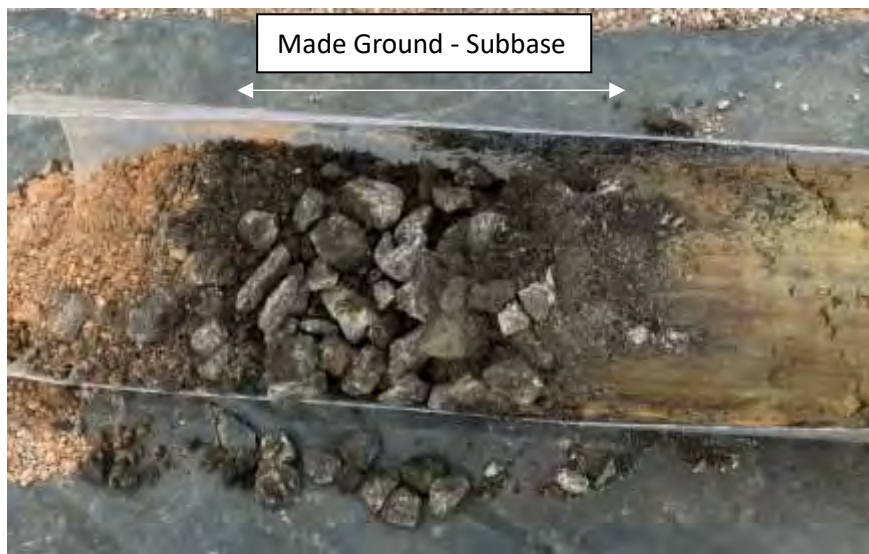
Figure 5-B: Made Ground – Subbase encountered in WS03

- 5.3.1 Made Ground – Subbase was found in all exploratory holes and extended to depths between 0.10m-0.15m. The Made Ground comprised dark grey, clayey gravel of limestone.
- 5.3.2 A photograph of the typical Made Ground - Subbase encountered is presented below.

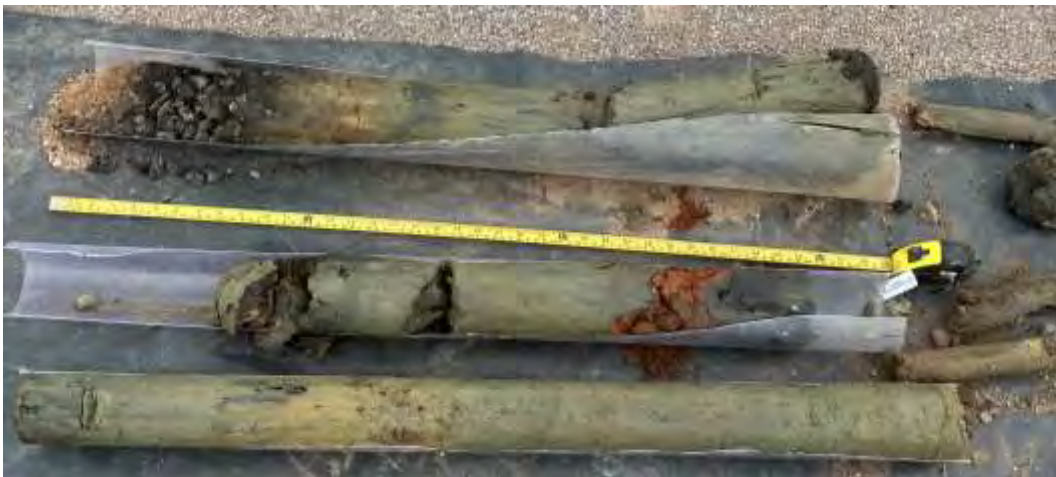
Figure 5-C: Made Ground encountered in WS03

- 5.4.1 Made Ground was encountered within the eastern part of the development area, with the deepest deposits in the northeastern corner, which is consistent with the anticipated cut and fill based on local levels. The Made Ground generally comprised firm, greenish grey, occasionally mottled orangish brown, gravelly clay with gravels of flint, brick and occasional ash.
- 5.4.2 Towards the northwestern corner, Made Ground was also encountered to a depth of 0.6m and comprised soft, orangish brown clay.
- 5.4.3 Photographs of the typical Made Ground encountered is presented below.

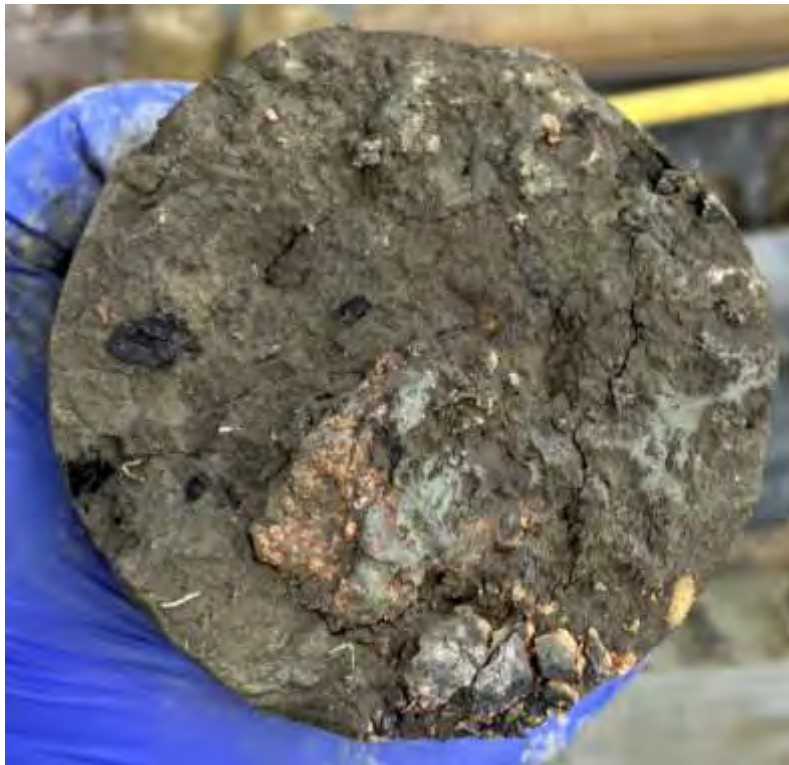
*Figure 5-D: Made Ground excavated from WS01*

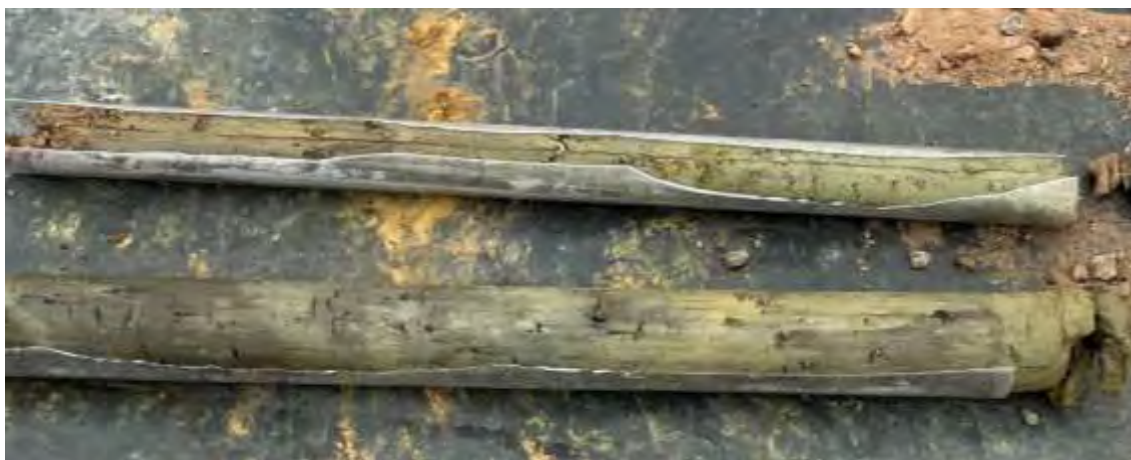
*Figure 5-E: Alluvium encountered from 2.3m depth in WS02*

- 5.5.1 Alluvium was encountered in WS02, excavated to the east of the development area in the approximate location of the former stream. The base of the Alluvium was not proven but had a minimum thickness of 2.15m BGL.
- 5.5.2 The Alluvium comprised a firm, greenish grey, slightly gravelly clay. Gravel consists of flint.
- 5.5.3 Photographs of the Alluvium encountered are shown below.

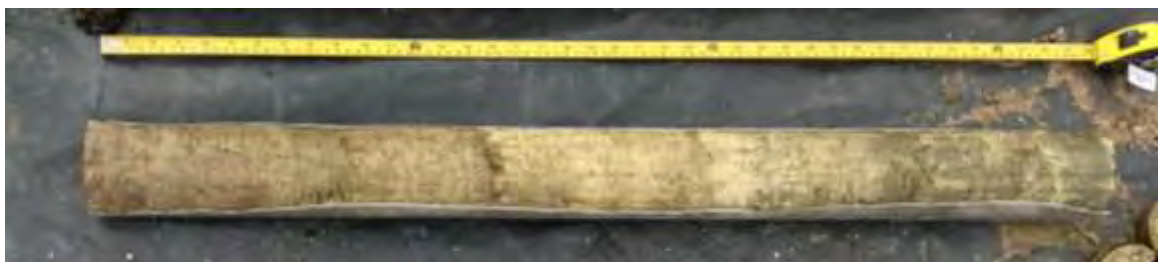
*Figure 5-G: Photograph of the Wadhurst Clay Formation encountered in WS04*

- 5.6.1 The Wadhurst Clay Formation was found across the site and extended beyond the termination depths of the boreholes.
- 5.6.2 The Wadhurst Clay Formation typically comprised stiff, yellowish brown, yellowish grey and greenish grey, slightly gravelly, laminated clay. Gravel consisted of mudstone.
- 5.6.3 A photograph of the typical Wadhurst Clay Formation is shown below.

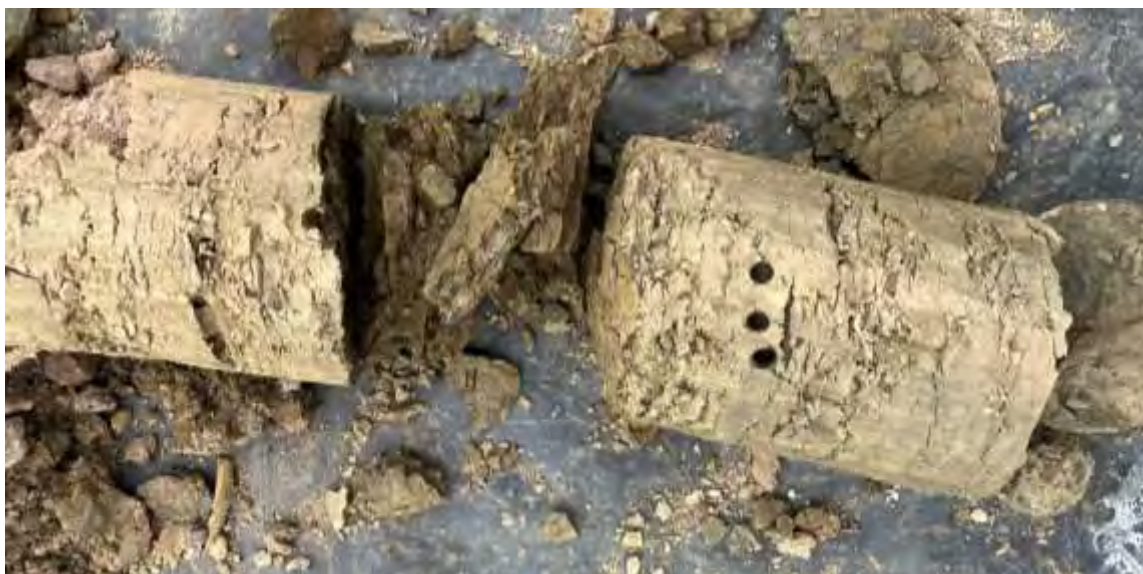
Figure 5-H: Photograph of the typical Wadhurst Clay Formation encountered in WS05

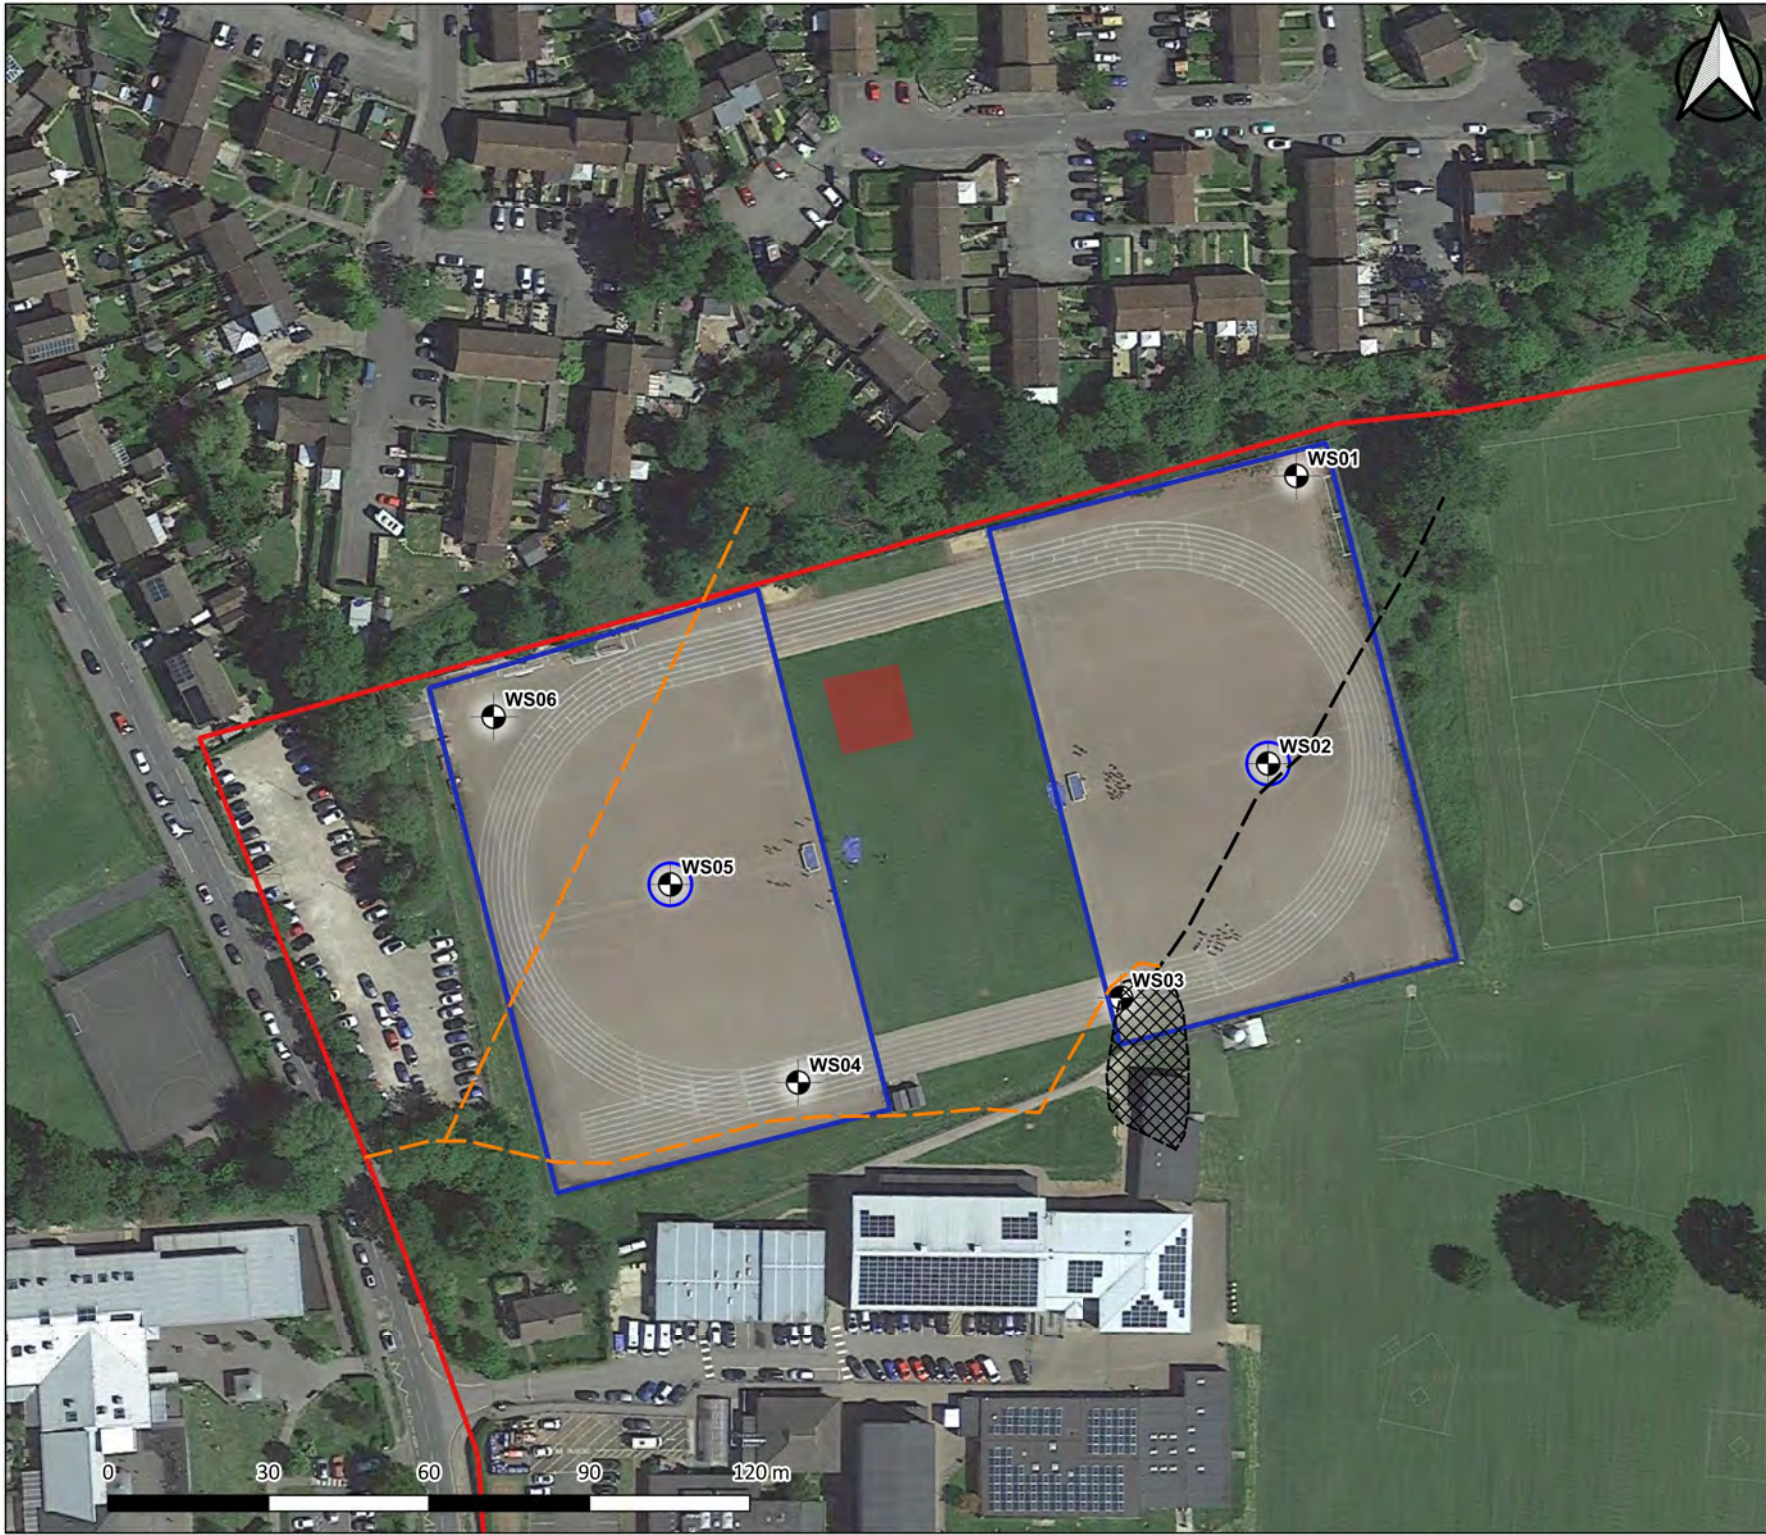
- Development Boundary
- WLS
- Infiltration Testing
- Approximate Anthrax Pit Location
- Site Boundary
- Historic Pond
- Historic Stream
- Potential Historic Stream

- 2.3.2 In addition, prior to attending site, Notts Sports advised that three **concrete covered anthrax pits** were recorded on historical plans of the school, one within the grassed area of the running track and two others within the wider school site. The approximate location of the pit local to the proposed pitches is shown on Drawing 01 in Appendix A.

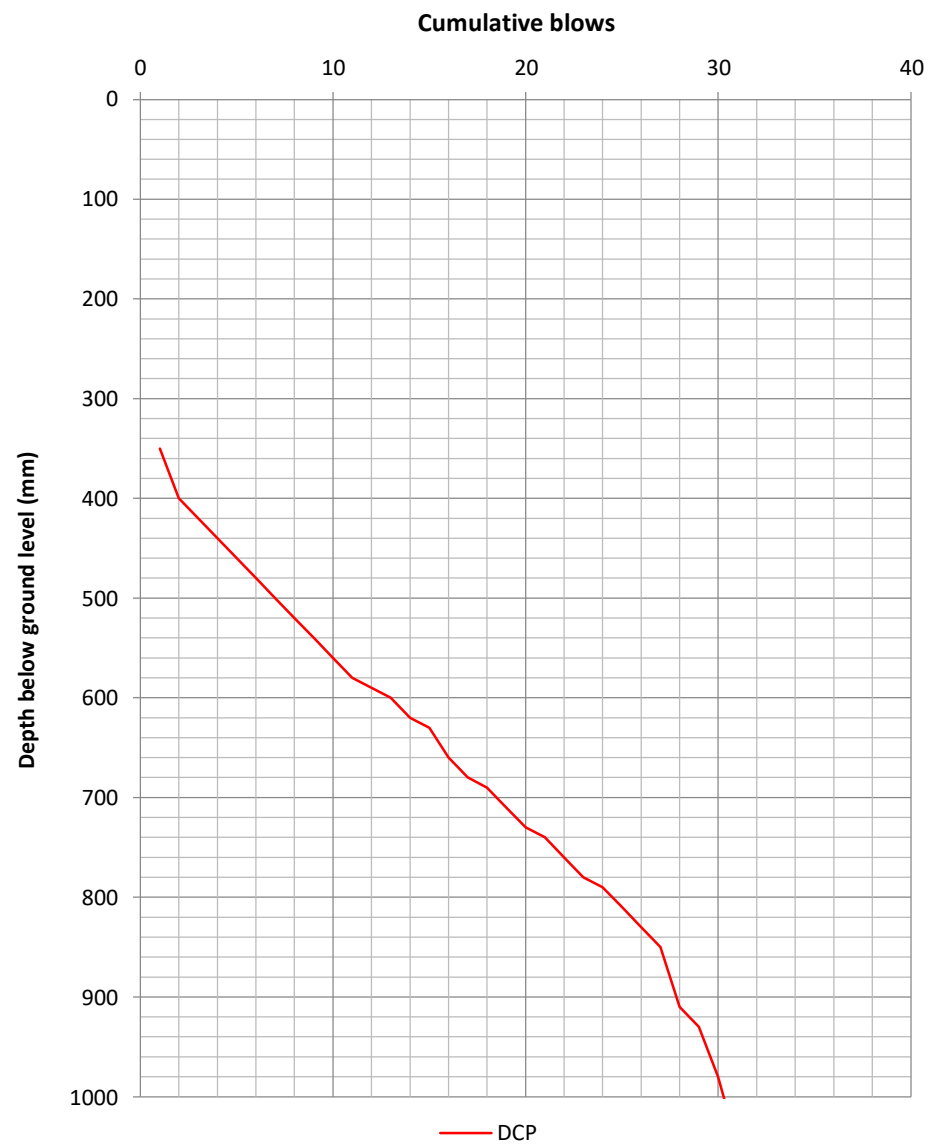
Plot showing number of blows against depth

Plot showing CBR (%) against depth
