**POLLARDS FARM, DITCHLING ROAD,  
BURGESS HILL, RH15 0SE  
PHASE II GEO-ENVIRONMENTAL  
ASSESSMENT  
PWX CONSTRUCTION LTD  
30<sup>TH</sup> MAY 2025  
LS8465**

| Title: | PHASE II GEO-ENVIRONMENTAL ASSESSMENT | |
| Project: | CONVERSION OF AGRICULTURAL BARN INTO A DETACHED HOUSE | |
| Reference: | LS8465 | |

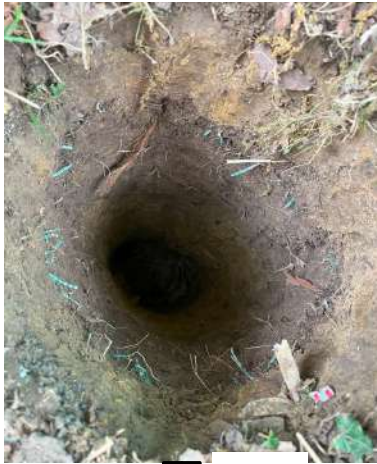
HP01 comprised grass over brown slightly clayey slightly gravelly Sand. Sand is fine to medium. Gravels are fine angular to rounded flint, plastic and metal fragments.

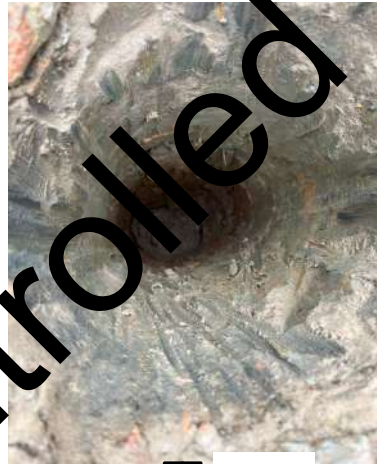
Backfill was encountered at HP02 and was proved to a depth of 0.50mbgl. It comprised blueish grey mottled red and orange slightly gravelly Clay. Gravels are fine to coarse angular to rounded flint.

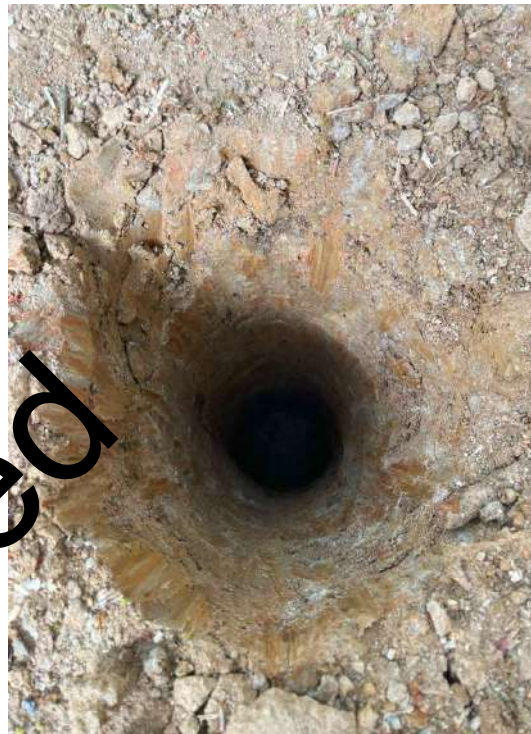
In summary, the Weald Clay comprised light brown/blue-grey/red-orange mottled blue-grey and orange-brown Clay (locally slightly silty), becoming mottled blue-grey and red-orange with depth. HP05 was noted as very gravelly with fine mudstone fragments 0.70-0.90mbgl.
