## **Biodiversity Net Gain (BNG) Report**

### **Land at West Hoathly Road**

- 1.1 The Ecology Partnership was commissioned by Devine Homes to undertake a Biodiversity Net-gain calculation for the proposed development at land at West Hoathly Road, East Grinstead, RH19 4RQ hereafter referred to as 'the site'.
- 1.2 The site is located east of West Hoathly Road in the town of East Grinstead, East Sussex (TQ 39244 36695). The site covers approximately 1.91ha and comprises woodland, sheep-grazed grassland and boundary hedgerows and treelines. The southern boundary is adjacent to further deciduous woodland. The surrounding area consists of grazed fields to the east and a playing field to the north.

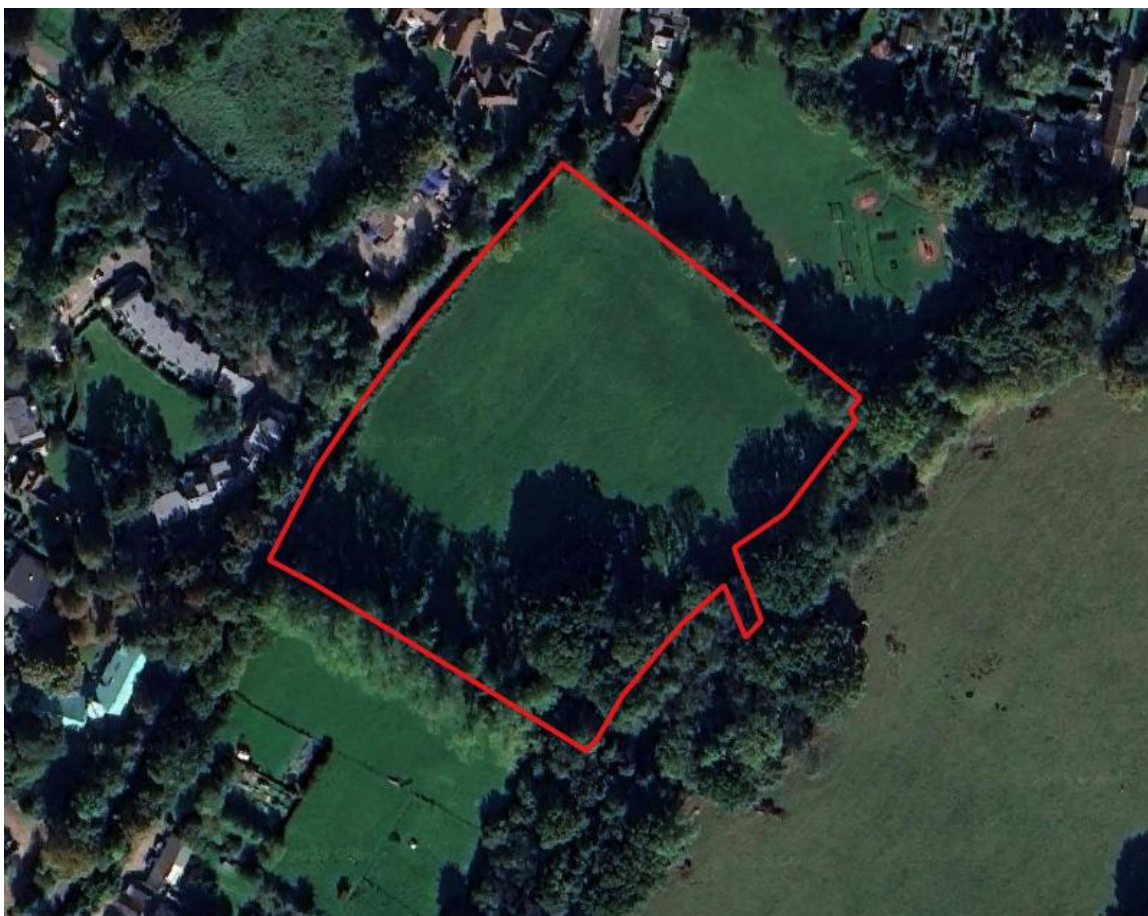
*Figure 1: Site red line boundary*

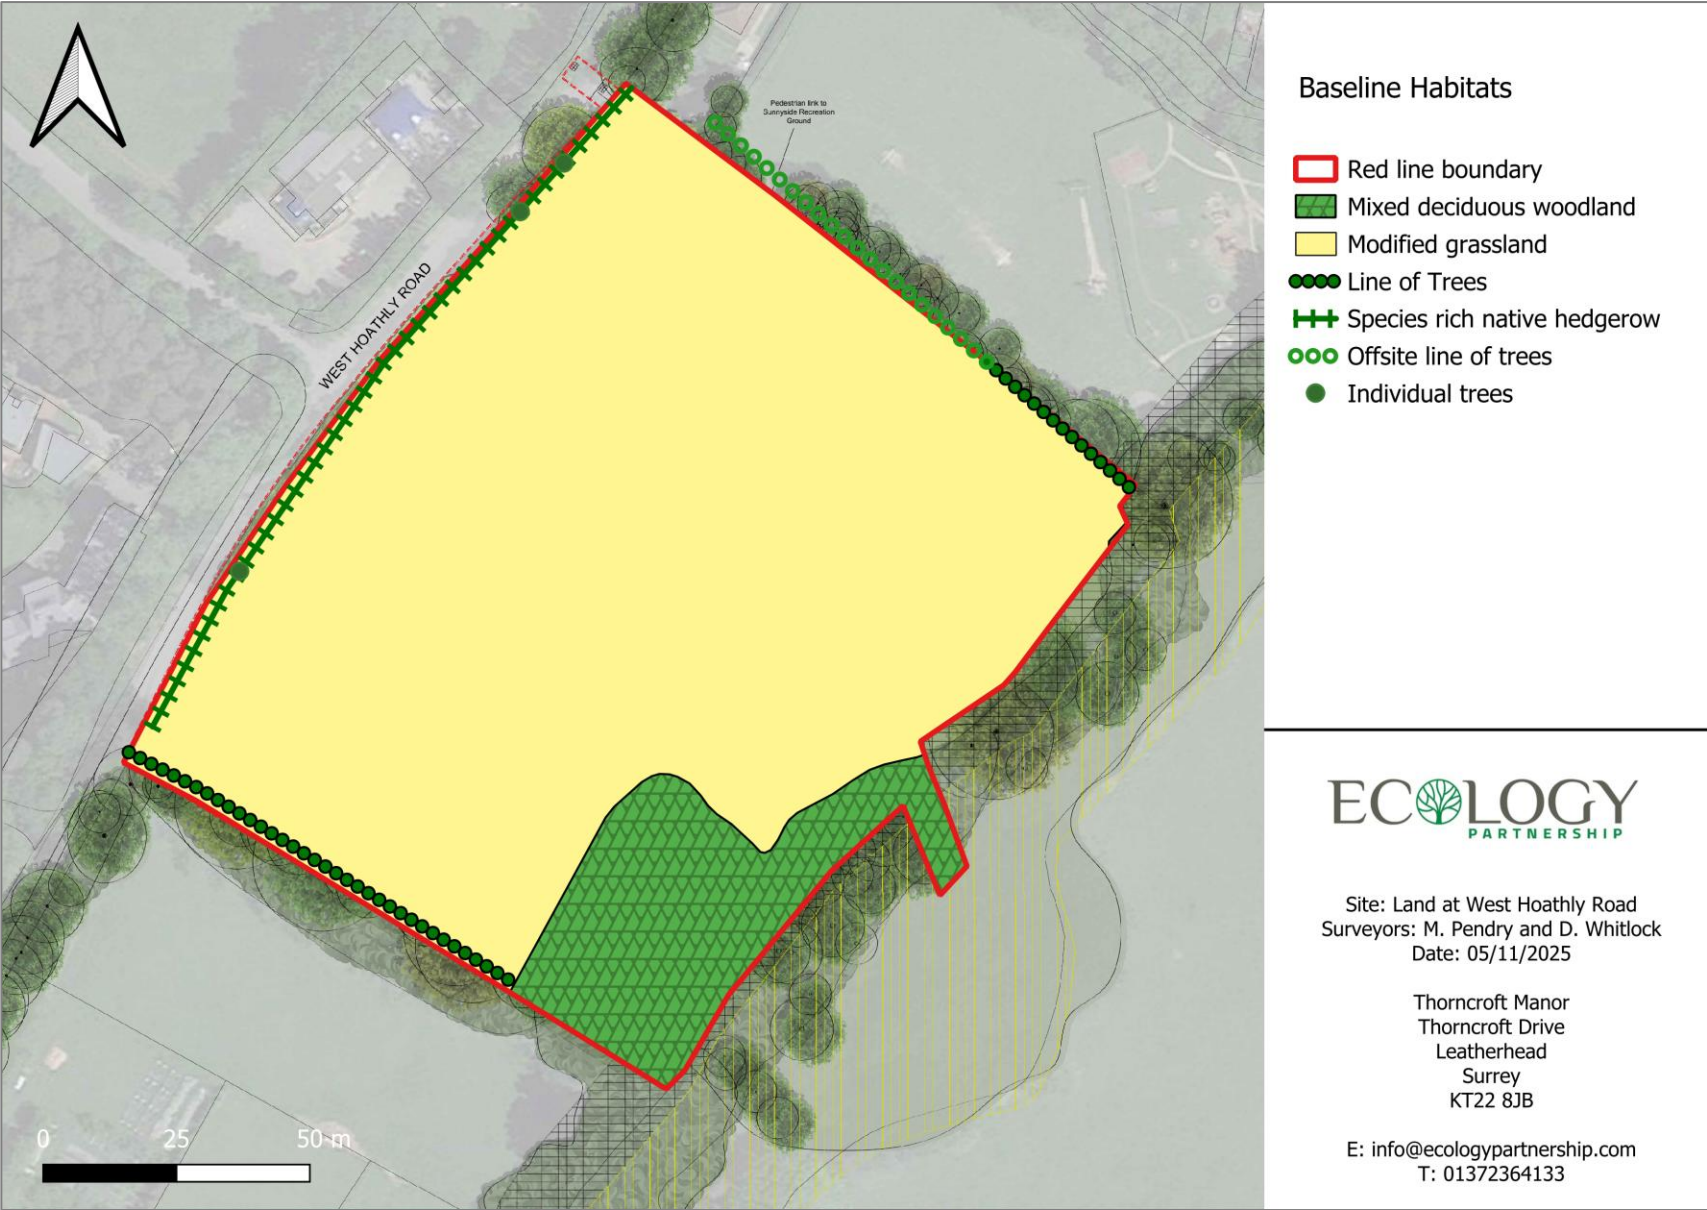
Figure 2: Habitats present on site pre development

- 3.1 The habitats currently present on site have been divided into a number of habitat types, each of which was subject to a condition assessment. The results from the metric are shown in Table 1, 2 and 3 overleaf, with the baseline habitat map shown in Figure 2. The proposed habitats are shown in Table 4, 5 and 6 as well as Figure 3.
- 3.2 The habitats currently present on site have been assessed as having a value of **7.83 habitat units**, **2.17 hedgerow units** and **0.07 watercourse units**.

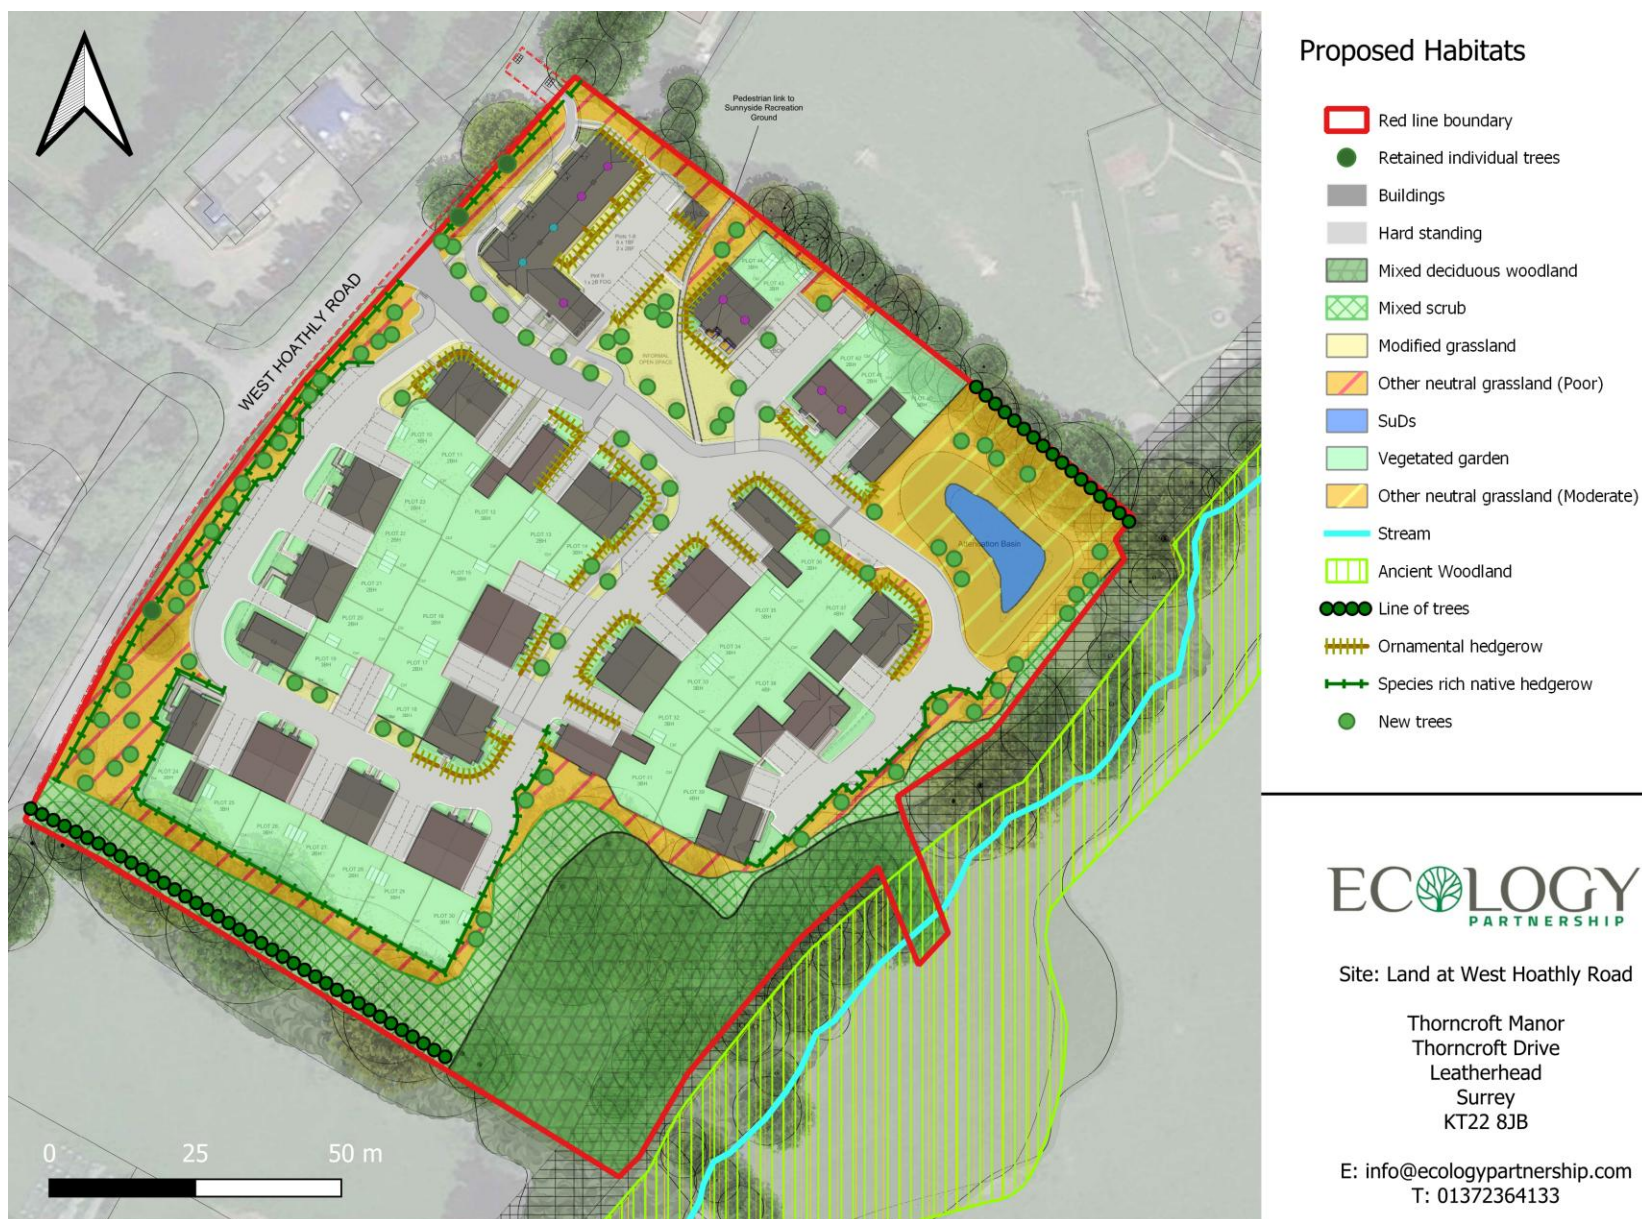
Figure 3: Post development habitat map

- 3.3 The proposed development is largely centred on the existing grassland, whilst retaining most of the boundary habitats. The woodland in the south of the site and both treelines will be retained. Two small sections of the western native hedgerow will be lost to facilitate site access, though new species rich native hedgerow will be planted to offset this loss.
