Rear stud wall – request to remove to return the room to its original form

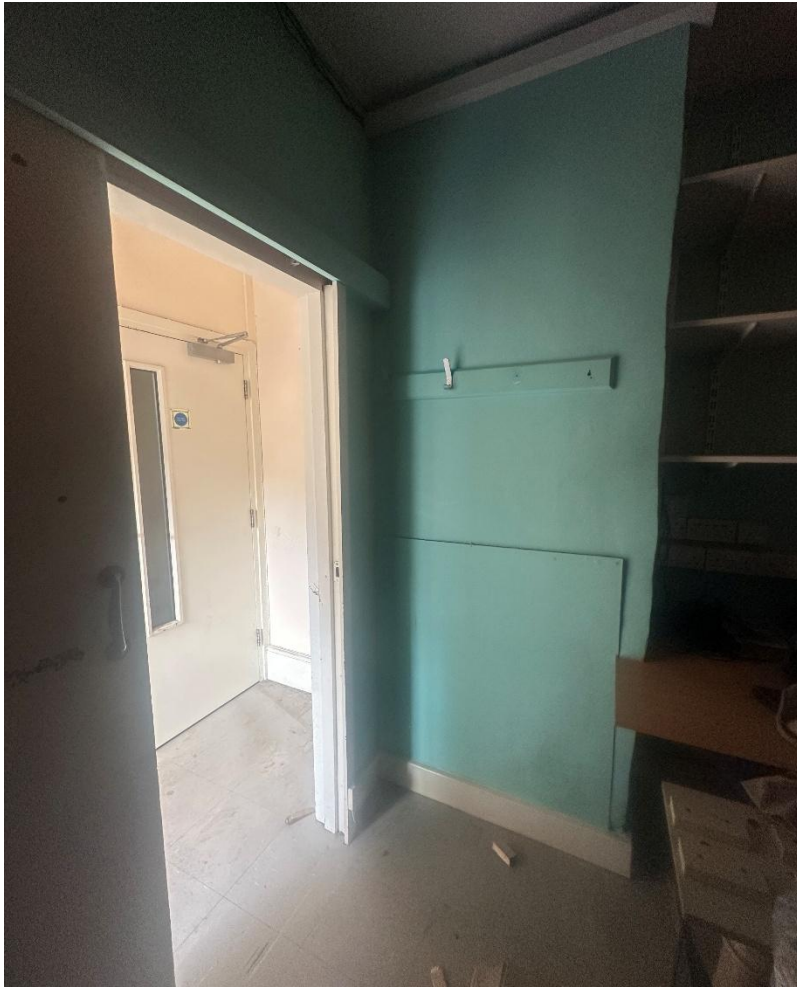
**Image 1** – shows a picture of the stud wall from inside the storage cupboard and you can see that it has been built up abutting the chimney breast leaving a small unlit and unsympathetic space.

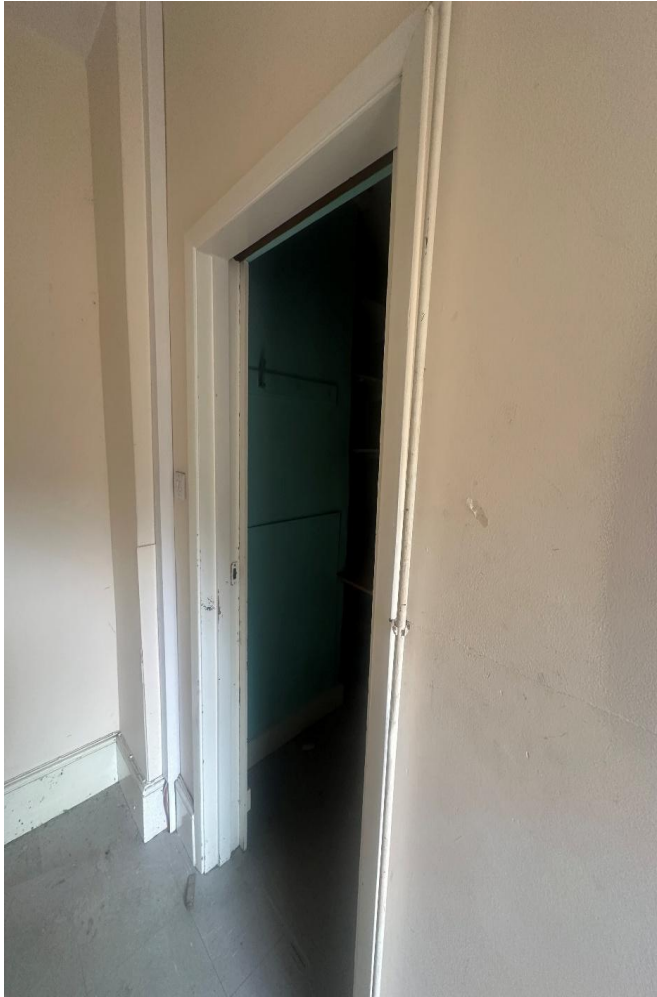
**Image 2** shows from the other side of the stud wall and you can clearly see the other side of the chimney breast and where the wall has been built up against the front of it and over the top of the fireplace draft cover.

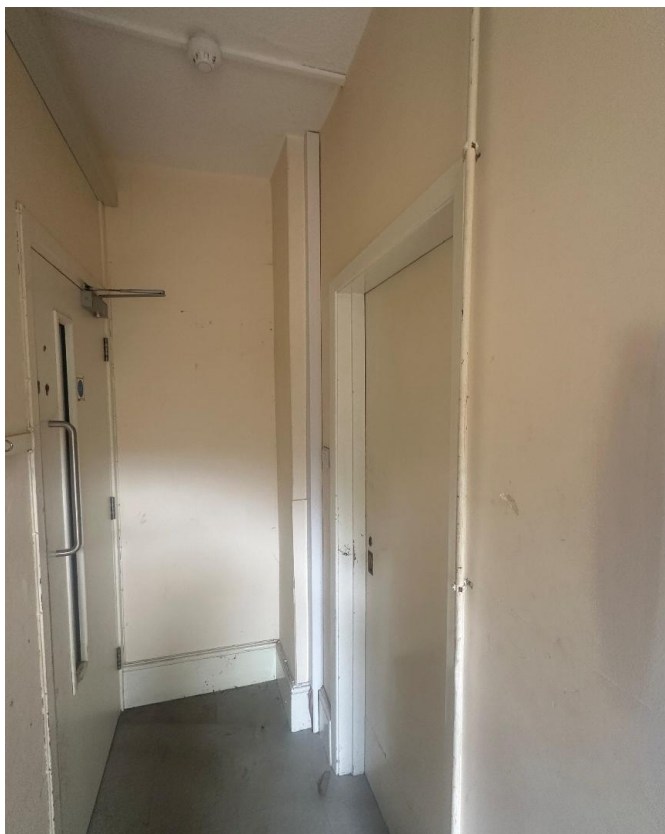
**Image 3** shows that the stud wall has not only cut off the chimney breast and created a small unlit storage cupboard but it has created this narrow corridor which does not reflect the natural form of the house .

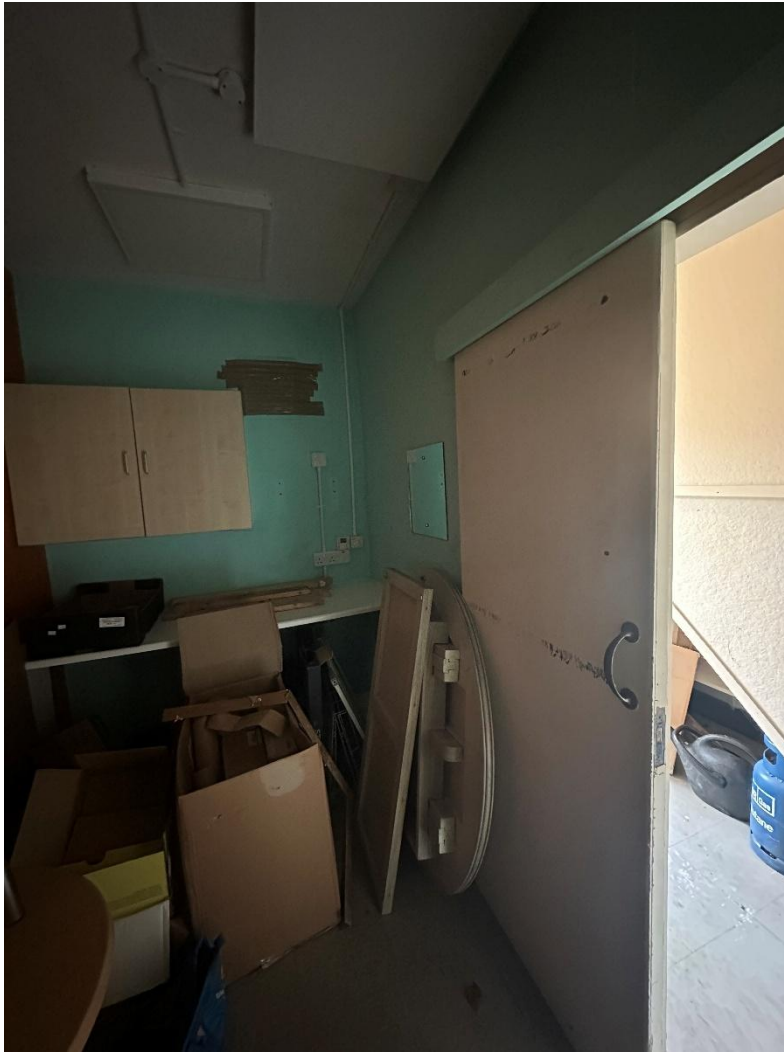
**Image 4** shows the inside of the storage cupboard that has been created by the insertion of the stud wall, there is no window or natural light and does not reflect the original form.

There is an existing fireplace in here and due to no ventilation it currently does not comply with building regulations therefore the stud wall would need to be removed so that I can reinstate the original fireplace and original form of the rear reception room.

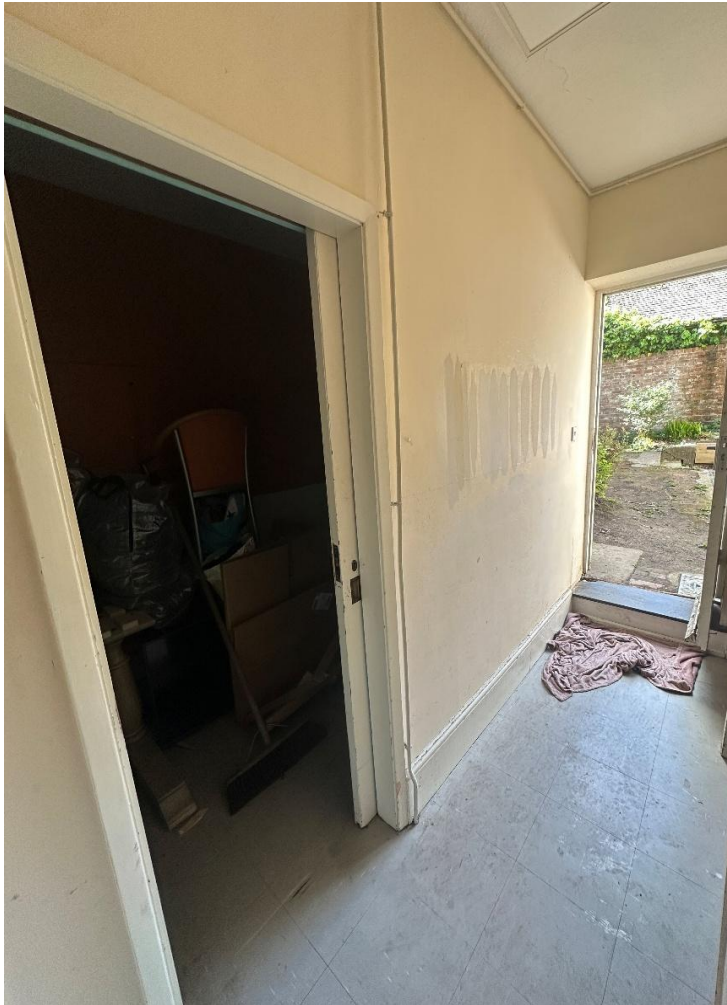
**Image 5** shows the view looking down alongside the stud wall on the left into the garden and you can again see that it has cut off the room and created a narrow corridor and cupboard

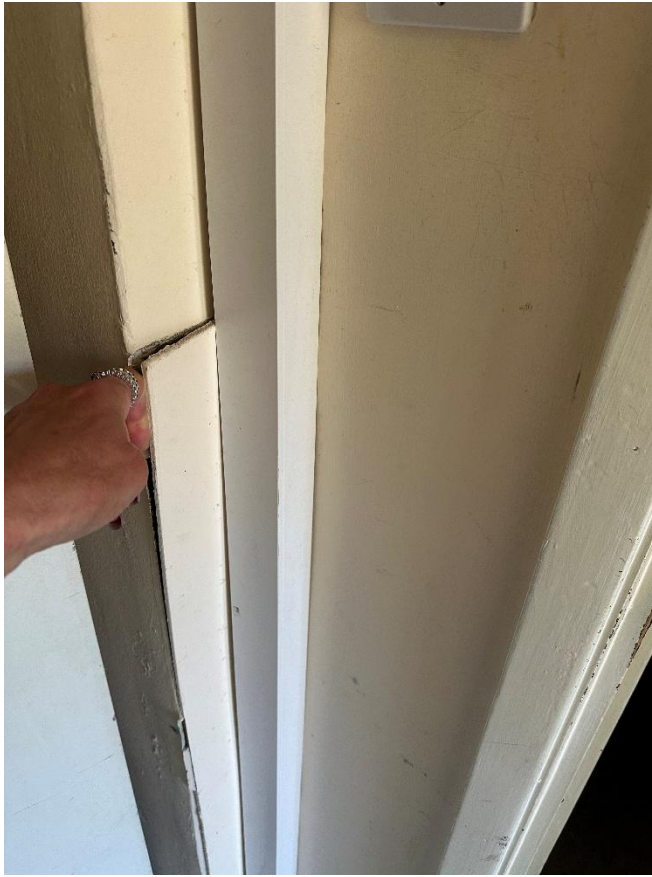
**Image 6** shows the draft cover of the fireplace has been built over by the insertion of the stud wall so certainly a much later addition to create a storage cupboard for the commercial premises

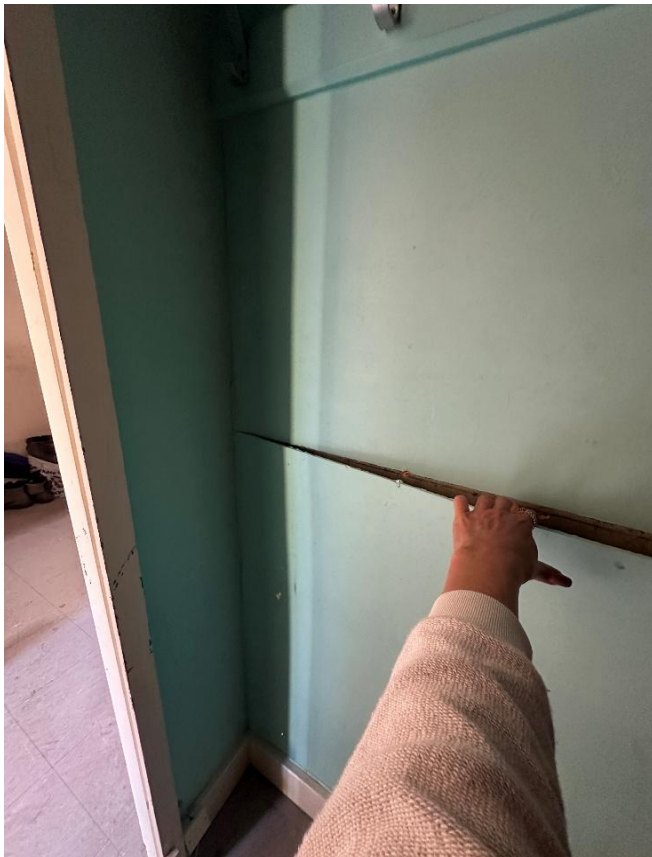
**Image 7** shows the cover of the fireplace from inside the cupboard which again shows the wall built over the chimney breast and draft cover.

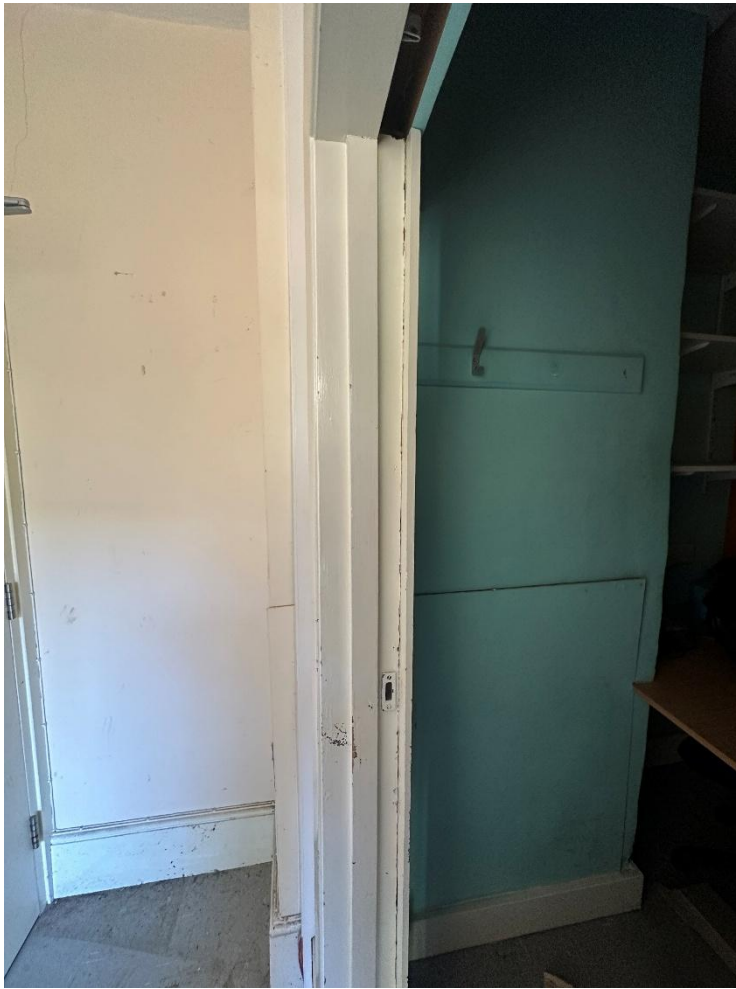
**Image 8** shows the chimney breast both sides of the stud wall with the wall clearly built over the top of the cover and cutting off the chimney breast, by removing this non original stud wall I wish to reinstate the room to its original form and add light and features back into the space rather than the current storage room.
