GROUND APPRAISAL REPORT

LVS HAS SOCKS, LONDON ROAD

SAYERS COMMON, HAS SOCKS

WATES DEVELOPMENTS LIMITED

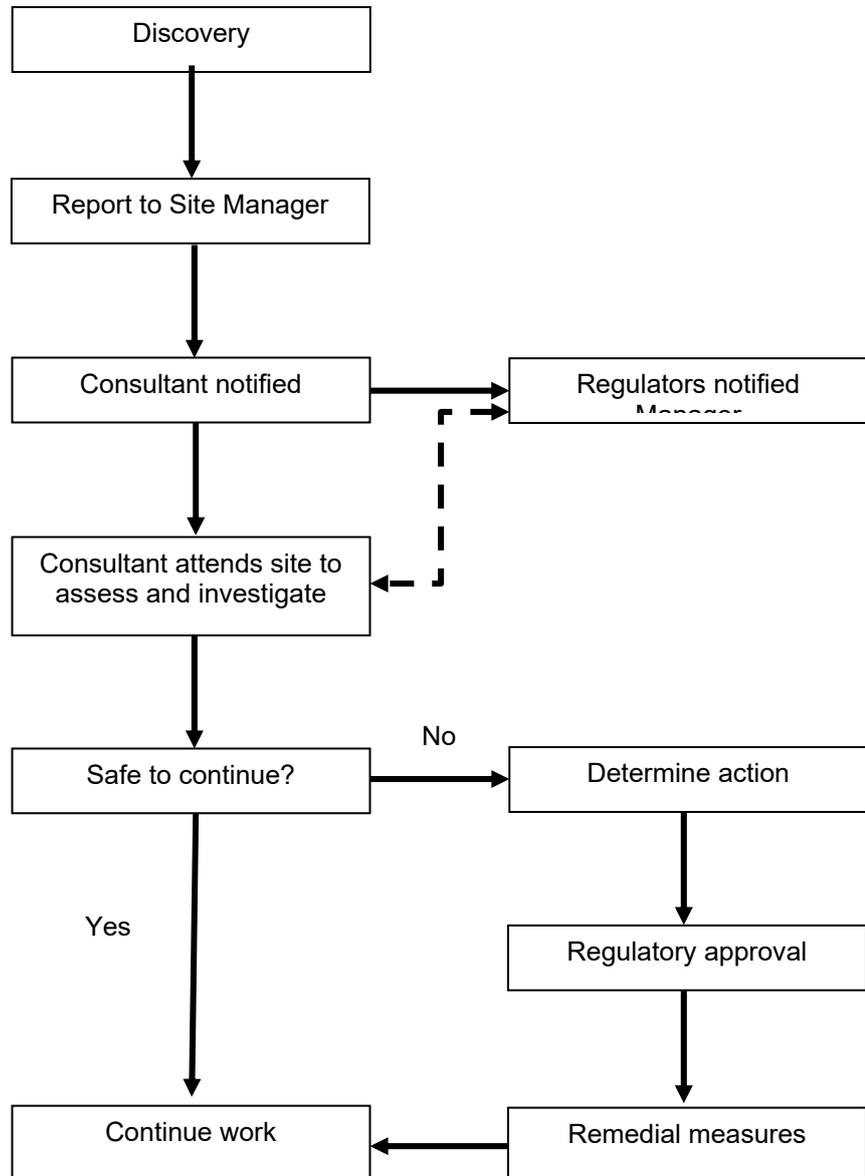
Chart 1 Discovery Strategy Process

The process is shown below.

- Where remedial action is required, regulatory consultation and approval will be sought;
- A record will be produced by the Consultant and held on site (with copies held by the Consultant, Client and Local Authority/other relevant organisation), detailing the discovery, assessment works undertaken, findings thereof, confirmation either of no action required or detailing the remedial action taken and validation thereof.

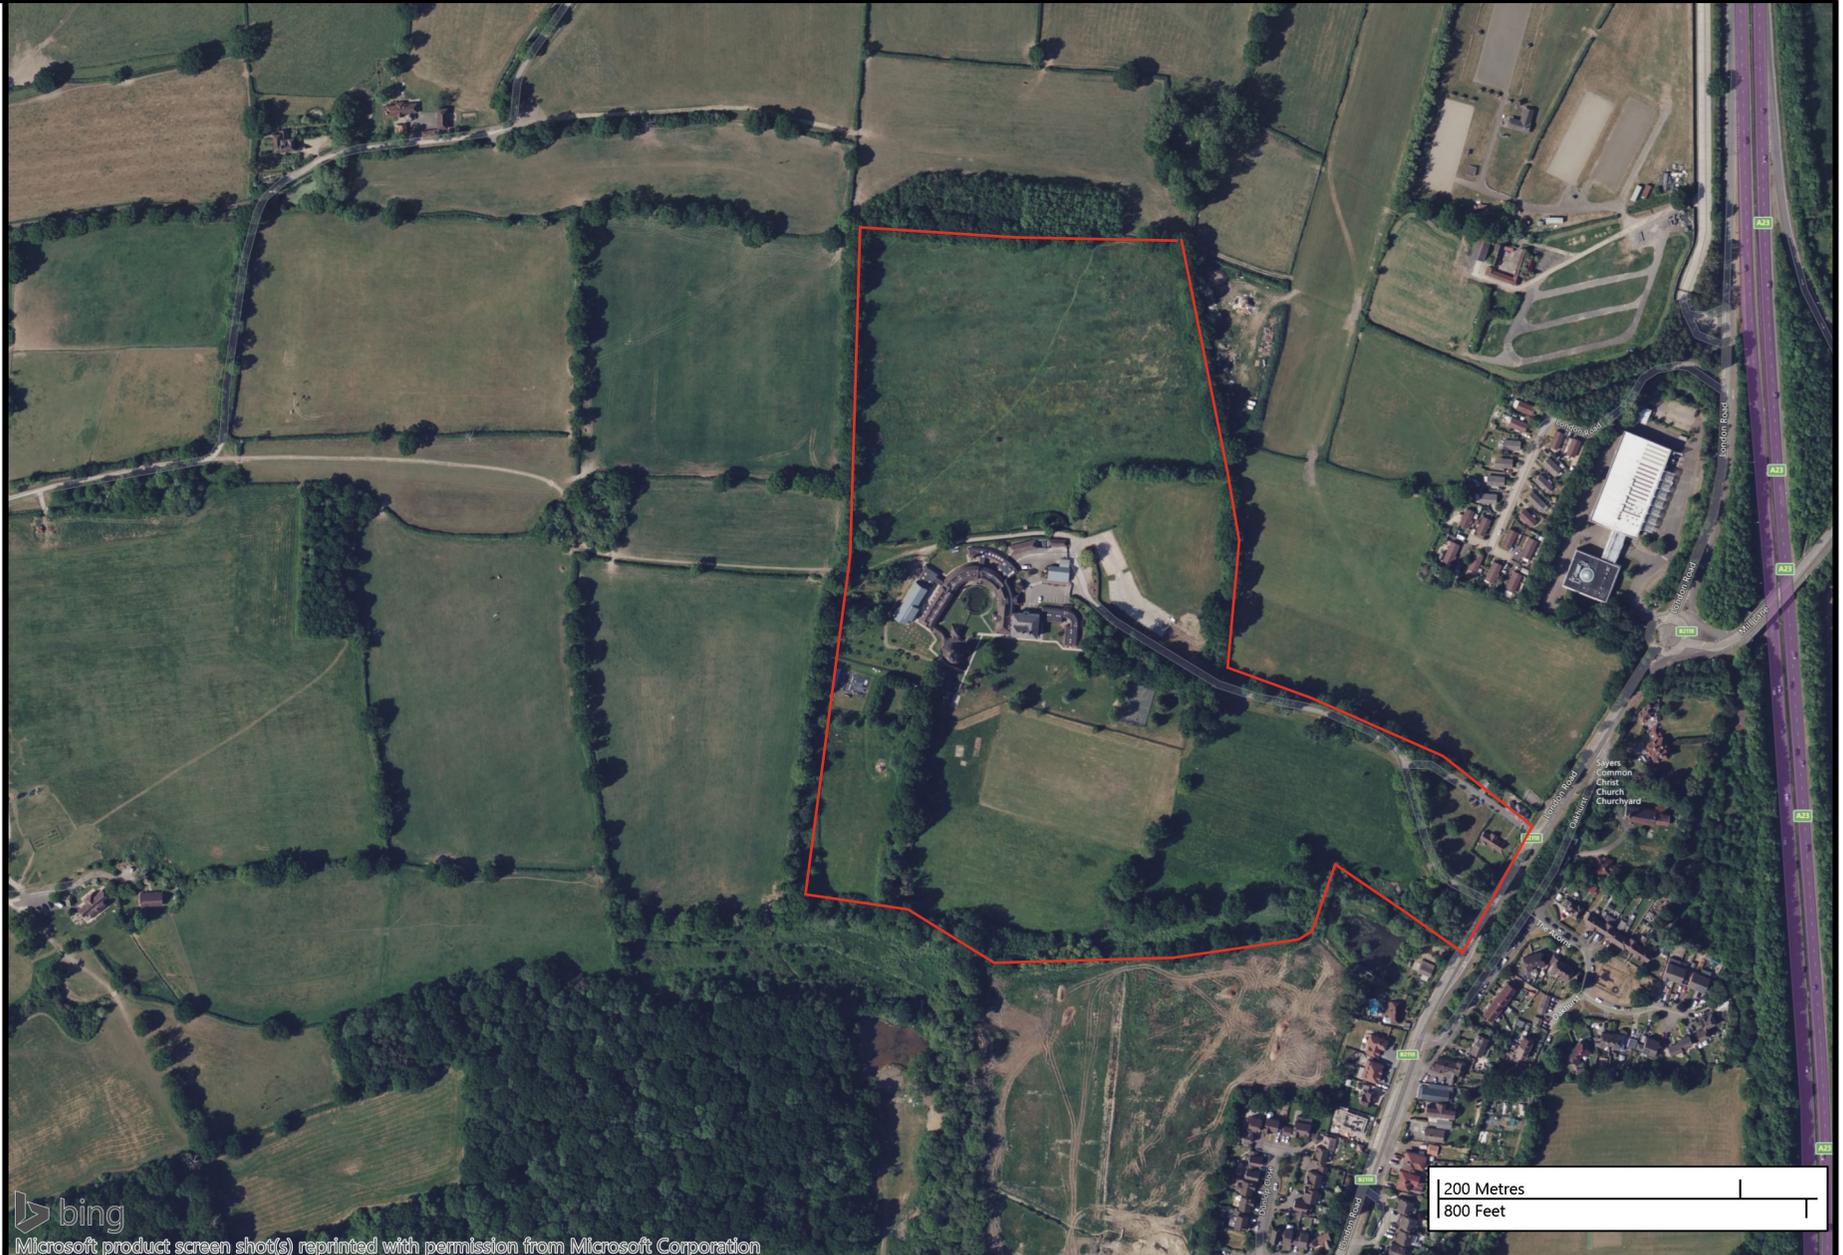
FIGURE 2

Site Investigation Plan

Project:	Sayers Common			Title	Exploratory Hole Location Plan	
Client:	Wates Developments Ltd			<p style="text-align: center;">Geo-Environmental Services Ltd</p> <p style="text-align: center;">Unit 7 Danworth Farm, Cuckfield Road</p> <p style="text-align: center;">Hurstpierpoint, West Sussex BN6 9GL</p> <p style="text-align: center;">+44(0)1273 832972 www.gesl.net</p>		
Ref No:	GE22666	Revision:	1			
Drawn:	TL	Date:	22/08/2024			
Figure:	2	Scale:	nts

The locations of the exploratory holes are presented in Figure 2.

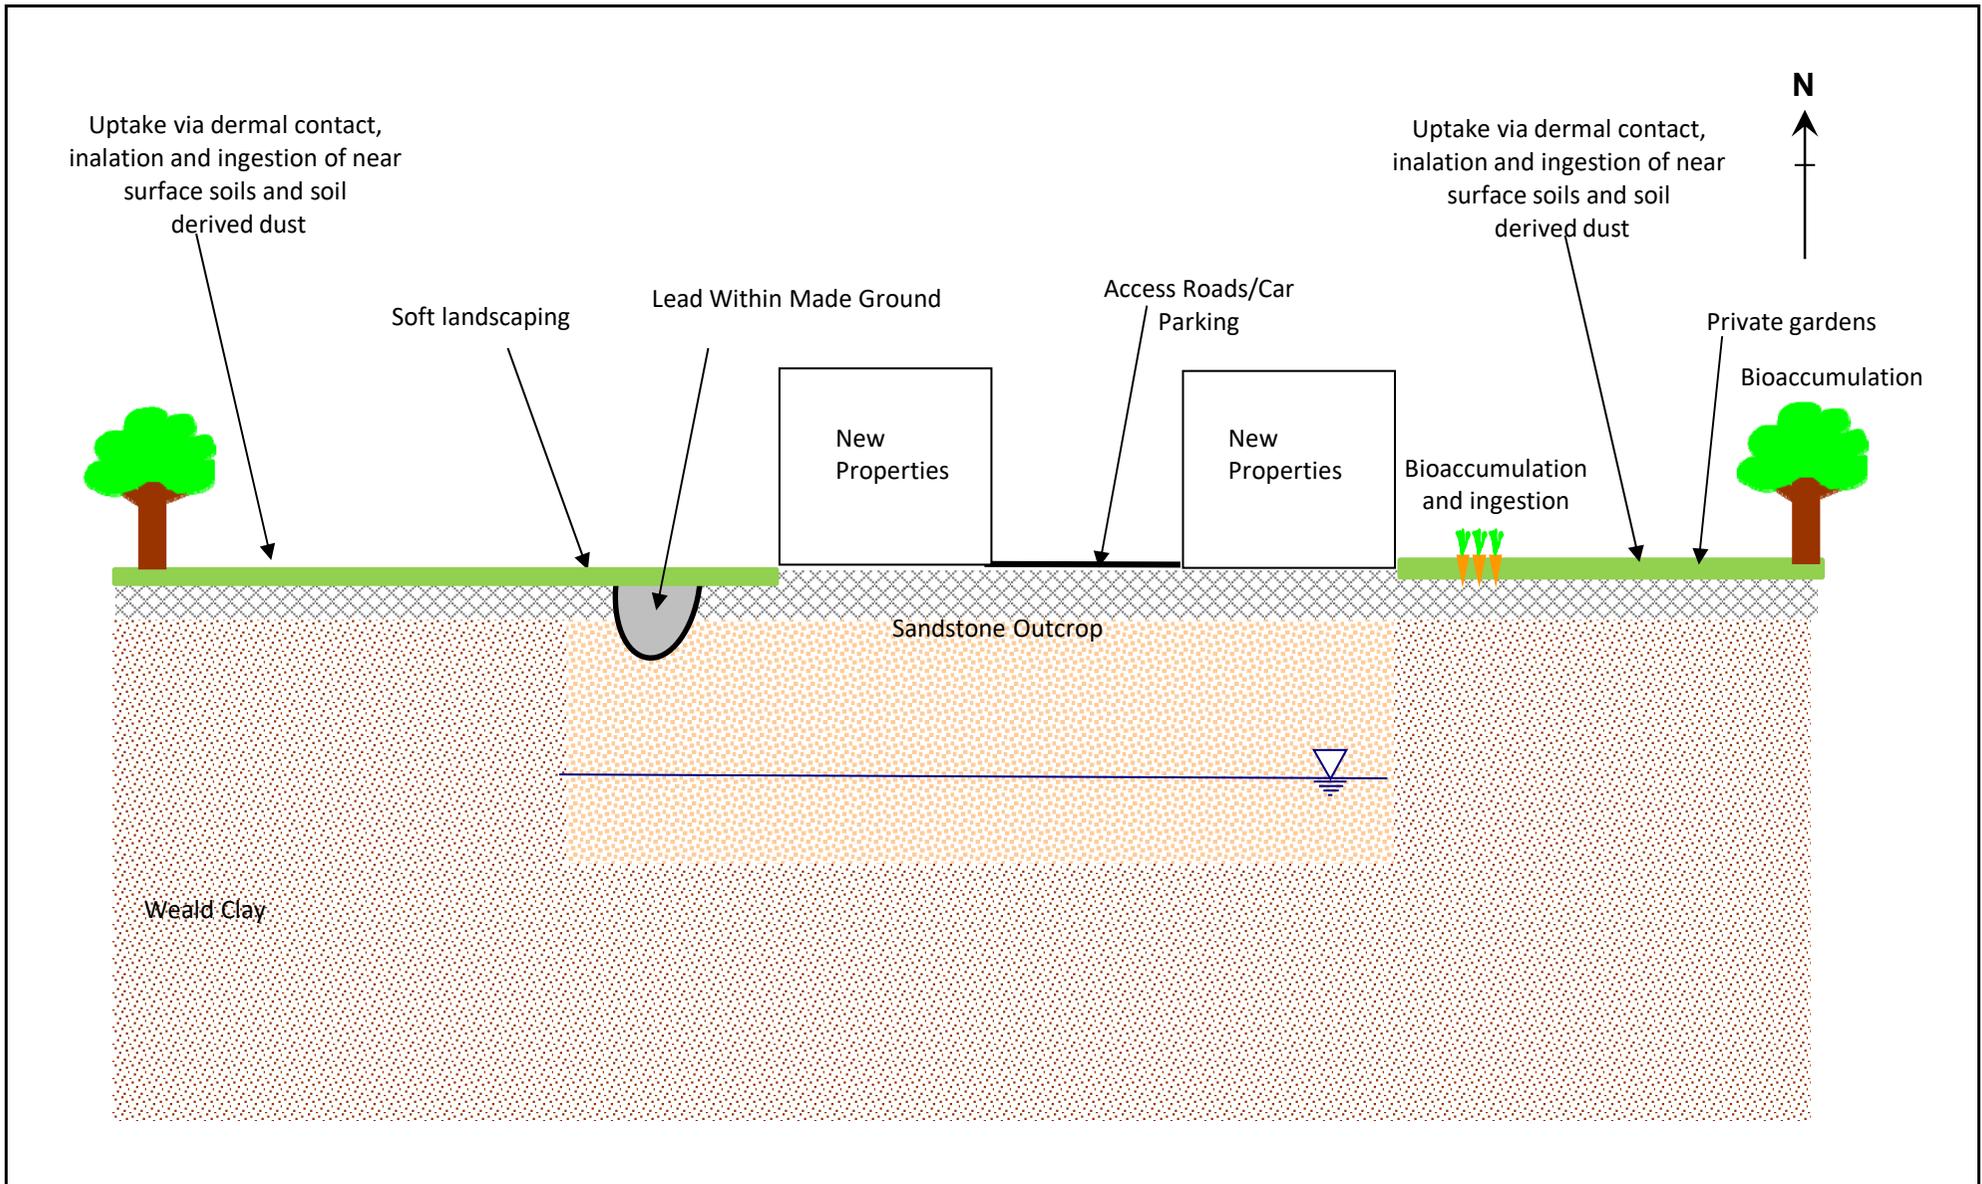
Graphical Conceptual Site Model (Future Use)

Project:	LVS Hassocks, Sayers Common			Title	Conceptual Site Model (Future Land Use)	
Client:	Wates Developments Limited			Geo-Environmental Services Ltd Unit 7 Danworth Farm, Cuckfield Road Hurstpierpoint, West Sussex BN6 9GL +44(0)1273 832972 www.gesl.net		
Ref No:	GE22666	Revision:	1.0			
Drawn:	AP	Date:	27/09/2024			
Figure:	3	Scale:	Not To Scale
