Bat Emergence and Re-Entry Surveys (BERS)

Lullings Cottage, West Hill, Balcombe, Haywards Heath, West Sussex RH17 6Q

This report is prepared to inform a planning application for the proposal described as: the demolition and rebuild of two garden sheds and the existing cottage.

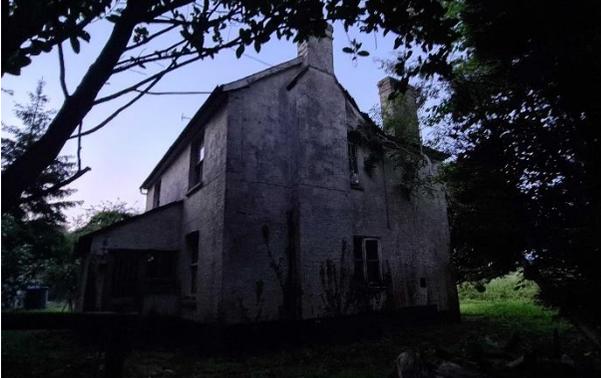
Surveyor observations		
<p><i>Surveyor 1</i></p>	<p>No bat emergences or re-entry observed. The first call heard was very distant Noctule at 21:13. From 21:17 to 22:06 there was constant activity from both common and soprano pipistrelles, mostly heard but not seen. At 21:40 a common pipistrelle was observed flying above this tree line from west to east. At least seven separate passes were recorded by both common and soprano pipistrelles flying between the tree line and the building, in from both the west and the east.</p>

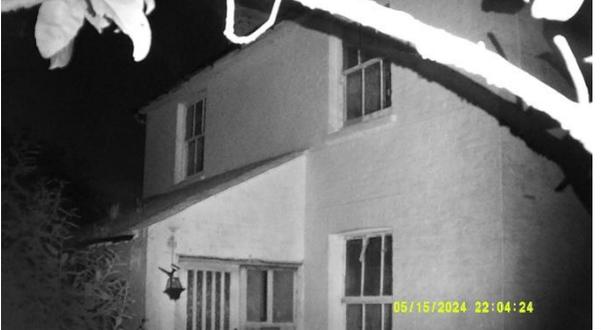
<p><i>IR position 1</i></p>	<p>The footage reflected the view of surveyor 1.</p>

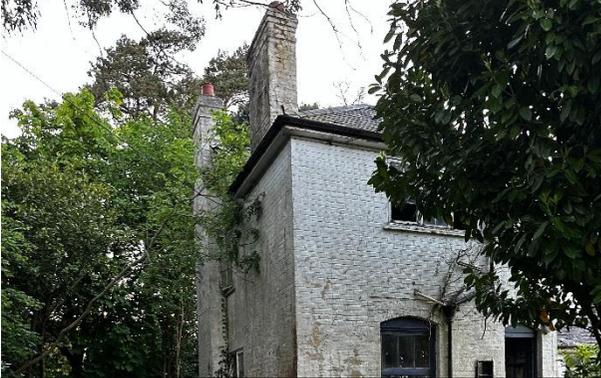
<p><i>Surveyor 2</i></p>	<p>No bat emergences or re-entry observed. The first bat of the night was a Noctule heard not seen at 21:12. From 21:17 to 21:28 several common and soprano pipistrelles were seen foraging in front of the eastern elevation of B1. Several more common and soprano pipistrelles were heard but not seen until the final bat, a soprano pipistrelle, was heard at 22:03.</p>

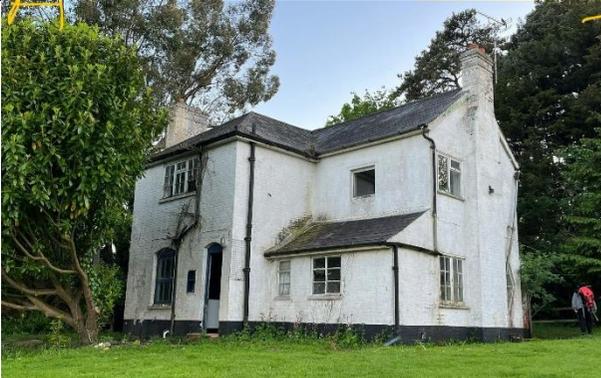
<p><i>Surveyor 3</i></p>	<p>No bat emergences or re-entry observed. The detector recorded numerous passing bats with the first being a Noctule at 21:12. With onwards Common Pipistrelle passing directly overhead from the open fields towards B2. Common pipistrelles, Noctules and a Soprano pipistrelle were recorded until 21:52 when the final bat, a Noctule, was heard.</p>

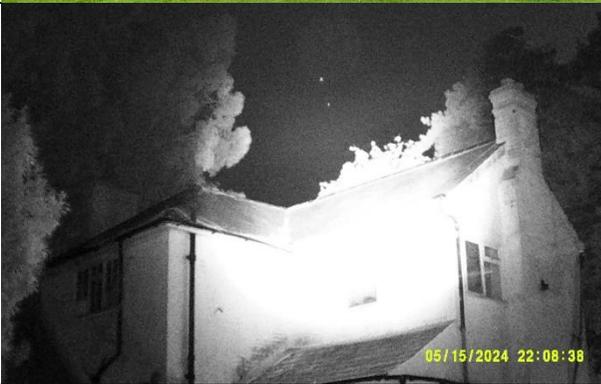
<p><i>IR position 3</i></p>	<p>The footage reflected the view of surveyor 3.</p>

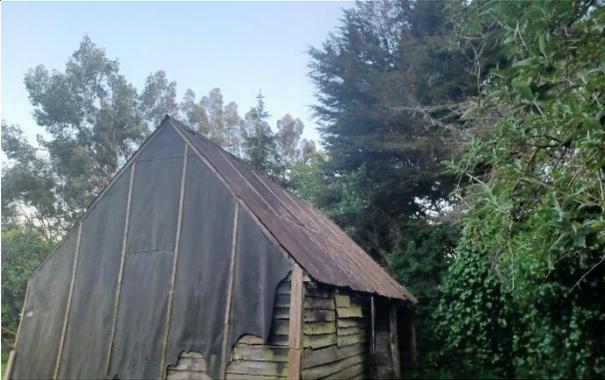
Results							
Date of survey	Start, end and sunset time	Species and numbers	Roost type	Structure reference	Roost location	Access points	Dimensions and explanation of roost location
15/05/2024	20:43 20:28 - 22:07	No emergences	N/A	N/A	N/A	N/A	N/A
Surveyor Observations							
<i>Surveyor 4</i>		<p>No bat emergences or re-entry observed. There was foraging and commuting activity by Common pipistrelle, Soprano pipistrelle, Noctule and Barbastelle throughout the duration of the survey. The first bat activity was a Noctule at 21:02, heard not seen. There was intermittent activity by Common pipistrelles and Soprano pipistrelles from 21:03 until 21:33. At 21:33 there was a foraging Noctule followed by a Common Pipistrelle at 21:37. At 21:38 there was a foraging activity by a Western Barbastelle. followed by Common Pipistrelles' foraging 21:44 until 21:48. Noctule activity was recorded at 21:51 and 21:55. The last bat activity was at 22:05, a Common Pipistrelle pass.</p>

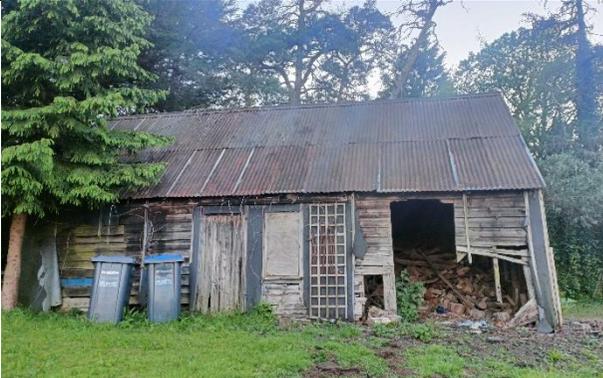
<p><i>Surveyor 5</i></p>	<p>No bat emergences or re-entry observed. The first bat was a Noctule at 20:43, heard but not seen. Several more Noctules were heard but not seen up until 21:22. A Natterer’s bat was heard but not seen at 20:49. Both soprano and common pipistrelles were heard and seen from 20:58 to 21:45. Passes observed from pipistrelles were concentrated above surveyor 4, at the northern elevation of B2. A brown long-eared bat was heard not seen at 21:38. The final bat was a common pipistrelle heard not seen at 21:45.</p>

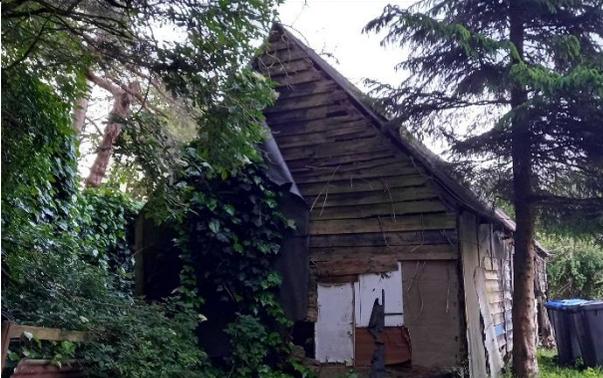
<p><i>Surveyor 6</i></p>	<p>No bat emergences or re-entry observed. The first bat was a common pipistrelle at 21:14 seen passing from west to east over B2. From this point to the end of the survey, many more common pipistrelles were heard and seen. Passes were concentrated over B2, from west to east or from north to south and back.</p>

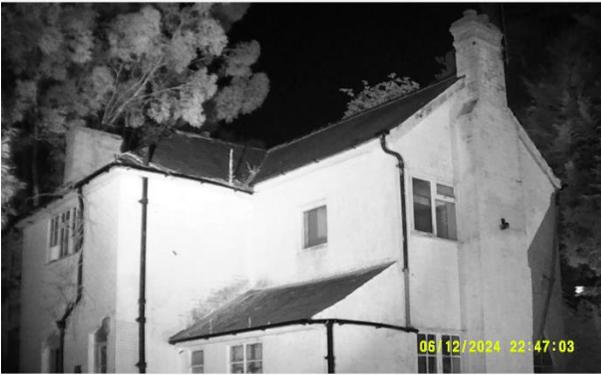
<p>An infrared night photograph showing the exterior of Lullings Cottage. The building is white with dark window frames and a chimney. The image is timestamped '06/12/2024 22:47:03' in the bottom right corner.</p>
<p><i>Surveyor 4</i></p>	<p>No bat emergencies or re-entry observed. The first bat detected was a noctule at 21:32. A noctule was then seen and heard foraging and passing over head of site intermittently until 21:48. A common pipistrelle passed west to east over the north side elevation of B1 at 21:52. Between 22:07 - 22:54, infrequent common pipistrelle activity was detected with one further pass seen from west to east.</p>	
<p><i>IR position 4</i></p>	<p>No bat emergencies or re-entry observed. No bat activity was recorded.</p>

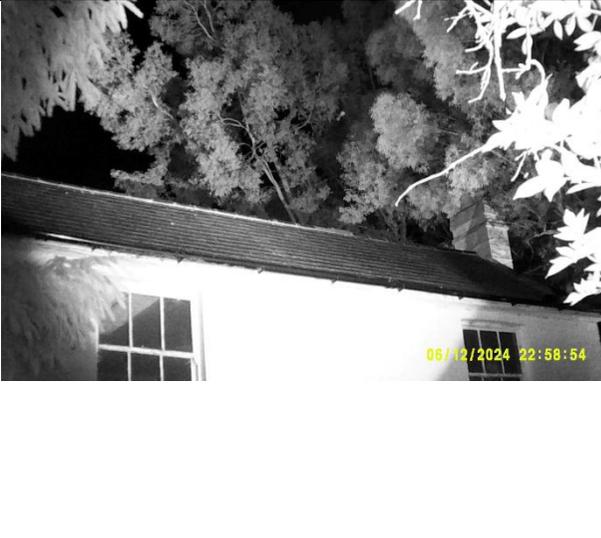
<p>An infrared night photograph showing a close-up view of the side of Lullings Cottage, focusing on a window and the roofline. The image is timestamped '06/12/2024 22:58:54' in the bottom right corner.</p>

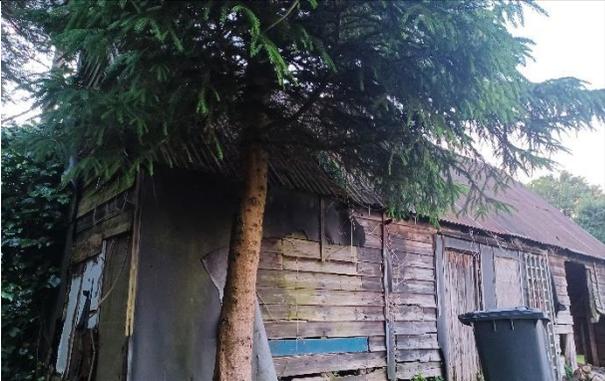
Building B2							
<i>Building inspection prior to survey</i>		The roost features identified during the Preliminary Ecological Appraisal and Preliminary Roost Assessment were subject to an inspection prior to the BERS to check for evidence of roosting bats.					
<i>Surveyor and position</i>		Surveyor 5 – Diego Landaberea – One year bat survey experience – observing the southern and eastern elevations Surveyor 6 – Tom Smith – One year bat survey experience – observing the northern and western elevations					
<i>Equipment used</i>		Echometer Touch 2, Magenta 4, IR cameras, IR torches					
Results							
Date of survey	Start, end and sunset time	Species and numbers	Roost type	Structure reference	Roost location	Access points	Dimensions and explanation of roost location
12/06/2024	21:16 21:00 – 23:00	No emergences	N/A	N/A	N/A	N/A	N/A
Surveyor Observations							
<i>Surveyor 5</i>		No bat emergence or re-entry observed. The first bat activity was a Noctule passing at 21:32 and again at 21:35, with intermittent foraging activity by Noctule between 21:39 to 21:51 to the south-west. This was followed by a common pipistrelle at 21:53 heard not seen. At 22:29 a Brown long eared commuted from North to South-west. At 22:45, 22:51 and 22:53 soprano pipistrelle was seen passing over B2 north to south. At 22:46 a Daubenton’s bat was heard but not seen. The last bat activity was a Soprano pipistrelle, heard but not seen at 22:53.

<p><i>IR position 5</i></p>	<p>The IR camera was positioned to focus on the eastern elevation of B2, including areas of the roof not visible to surveyor 5 due to the tree.</p>

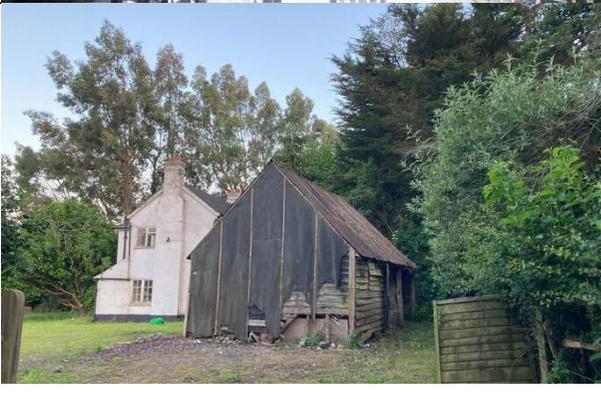
<p><i>Surveyor 6</i></p>	<p>The first bat, at 21:23, was seen not heard passing north to southeast from behind surveyor 6 (unidentified species due to lack of echolocation). Between 21:23 and 22:54 commuting routes established from north to southeast and north to southwest over B2; three common pipistrelles via north to southeast, and four pipistrelles (three common and one soprano) via north to southwest. Noctules were observed foraging above the site intermittently throughout survey between 21:32 and 21:46. A Daubenton's was heard not seen at 21:46. The last bat was a common pipistrelle commuting north to southeast at 21:54.</p>
