MINOR INTERIOR ALTERATIONS TO BARLANDS, THE STREET,  
WARNINGLID, WEST SUSSEX, RH17 5SZ

HERITAGE STATEMENT & IMPACT ASSESSMENT

REPORT NO. 2024582/2  
August 2025

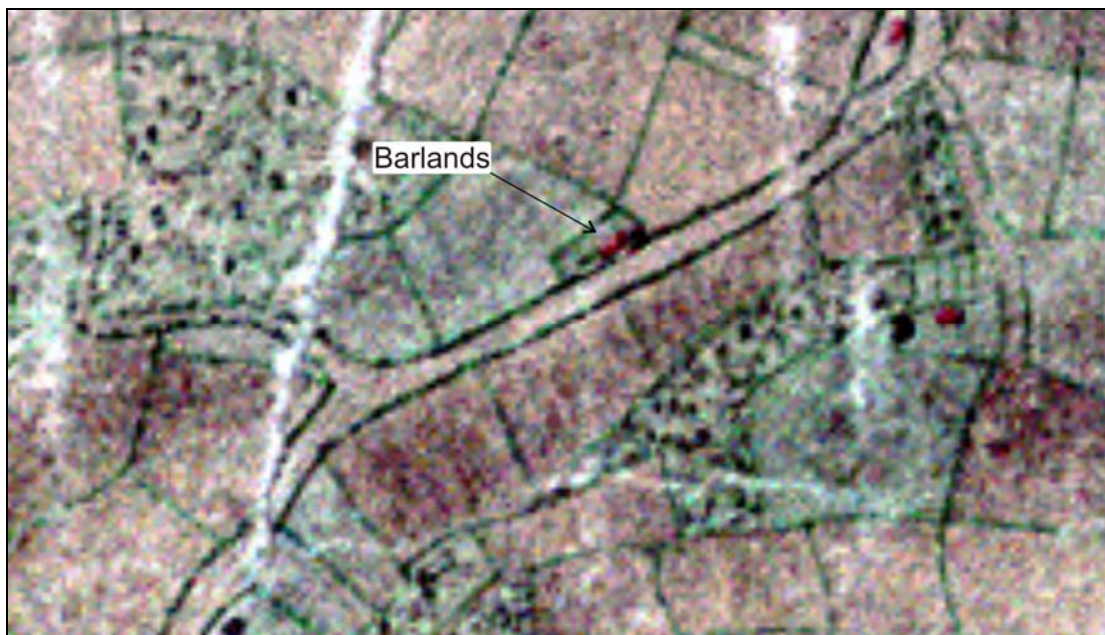
- 5.1.1 The surveyor's draft Ordnance Survey map shows the property comprising an east - west oriented domestic range (shaded pink). A pair of probable ancillary building are shown flanking the house (shaded grey). The scale is insufficient to determine any further detail at this stage (Figure 2).

Figure 2: Ordnance Survey Surveyor's Draft c.1800

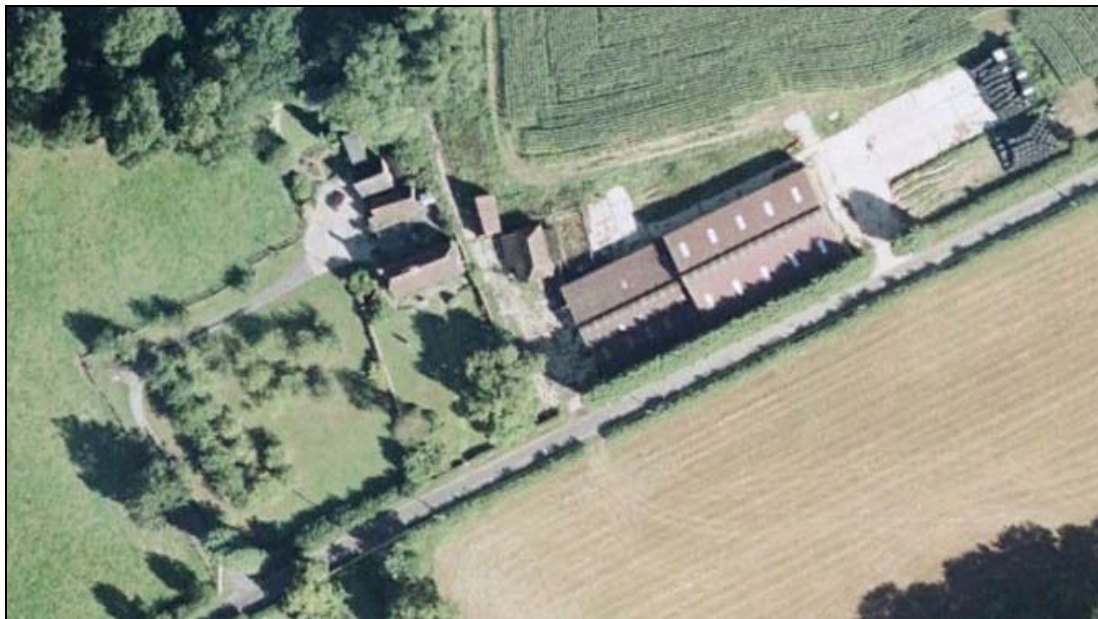
Figure 8: Google Earth image of the property taken in January 2001 showing the expansion of the modern farmstead to the east of Barlands and the additional buildings to the north of the domestic group

- 5.2.7 By 2001, the detached building to the northwest of the house had been removed and two new buildings had been added to the north of the existing north ancillary range (Figure 8). The farmstead to the east had gained a further substantial multi-purpose shed at its eastern side close to the highway (Figure 8). The southern of the two surviving historic farm buildings had been further truncated at its south end (Figure 8).

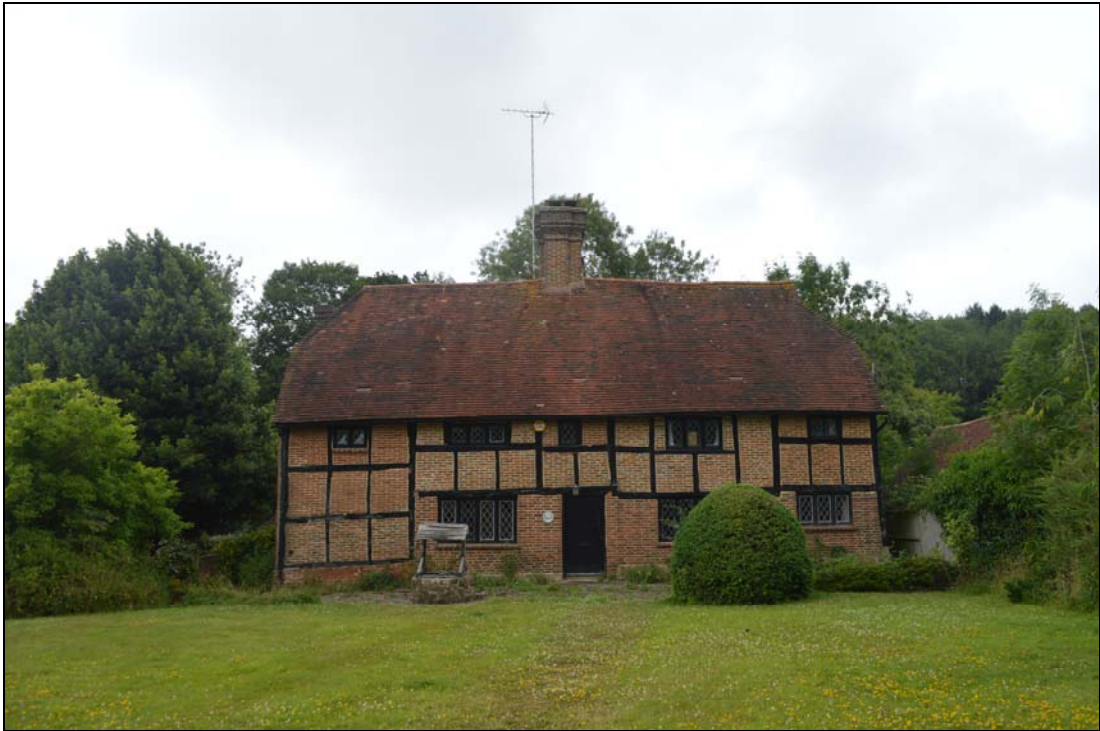
- 6.1.9 The wall framing at the western end of the house on its southern side lacks a side-girt that is included in all other areas of extant framing, suggesting that this part of the wall has been made to match aesthetically, perhaps to fit the remains of the earlier frame within the building (Plate 1). The rebuilt south elevation may relate to the Phase 4 building campaign, or indeed later phases of construction with the aim to make the fabric on the publicly visible southern side of the building broadly match.

Plate 1: The south side of the house as arrived at by the 18<sup>th</sup> century showing the contrast in construction between the rebuilt western end and its predecessors to the east

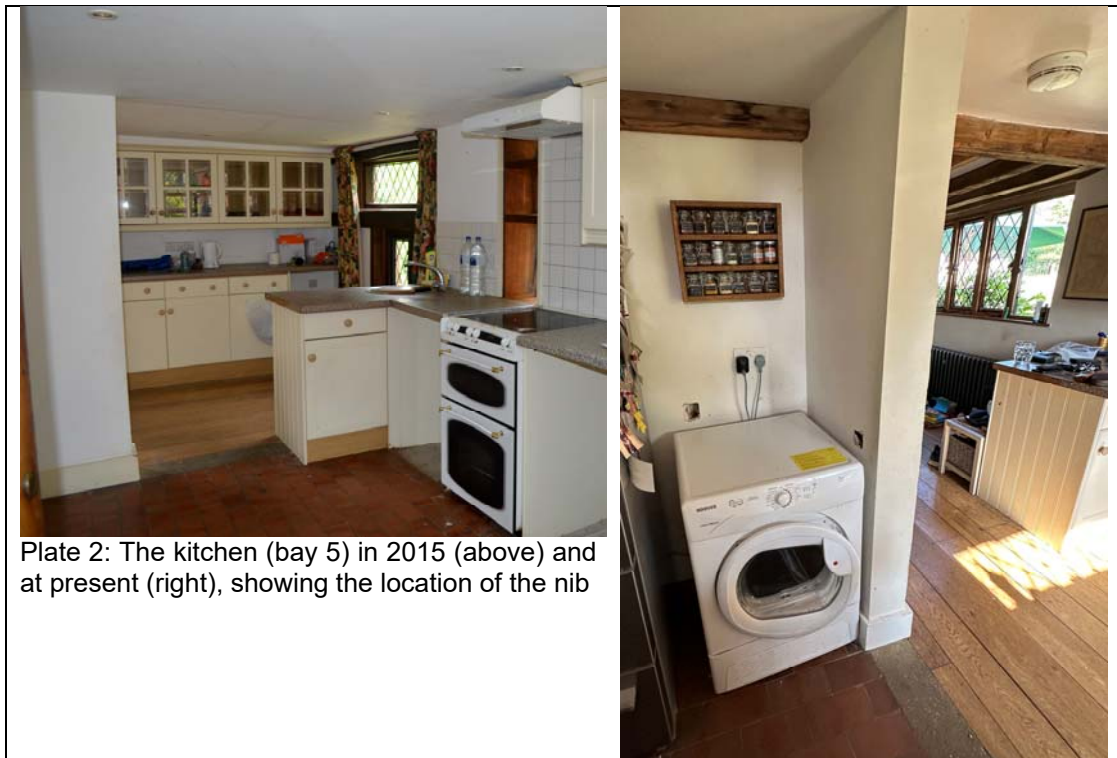
8.2.1 The east – west projecting 'nib' appears to be the remains of a partition wall inserted into the western bay of the building (bay 5). The concrete base extant in the floor surface, in addition to a step in the ceiling finishes, clearly show the continuation of the wall-line (Plate 2).

Plate 2: The kitchen (bay 5) in 2015 (above) and at present (right), showing the location of the nib

8.2.2 Keyhole investigations involving the removal of areas of plaster-board on the side of the existing nib revealed block-work, fabric commensurate with the concrete base extant in the floor and the step in the ceiling, the features clearly indicative of 20<sup>th</sup>

century alterations to the building, with most of the wall subsequently removed leaving the nib in situ as it abuts the partition between bays 4 and 5 (Plate 2).

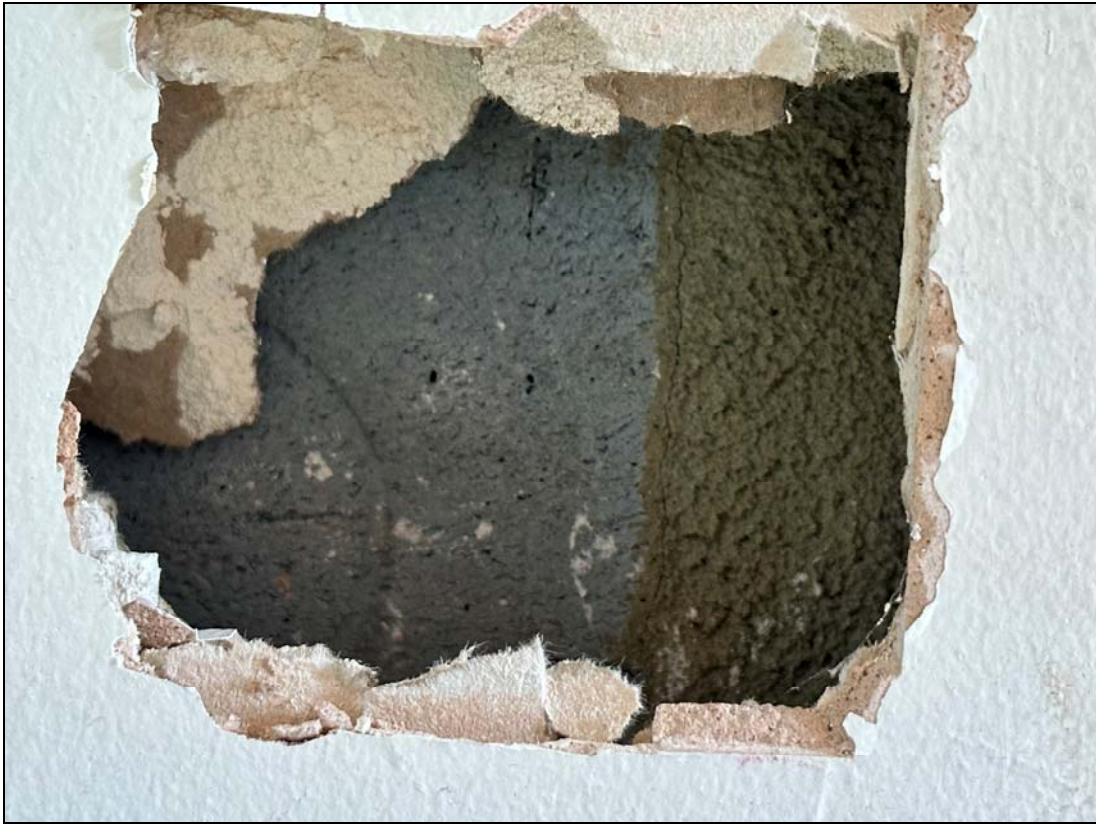
Plate 3: Detail of the block-work revealed behind the modern plaster board dry-lining system

- 8.2.3 The proposed removal of the remainder of the block-work wall will affect only modern, 20<sup>th</sup> century material. The removal of the block-work remains will reinstate the proportions of the bay and in so doing better express the original form of the room and the western end of the building as first built in the mid-to-late 16<sup>th</sup> century, or very early in the 17<sup>th</sup> century.

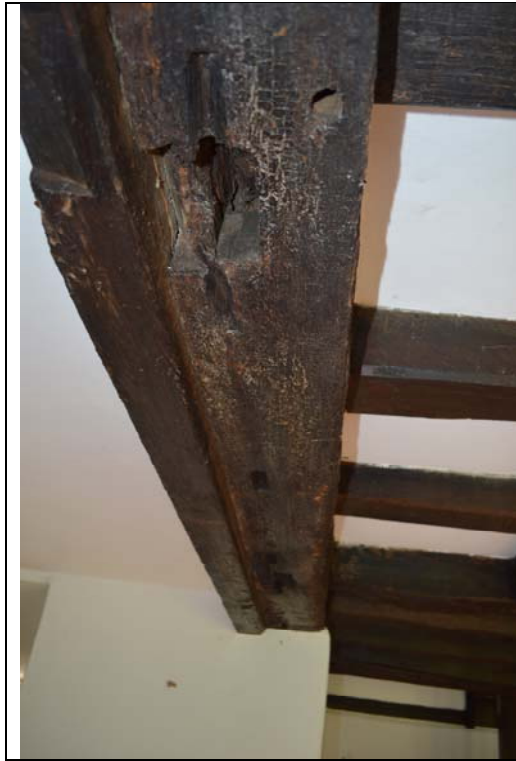
- 8.2.6 The earlier of the two beams is situated to the east and includes soffit jointing for infill, comprising a pair of stud mortises and a series of rectangular stave-holes (Plate 4). The jointing is set towards the west side of the beam, commensurate with the location of an end wall.

- 8.2.7 The beam to the west side of the T5 cross-beam is of lesser scantling, lacking any soffit jointing (Plate 4). It is unclear when the later beam was added, although it is suggested that this took place either with the rebuilding of the T5 partition, which based on keyhole investigations is in brick in whole or in part, or inserted into the building when the eastern part of the wall was removed to create the existing wide opening between bays 4 and 5 (Plate 5).

Plate 4: The two adjacent beams at the junction of bays 3 and 5

- 8.2.9 The scheme has been revised to relocate the new fixture to the more modern beam: this focuses the alteration on the most recent fabric and ensures that the soffit jointing extant on the neighbouring, earlier, beam will remain visible and unaffected by the installation.
