**Ref: The Potting Shed at The Holt, Ardingly.**

The Ecology Co-op undertook a bat scoping assessment at the Holt Property on Selsfield Road near Ardingly on the 23<sup>rd</sup> of December 2024 at the request of Philip Stinson. This assessment was undertaken further to a proposal to renovate this building, which is in a serious state of decline. The survey was undertaken in accordance with best practice guidance produced by the Bat Conservation Trust<sup>1</sup>.

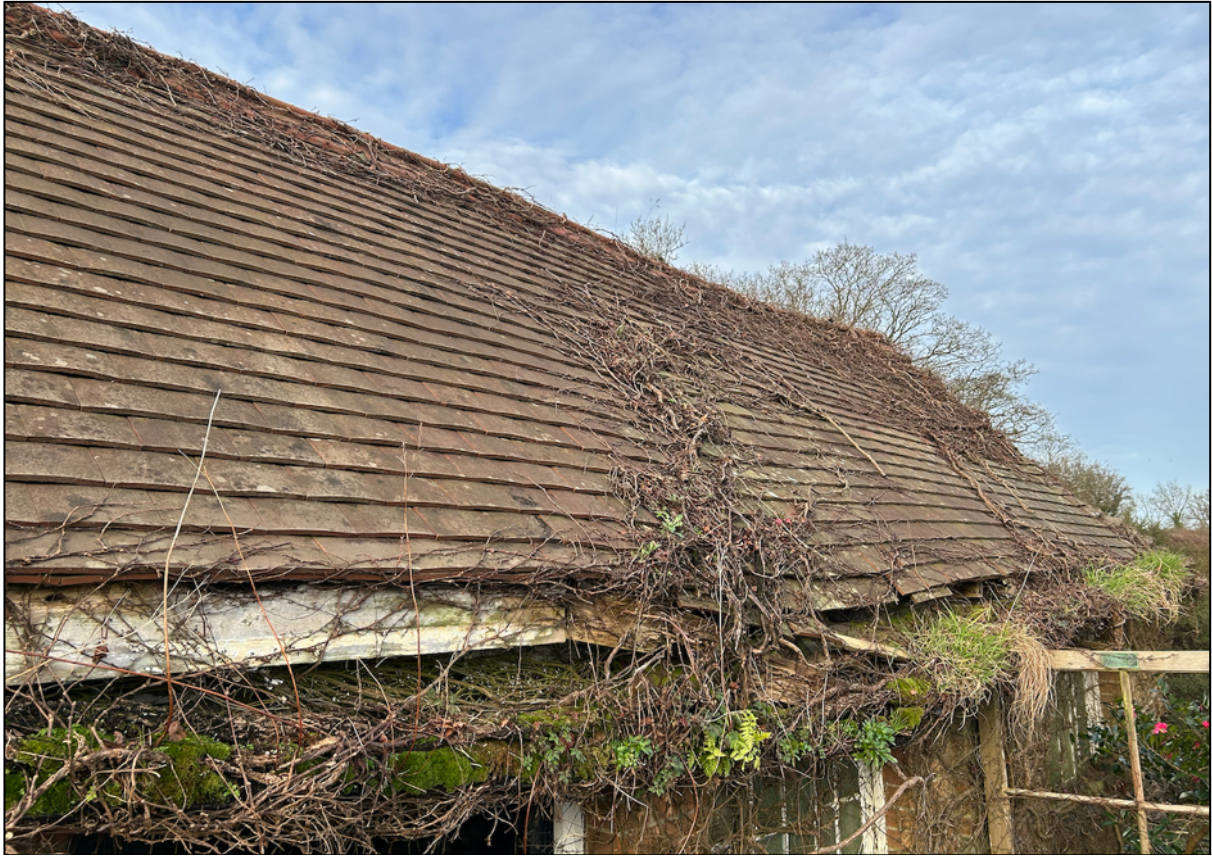
**Photograph 1.** The eastern face of the potting shed roof, with generally tight-fitting roof tiles, but clear signs of decay.

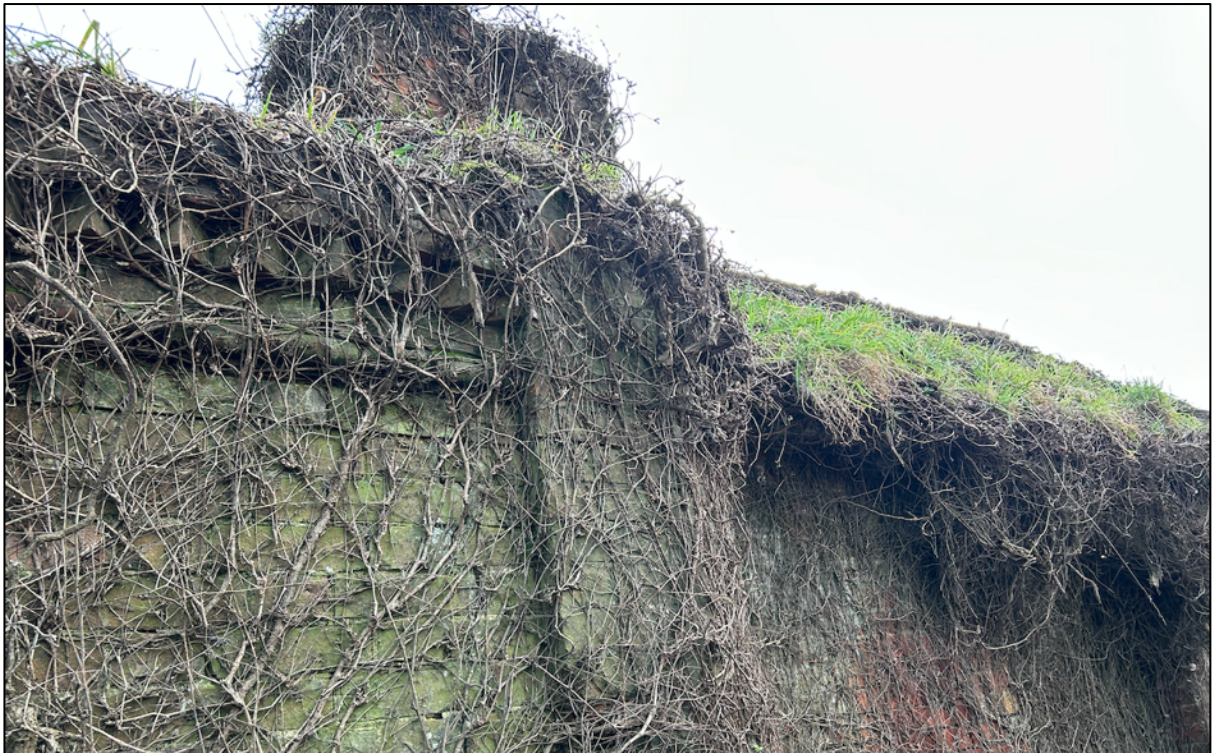
**Photograph 2.** A restricted view of the western face of the shed, which sits directly adjacent to the B2028

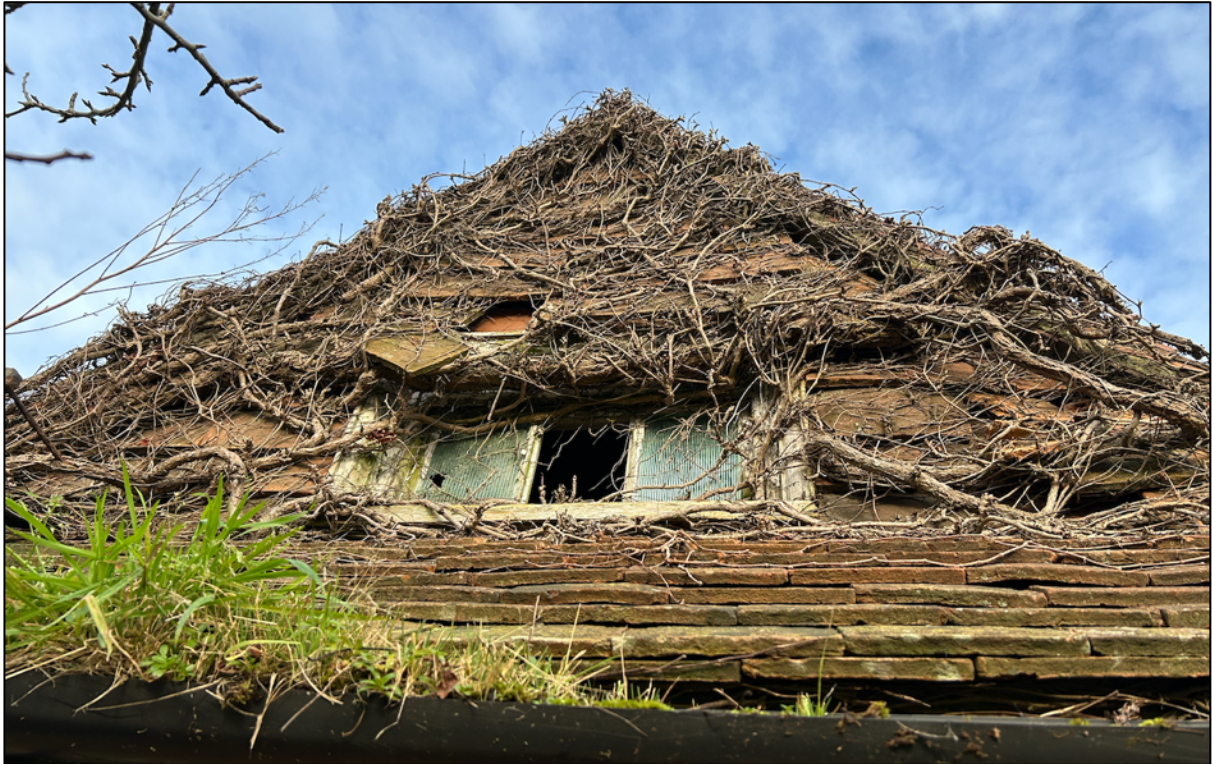
**Photograph 3.** The southern face of the building, where there are some large tile gaps there were closely inspected from a ladder. No evidence of use by bats was found.

2. Prior to commencement the loose tiles identified must be inspected with an endoscope by a suitably licensed ecologist where practically accessible. In the unlikely event that bats are found roosting within these features, works will not be allowed to commence until a bat licence has been applied for and approved by Natural England. This may require further surveys to inform the licence.

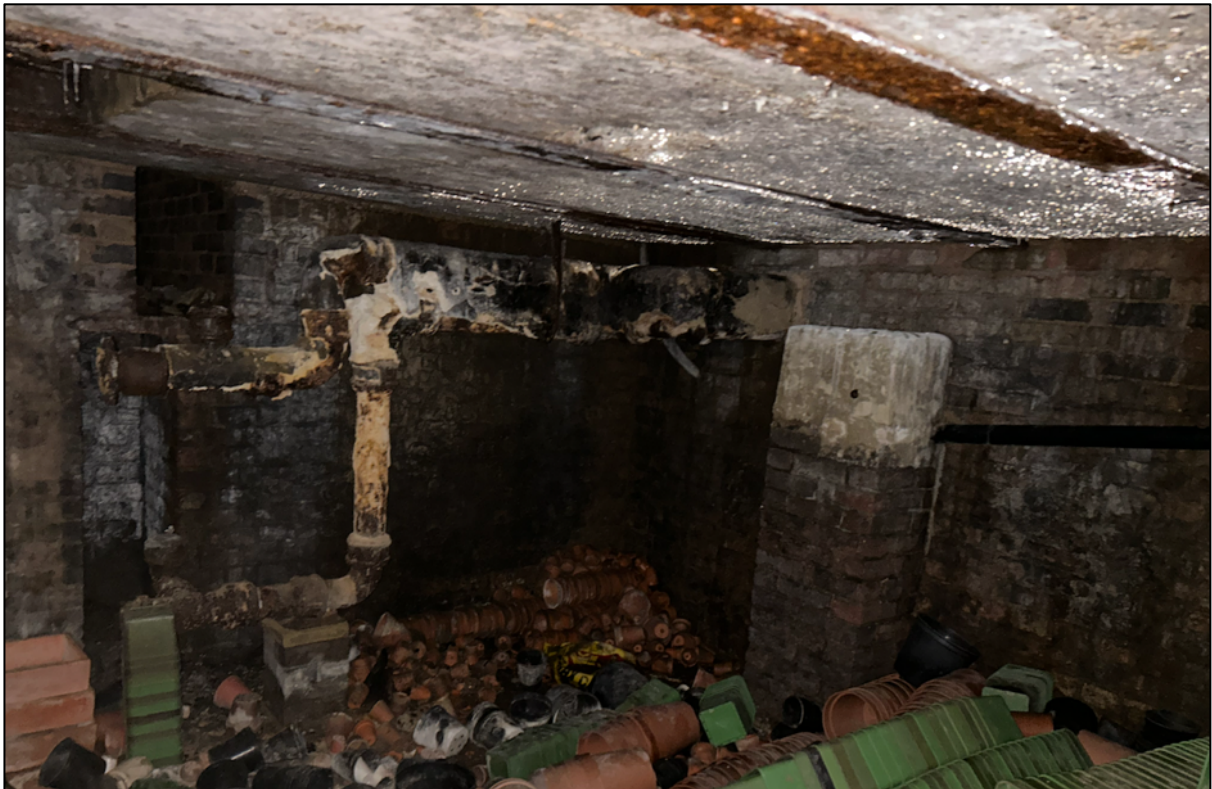
**Photograph 4.** An underground area understood to have formerly been used for heating a greenhouse.

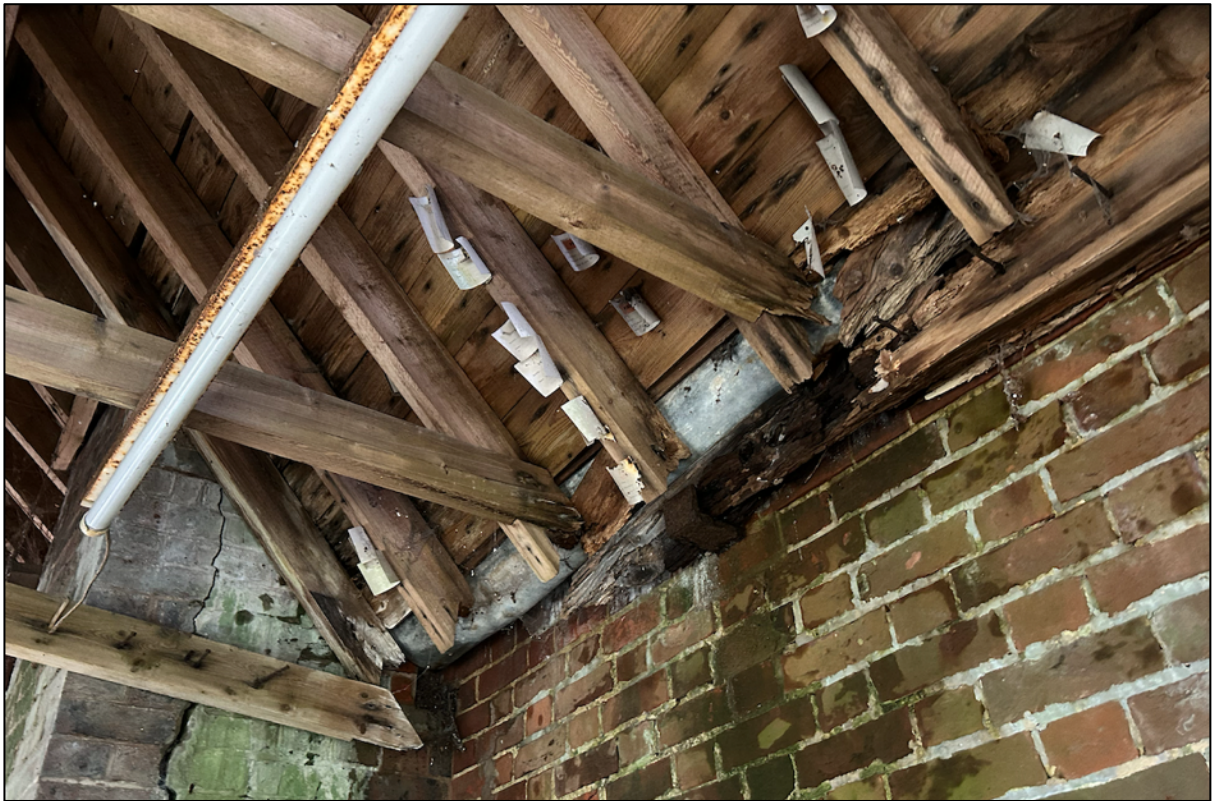
The proposals include urgent repairs to the building and its refurbishment. Part of the roof on the western face has badly degraded and has slumped away from the wall plate, whilst underlying damage to the western wall was also visible. This work will include the replacement of the roof, with damage to the rafters visible.

**Photograph 5.** A degraded section of roof on the western side of the building where the rafters have detached from the wall plate.

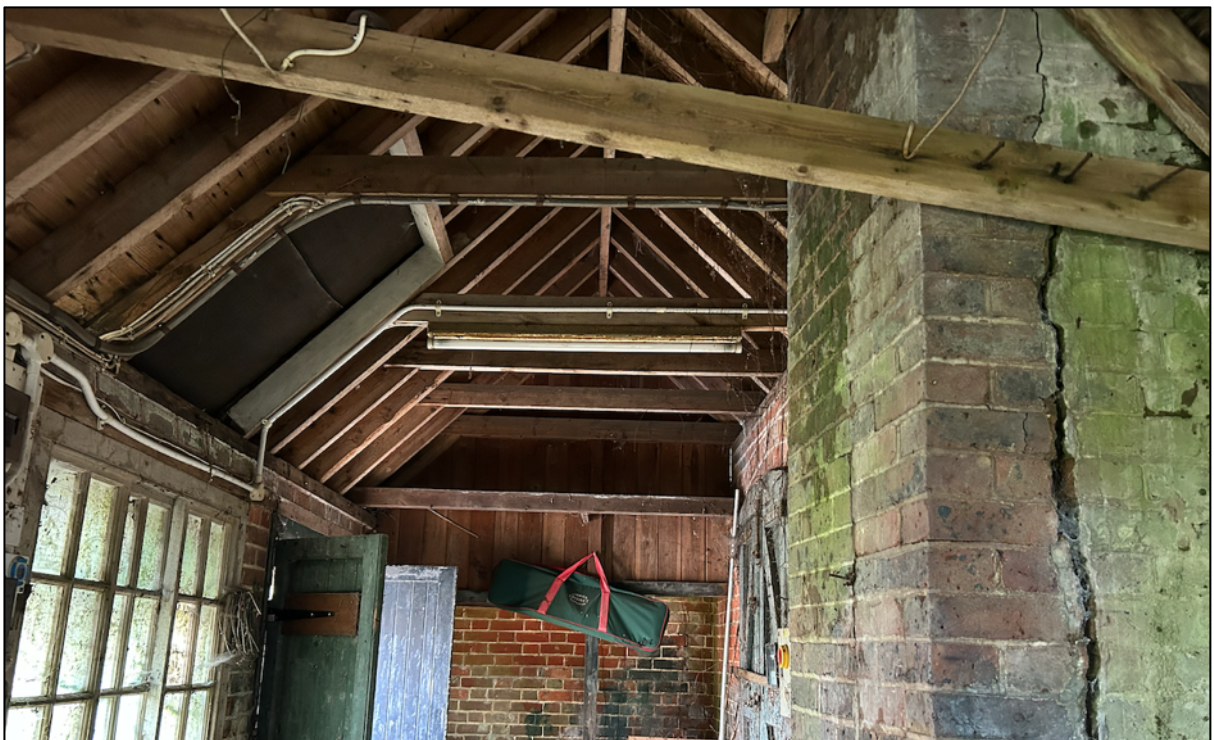
| Building section | Description of features | Assessment of suitability (Collins 2016) |
|---|---|---|
| Interior | <p>Internally the building is open to roof height and is clad with timber sarking. Some light cobwebbing was visible along the ridge of the roof. At the northwestern corner a partial collapse in the roof has led to a section of the roof dropping below the wall plate.</p> <p>A chimney breast is present on the western wall, with a large crack visible up most of its length, though this is not a sufficient crevice for bats.</p> <p>The internal aspects are lit via a small window on the northern face and two larger windows within the eastern wall.</p> <p>An underground former heating room for a former greenhouse positioned next to the potting shed was inspected for its potential to support hibernating bats. This space has a concrete lintel roof that is devoid of features that might support bats and similarly the brick walls appear largely featureless. Whilst the whole space could not be explored extensively, it appears to lack suitable features for hibernation, though of note a single egg sack for a cave spider (<i>Meta sp.</i>) was noted.</p> <p>No evidence of use by bats could be found inside the building, through close inspection.</p> | Low bat roost suitability |

**Photograph 6.** The internal aspect of the shed, which is open to roof height and well lit.
