# **Land Contamination and Ground Condition Report**

**Birch Trees Farm Cuckfield Road Ansty West Sussex RH17 5AG**

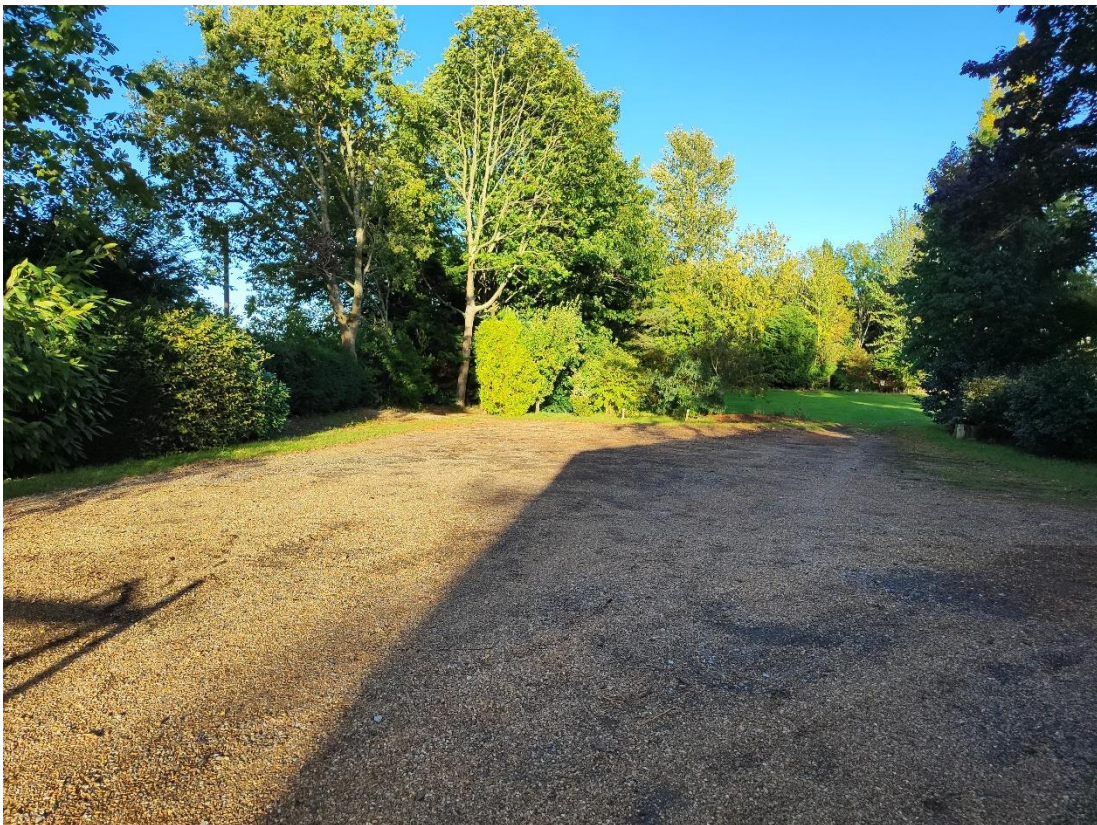
The dwelling and associated development, will be located on a hardstanding surfaced area, made up of a hardcore base and gravel. This area is currently used as additional parking area for the adjoining caravan site, which has been running for the past 40 years. There is a utilitarian building on the application site, which will remain in situ.

Site Location (from the east)

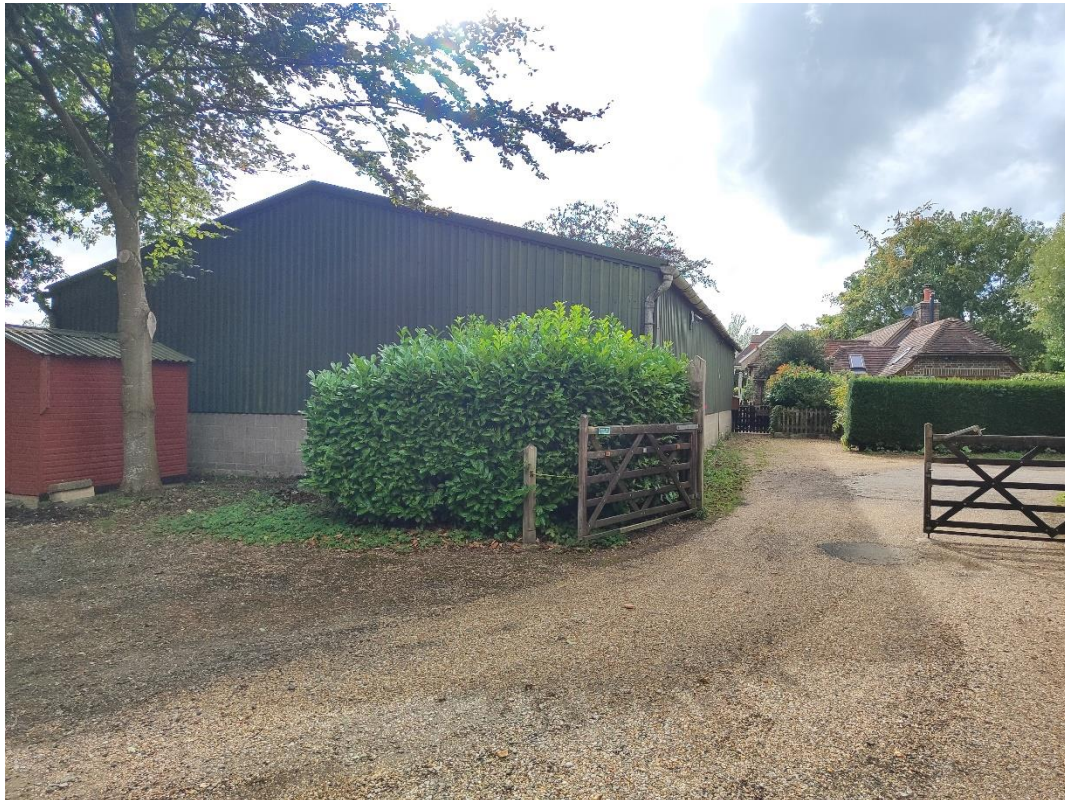
Utilitarian building to the west of the proposed dwelling site

The site area includes a utilitarian building which historically has been and is still used for the following activities.

- Garden and agricultural machinery storage and workshop.
- Wood store.
