Preliminary Ecological Appraisal and Preliminary Roost Assessment

Survey site: Badgers Brook, London Road, Bolney, RH17 5PY

Client: MGR Horsham Ltd

The demolition of the current buildings on site and the construction of six residential dwellings.

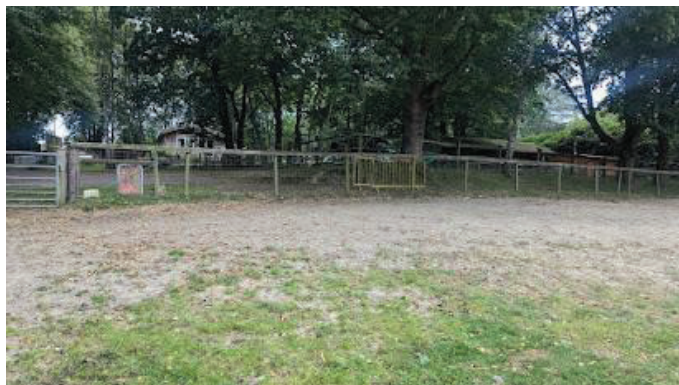
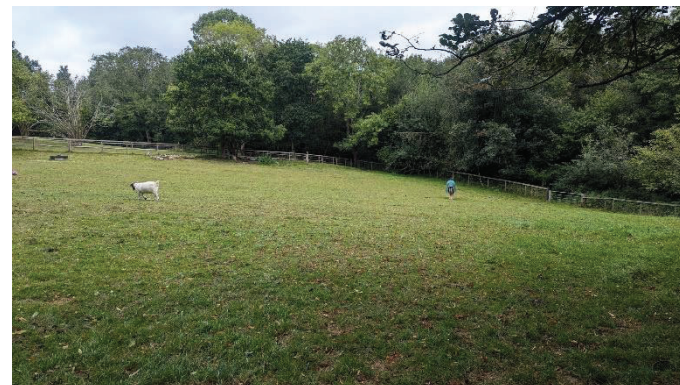
w1f7- Other Lowland mixed deciduous woodland

A woodland is located to the east of the site, and continuous offsite for several hectares. Species presents include sycamore, birch, ash, lime, and cherry. A dense understorey is present and consists of consists of elder, bracken, and nettle.

<i>Recommendations</i>	Best practice measures to minimise the impact on the deciduous woodland must be implemented during construction. A Construction Environment Management Plan (CEMP) may be required for this. Heras fencing should be installed to prevent encroachment onto the deciduous woodland.
Locality and Designated Sites	
<i>Summary of Survey Findings</i>	There are no designated sites within a 2km radius of the site.
<i>Foreseen Impacts</i>	No impacts foreseen due to the distance from the designated sites and small size of the project.
<i>Recommendations</i>	None required.
Invasive / Non-native species	
<i>Summary of Survey Findings</i>	Rhododendron ponticum was identified on the site, which is listed as an invasive, non-native species under Schedule 9 of the Wildlife and Countryside Act 1981.
<i>Foreseen Impacts</i>	The proposed plans may disturb the rhododendron.
<i>Recommendations</i>	Rhododendron should be dug up, including roots, and disposed of in line with appropriate controlled waste measures.

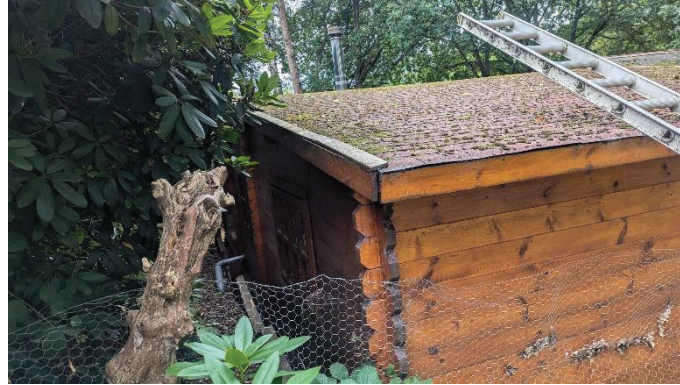
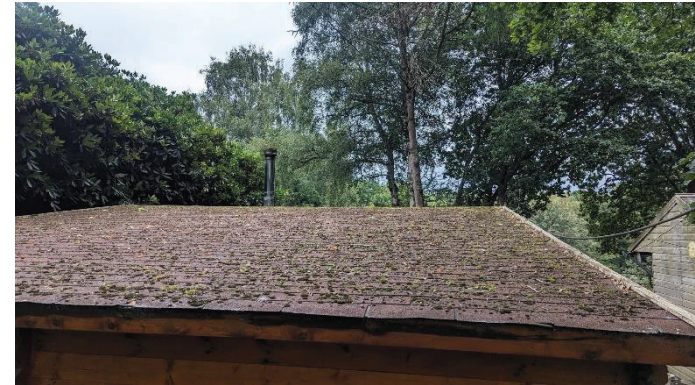
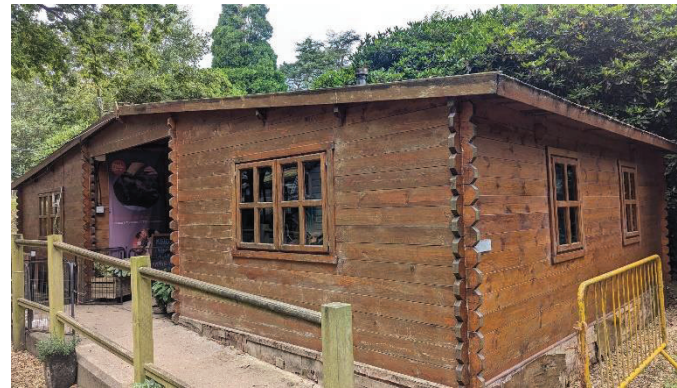
B3 is a timber cabin with a with a gabled roof lined with bitumen flet. The timber slats have no gaps underneath. The bargeboards, soffits, and window and door frames appear in good condition with no gaps present. The bitumen felt has no tears or gaps present. There is no lift space present in this building.

This building was assessed as having negligible roosting value for bats due to the lack of roosting features.

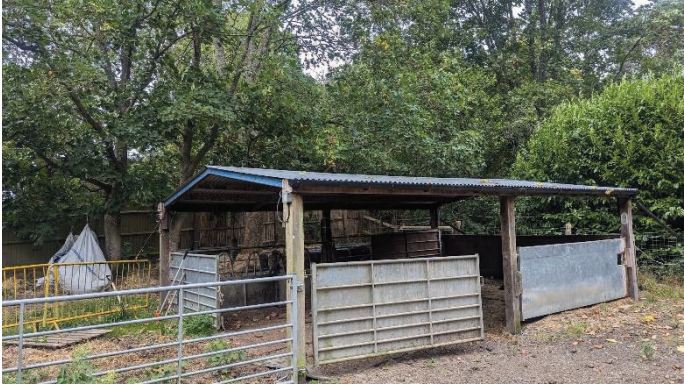
B4 is an open sided shelter constructed of timber beams and a corrugated metal roof. The roof is single skinned so no crevices are present for roosting. The interior is exposed to external conditions and light creating unsuitable habitat for void dwelling bats.

<p>This building was assessed as having negligible roosting value for bats due to the lack of roosting features and the abundance of light and exposure.</p>

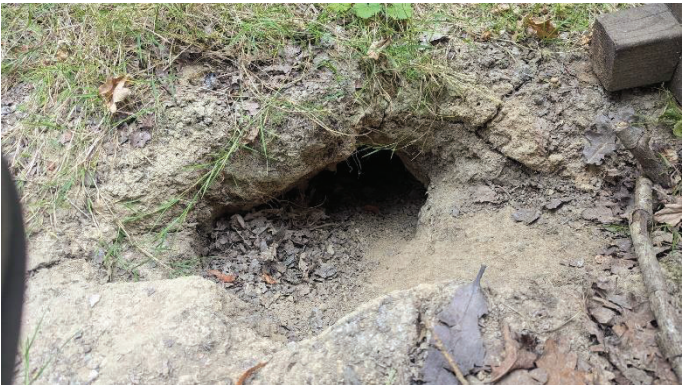
Badger	
<i>Summary of Survey Findings</i>	<p>A single badger hole was present at the northern elevation of the site. The hole had leaf litter present around the entrance. Badgers often keep holes clear, so this indicated a lack of use of the hole. However, badgers often return to holes occasionally.</p> <div style="text-align: center;">

</div> <p>Grassland, woodland, and scrub on site can provide good foraging and commuting habitat for badgers. There is good connectivity to the wider landscape due to hedgerows, grassland, and woodland.</p>
<i>Foreseen Impacts</i>	<p>The proposed development will occur nearby to the sett entrance. Works could result in the disturbance or damage of the badger sett on the site and could kill or injure any badgers present.</p>
<i>Recommendations</i>	<p>Badger surveys will be required to characterise the sett types present and the usage of the site by badgers. This will comprise the deployment of wildlife cameras over a period of 3-4 weeks and such surveys can be undertaken throughout the year, in accordance with current survey guidelines (Harris et al, 1989). Disturbance, damage or destruction of active badger setts will require a badger development licence.</p>
