**GEOTECHNICAL  
ASSESSMENT REPORT**

**HILGAY COTTAGE  
BIRCHWOOD GROVE ROAD  
BURGESS HILL  
WEST SUSSEX**

**PROJECT REFERENCE: P17576**

**REPORT REFERENCE: R17049**

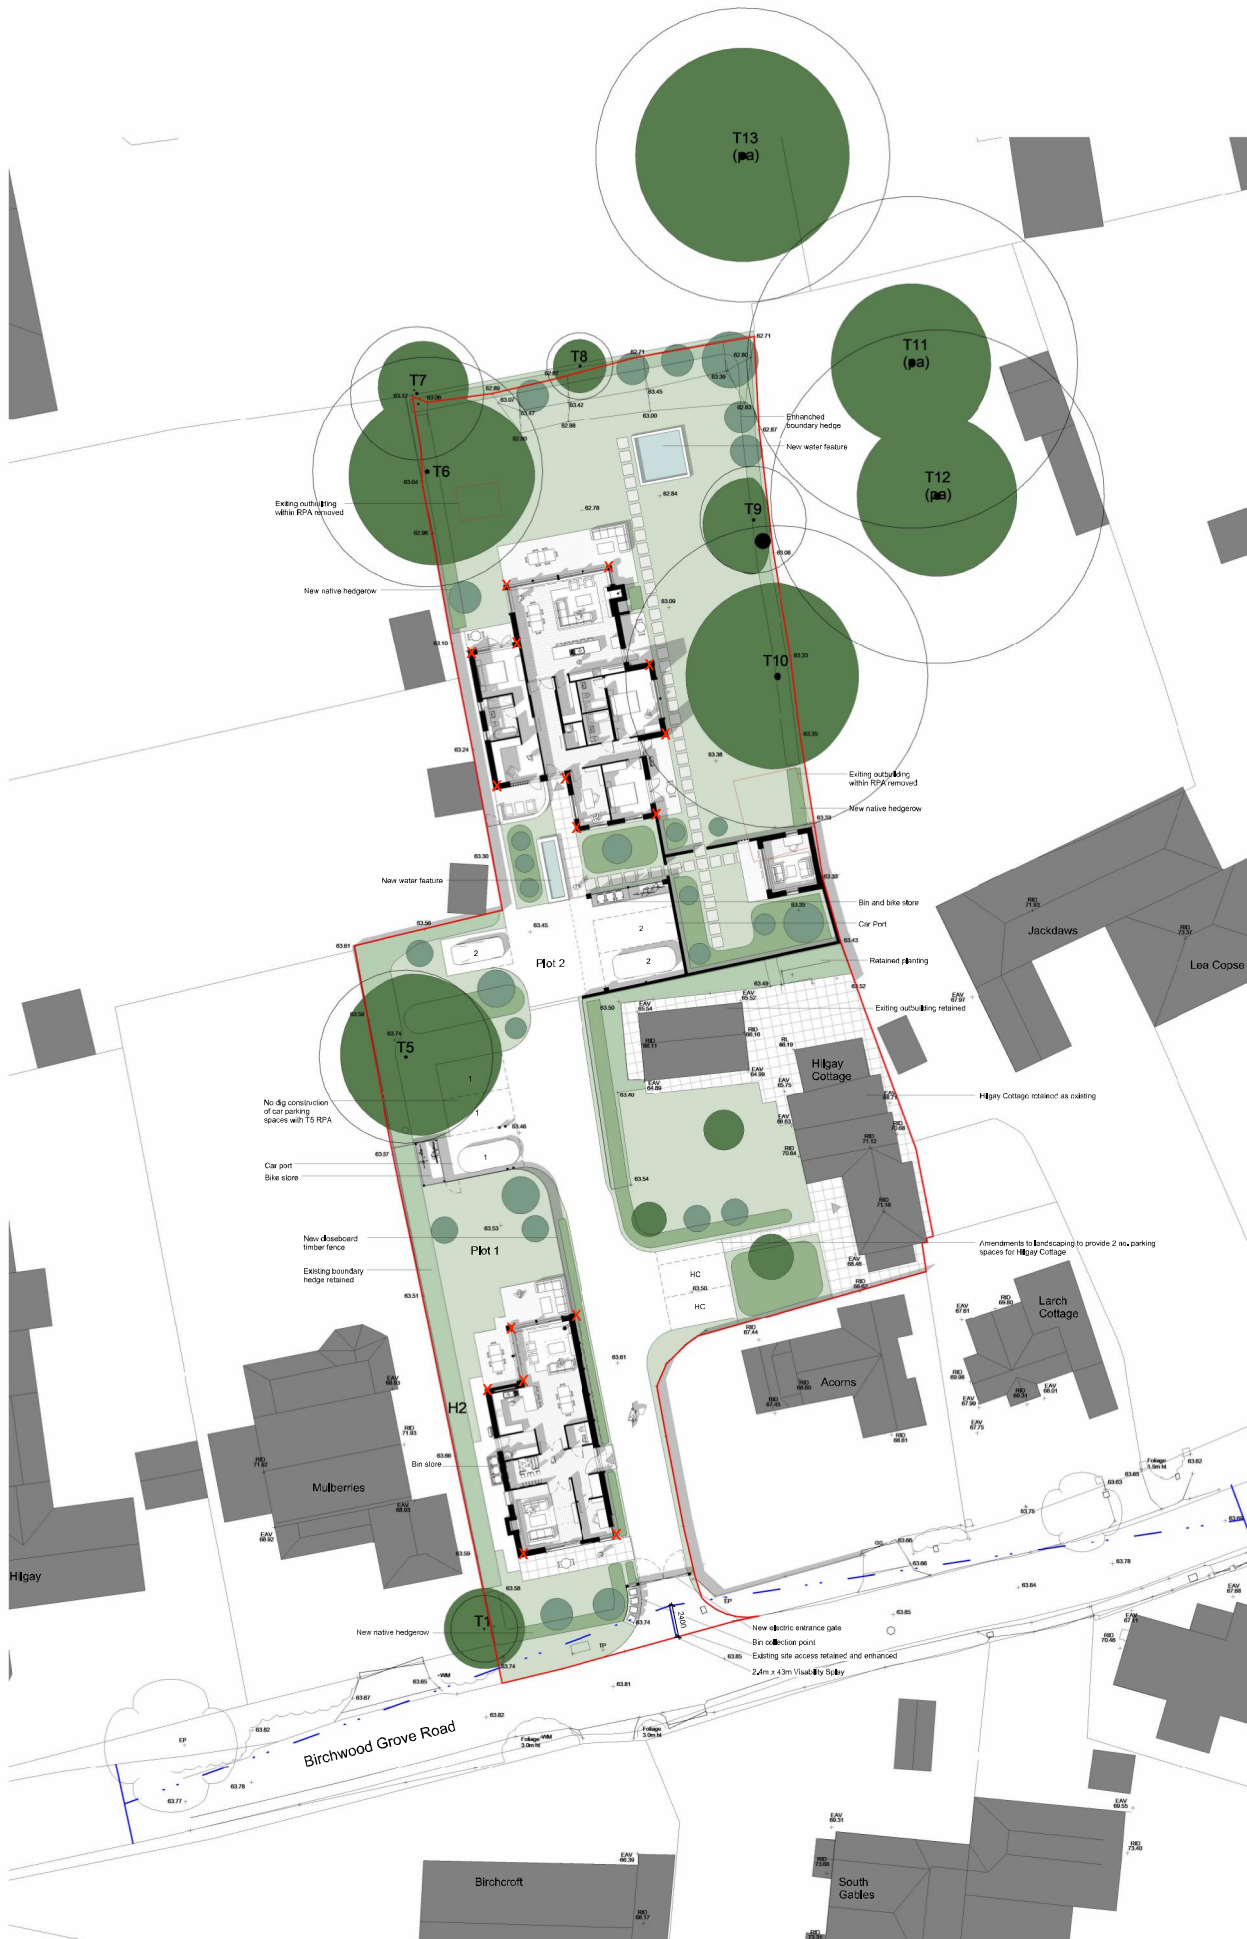
### Proposed Development Layout

The development proposals are understood to comprise the construction of two dwellings, complete with an access road, parking areas, gardens, areas of both hard and soft landscaping and a separated garden room for plot 2.
