**GEOTECHNICAL AND  
GROUND CONTAMINATION  
RISK ASSESSMENT REPORT**

**IMBERHORNE  
LOWER SCHOOL  
WINDMILL LANE  
EAST GRINSTEAD  
WEST SUSSEX**

**PROJECT REFERENCE: P17617**

**REPORT REFERENCE: R17152**

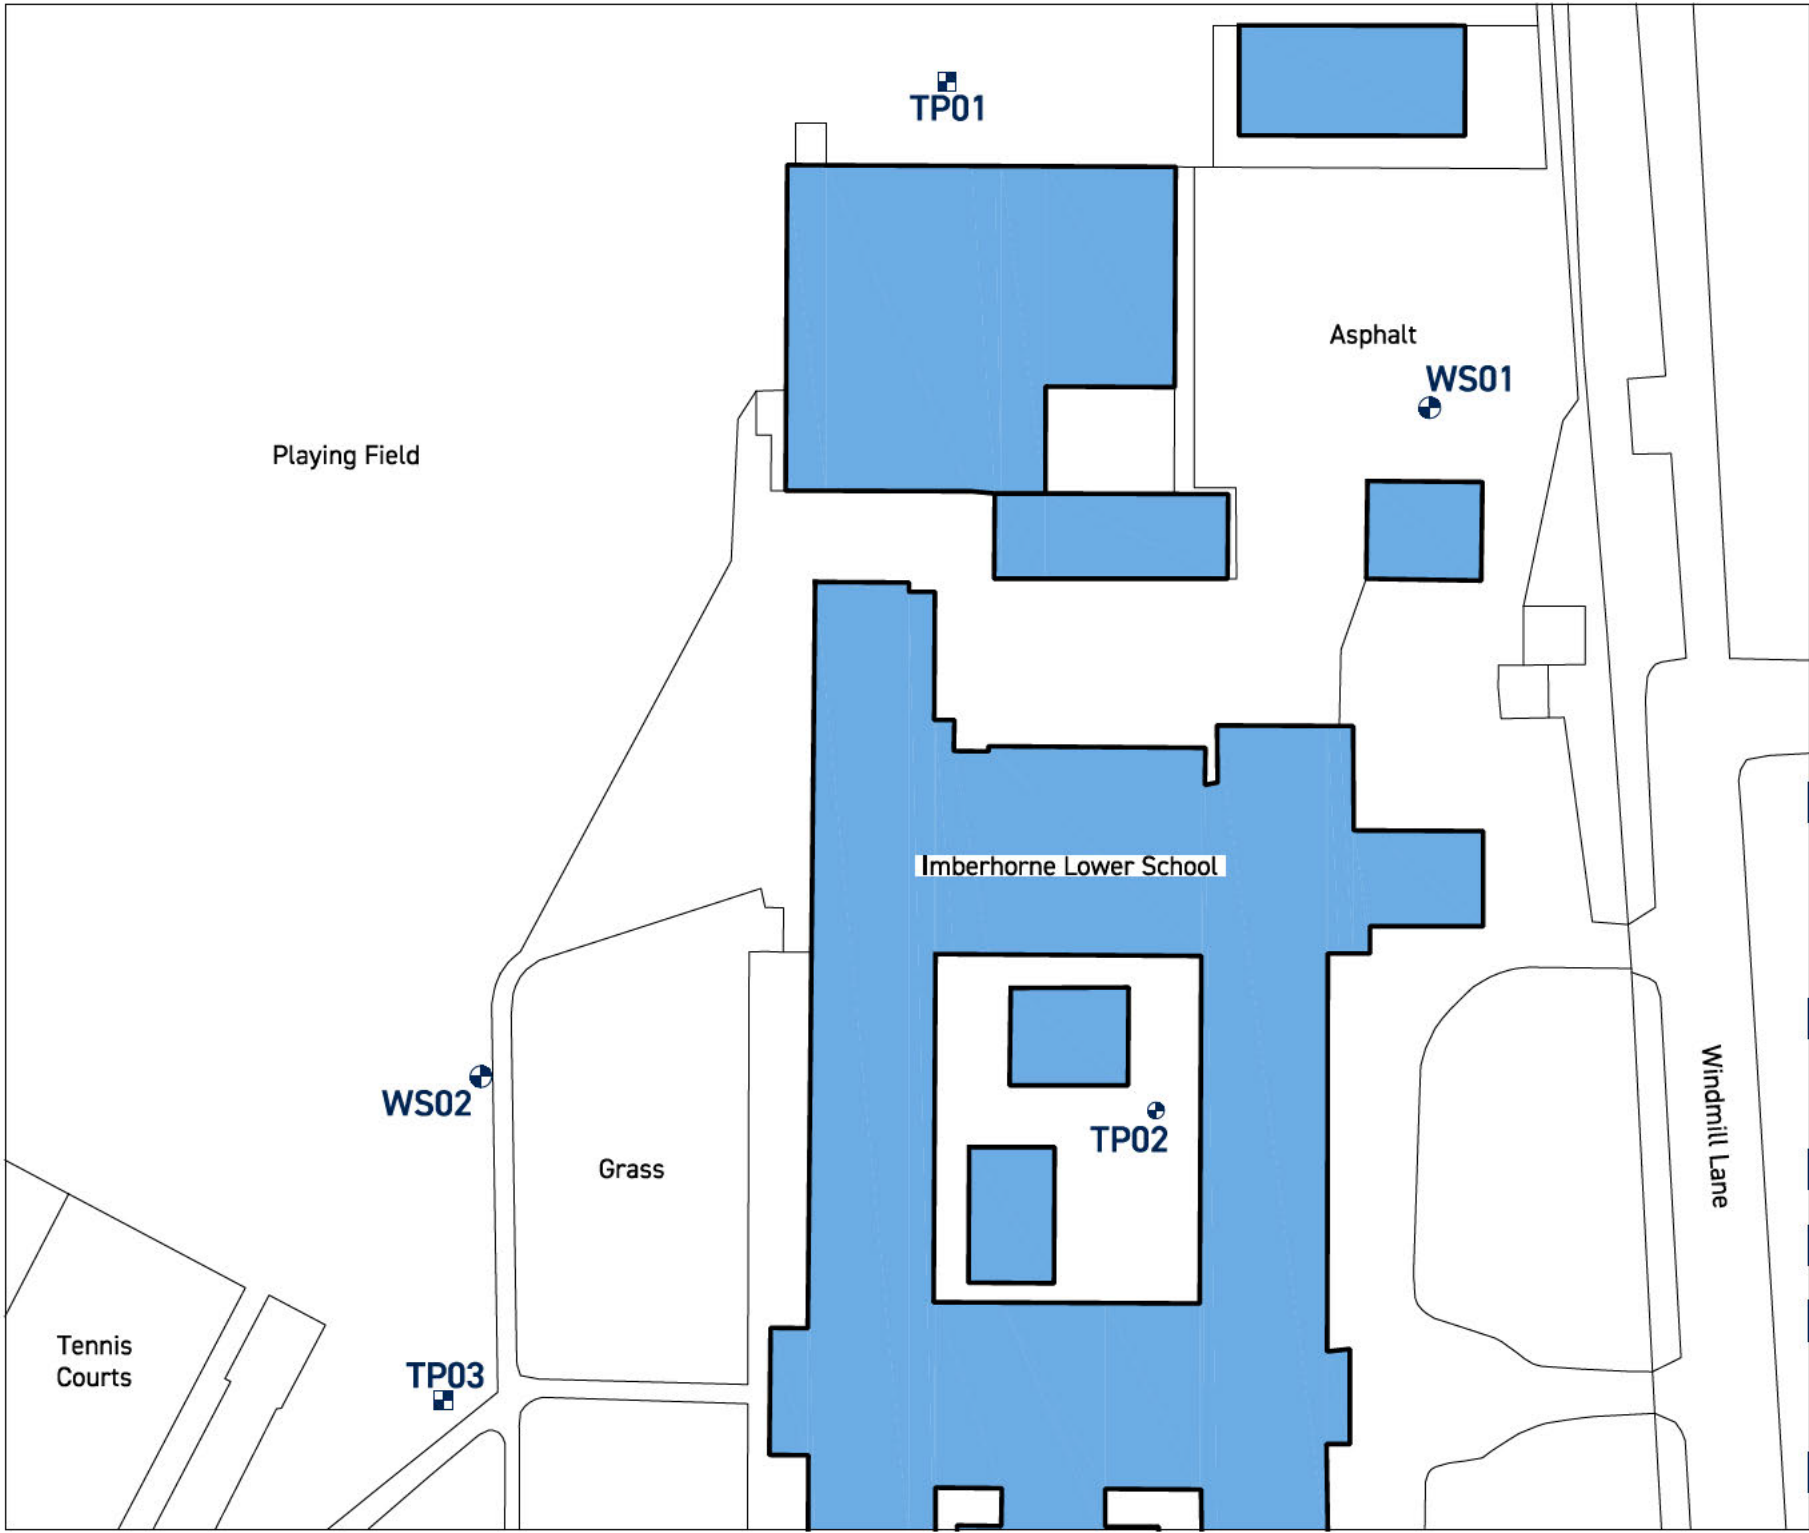
- Figure 1 Site Location Plan
- Figure 2 Site Plan
