**BS5837:2012 TREE SURVEY AND  
ARBORICULTURAL IMPACT ASSESSMENT:  
Marshalls Manor, High Street, Cuckfield, RH17 5EL**

Our reference: GHA/DS/164440:23

Location: Marshalls Manor, High Street, Cuckfield, RH17 5EL

Client: Gould Baxter

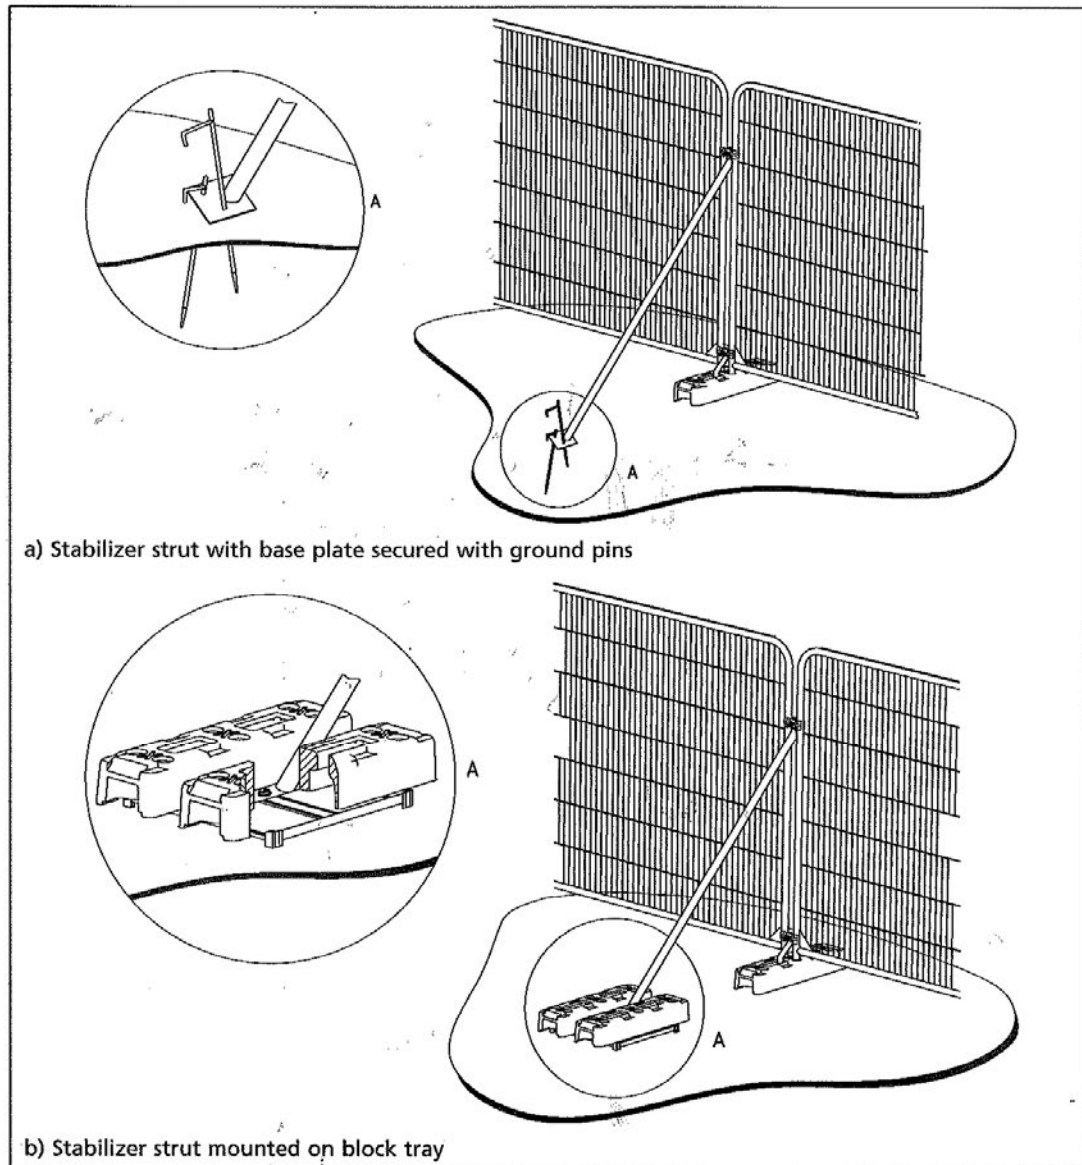
Figure 3 Examples of above-ground stabilizing systems

**Appendix C**  
**TREE FENCING DETAIL**

It is essential for the future health of the trees to be retained on site, that all development activity is undertaken outside the root protection zone of these trees. The position of the fence **MUST** be marked out with biodegradable marker paint on site and agreed with appropriate representatives from the LPA and contractor. The fencing **MUST** be erected **prior** to any works in the vicinity of the trees and removed only when all development activity is complete. The protective fencing **MUST** be as that shown in BS 5837 (see Appendix C). The herras panels **MUST** be joined together using a minimum of two anti-tamper couplers which **MUST** be installed so they can only be removed from the inside of the fence. The panels **MUST** supported by stabilizer struts, which **MUST** be installed on the inside and secured to the ground using pins or appropriate weights.
