**BACKWOODS LANE, LINDFIELD**  
**RH16 2ED**  
PHASE I AND II GEOTECHNICAL  
ASSESSMENT  
**LINDFIELD PARISH COUNCIL**  
16<sup>TH</sup> FEBRUARY 2024  
**LS7360**

| <b>Project:</b> | <b>REDEVELOPMENT OF THE LAND INTO PUBLIC TOILETS</b> |
| <b>Client:</b> | <b>LINDFIELD PARISH COUNCIL</b> |

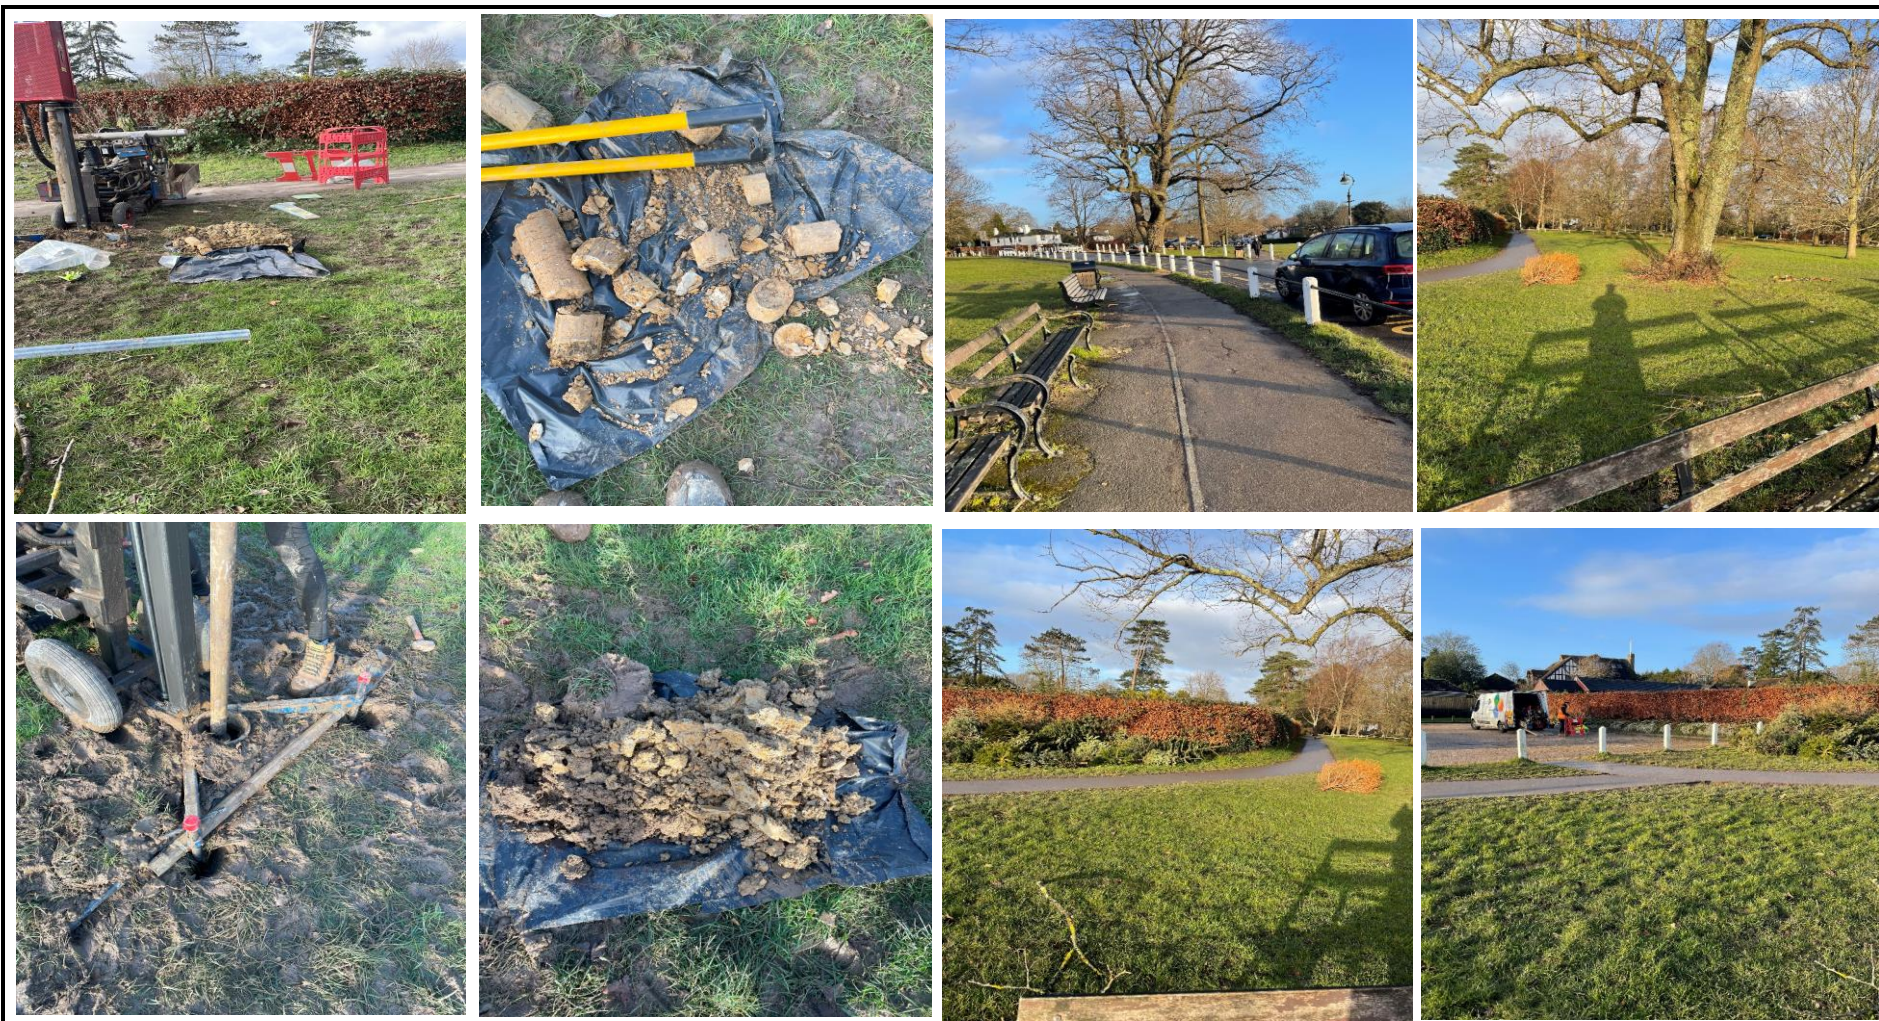
| | TITLE: Supplementary Investigation Layout | | REF: LS7360 | PREPARED: ON |

| | PROJECT: Backwoods Lane, Lindfield RH16 2ED | | FIGURE: 3 | CHECKED: ET |
