# BAT SURVEY AND ASSESSMENT REPORT

Greenworld, Canisron Lane, Ashurst  
Wood, West Sussex, RH19 3SD

| Type | Bat Survey & Assessment Report | | |

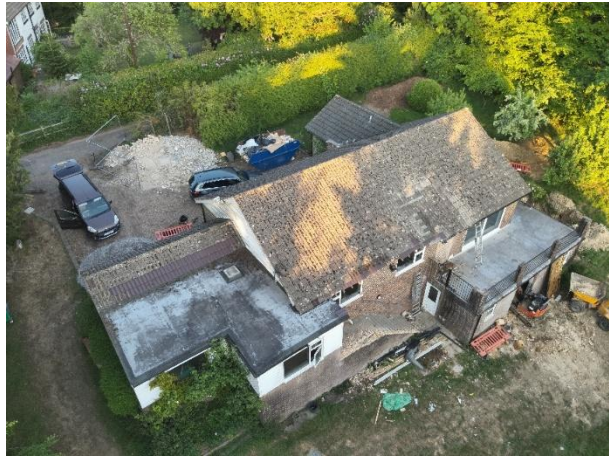
*Photograph 1.*

Aerial view of the site showing the roof structure taken using DJI Mavic 3T before the first survey on 13<sup>th</sup> May 20225. Lower row of roof tiles exposed creating new access points that could be used by bats. Chimney removed, small porch over main door removed and flat roof section around northwest corner removed.

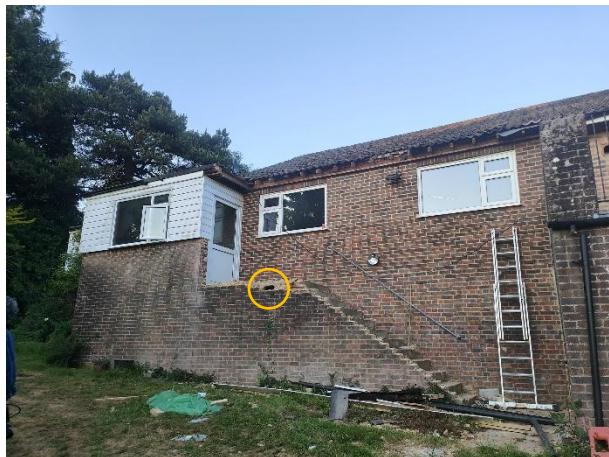
*Photograph 2.*

Wall cavity on external stairs before removed between first and third emergence survey (see below). Bottom row of tiles open where section of fascia missing.

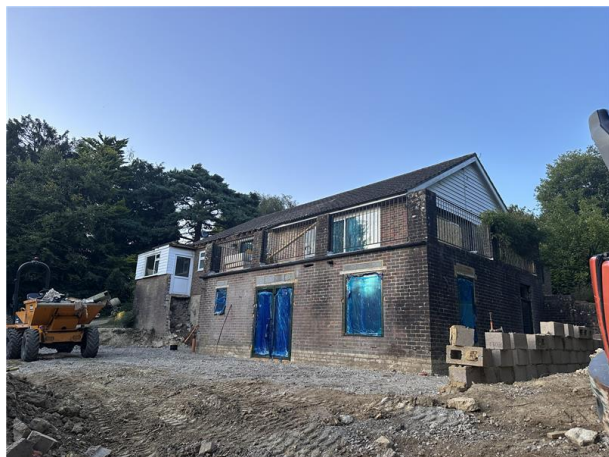
*Photograph 3.*

View of southwest elevations taken prior to final emergence survey on 14<sup>th</sup> July 2025 showing external stairs removed.

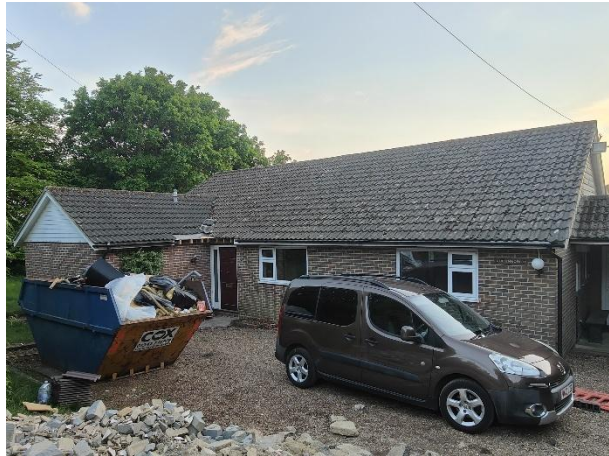
*Photograph 4.*

View from entrance to site of north and eastern elevations of main section of building and side extension showing missing section of fascia/ porch roof missing. Taken during update building inspection prior to first emergence survey visit on 13<sup>th</sup> May 2025

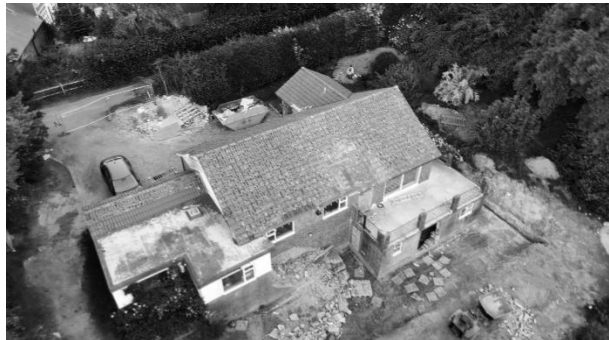
*Photograph 5.*

Drone footage taken 11<sup>th</sup> June 2025 showing the chimney and flat roof sections along southern elevation as well as staircase missing since initial PRA survey carried out in February (Arbtech, 2025)

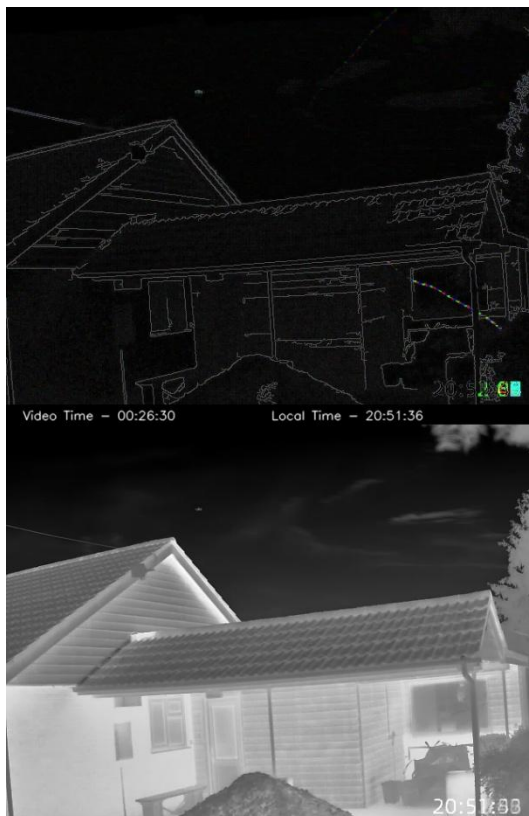
*Photograph 6.* Roost R1 – Ripped felt lining. Feature not directly viewed but bats first seen circling inside the open covered pitched roof area before flying out. Occupied by a maximum count of three common pipistrelle bats. Bat recorded using this feature on all three emergence survey visits. Wildlife Imaging Systems still image of infra-red camera footage at 20:51 for location S1A, 13<sup>th</sup> May 2025. For each of the roost photos top shows analysed composite image, below shows actual video footage (provided on first instance of surveyor location/ view).

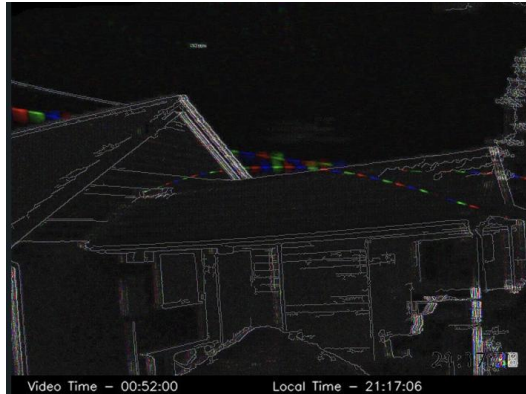
*Photograph 7.* Roost R2 - behind a section of weatherboarding where this meets the ridge of the open pitched northern section. – single common pipistrelle bat recorded using this feature during the first survey visit only. Wildlife Imaging Systems still image of infra-red camera footage at 21:17 for location S1A, 13<sup>th</sup> May 2025.

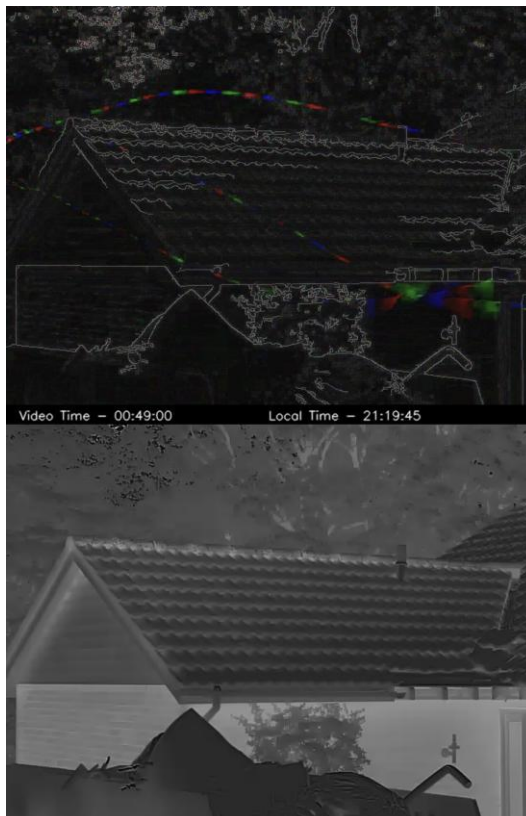
| Roost Number | Time | Species (Count) | Description | Photo |
|---|---|---|---|---|
| R3 | 21:19 | Common pipistrelle (1) | from under a section of missing fascia on the western elevation of the northern roof section. | Photograph 8 |

*Photograph 8.* Roost R3 - Single common pipistrelle bat recorded emerging from under missing section of fascia/ where porch is missing on northeast elevation during first survey only. WIS still image of thermal imaging camera footage 21:19 Location S1, 13th May 2025.

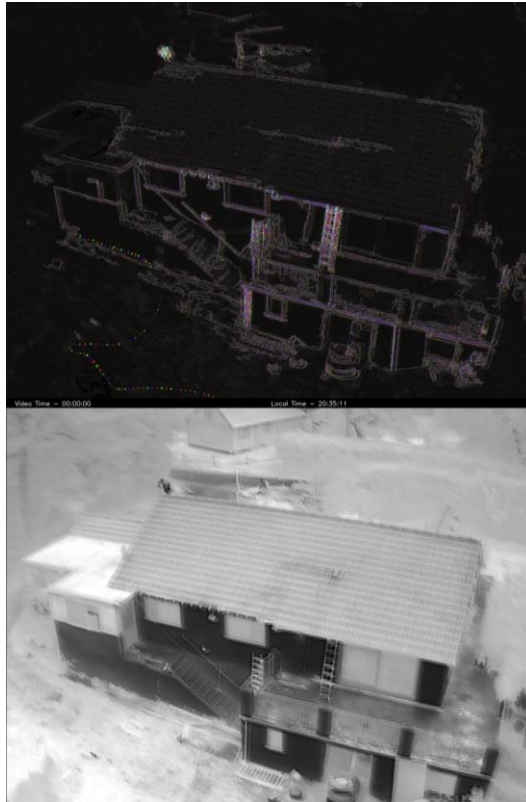
*Photograph 9.* Roost R4 - Two common pipistrelle bats recorded to likely emerge from a wall cavity around northwest corner during first survey visit on 13th May 2025 only. WIS still image of bat recorded to emerge at 21:35 (also recorded at 21:45).

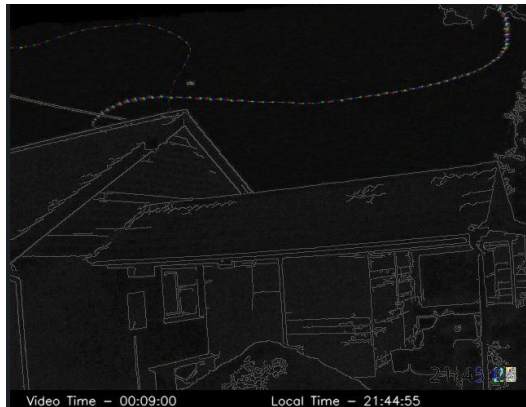
*Photograph 10.* Roost R5. Single common pipistrelle recorded to emerge from under ridge tile eastern side of main roof, close to northern end on first survey only. Wildlife Imaging Systems still image of infra-red camera footage at 21:44 for location S1A, 13th May 2025.

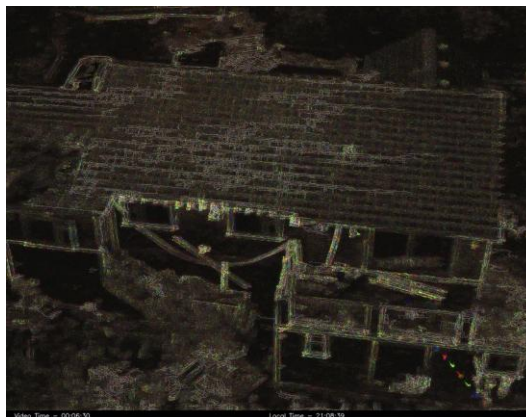
*Photograph 11.* Roost R6 – WIS summary image of drone camera footage from second survey visit on 11th June 2025 only – total of two common pipistrelle bats emerging from under bottom row of tiles on SW elevation above balcony area.

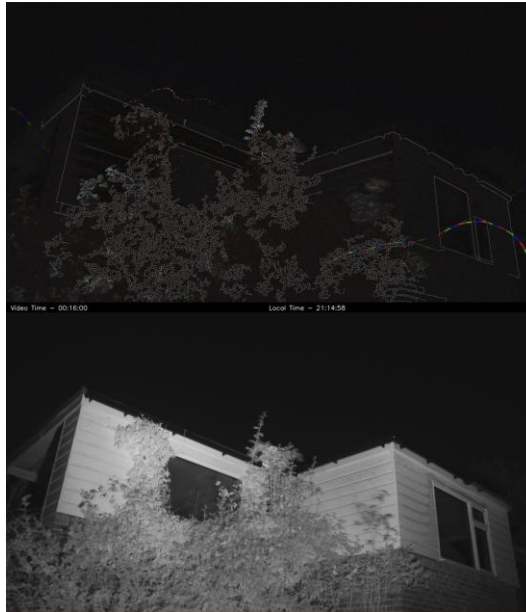
*Photograph 12.* Roost R7 - Video summary footage (Wildlife Imaging Systems output file) from unattended thermal imaging camera deployed at Location 4 showing common pipistrelle bat emerging from under open northern section at 21:15 during the final survey on 14<sup>th</sup> July 2025. Total of three common pipistrelles recorded using feature during final survey only. As this feature was not directly viewed it is possible these bats also emerged from R1 but exited the building northwest rather than east as recorded for R1.

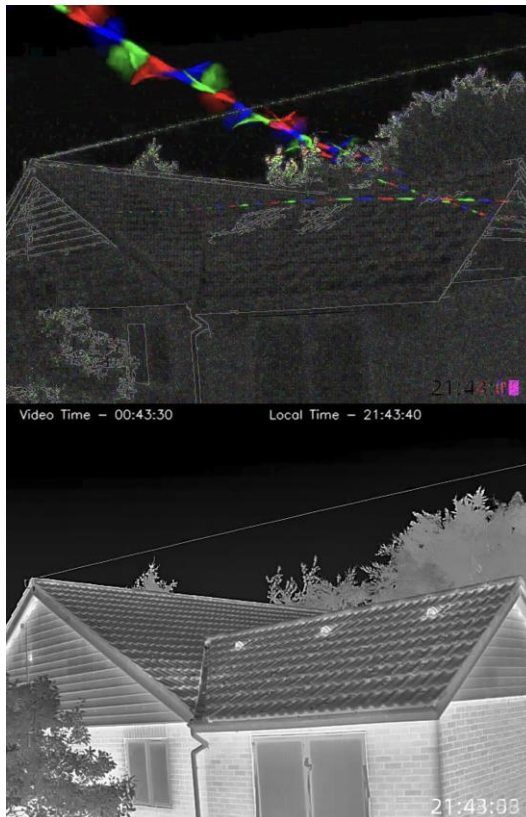
*Photograph 13.* Roost R8 – single common pipistrelle bat recorded to emerge from under roof tile on eastern elevation of main roof, towards southern end at 21:43 on final survey visit 14<sup>th</sup> July 2025 only.
