**Ref: Solar panel installation at Princess Royal Hospital.**

The Ecology Co-op undertook a bat scoping assessment at Princess Royal Hospital, Haywards Heath on the 4<sup>th</sup> of March 2026 at the request of Batcheller Monkhouse. This assessment was undertaken further to a proposal to install solar panels at various points on the hospital roof. The survey was undertaken in accordance with best practice guidance produced by the Bat Conservation Trust<sup>1</sup>.

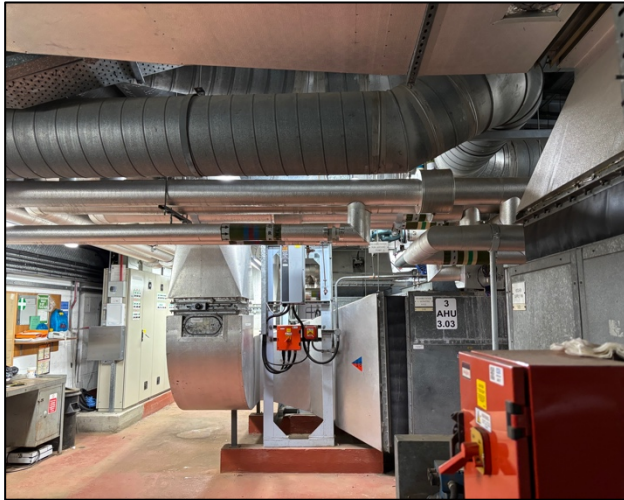
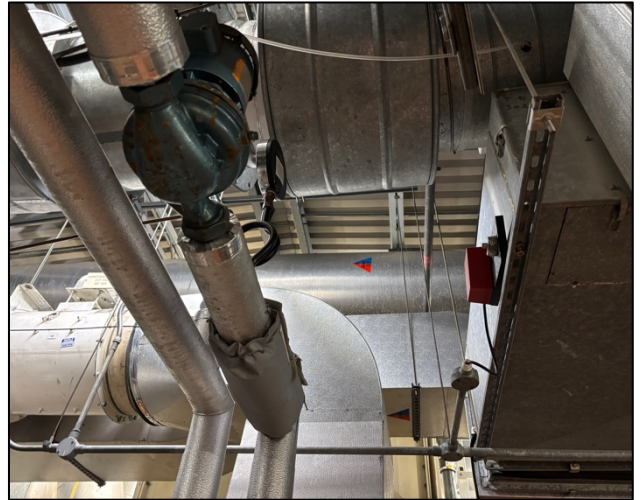
| Building section | Description of features | Assessment of suitability <sup>1</sup> |
|---|---|---|
| Hospital interior – plant rooms | <p>The upper levels of the hospital features many plant rooms housing extensive building services infrastructure (e.g. electrical panels, insulated pipework and ventilation ducting). These rooms are well-lit, accessed regularly and are very noisy due to the continuous running of electrical equipment and cooling systems. The flat roofs of corrugated metal construction leave small gaps above the outer walls which could provide access to bats, but with no internal lining on the underside of the metal, these rooms lack traversable surfaces and enclosed cavities for roosting bats.</p> | No bat roost suitability |

**Photograph 1a and 1b.** Example of the plant rooms scattered across the top floor of the hospital.

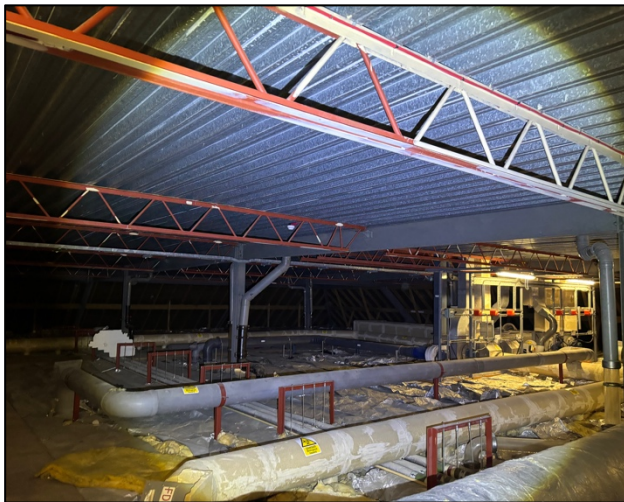
| Building section | Description of features | Assessment of suitability <sup>1</sup> |
|---|---|---|
| Hospital interior – roof voids | <p>A number of large roof voids are interspersed between the plant rooms, internal corridors and other rooms on the top floor. These spaces were accessed internally and are largely empty, containing some scattered services infrastructure (predominantly insulated pipework). Each void is around 2-3m in height at its tallest, with sloped sections around the edges of the building. The voids contain partially boarded concrete floors with extensive mineral fibre insulation. The central portion of the roof is of flat, corrugated metal construction, and the hipped outer edges are timber framed, covered with bitumen-lined clay interlocking tiles. The lining is visibly in good condition, with no significant tears or gaps offering access to/from the tiles. There are visible daylight gaps at the eaves which could act as an access point for bats. However, with the sloping roof lining leading to flat, well-sealed corrugated metal roofing, the voids offer little in the way of roosting opportunities for bats.</p> <p>Occasional rodent droppings were observed (both rat and mouse), but no signs of bats were identified during the survey.</p> | Low bat roost suitability – unaffected by proposed works |

**Photograph 2a and 2b.** Example of the roof voids scattered across the top floor of the hospital, including services infrastructure (left) and the underside of the bitumen-lined tiles (right).

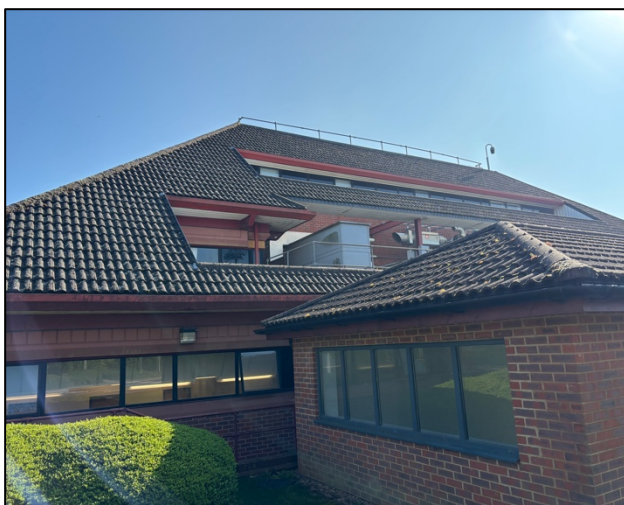
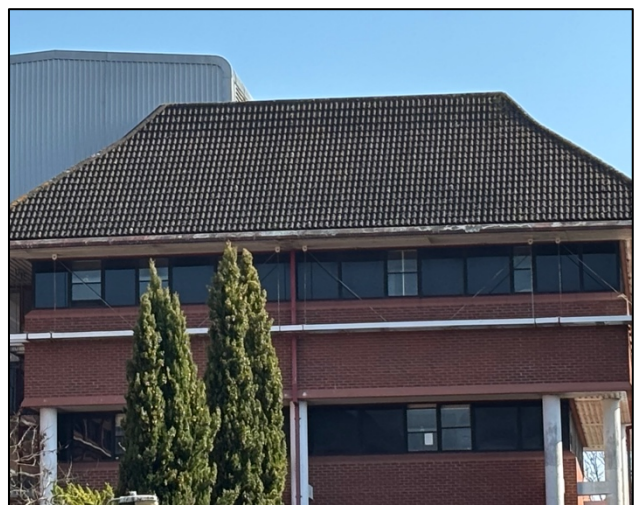
| Building section | Description of features | Assessment of suitability <sup>1</sup> |
|---|---|---|
| Hospital exterior | <p>The exterior of the hospital is constructed largely of brick walls, with a complex and irregular roof reflecting the large and composite nature of the building itself. The roof is predominantly flat and comprises sections of corrugated metal sheeting and concrete/gravel-covered surfaces. Many of the flat roof sections terminate at shallow hipped edges clad in tiles. In addition, several lower tiled pitched roofs are present, creating a tiered roof profile across parts of the building.</p> <p>The factory-form clay interlocking tiles are generally in good condition, with no gaps created by lifted/warped/broken tiles around the vast majority of the building. A small number of gaps were noted beneath broken and/or lifted tiles near to the roof apex on the southern and eastern roof faces in the southeastern portion of the building, although these tiles lay outside the zone of influence of the proposed construction. Due to the height and context of the roof, it was not possible to photograph these gaps. No gaps were identified within areas to be affected by the works.</p> | Low bat roost suitability |

**Photograph 3a and 3b.** Example of the tiled roof hips on the outer edges of the building.

Given the 'low' suitability of the roof as a whole, it is important that all tiles are removed carefully and by hand. In the unlikely event that a bat is discovered, the feature must be 'made good' where possible, works would need to cease immediately and a licensed ecologist be contacted. Work would likely not be able to continue until an EPS mitigation licence has been obtained.

Additionally, the site can be enhanced for bats by incorporating the features below into the fabric of the building. Where bat access tiles are used, only a Type 1F bitumen lining must be used instead of modern breathable membranes such as Tyvec, which over time fray and entangle bats. The bat boxes and features should be installed under the instruction of a suitably licensed ecologist to ensure that the positioning is optimal, but generally locations above 3.5m in the most southeasterly facing aspect of the building would be best.
