**Brookleigh Eastern Primary  
School, Brookleigh, Burgess  
Hill**

**Transport Statement  
Addendum**

For  
**Homes England**

Project No.  
**14176**

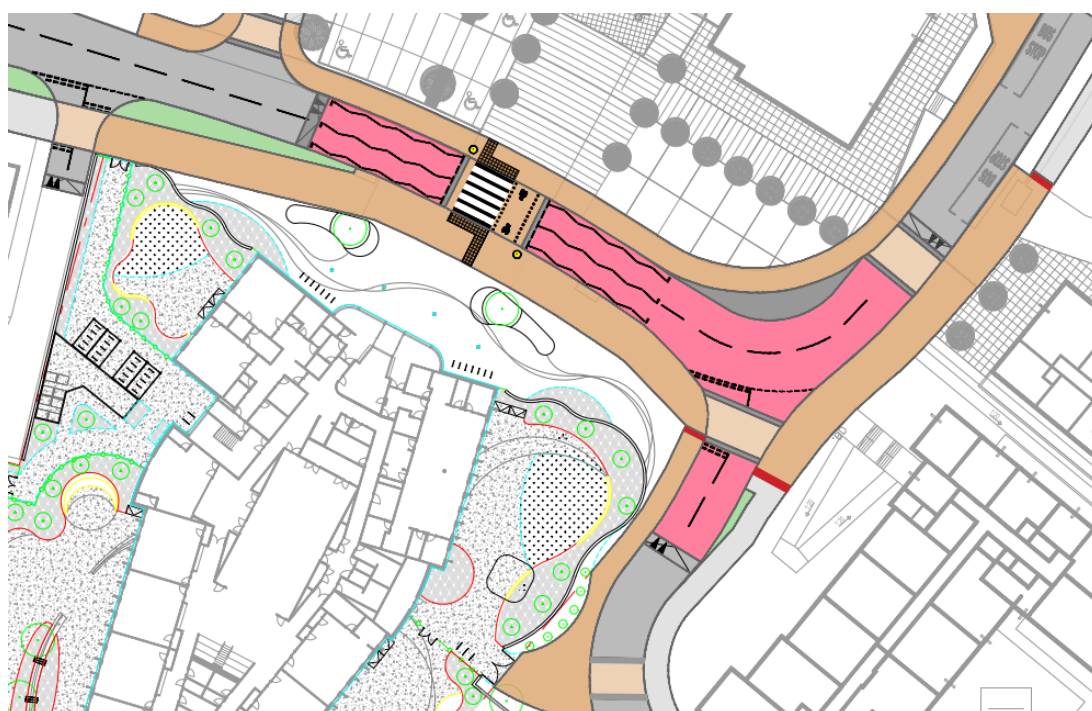
Figure 3.1: Updated Layout

3.1.2 On that basis, drawing 14176-CRH-XX-XX-DR-H-6180 was revised (P4 version) to take this into account along with the amendments outlined in paragraph 2.1.6. A snapshot of the changes is included in Figure 3.1 below and in Appendix 3.

3.1.3 The proposed parallel crossing also includes the required zig-zag lining to prevent unwanted car parking and as such, seeks to address comments raised within the January RSAA1.

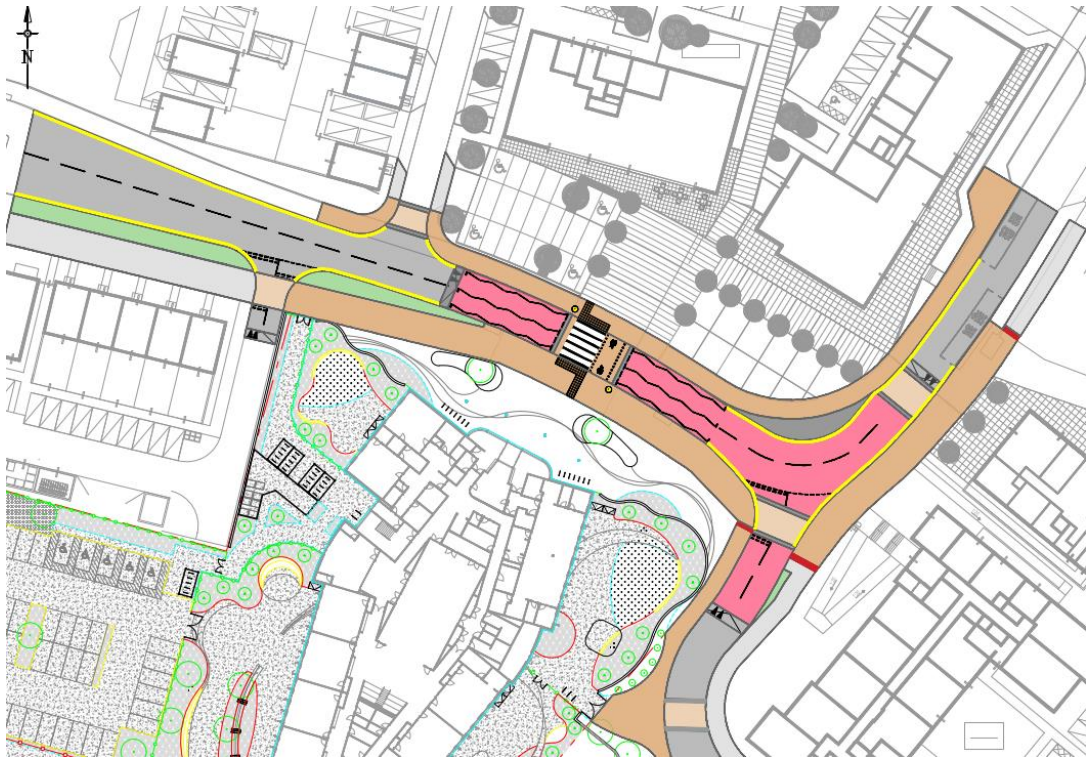
Figure 5.1: Indicative Remedial Measures

- 5.2.1 In the event that there are issues emerging adjacent to the Primary School in relation to set-down and parking, it is proposed to implement further road markings along the immediate EBLR frontage which will provide enforceable restrictions preventing parking/ set down on the EBLR.
- 5.2.2 An indication of these measures is included in Figure 5.1 below. It should be noted that these are very much indicative at this stage and consultation in terms of any final scheme will need to be had with MSDC (as planning authority), WSCC (as highway authority), the school and Sussex Police.

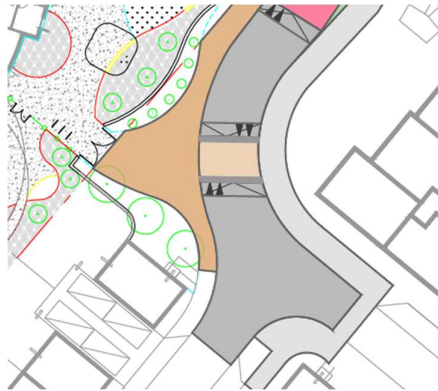
**Summary** Raised table on the bend may increase the risk of loss of control incidents at this location.

A raised table has been installed on a horizontal bend. See below:

Vehicles negotiating the bend are already subject to lateral acceleration, and the introduction of a vertical deflection at this location creates conflicting vehicle dynamics. As a result, drivers may experience sudden changes in tyre loading and reduced grip while steering, increasing the likelihood of loss of control. This risk is heightened for motorcyclists and cyclists, whose stability is more sensitive to mid-corner vertical displacement. The feature is also located on a curved alignment where forward visibility is limited, reducing the time available for drivers to perceive and react to the raised table. These factors may contribute to loss-of-control collisions, encroachment into opposing traffic lanes, or falls involving two-wheelers.

**RECOMMENDATION:** It is recommended that the raised table be relocated to a section of straight alignment where approach visibility is adequate and where vertical deflection will not conflict with lateral vehicle loading.

| RSA Problem Number | RSA Problem | RSA Recommendation | Design Organisation Response | Design Organisation Response | Agreed RSA Action |
|---|---|---|---|---|---|
| 3.3.1 | <p>Raised table on the bend may increase the risk of loss of control incidents at this location.</p> <p>Vehicles negotiating the bend are already subject to lateral acceleration, and the introduction of a vertical deflection at this location creates conflicting vehicle dynamics. As a result, drivers may experience sudden changes in tyre loading and reduced grip while steering, increasing the likelihood of loss of control.</p> | <p>It is recommended that the raised table be relocated to a section of straight alignment where approach visibility is adequate and where vertical deflection will not conflict with lateral vehicle loading.</p> <p>If relocation is not feasible, the designer should consider alternative traffic-calming measures that do not introduce vertical displacement on a bend, and/or provide enhanced advance warning and conspicuity measures to mitigate the risk.</p> | <p><b>ACCEPTED</b></p> <p>It is proposed that the vertical deflection element of this raised table be removed. We feel it is appropriate for a uncontrolled crossing to remain in this position given the presence of the nursery / reception entrance. Vehicle speeds are expected to be very low in this area.</p> | | |
