## **APPENDIX C – SITE VISIT PHOTOGRAPHS AND ACCOMPANYING FIGURES**

Catchment A

**Table 3.1: Catchment A Photographs**

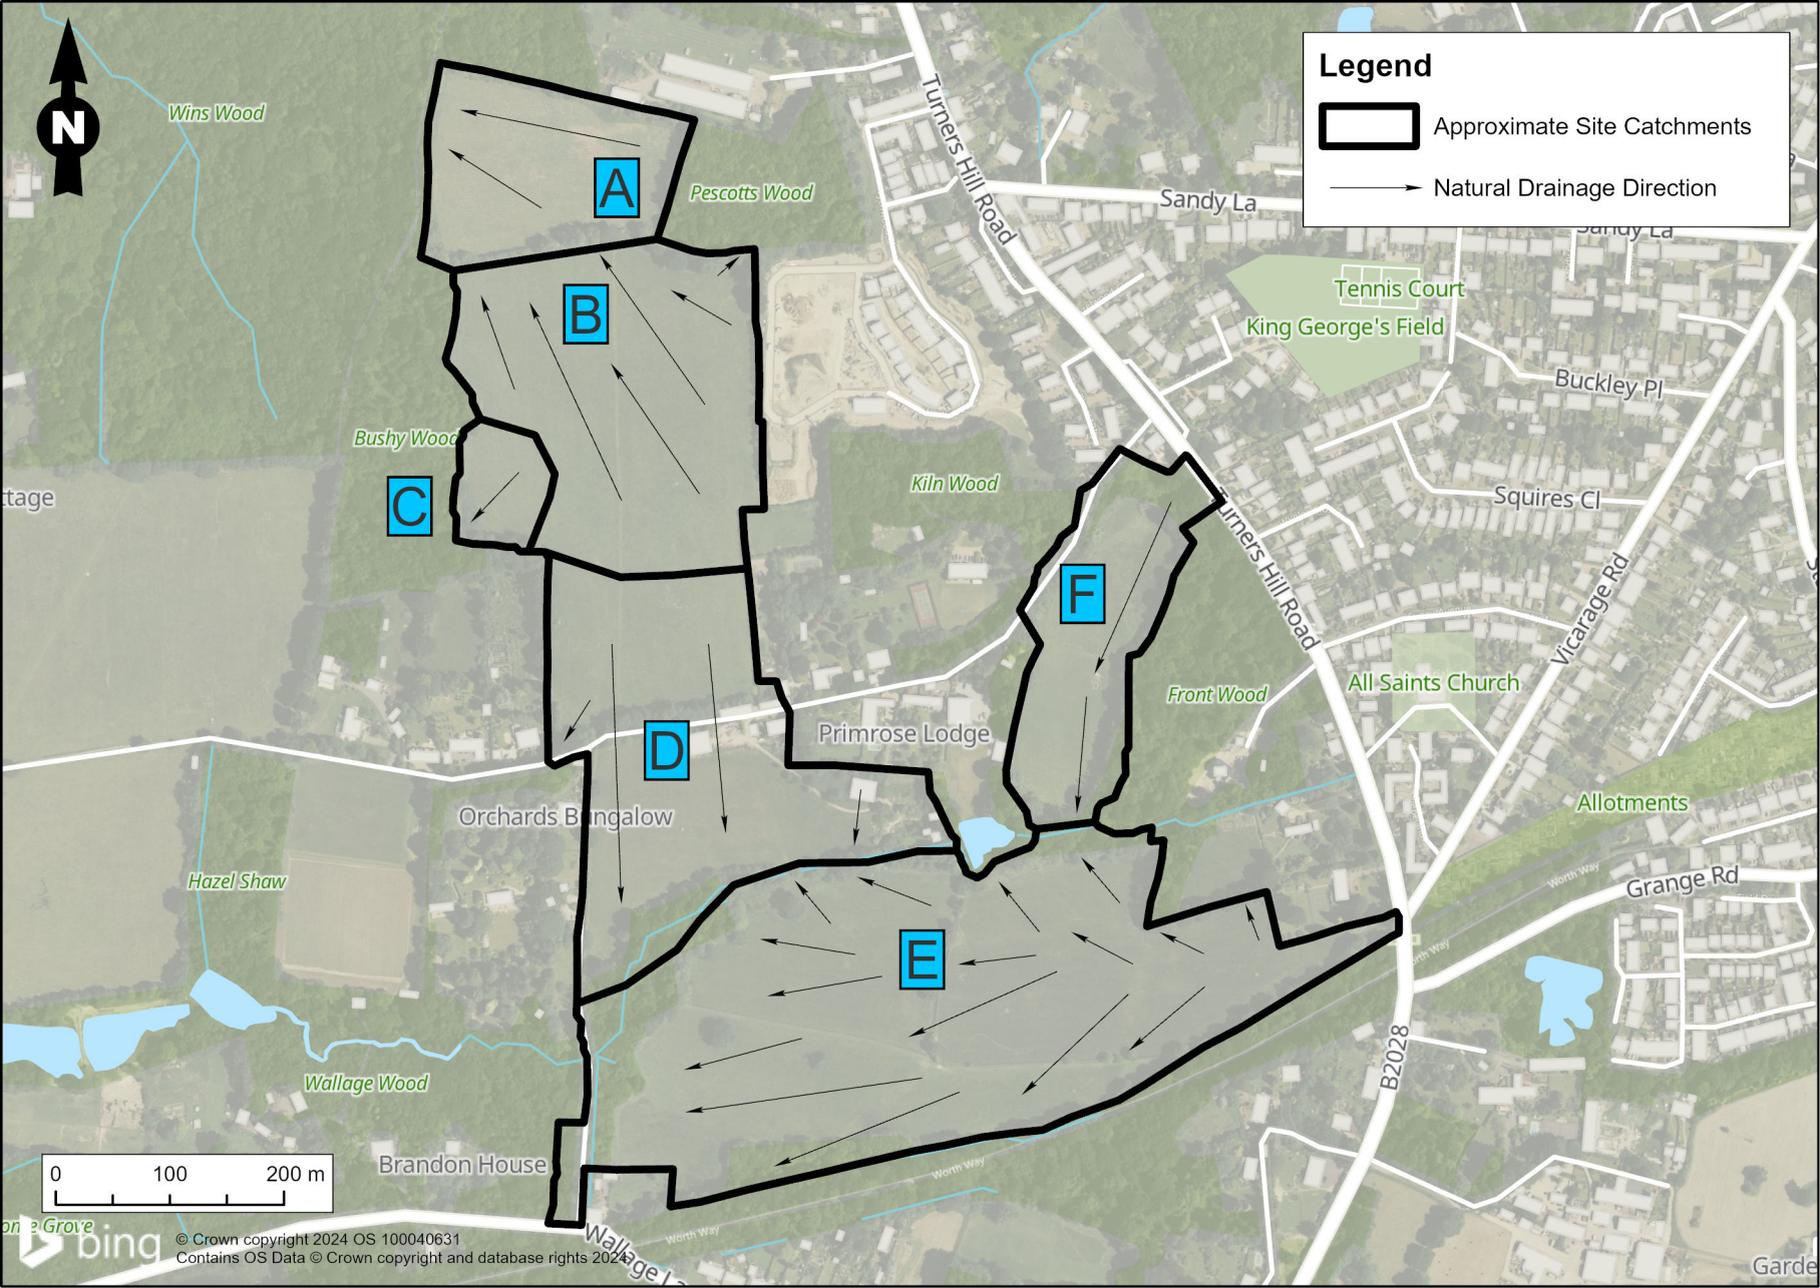
Approximate Site Catchments
-

Natural Drainage Direction

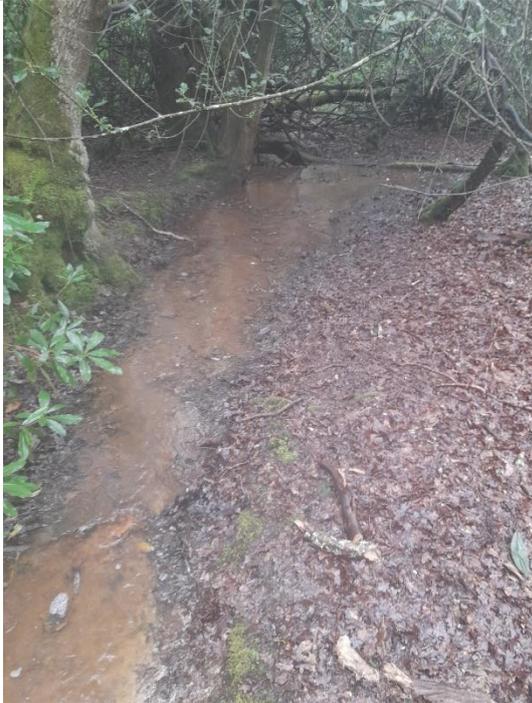
**1.** View of watercourse to the northwest of the site looking west. Watercourse shown to take flows from north of site and direct them westward. Topography visibly sloping from east to west.

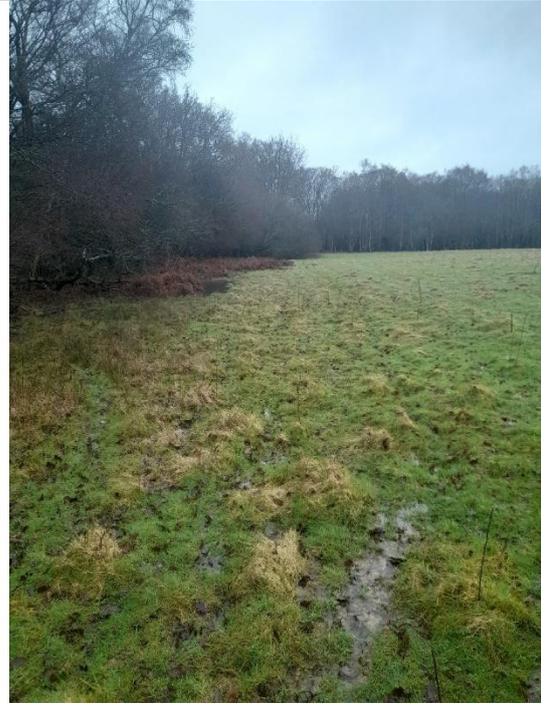
**2.** View of Catchment A looking north along western boundary. Standing water visible in west of site. Topography visibly sloping from east to west.

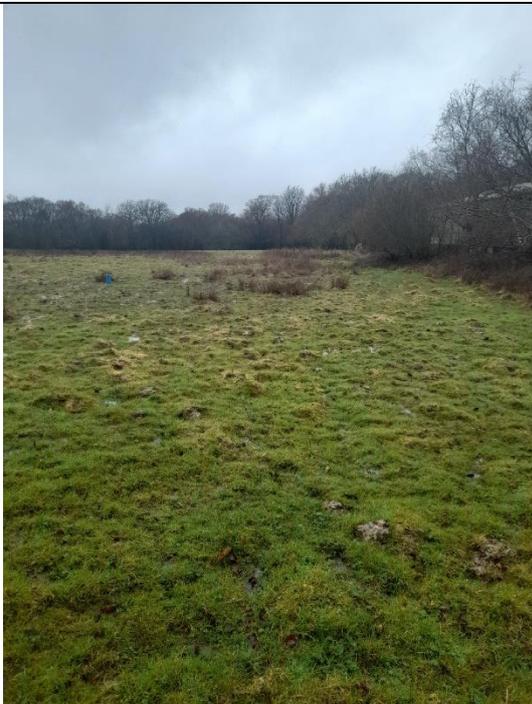
**3.** View of Catchment A in the northeast of the site looking west. Topography typically sloping from east to

west although another low point is present in the northeast corner of the catchment.

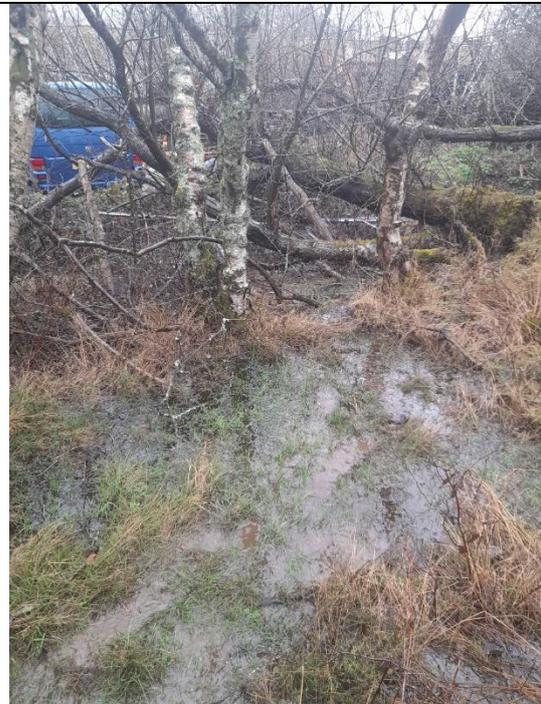
**4.** Surface water flooding in the northeast corner of the site.

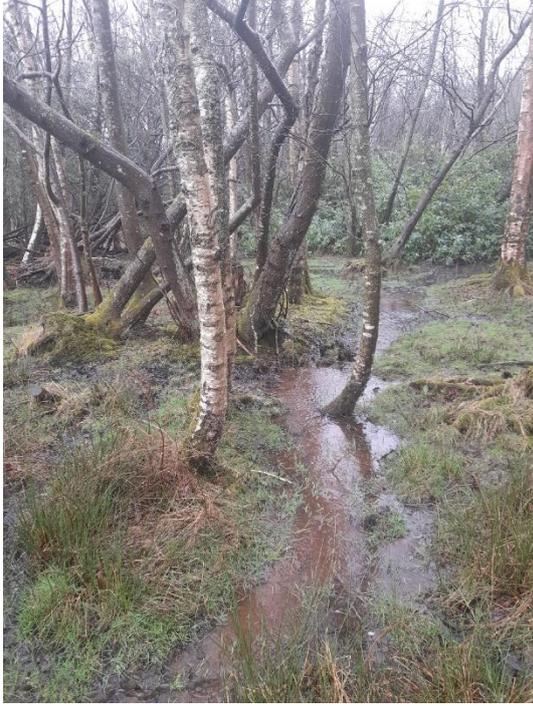
**5.** Surface water flooding in the north of the site. Looking west. Flow observed to be east to west.

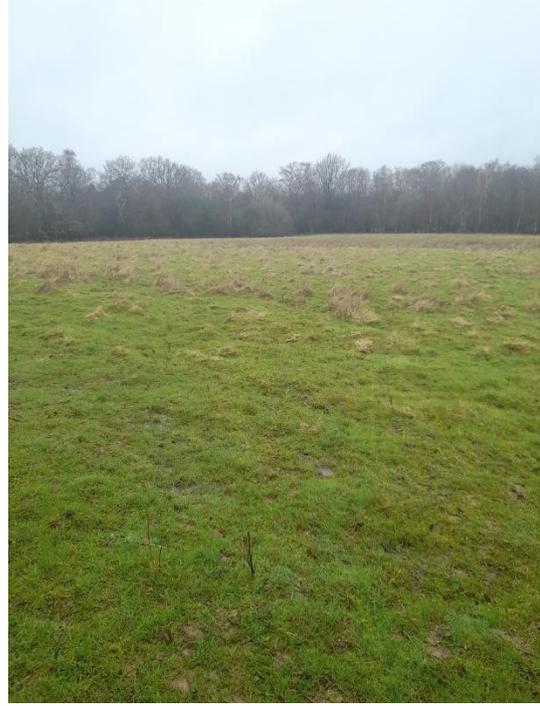
**6.** View of Catchment A looking northwest from the south of the catchment. Land shown to be sloping from southeast to northwest.
