Preliminary Roost Assessment

Survey site: The Granary at North Hall, Staplefield, West Sussex, RH17 6AS

This report is prepared to inform a planning application for the conversion of an existing outbuilding to ancillary uses to the main dwelling and for other ancillary works to the building at North Hall Mallions Lane Staplefield.

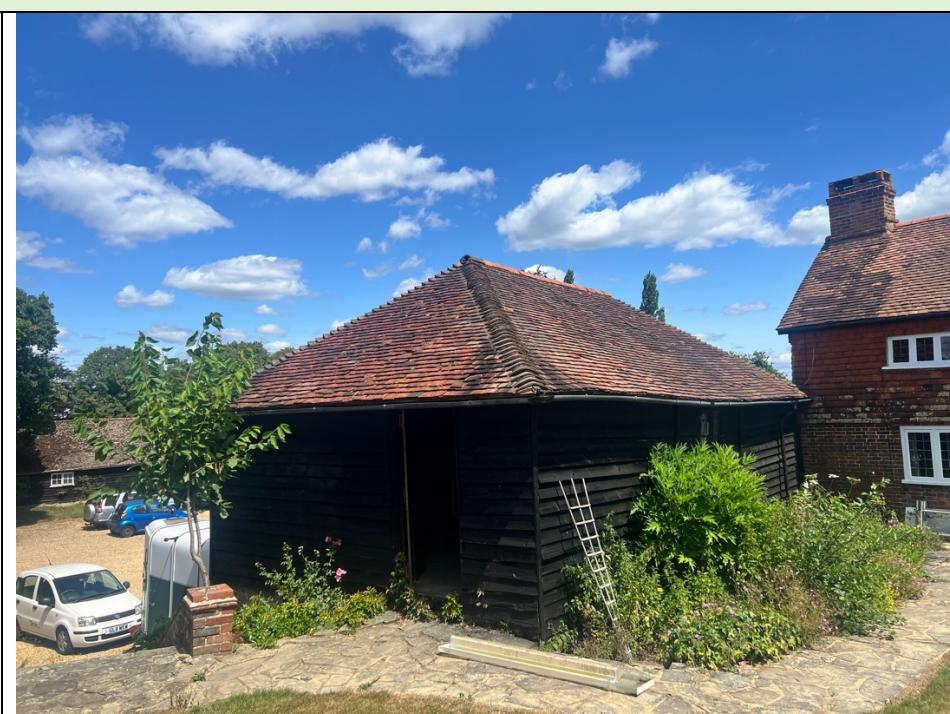
B1 is a former granary barn structure with a pitched and hipped roof. The roof is constructed with clay roofing and ridge tiles. The walls are constructed with brick and mortar with local sandstone blocks, timber cladding is present on the upper level exterior. The windows and doors were timber framed.

B1 is assessed to have **high** habitat value for roosting bats due to the presence of lifted and missing roofing and ridge tiles, lifted timber cladding, gaps in brickwork and mortar pointing, holes present in the walls, and gaps underneath the eaves.

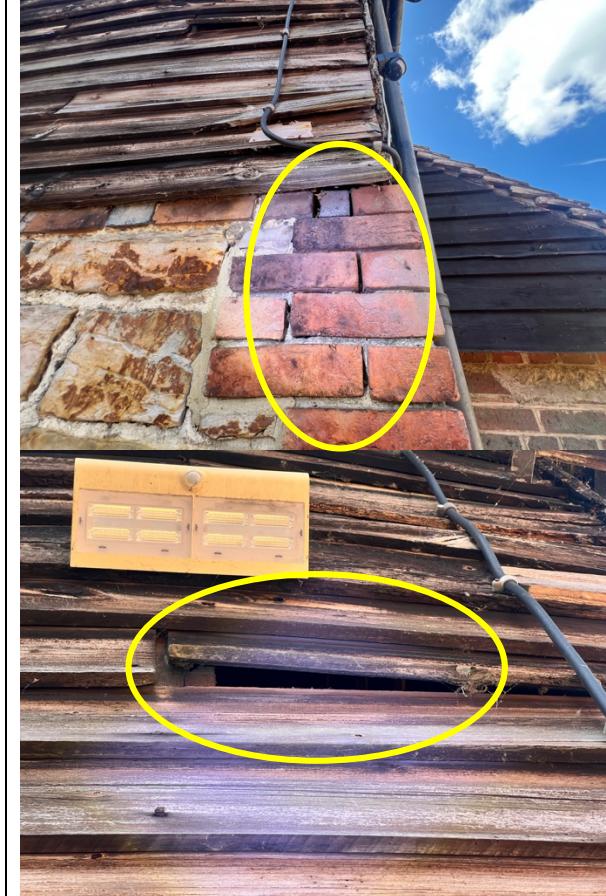
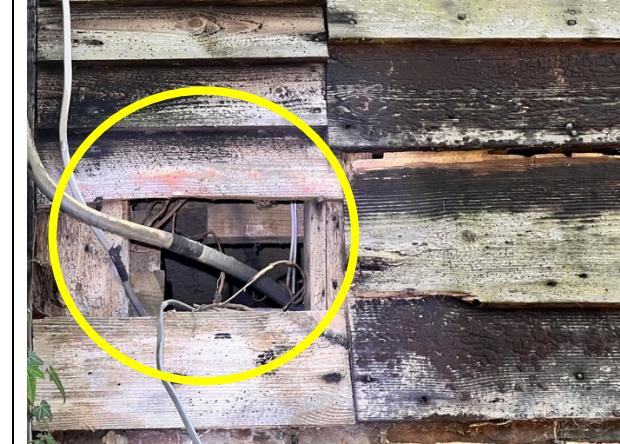
Feature	Materials	Condition/description	Suitability/access/evidence of bats	Photos
Walls	Brick, mortar, sandstone, timber cladding	<p>Gaps and crevices were observed within the mortar pointing between the bricks and sandstone.</p> <p>Lifted timber cladding was found to be widespread across the upper level exterior.</p> <p>A large hole was observed on the eastern elevation of B1.</p>	<p>There is opportunity for crevice-dwelling bats to roost in the gaps in the mortar and underneath the lifted timber cladding.</p> <p>The hole on the eastern elevation provides access to the internal structure suitable for void-dwelling bats.</p> <p>No evidence of bat use found.</p>

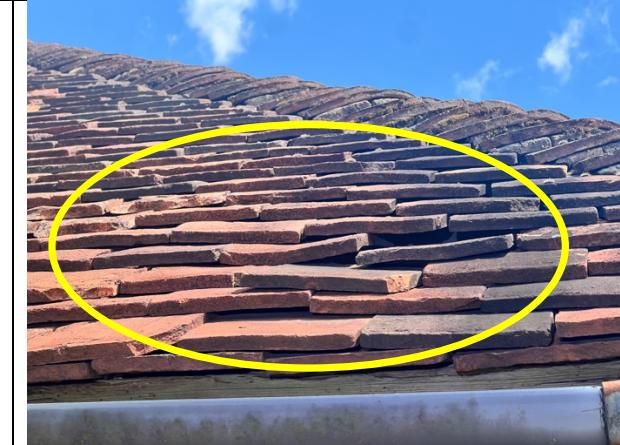
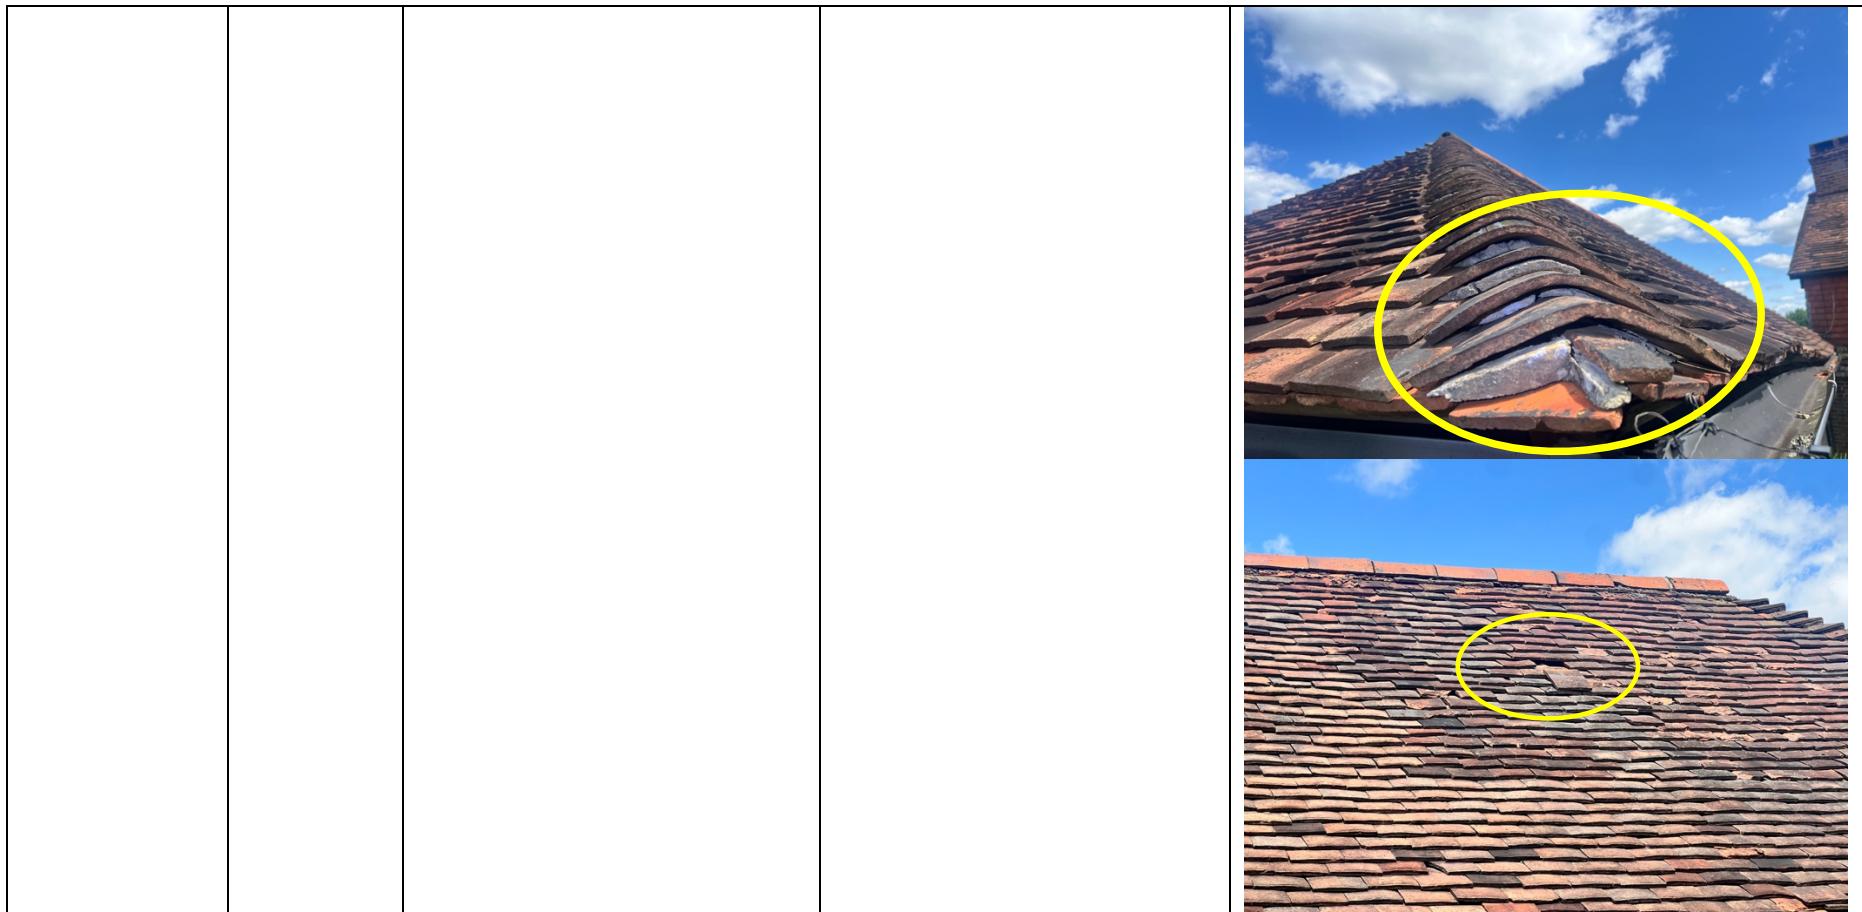
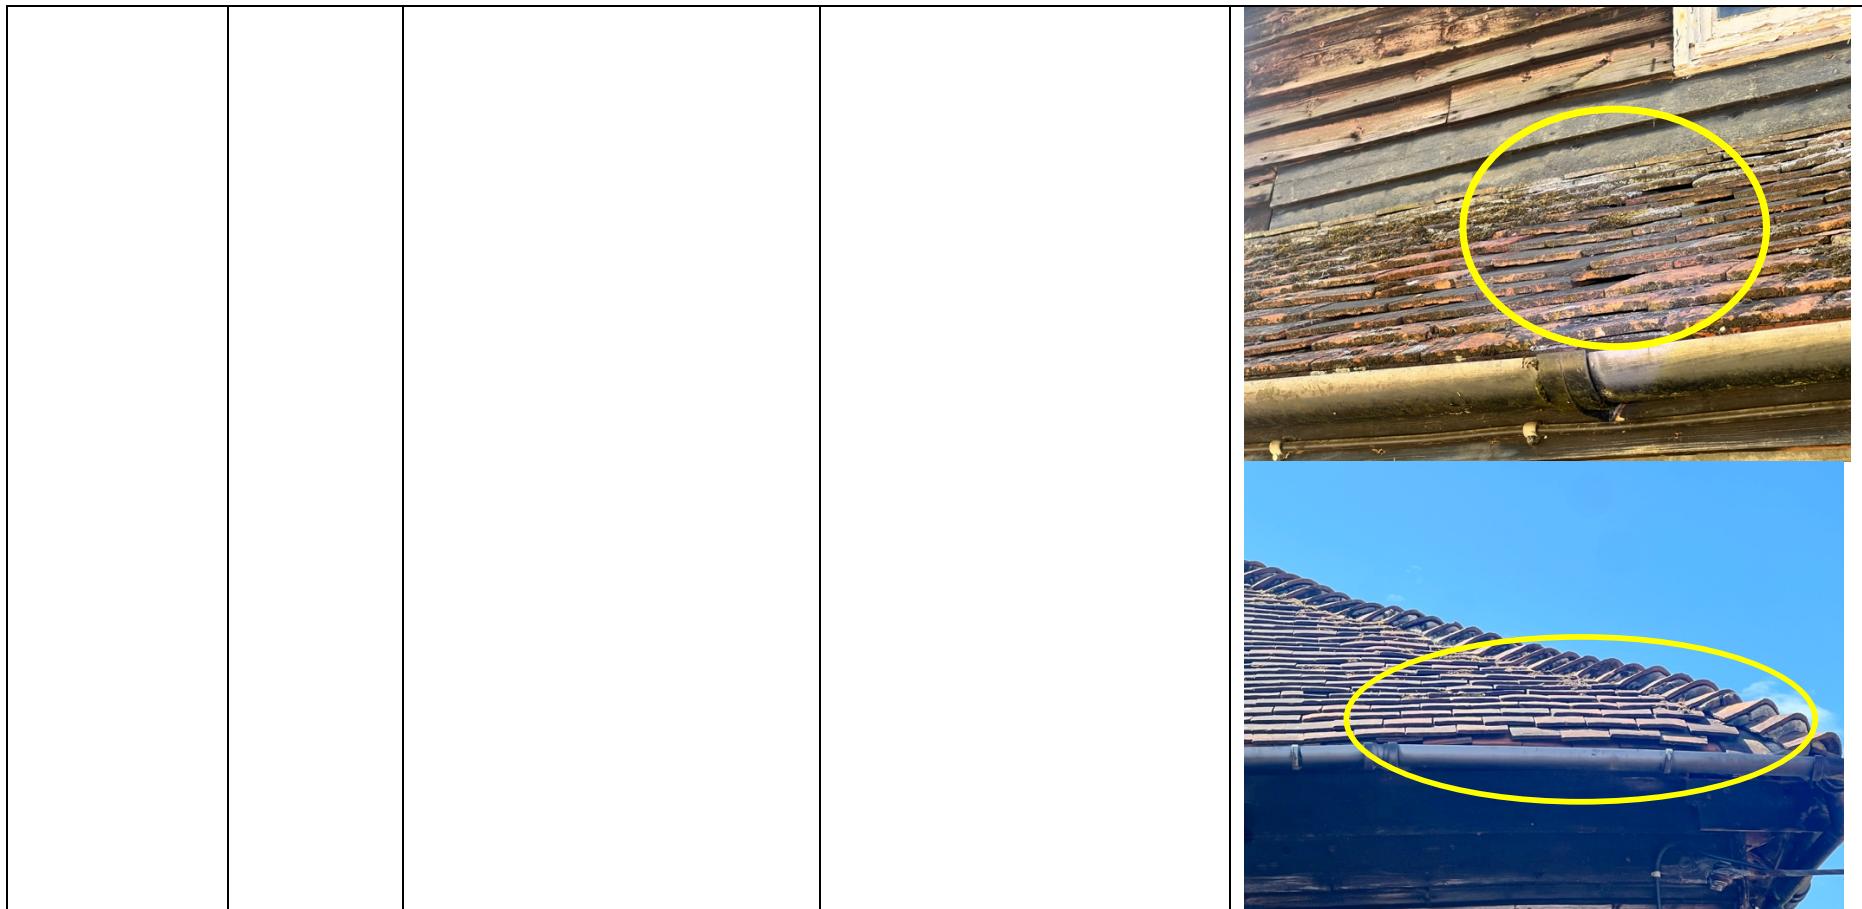
Roof	Clay tiles	<p>Lifted clay tiles were ubiquitous throughout the roof on all elevations.</p> <p>There were four missing tiles present, leaving gaps in their absence.</p> <p>Gaps were observed where cement has crumbled under the ridge tiles.</p>	<p>There is opportunity for crevice-dwelling bats to roost under the lifted roof tiles, in the gaps where tiles are missing, and underneath the ridge tiles with missing cement.</p> <p>No evidence of bat use found.</p>

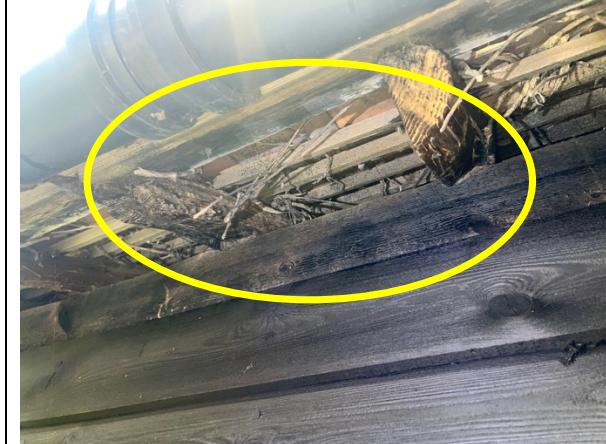
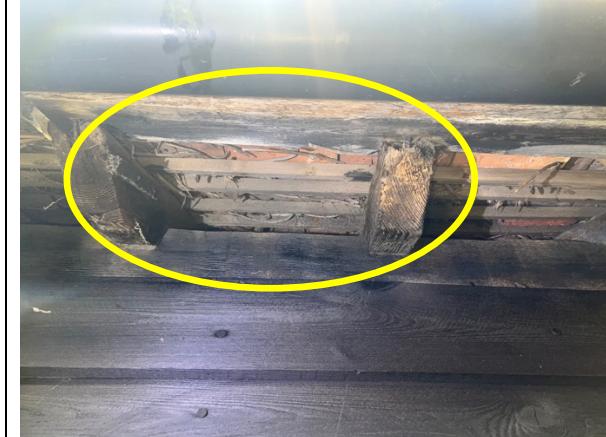
Eaves	Timber	<p>Gaps underneath the eaves were widespread, providing access internally.</p> <p>The gaps under the eaves allow suitable access areas to the internal space of B1, providing suitable roosting habitat for void-dwelling bats.</p> <p>No evidence of bat use found.</p>

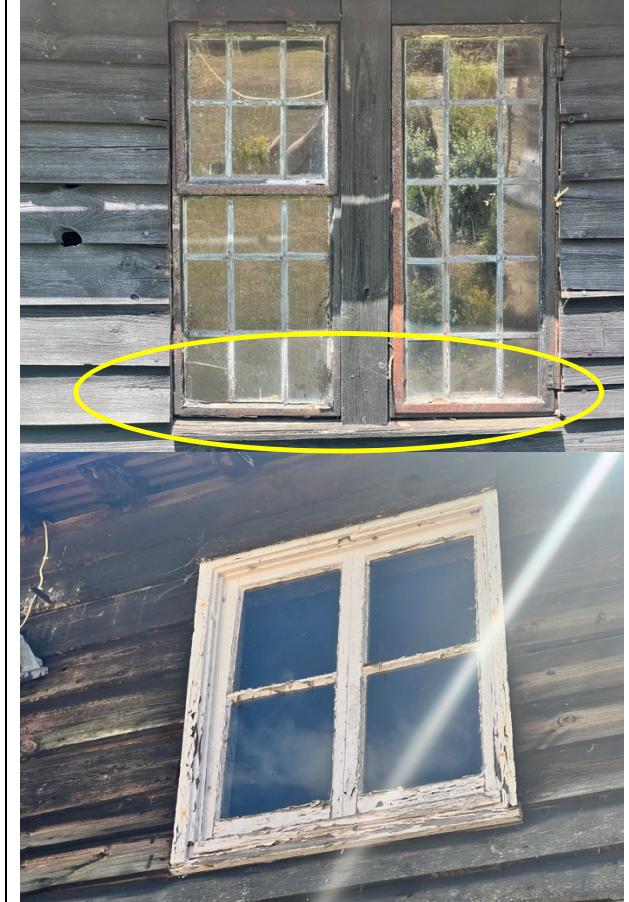
Window/doors frames and lintels	Metal and timber framing	<p>The window frames were mostly flush with the adjoining cladding.</p> <p>Gaps were observed underneath the metal framing of the window on the northern elevation of B1.</p>	<p>There is opportunity for crevice-dwelling bats to roost under the metal framing of the window on the northern elevation of B1.</p> <p>No evidence of bat use found.</p>

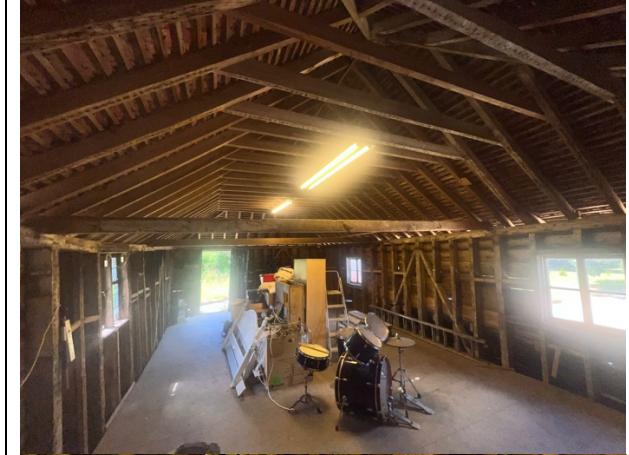
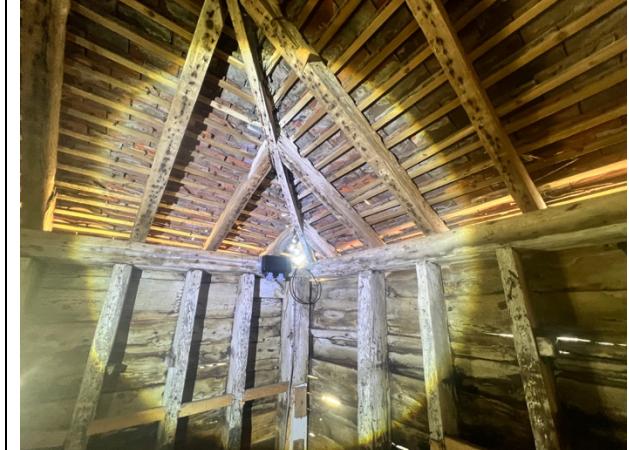
Internal voids	Timber framing	<p>The internal space was comprised of exposed timber beams and the underside of the clay roofing tiles.</p> <p>Light ingress was ubiquitous on all sides of the internal space, owing to the gaps under the eaves, tiles, and lifted timber cladding.</p>	<p>The presence of widespread access points provides suitable roosting habitat for void-dwelling bats.</p> <p>No evidence of bat use found.</p>

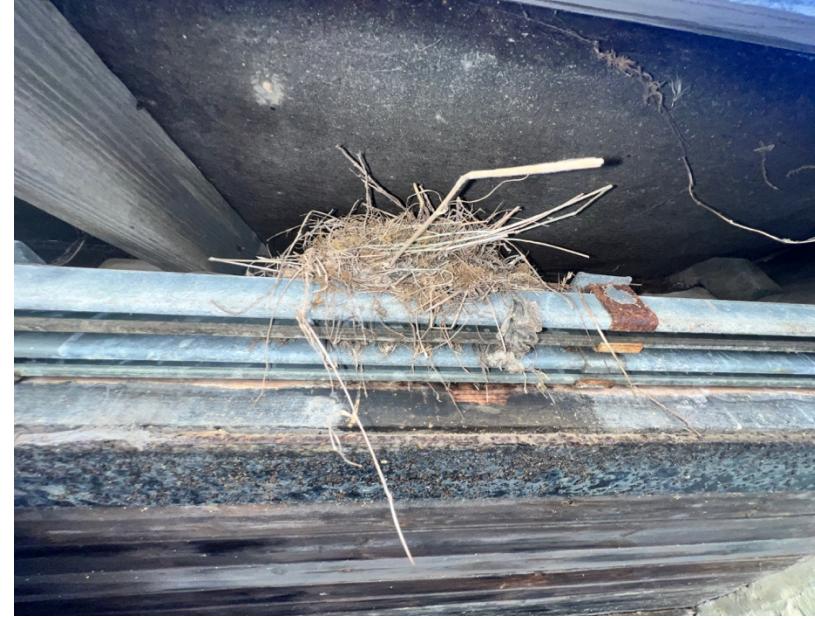
planning permission must have been granted and all relevant wildlife-related conditions have been discharged prior to submission.
<i>Enhancements</i>	To be confirmed upon completion of the surveys.
Nesting Birds	
<i>Summary of Survey Findings</i>	<p>B1 provides suitable opportunity for small nesting birds due to the large gaps under the eaves and holes in the walls. B1 provides unsuitable roosting potential for barn owls, due to the unsuitably small size of the holes and access points present.</p> <p>An inactive bird nest was observed on the northern elevation of B1, this was inspected and believed to be from previous breeding seasons.</p>

<p>Figure 1: Inactive bird nest on the northern elevation door frame.</p>

<i>Foreseen Impacts</i>	The proposed development could result in the destruction or the disturbance and subsequent abandonment of active bird nests.
<i>Recommendations</i>	Works should be undertaken outside the period 1st March to 31st August. If this timeframe cannot be avoided, a close inspection of the building should be undertaken immediately, by qualified ecologist, prior to the commencement of work. All active nests will need to be retained until the young have fledged.
<i>Enhancements</i>	The installation of one bird box appropriate for buildings (e.g. Ibstock Swift Eco Habitat or similar alternative brand) at the site will provide additional nesting habitat for birds in line with the measures outlined in the British Standard "Integral nest boxes. Selection and installation for new developments. Specification" (BS 42021:2022).
