# Report on a **PHASE 4 VALIDATION**

For the site:  
**Land to the Rear of North Road  
Haywards Heath  
West Sussex**

Prepared for:  
**Kauto Homes Limited**

Ref: 24/39368  
Date: December 2024

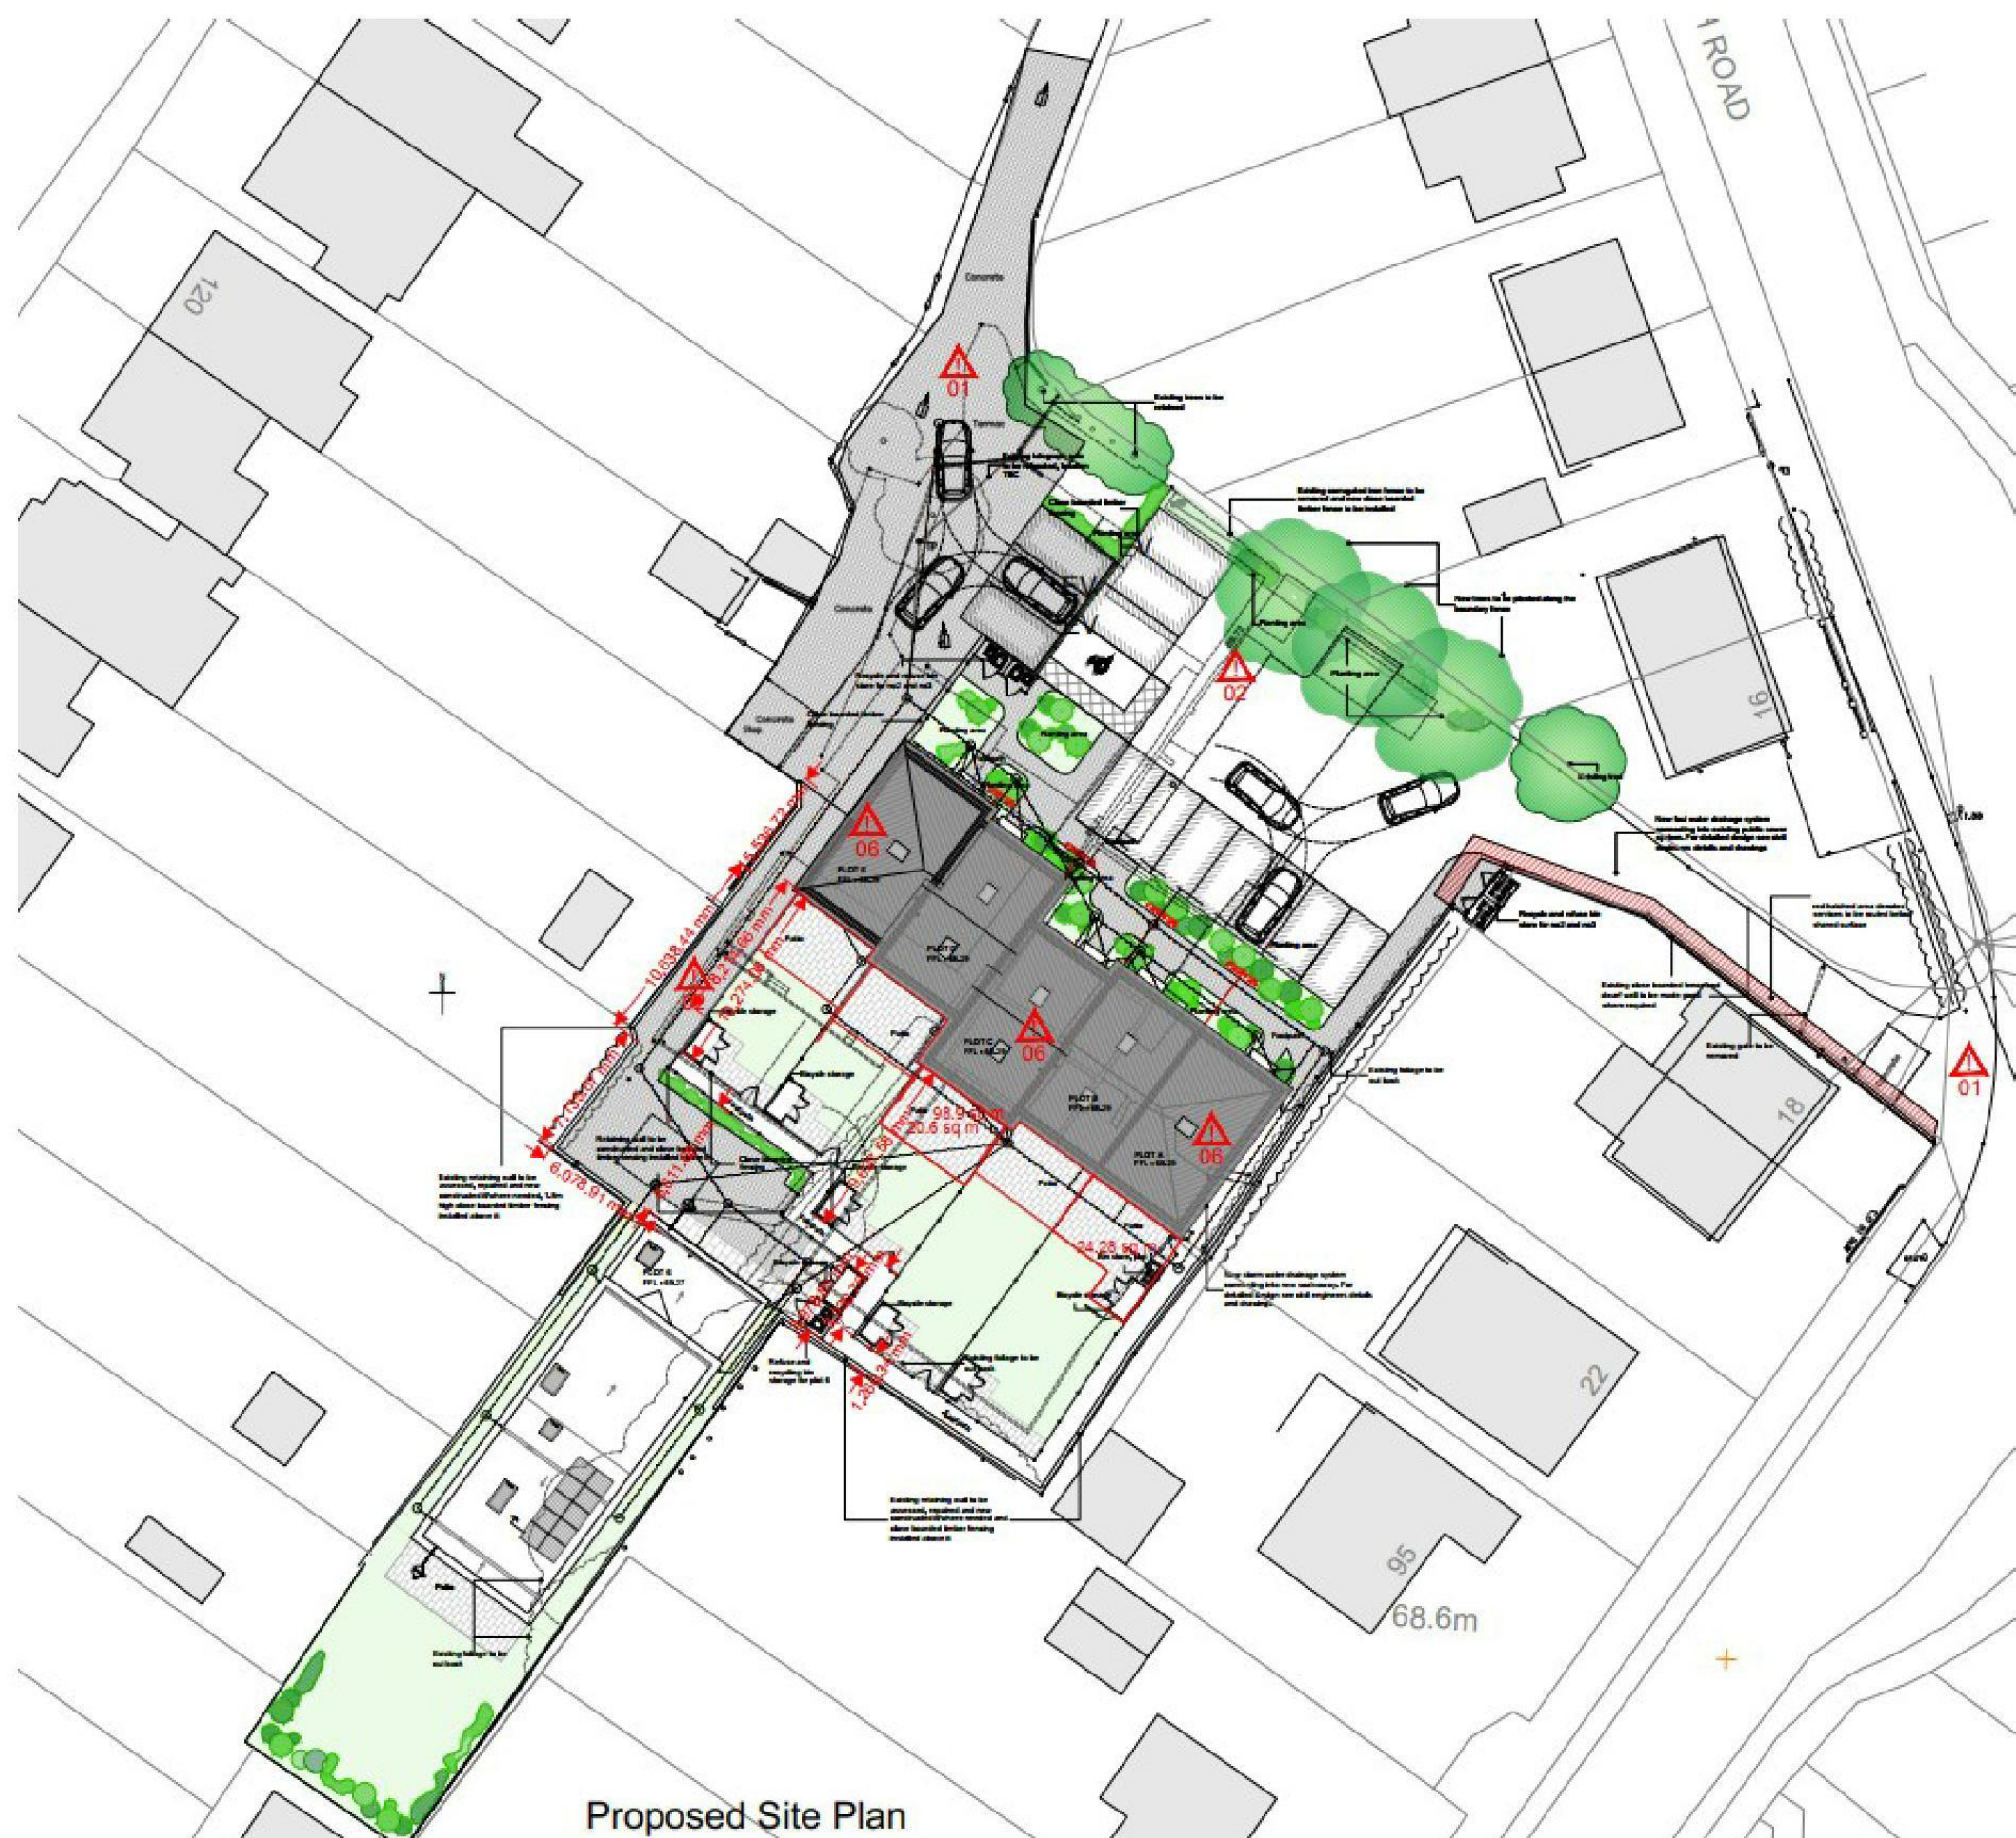
**Figure 2: Development Layout Plan**

The site development plan is presented below in Figure 2:

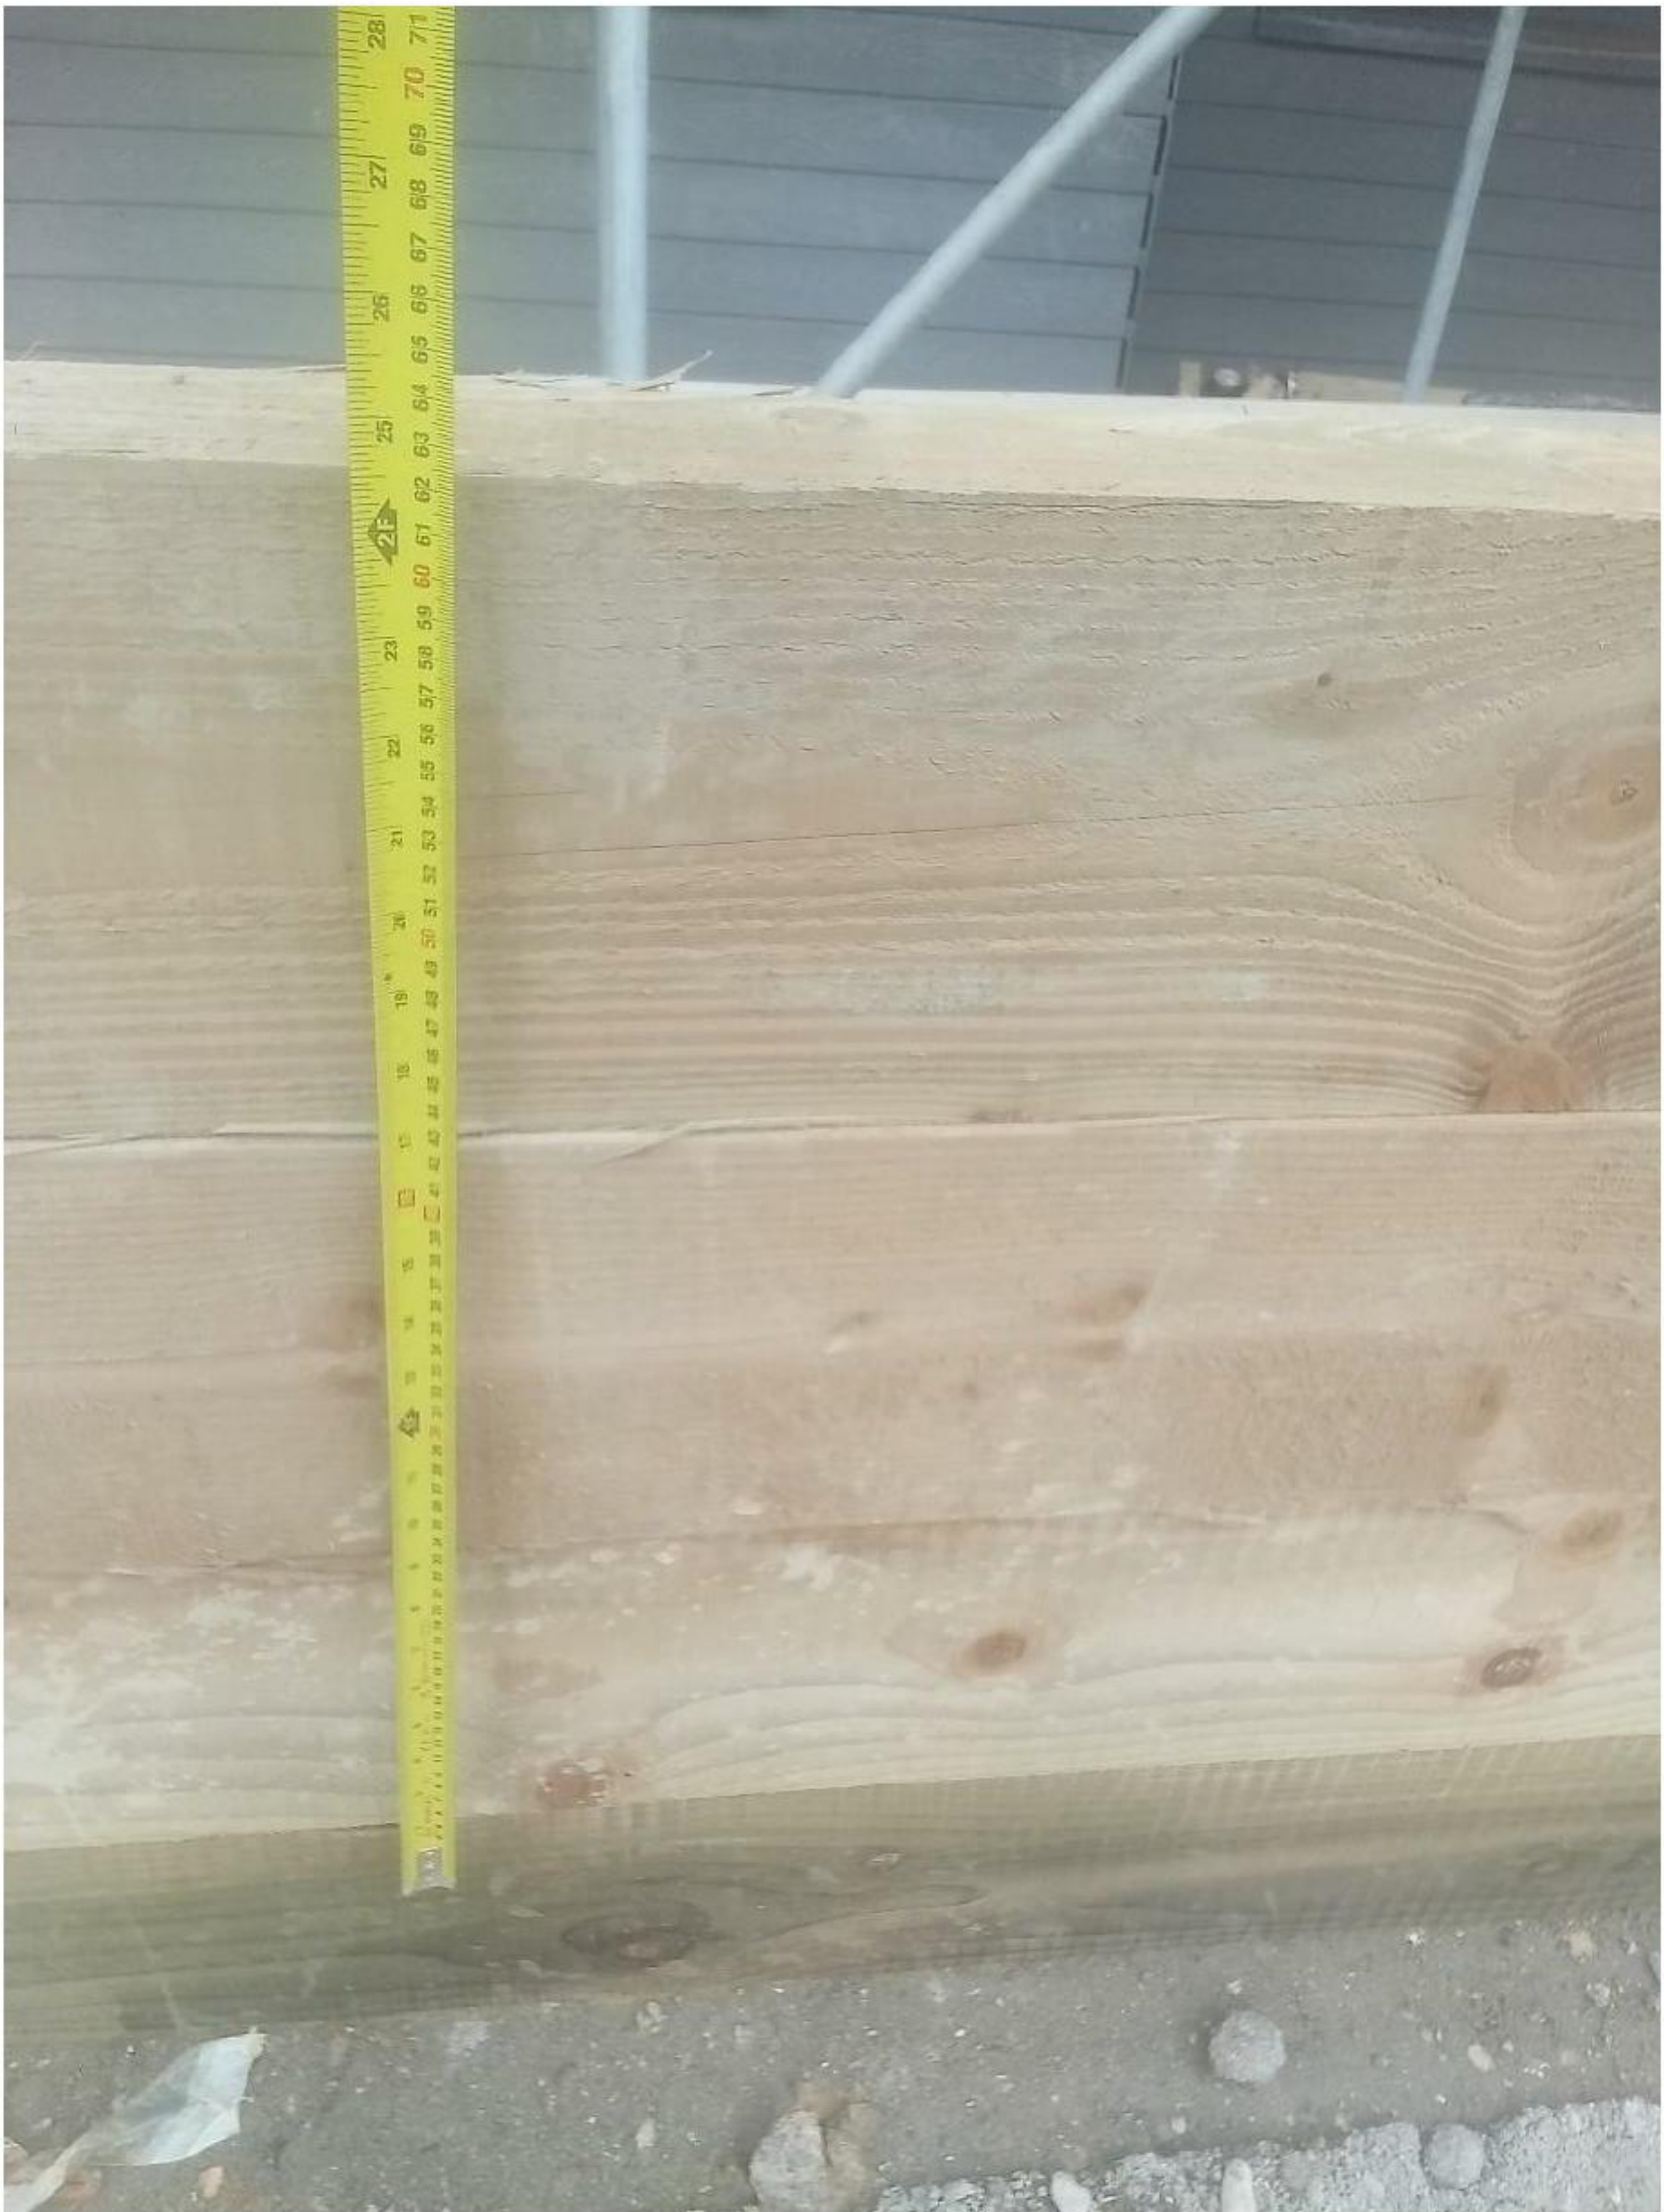
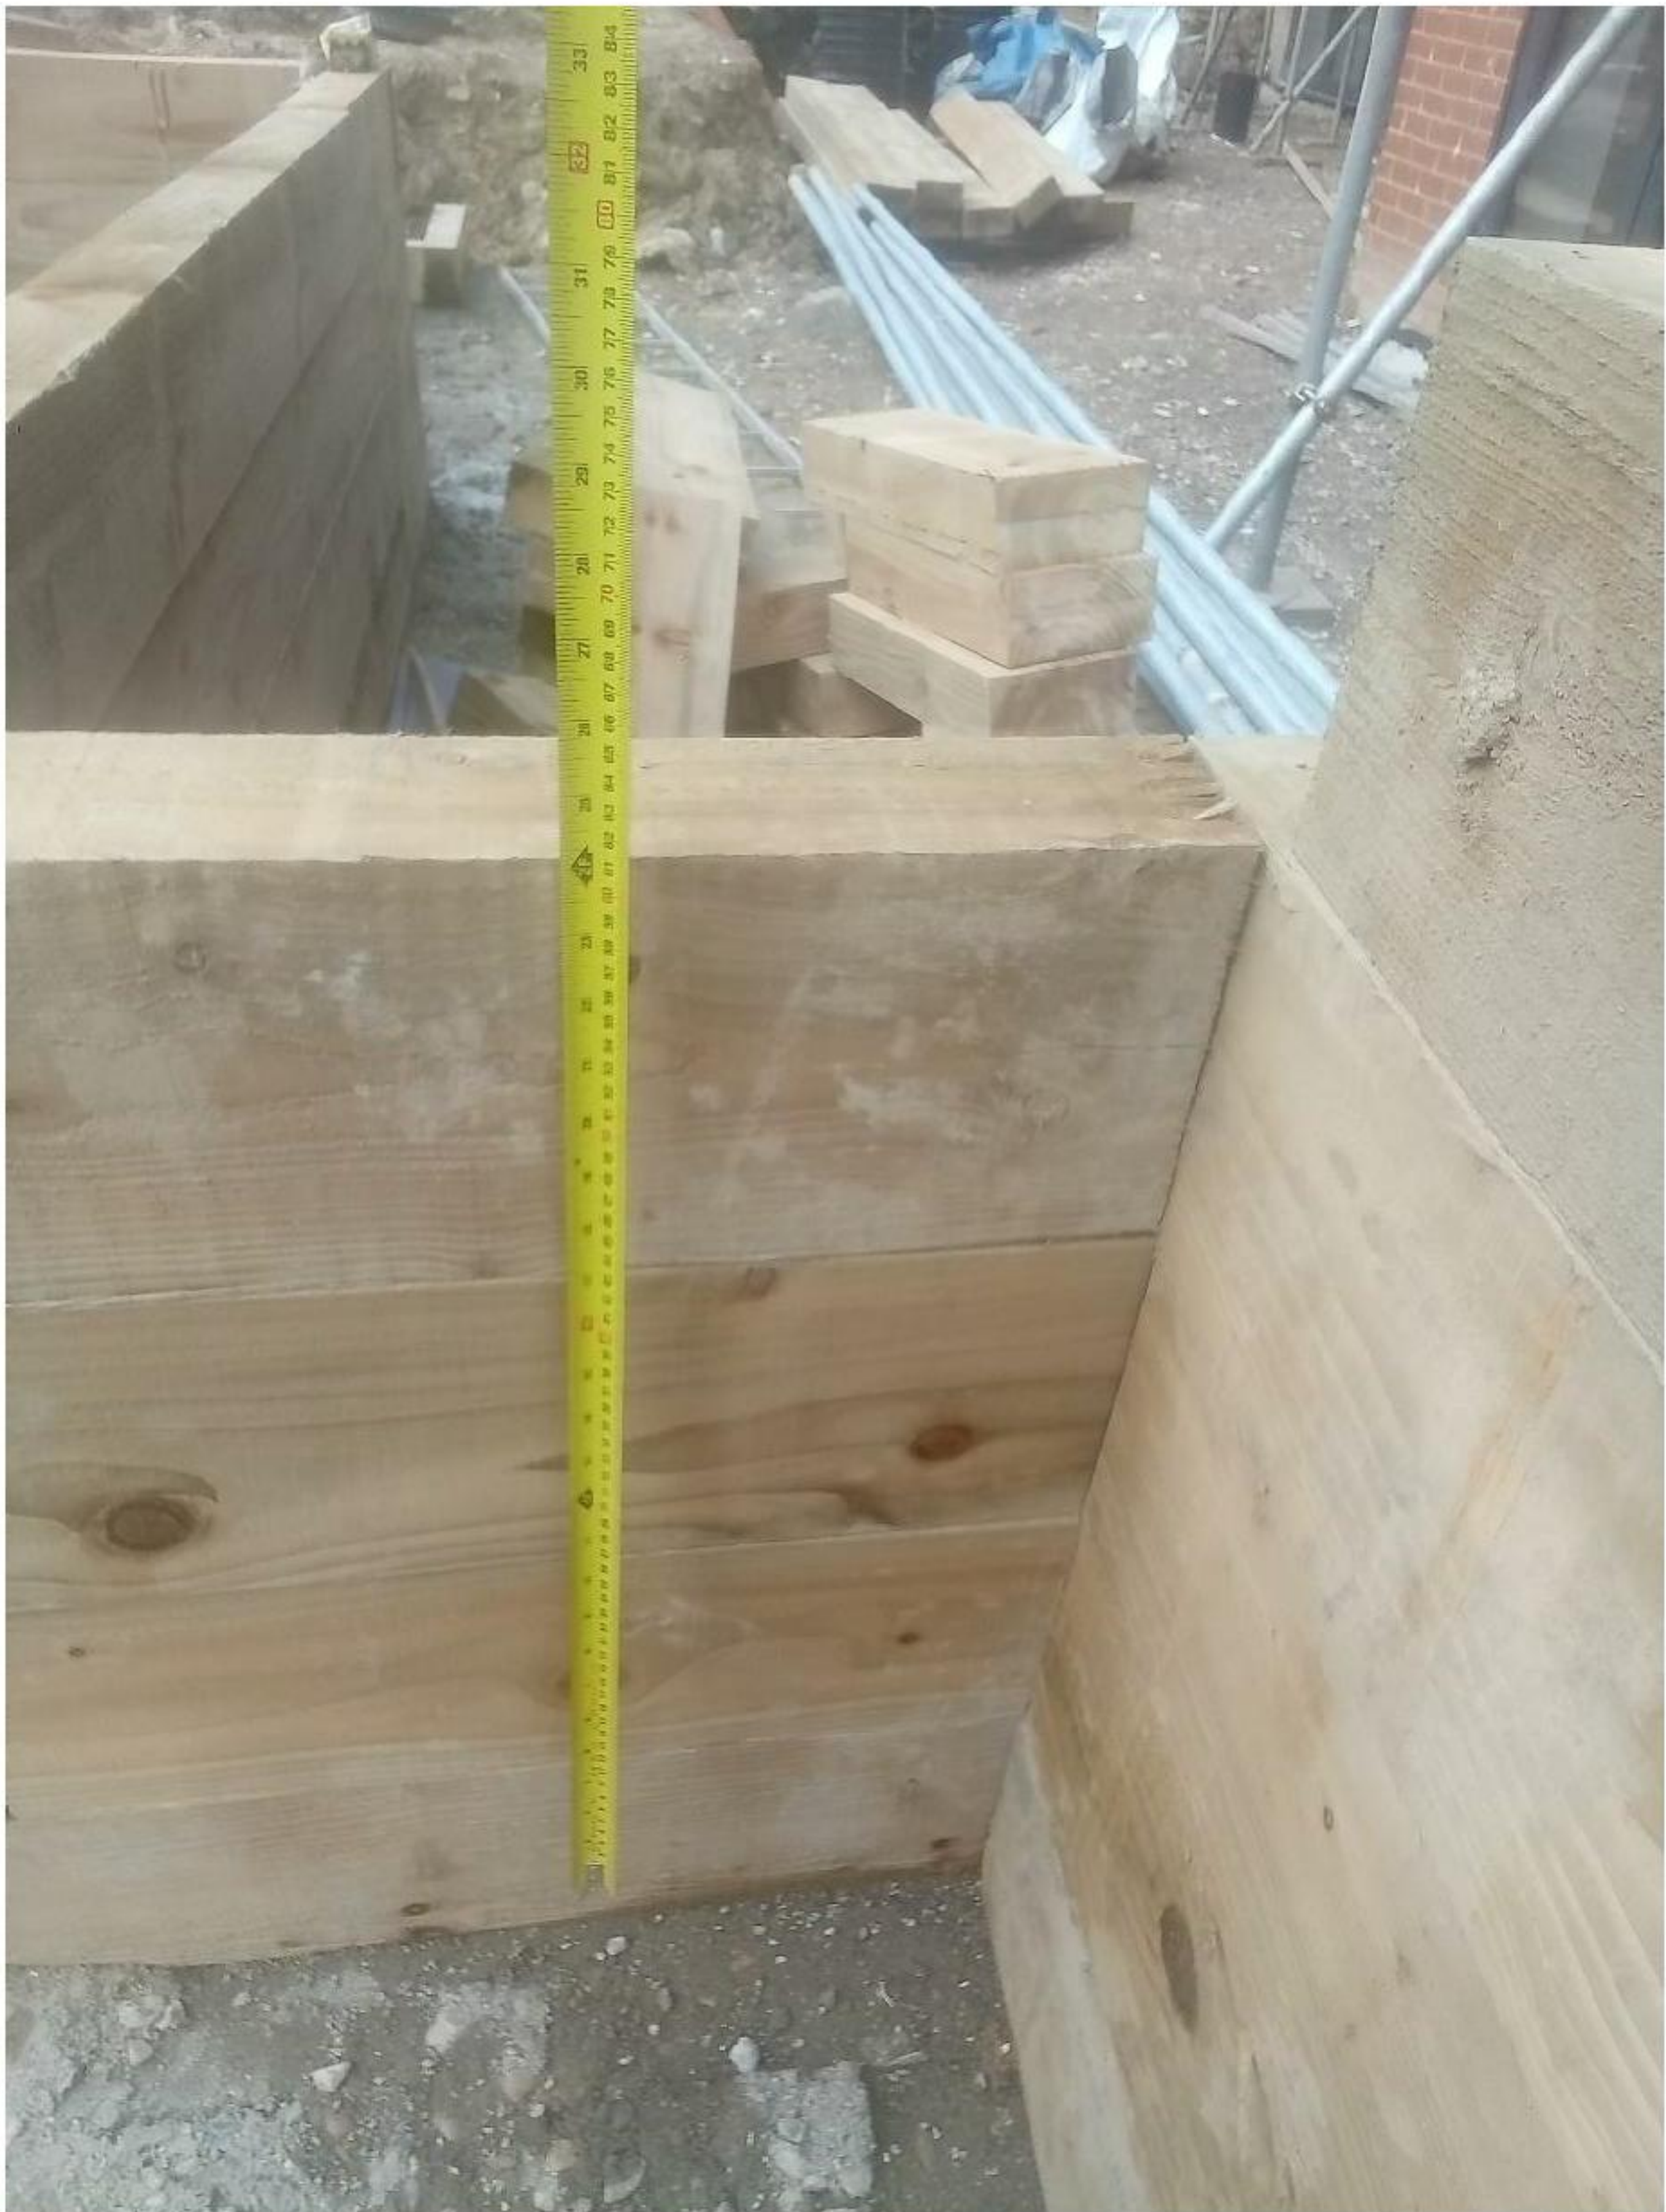
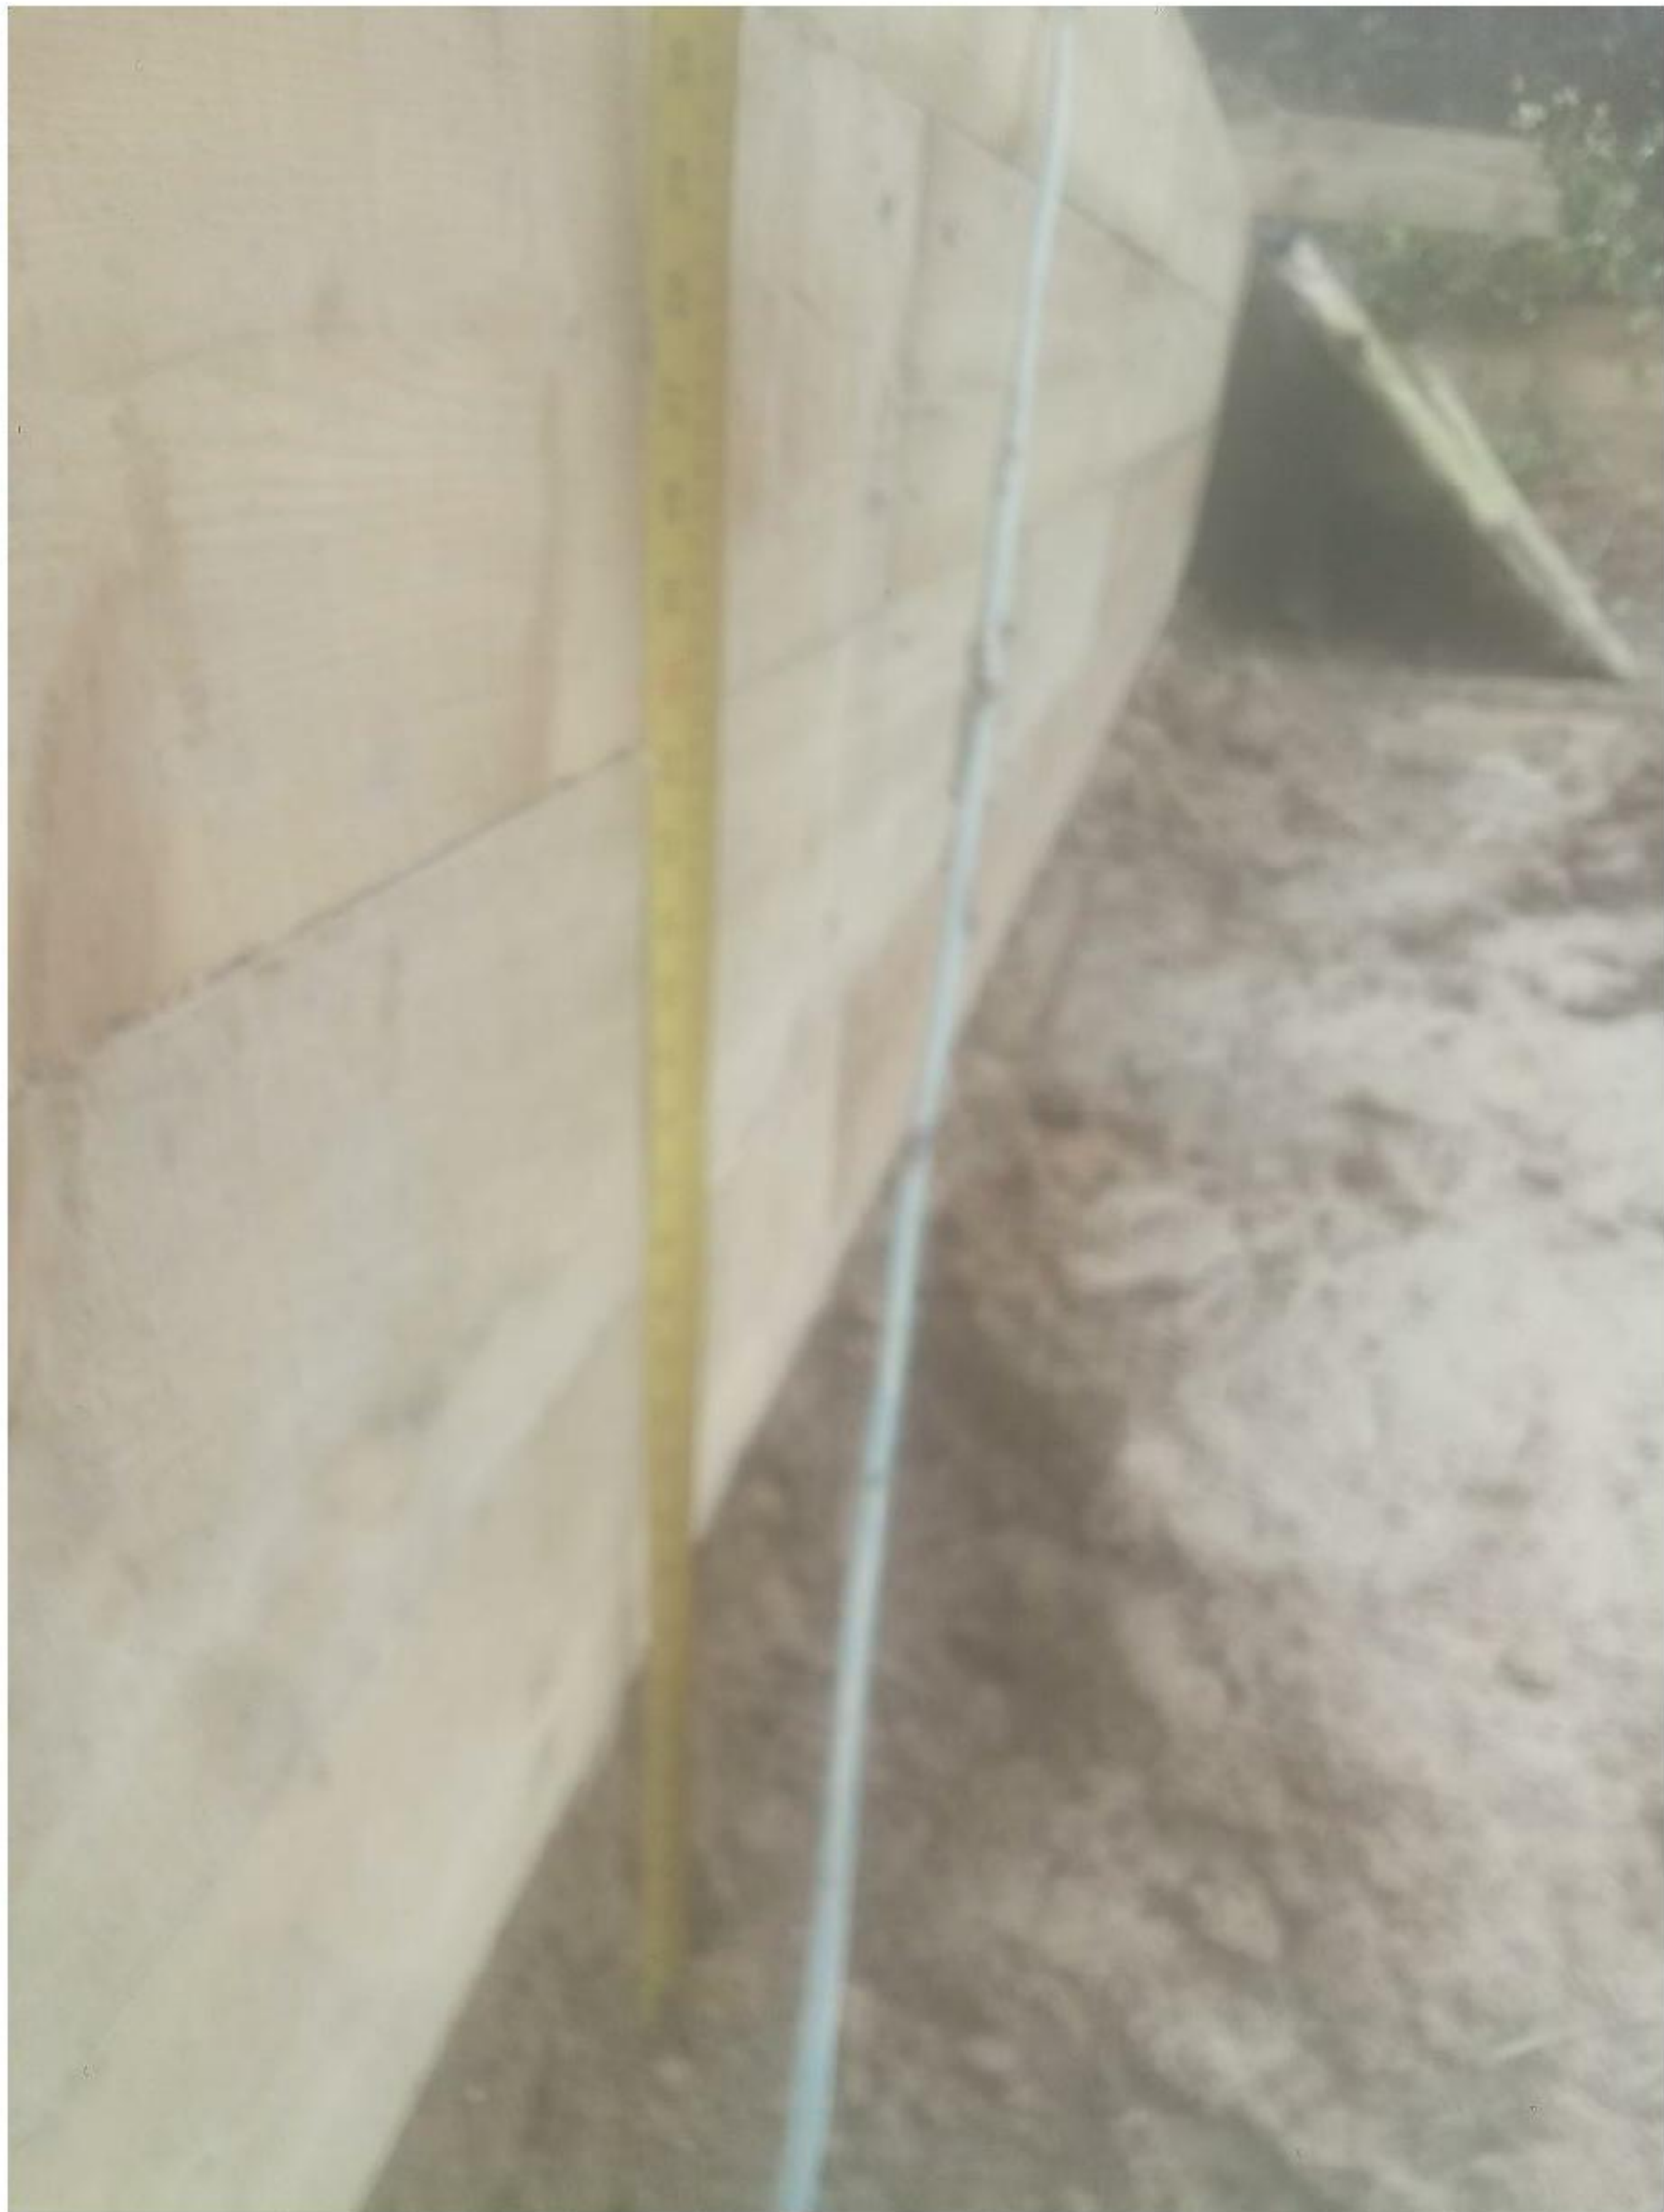
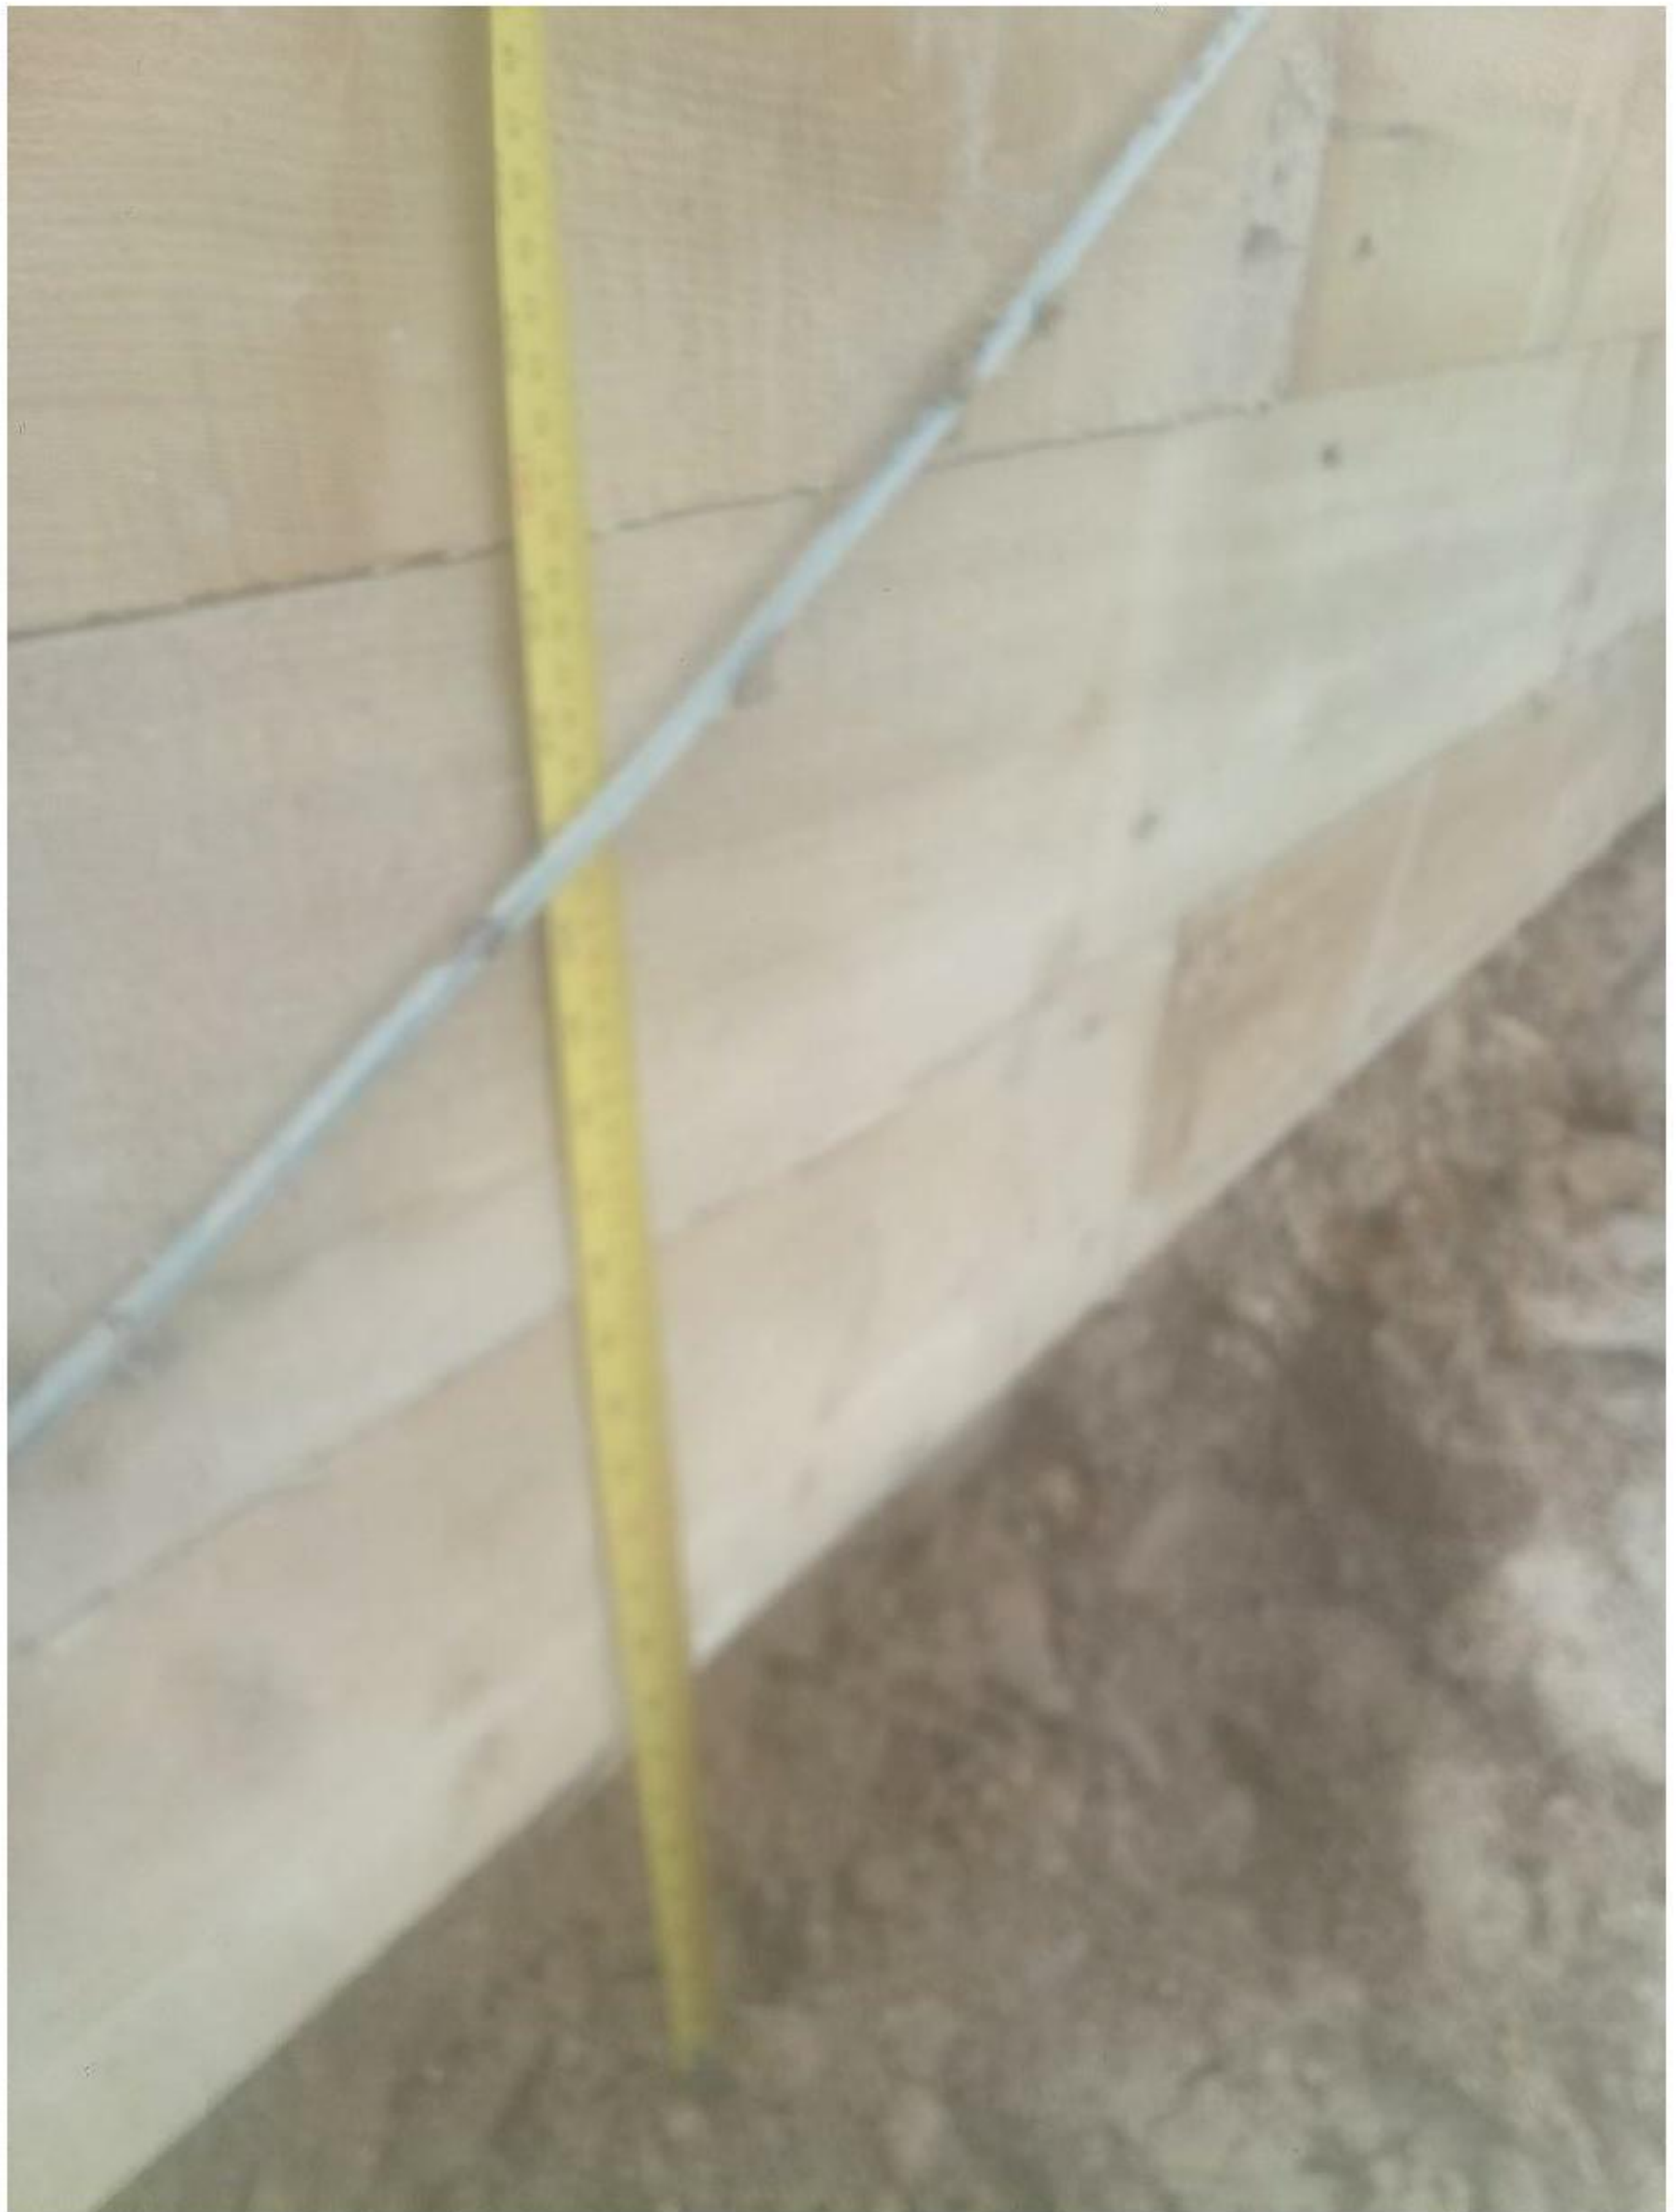
## Photographs

Photographic evidence of the landscaping and planter depths is presented in Appendix A of this report.

Ground level soft landscaping was created as part of the development together with a number of raised planters created around the site.
