## **BAT EMERGENCE SURVEY REPORT**

**Chownes Mead, Chownes Mead Lane, Haywards  
Heath**

On behalf of: RCM Partnership LLP

| <b>Reference:</b> | LLD3233-ECO-REP-004-01-BES | | | |

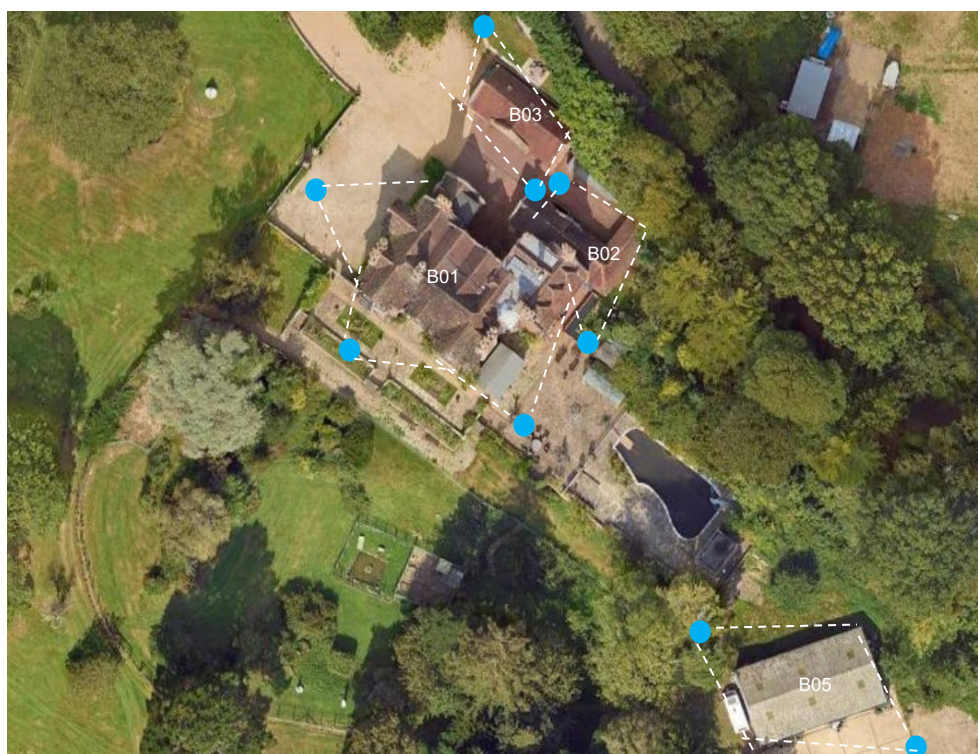
*Figure No. 01 – Location of Survey Points*

- 3.1.1 In accordance with current best practice guidelines (BCT, 2023), 3no. survey visits of B01, 2no. survey visits of B02 and B03 and 1no. survey visit of B05 were completed between 1<sup>st</sup> of July and the 19<sup>th</sup> of August 2024.
- 3.1.2 Surveys were led by a licenced surveyor or accredited agent, assisted by experienced ecologists. Surveyors were each assigned a point to adequately cover all potential roost features of each section of building which would be impacted.

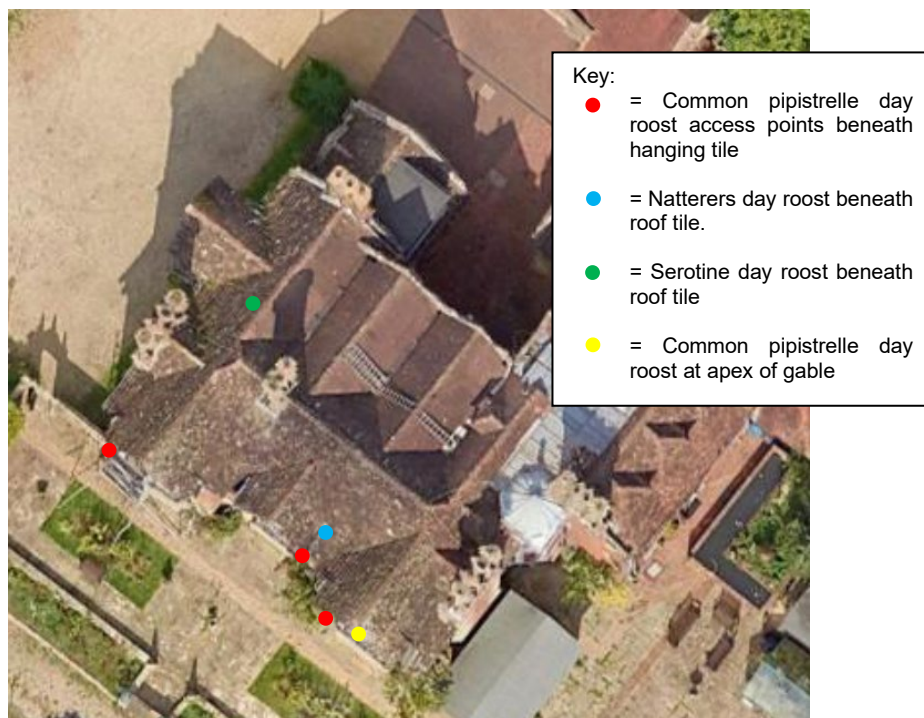
Figure 02 – Location of bat roosts and access points

- 4.3.1 A small number of common pipistrelles emerged from south-facing hanging tile during each survey. During the first survey visit on the 4<sup>th</sup> of July, 3no. common pipistrelle emerged from differing locations along the southern aspect of the property between 21:16 and 21:23. A single myotis bat also emerged from beneath a south-facing roof tile at 21:32.

- 4.3.2 The second survey visit recorded similar results, with 3no. pipistrelles emerging from hanging tile between 21:03 and 21:06. A single common pipistrelle was also noted as emerging from beneath a south-facing roof tile at 21:04, with an individual serotine emerging from west facing roof tile at 21:06.

- 4.3.3 4no. common pipistrelle emerged from south-facing hanging tile between 20:12 and 20:23, with a further 2no. common pipistrelle emerging from the apex of the south-eastern gable at 21:10 and 21:30.

- 4.3.5 During each survey 2no. kestrels were recorded perched in the eaves at sunset, before flying away to the south. These birds were considered to be actively hunting for bats, suggesting the presence of a long-standing roost within the building.

- 5.3 Should proposed works cause the destruction or damage of a bat roost (including blocking of access points during works), a licence shall be required from Natural England to allow works to progress. Mitigation measures will be agreed through the application process for a mitigation licence from Natural England but are likely to be as follows:

- Bat boxes at a number equivalent to 1no. box per roost to be impacted shall be installed to the southern aspect of adjacent mature trees.

- Following erection of bat boxes, a soft strip of any roof and hanging tiles in the vicinity of the known roosts required for removal shall be completed. All works shall be undertaken under ecological supervision.

- Existing adjacent vegetation should be retained to allow the continued use of these areas as foraging and commuting routes.
- Permanent compensatory roost features shall be installed within the building at a rate of 1no. feature per roost which is damaged / destroyed. The exact number and location of features shall be confirmed once designed proposals are finalised.
