**DUMBRELLS, CHURCH PLATT, CUCKFIELD  
WEST SUSSEX, RH17 5LA**

**HERITAGE STATEMENT**

**Prepared by Maggie Henderson  
Project No. 2016217  
February 2016**

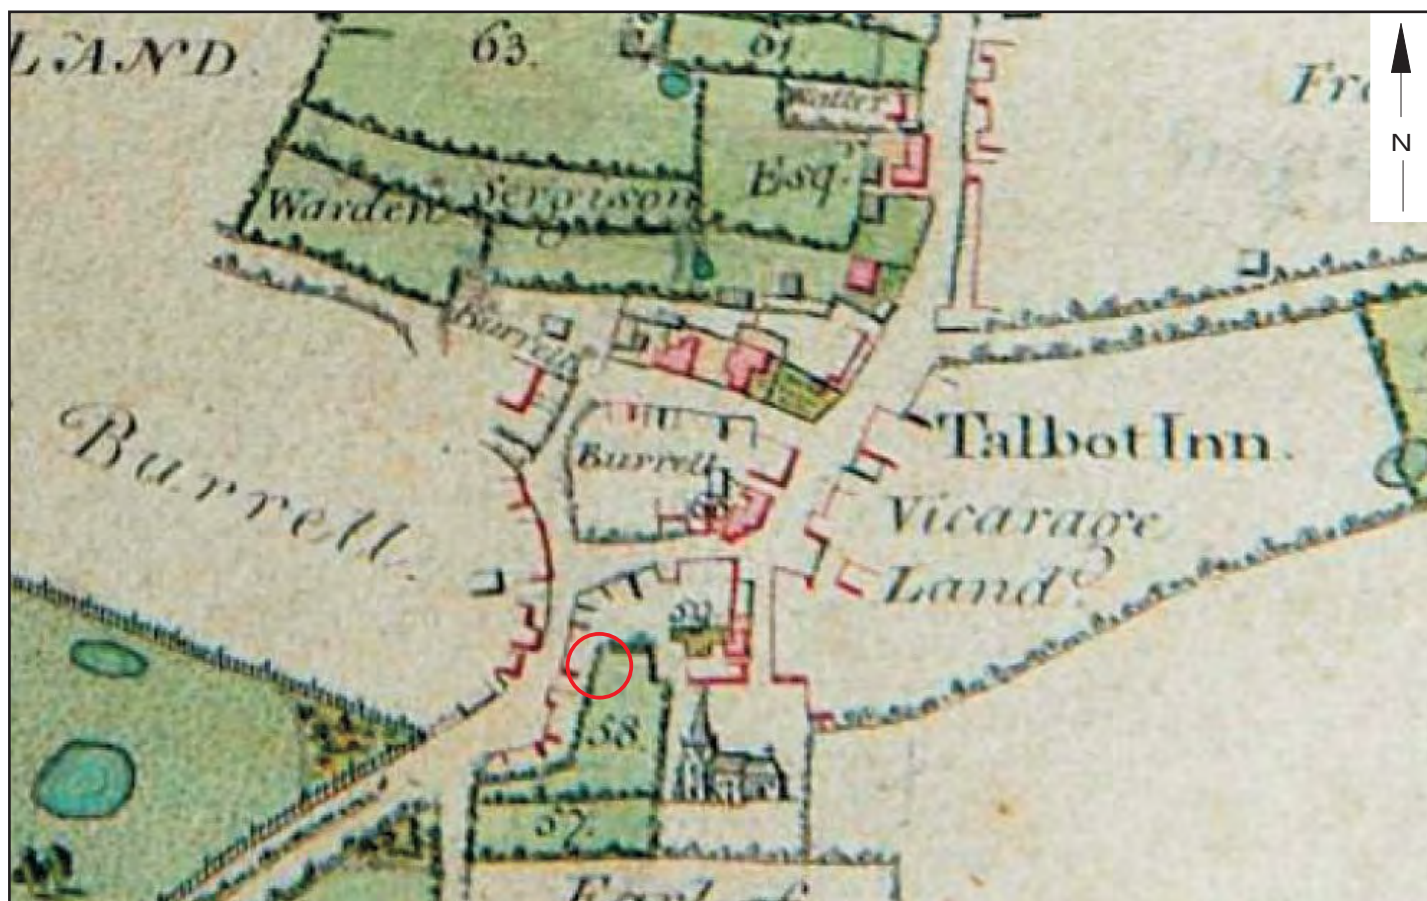
Budgen's 1809 Sergisson Estate Map (From Harris, R. B. Historic Character Assessment Report, 2005)

Cuckfield Tithe Map 1845

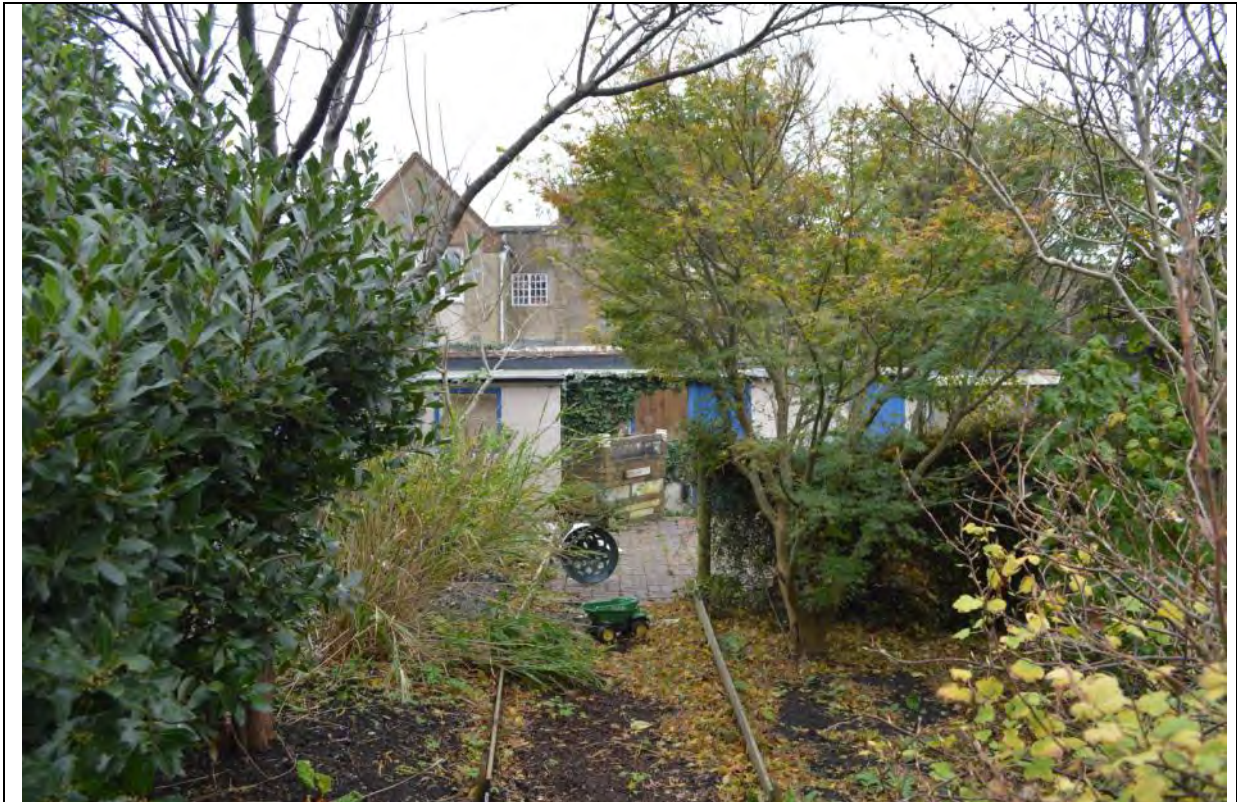
Plate 1: The breeze-block buildings against the eastern boundary garden wall

- 3.2 The principal elevation of Dumbrells faces east towards the Old School and the Church (The Church of the Holy Trinity), separated from the Listed buildings by Church Platt and a large garden defined on the eastern side by a brick wall, in English garden wall bond and further screened by a pair of sheds, a timber shed to the south and an inverted L-plan arrangement of breeze-block buildings with flat roofs to the north (Plate 1).

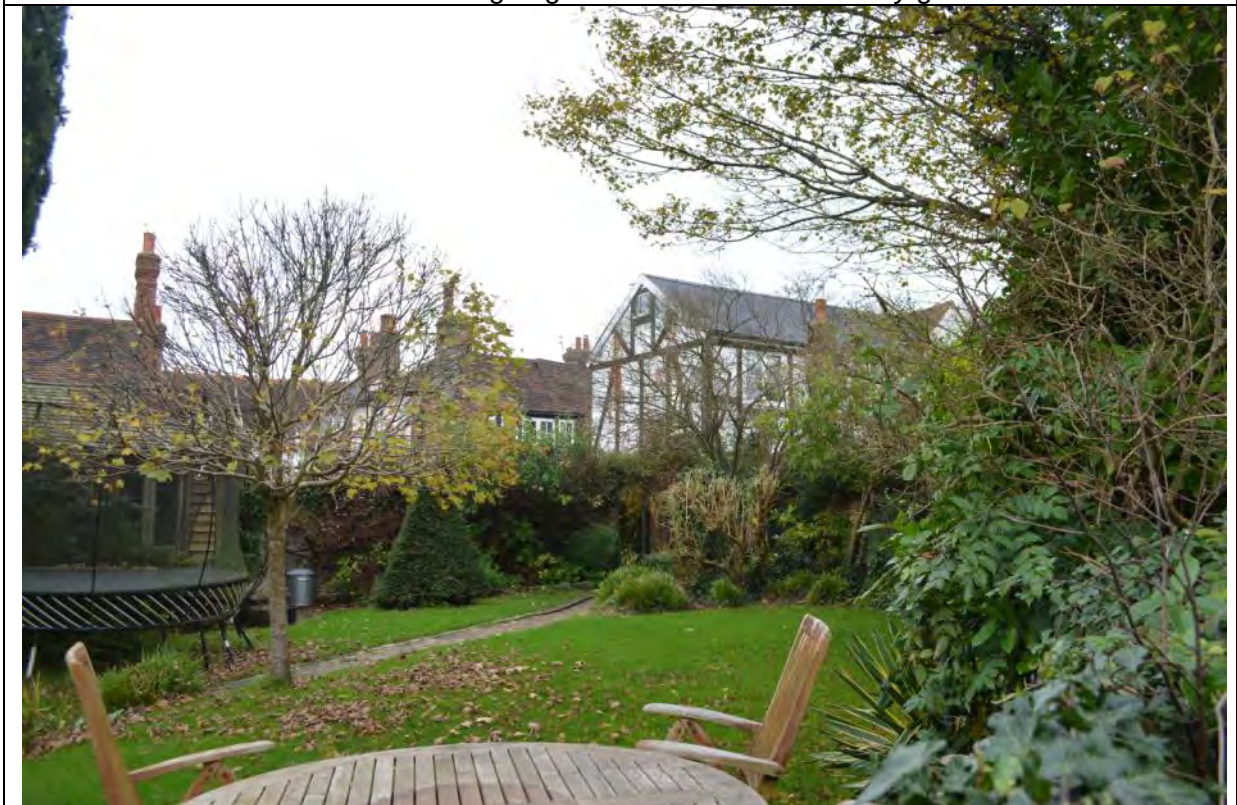
Plate 2: The south and east elevations of Dumbrells viewed from its gardens

- 3.3 The garden has well-established shrubs, areas set to lawn interspersed with the access path and areas of paving. The extent of the gardens, greenery, sheds, boundary wall and of course the buffer zone created by Church Platt in addition to the fact that Dumbrells is set well back abutting the rear ranges of the South Street front properties ensures that the visual impact of the house on the neighbouring heritage assets is minimal (Plates 2 & 3).

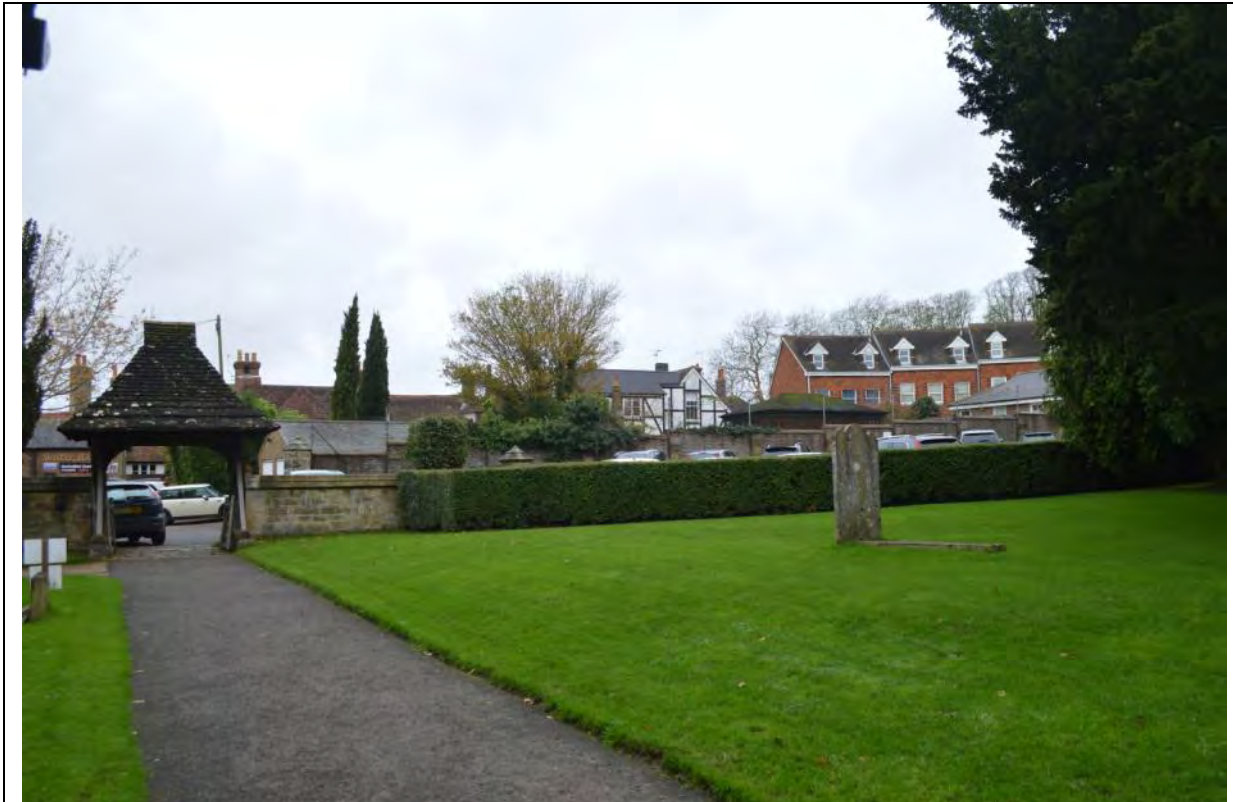
Plate 3: Dumbrells viewed from the doorway of the Church of the Holy Trinity

- 3.4 The setting of the house is discrete, due to the green screens and the distance of the house from the point of access in Church Platt (c. 325 m from the gate to the front door). The modern group to the north of Dumbrells does however impact slightly upon the garden setting as its mass and scale dwarfs its neighbour (Plate 3).

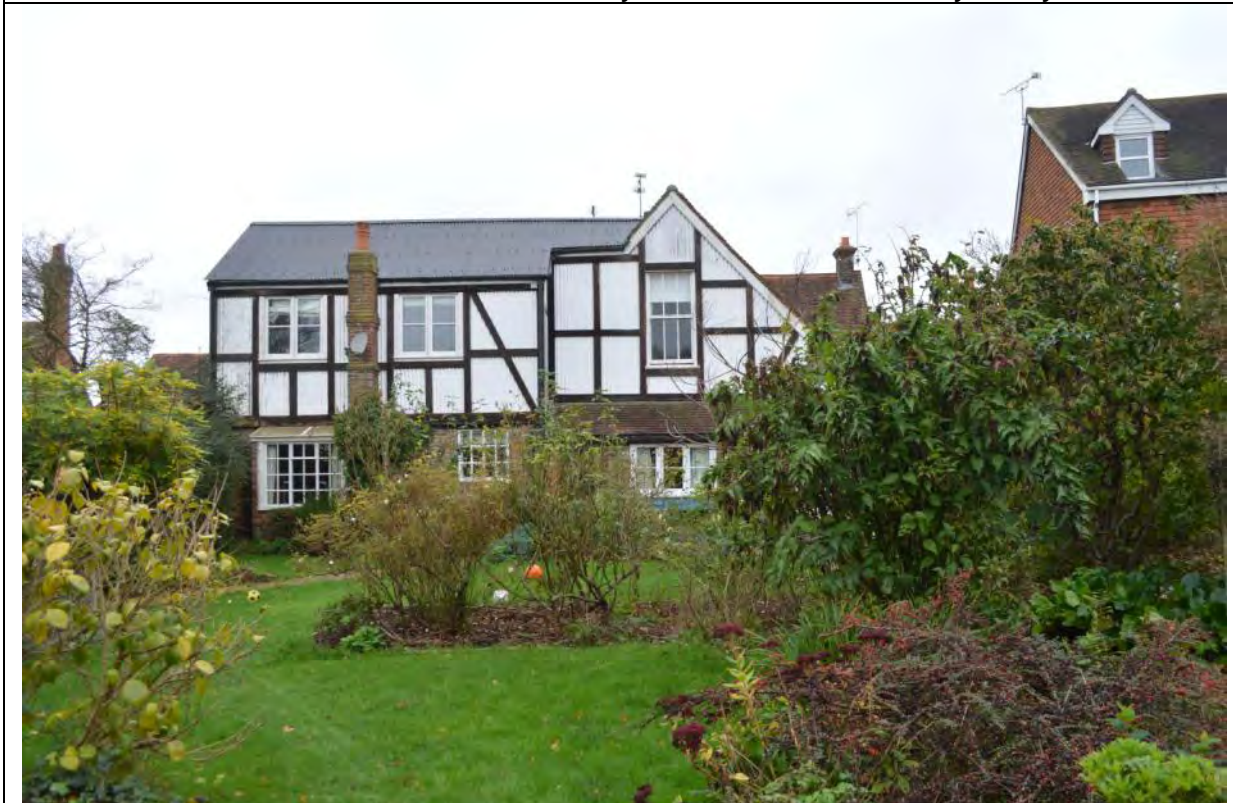
Plate 4: The principal, east – facing elevation

- 6.2.2 Two of the three distinct blocks shown on the early edition Ordnance Survey maps are discernable in the present building, these comprise a larger north – south oriented block (block 1) to centre and south with a 'cross-wing' at the north end (block 2), a shorter block with an east – west axis that terminates on the eastern side with a partial gabled effect roof-line (Fig. 6, Plate 4).

- 6.2.6 The upper floor throughout, is the first floor is clad in corrugated iron panels with applied stud work creating a mock Tudor effect (Plate 4).

- 6.2.10 The principal elevation includes quite an assortment of windows a single storey rectangular plan bay window at the southern end of the elevation has a three-light multi-paned window, the central of which is fixed, flanked by side-hung casements. The neighbouring window to the north is a multi-pane window (three rows of four-panes) that is fixed (Plate 4).

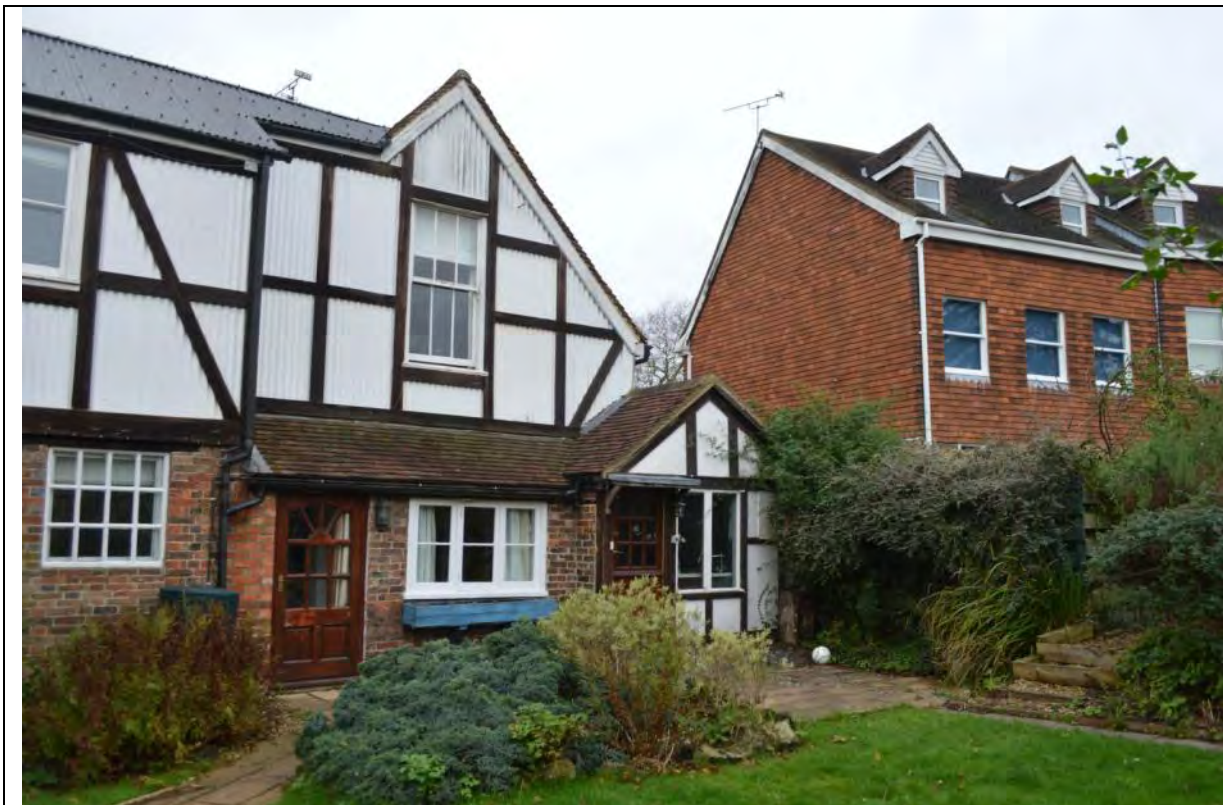
Plate 5: The north end of the east elevation (the face-wing, gabled extension and lean-to)

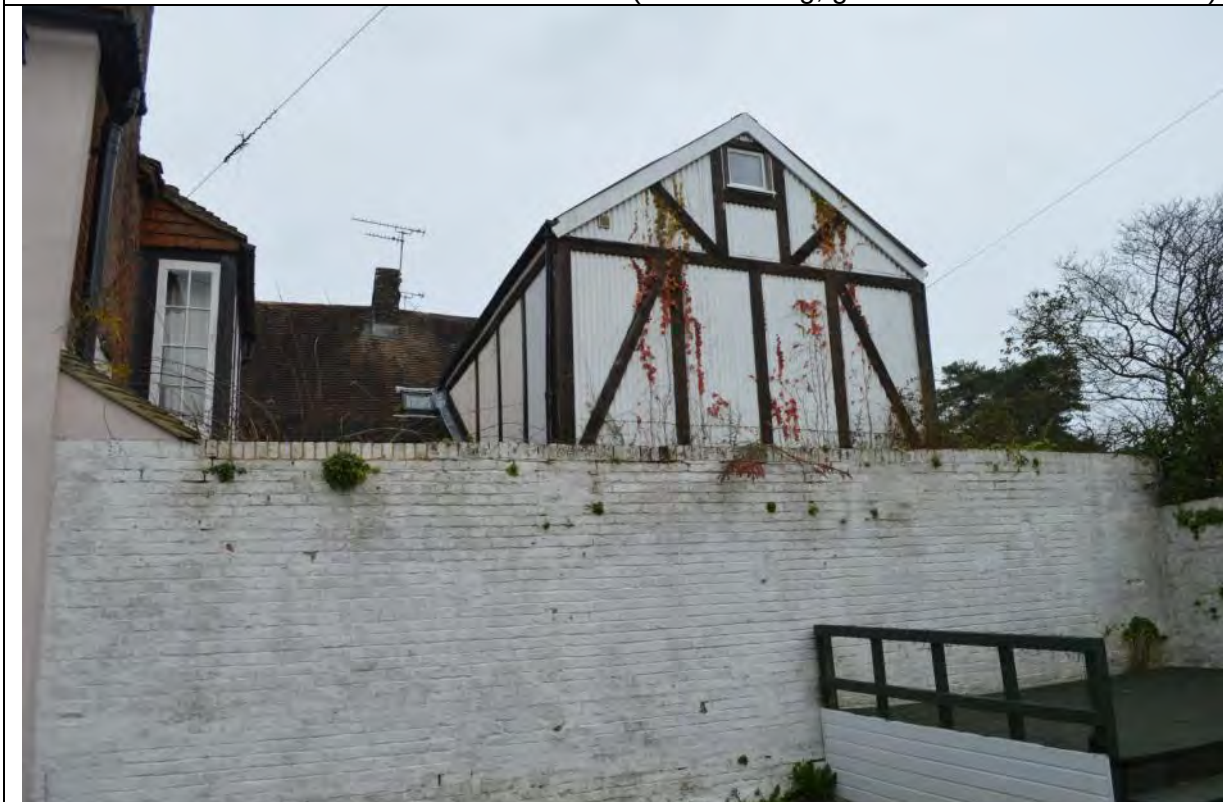
Plate 6: The south and part of the west elevation viewed from the back-plot of the neighbouring public house

- 6.2.9 The roof of the cross-wing (block 2) is under plain clay tile, continuing across from the rear range of Somners (Plate 6). The roof-slope to the east of the chimney stack, with a small roof-light *in situ*, belongs to Dumbrells, the remainder is Somners. The roof over the southern block (block 1) is under corrugated sheeting, of clearly modern origin (Plate 4). The lean-to porch and the gabled porch to the north of it have plain clay tile roofs.

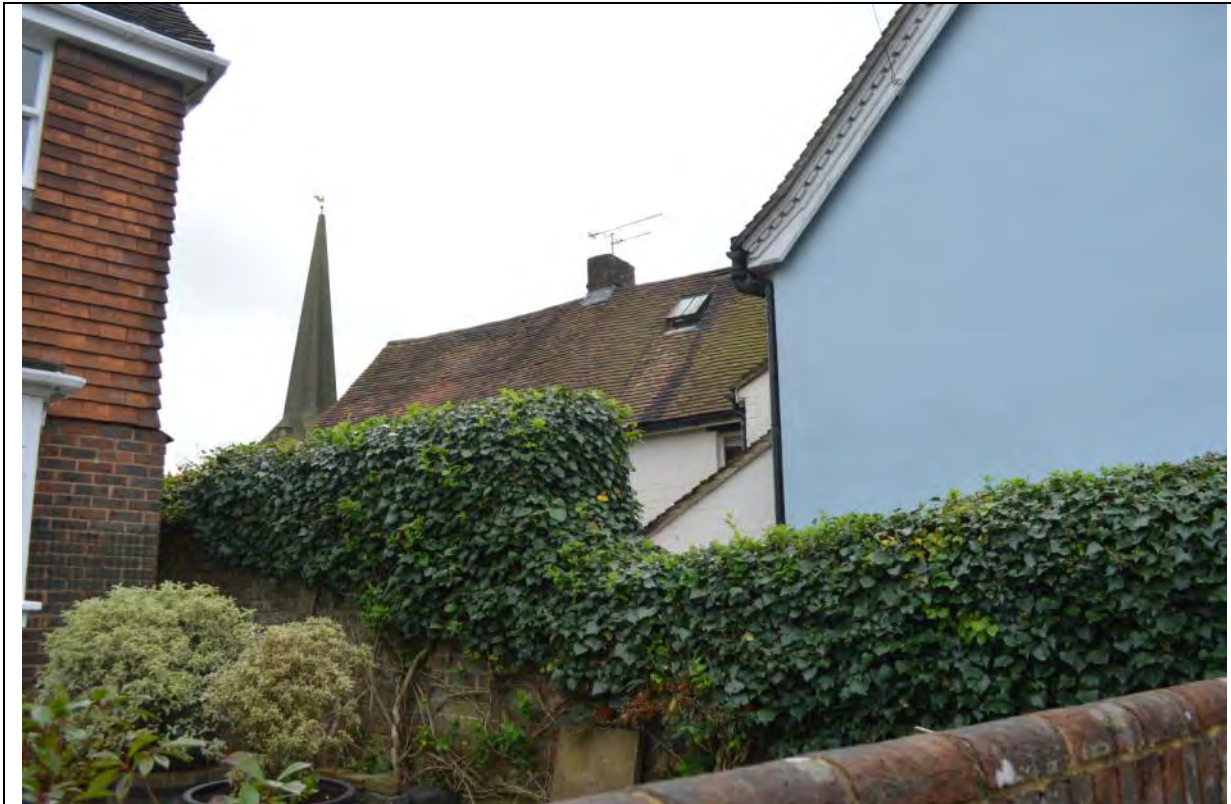
Plate 7: The north side of Dumbrells and Somners with the chimney at the junction of the two

- 6.2.15 There are two chimneys, one at the junction of the cross-wing between Dumbrells and Somners (Plate 7) and the other on the east elevation of block 1, between the regularly set first floor windows of that block. The latter is single flue and the stack is of brick.

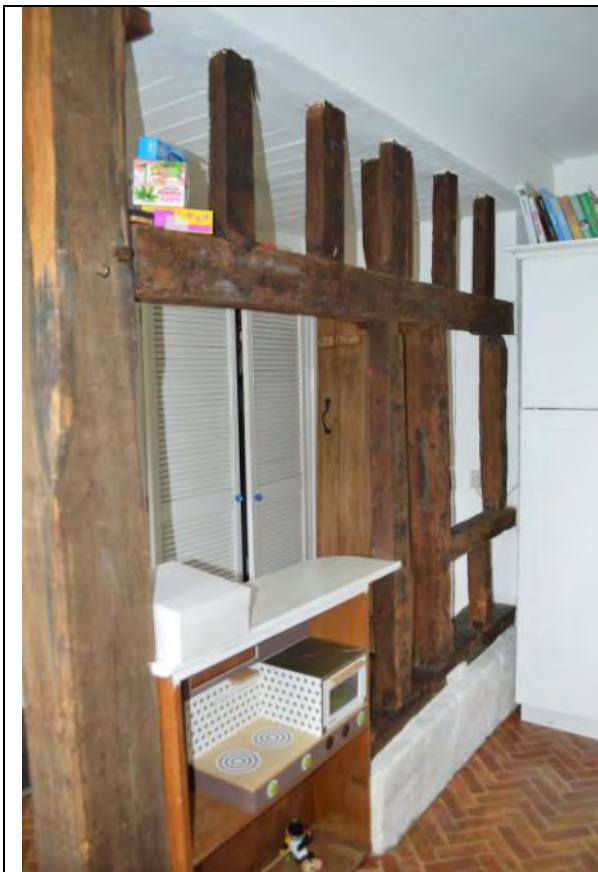
Plate 9: Timber framed wall in the current kitchen (cross-wing, block 2), viewed towards the rear (west) of the house

- 6.3.4 The timbers may be associated with the building adjacent to the west, a rear ranges of Somners (Fig. 6). It is worth noting that the sill beam appears to have been truncated: the tenon of the post is clearly identifiable in the mortise of the sill suggesting that the timber frame had continued, perhaps to match the retained wall remains in the kitchen of the cross-wing (Fig. 6; Plate 9).

- 6.3.5 The kitchen is bisected by the remains of a timber-framed wall that predates the remainder of the construction (excepting perhaps the post and sill beam noted above).

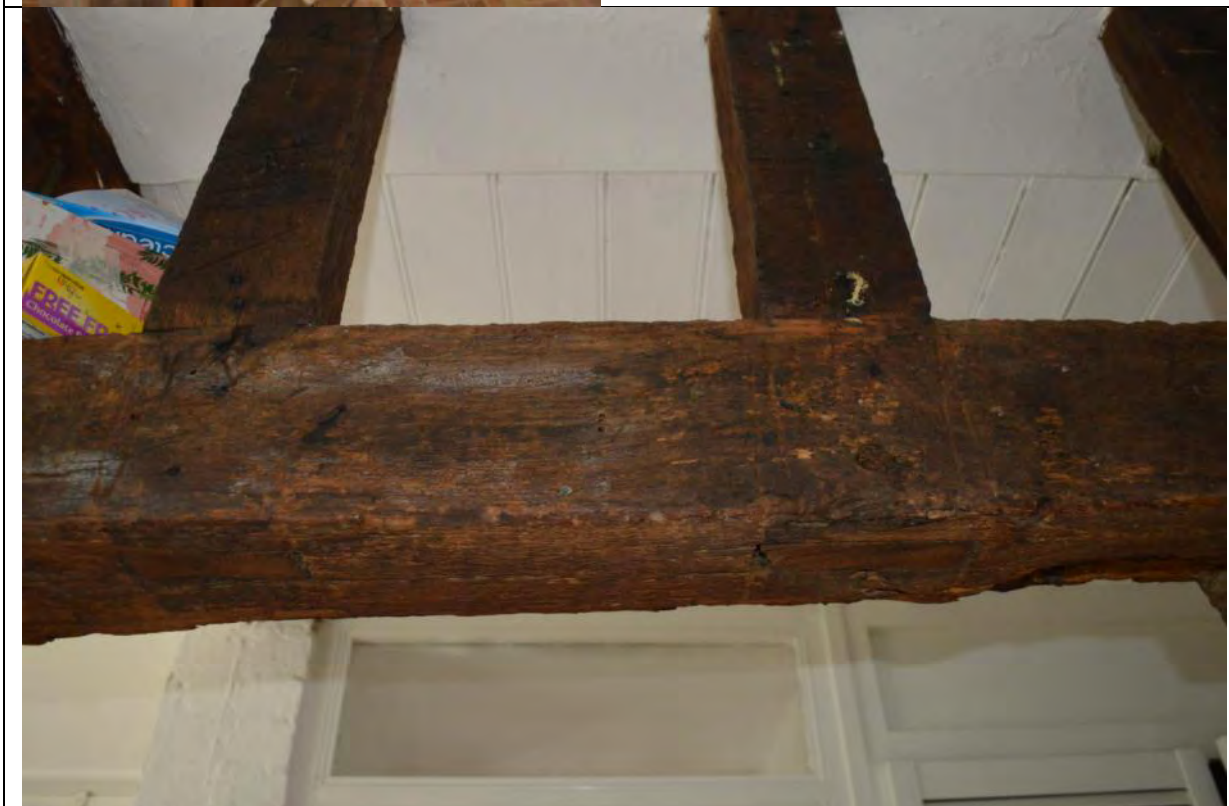
Plate 10: Details of the mid-rail with in situ studs above and mortises on the same alignment below, note that the studs are flush with the mid-rail

- 6.3.6 The remains comprise a low plinth surmounted by a sill-beam and above that a mid-rail (or side-girt?): the two horizontal members are lined by a series of wide studs, further studs can be seen above the mid-rail. The framing has been truncated at its eastern end, the rail carried on an inserted post, into which it has been jointed and pegged. The studs above the mid-rail are more consistent than those below, and the mid-rail includes redundant joining in its soffit for studs that would initially have aligned with those above, the details indicate that the lower part of the wall has been much modified (Plate 10).

- 6.3.7 The northern side of the studs are set flush with the mid-rail and the studs have clearly defined nail holes and pressure marks for battens that would have carried the wall finish: the southern side of the studs are comparatively clean, indicating that the studs were visible in that location. The flush finish on the north side indicates that this was the primary surface (Plate 10), and perhaps an original external one, forming the north side of the rear range of Somners.

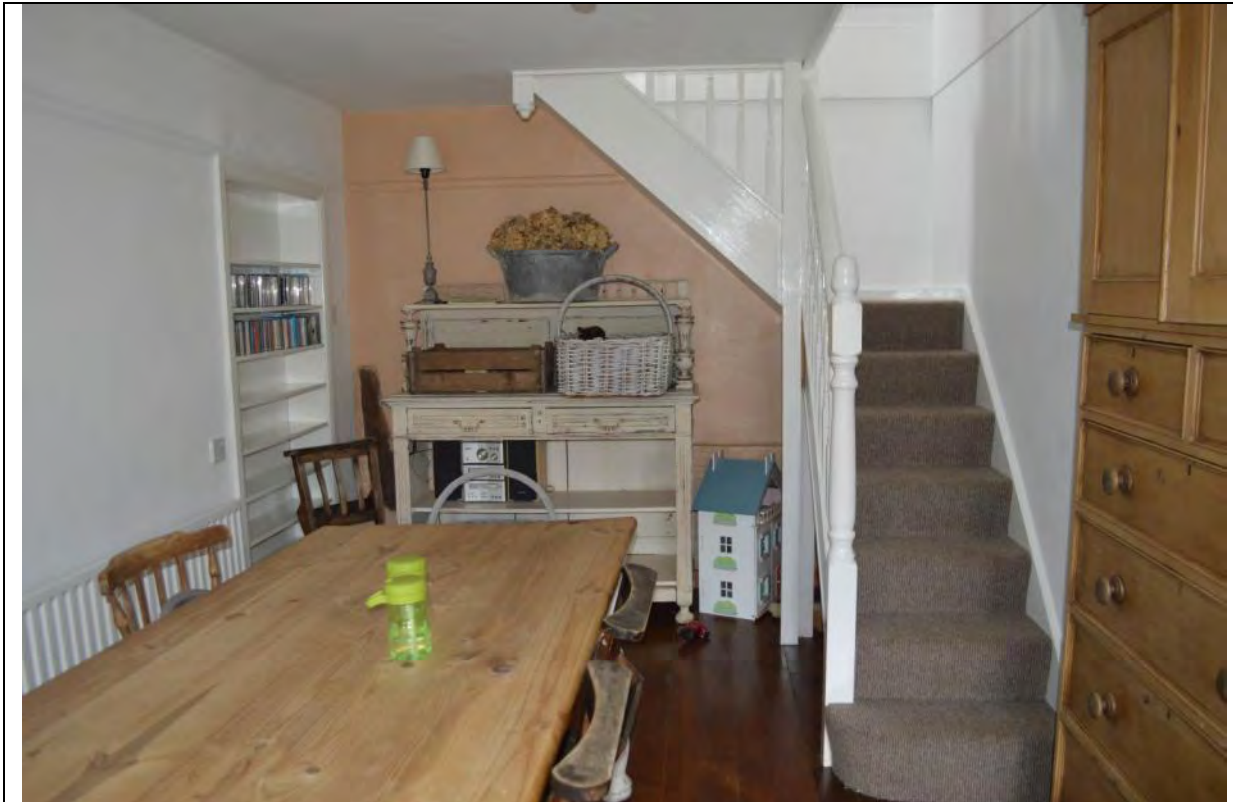
Plate 11: The west side of the dining room/stair hall with bookcase within a former doorway

- 6.3.9 There is a blocked doorway in the south wall of the dining room that had formerly linked the central and southern parts of the building: the doorway is evident within the dining room as a recess, now fitted out as a book case (Plate 11). The rear (west) wall adjacent to the blocked former doorway includes the retained post and sill beam of a timber-framed building as noted above (Plates 8 and 11).
- 6.3.10 The floor of the central room retains historic floor-boards with a varnished finish. The room has a moulded picture rail and the staircase type is consistent with an early 20<sup>th</sup> century origin, comprising moulded newels with acorn finials and elegant turned balusters (Plate 11)

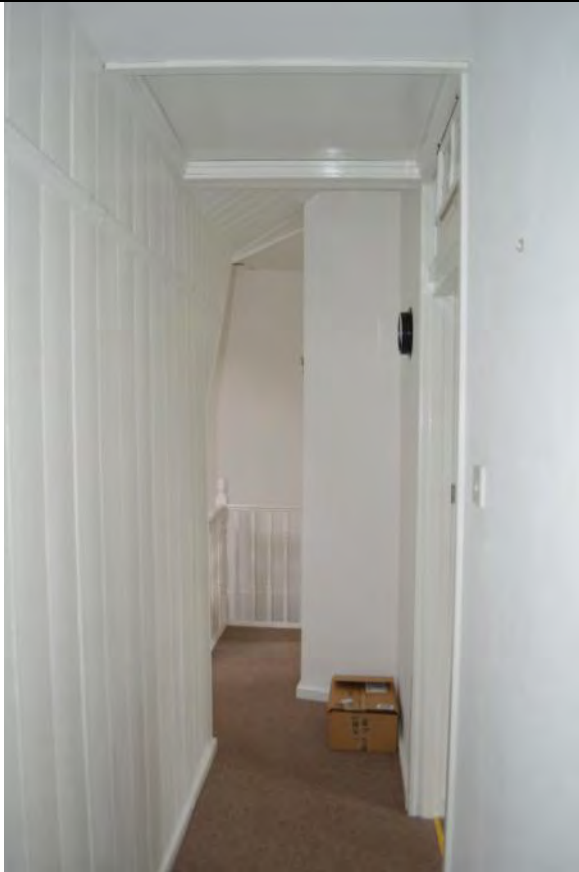
Plate 13: The corridor looking north, note matchboard to the west with picture rail and plain-finish to the inserted corridor wall on the east

- 6.4.10 That the corridor was inserted is evidenced by its plain finish in contrast with the matchboard and contemporary picture rail on the west wall of what is now the corridor. In addition, above the modern suspended ceiling can be seen the original matchboard partition between the two blocks. As noted above, the partition between what is now the central and southern rooms is a modern modification.

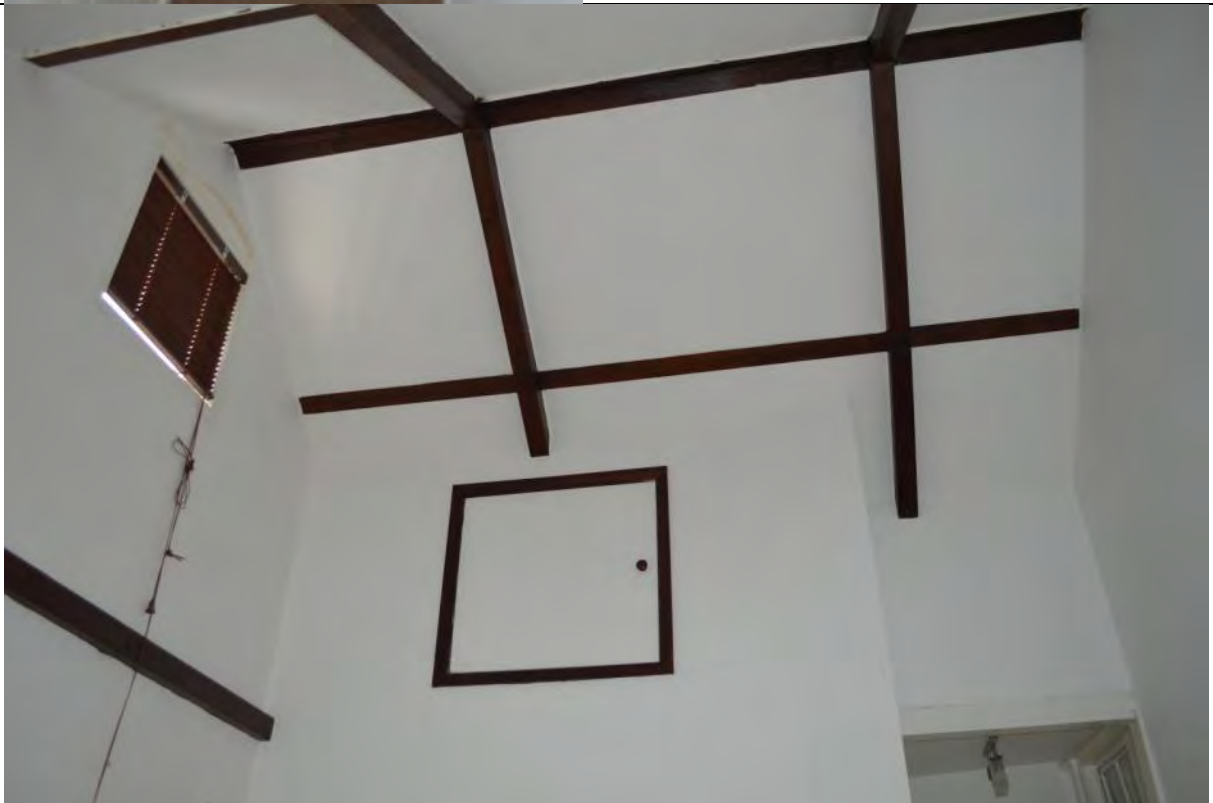
Plate 14: Interior of the southern room in block 1

- 6.3.16 The southern room of block 1 has no suspended ceiling, the roof-slopes have been plastered out excepting exposed softwood truss rafters, two tiers of purlins and a continuous ridge-board of narrow scantling (Plate 14).

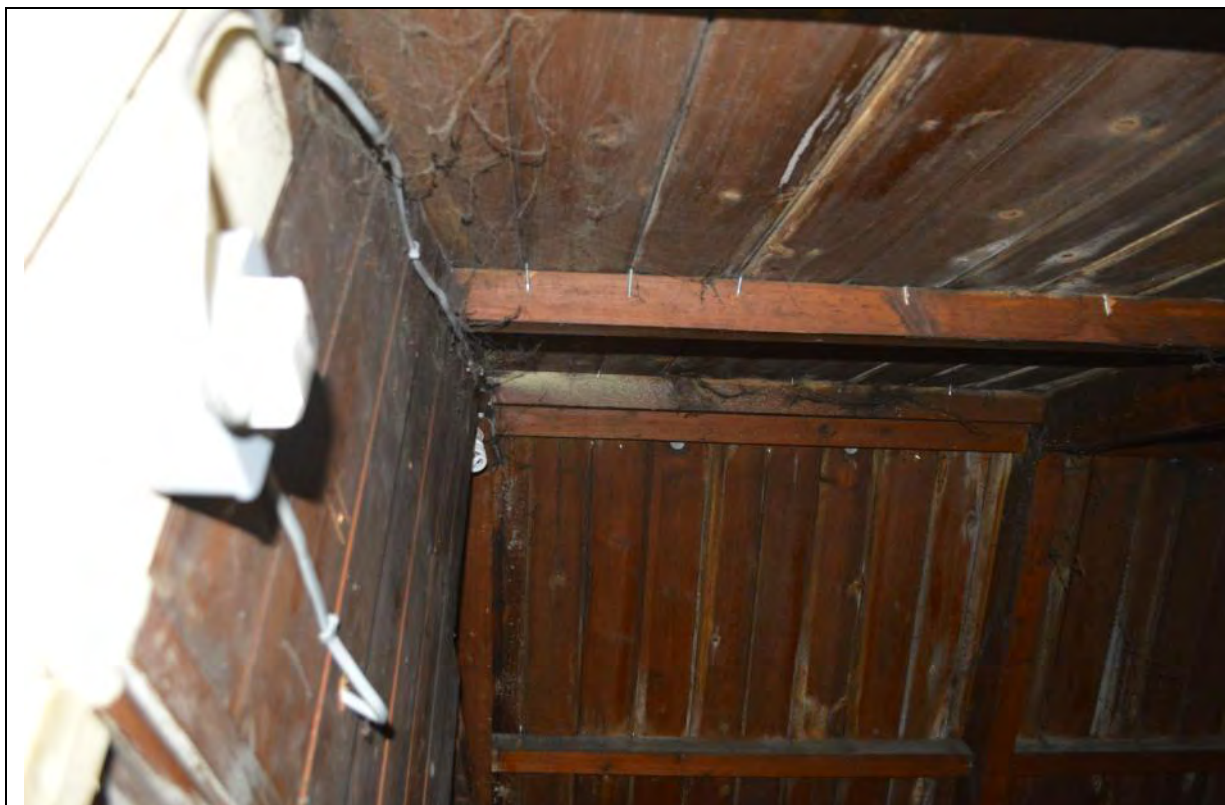
Plate 15: Interior of the matchboard lined roof structure over the central bedroom (block 1) and the matching partition between the central and northern room in block 2

- 6.3.20 As noted above within the south bedroom of block 1, the roof comprises trusses each with principal rafter pairs linked by two-tiers of purlins and a continuous ridge board (Plates 15 and 16); the roof slopes have vertically-set sarking boards, contributing to the overall match-board finish.

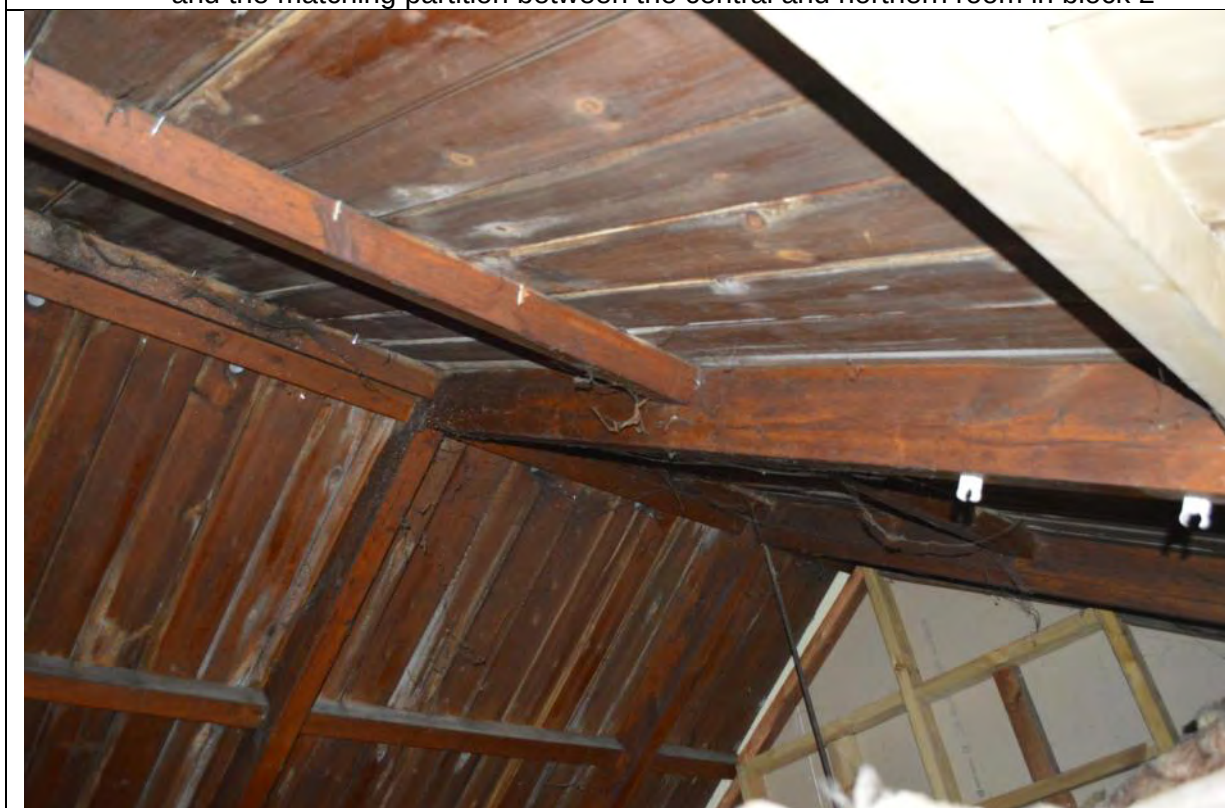
Plate 16: View south to the modern partition between the central and southern rooms

- 6.3.18 It is clear from the roof over the corridor and the central bedroom as accessed via the hatch in the corridor, that the present partition between the central and southern room is a modern one, in addition, the suspended ceilings are later modifications, the upper floor open to the roof in the first instance.
- 6.3.19 A partition had existed between the central and northern bedrooms, at the junction of blocks 1 and 2 (Plate 15). In this location there is a retained match-board finish and moulded detail, the historic partition construction is in stark contrast to the inserted modern equivalent at the south end (Plate 16).
