Ref: JK/26/37

### **Kennedy Avenue, East Grinstead: Ground Level Tree Assessment**

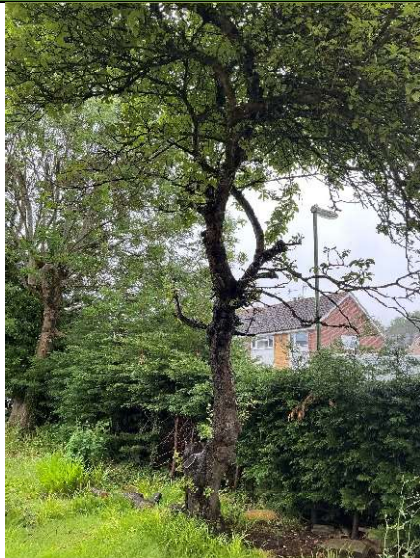
| Tree | BRP Category | Features | Photograph |
|---|---|---|---|
| T1 | Negligible | Domestic fruit tree ( <i>Malus sp.</i> ). No features. | |

Under current proposals all onsite trees will be lost and works to the onsite structure will be limited to the connection to the existing gable face and linkage of the roof to the new build areas. In consideration of the lack of any onsite roosting habitat associated with the trees or building assessed no further survey or mitigation works are required in regard to roosting bats.

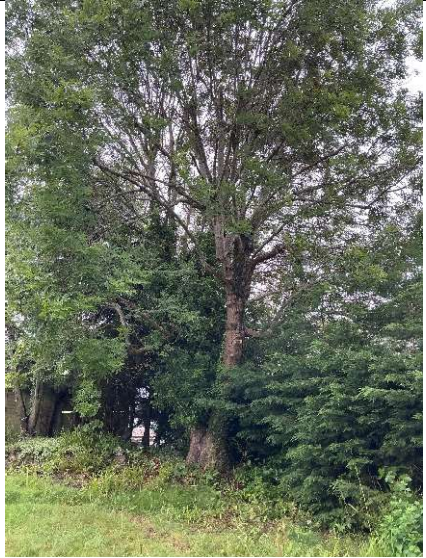
| Tree | BRP Category | Features | Photograph |
|---|---|---|---|
| T2 | Negligible | Ash ( <i>Fraxinus excelsior</i> ) – Some sparse Ivy ( <i>Hedera helix</i> ) cladding – no features. | |

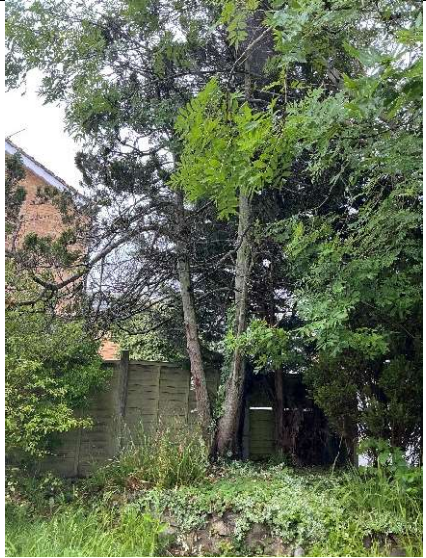
| Tree | BRP Category | Features | Photograph |
|---|---|---|---|
| G1 | Negligible | Comprising non-native Cedar ( <i>Cedrus sp</i> ) and Cypress ( <i>Cupressus sp</i> ). No features | |

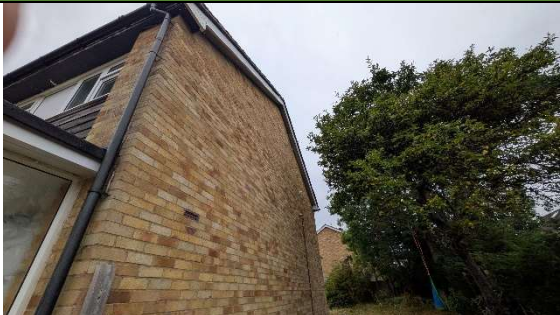
The structure was considered to provide negligible potential for roosting bats due to the lack of any potential roosting features present on the gable face or roof areas that will be associated with the development proposals.

| Photo and Notes | Photograph |
|---|---|
| P1 – View along the gable face proposed for connection to the development. | |

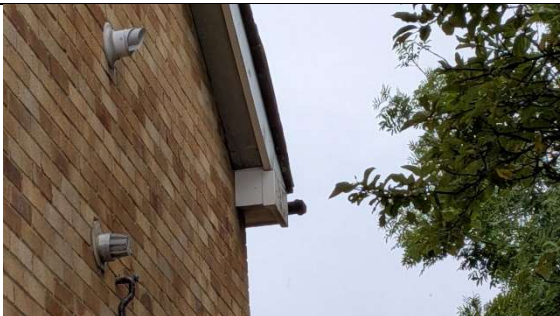
| Photo and Notes | Photograph |
|---|---|
| P2 – View of roof edge features showing good condition and lack of features. | |

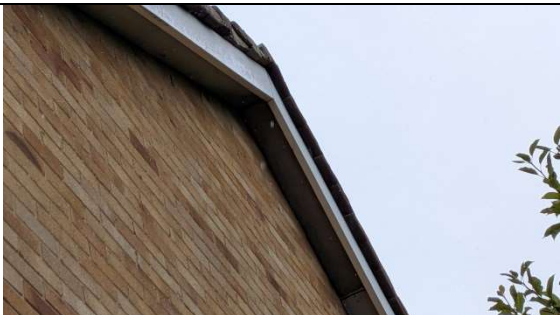
| Photo and Notes | Photograph |
|---|---|
| P3 - View of roof edge features showing good condition and lack of features. | |
