**ARBORICULTURAL IMPLICATIONS ASSESSMENT  
FOR PROPOSED REAR EXTENSION**

**FERN COTTAGE  
BONFIRE LANE  
HORSTED KEYNES**

**Our ref: J66.67  
12<sup>th</sup> June 2025**

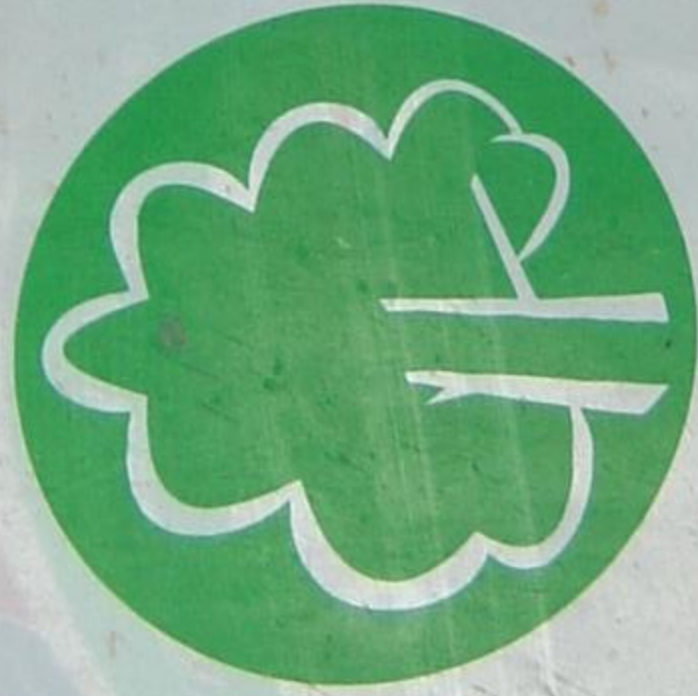
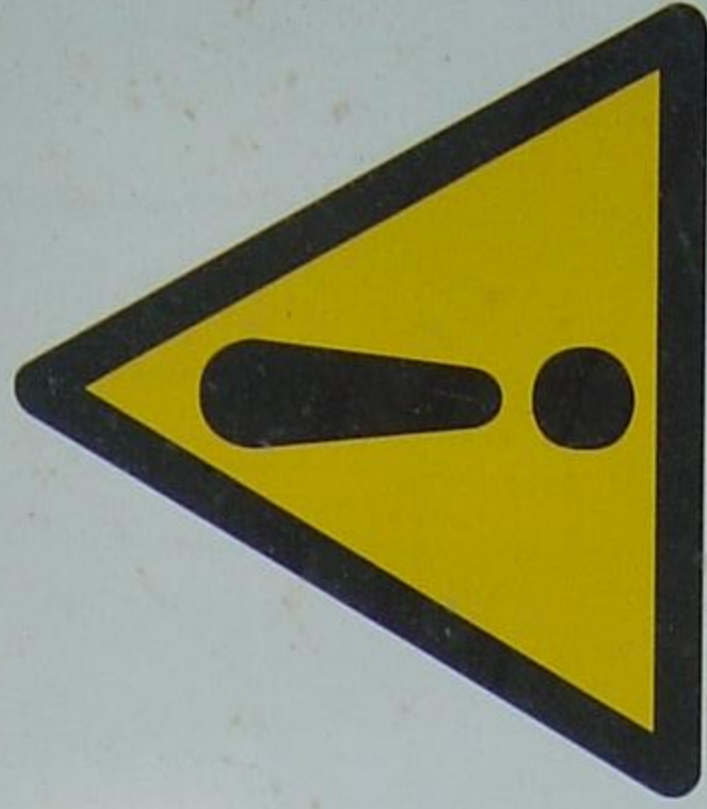
**PROTECTIVE FENCING.  
THIS FENCING MUST BE  
MAINTAINED IN ACCORDANCE  
WITH THE APPROVED PLANS  
AND DRAWINGS FOR THIS  
DEVELOPMENT**

**TREE PROTECTION AREA  
KEEP OUT!**

- 10.2.2 Examples of the fencing specification and signage required are included in Appendix 4.
