# Boundary wall repairs at Sackville College .

## Design Access and Heritage Statement.

August 2024

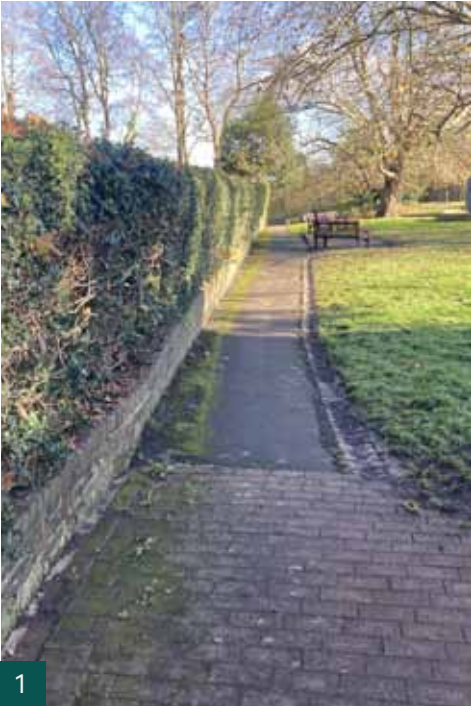
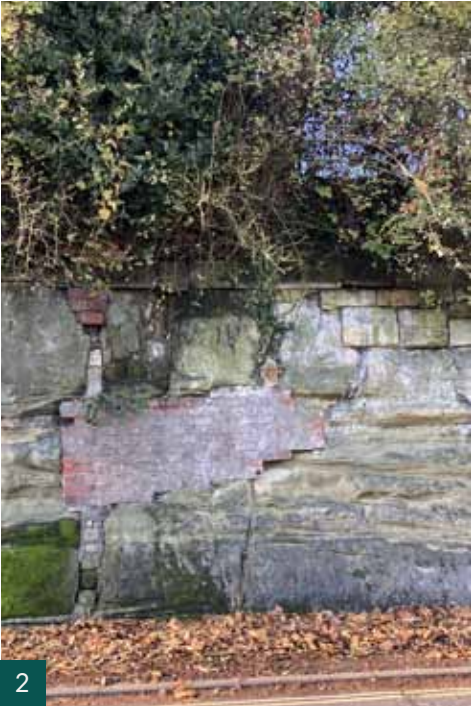
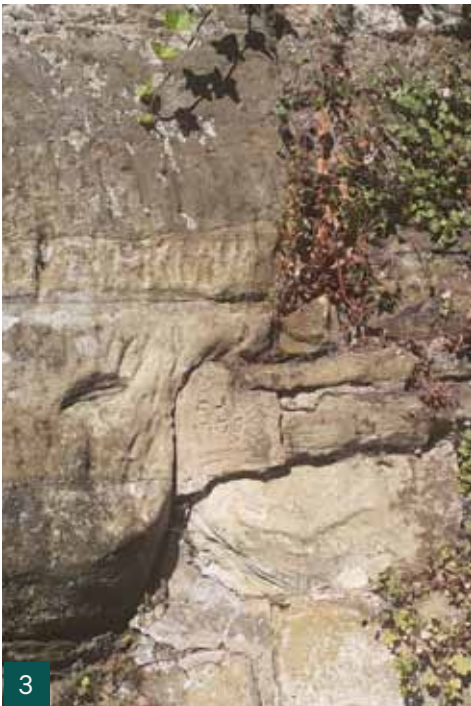
Photograph 1 of Boundary Wall to High Street, Photograph 2 & 3 of the Wall to be repaired to College Lane.

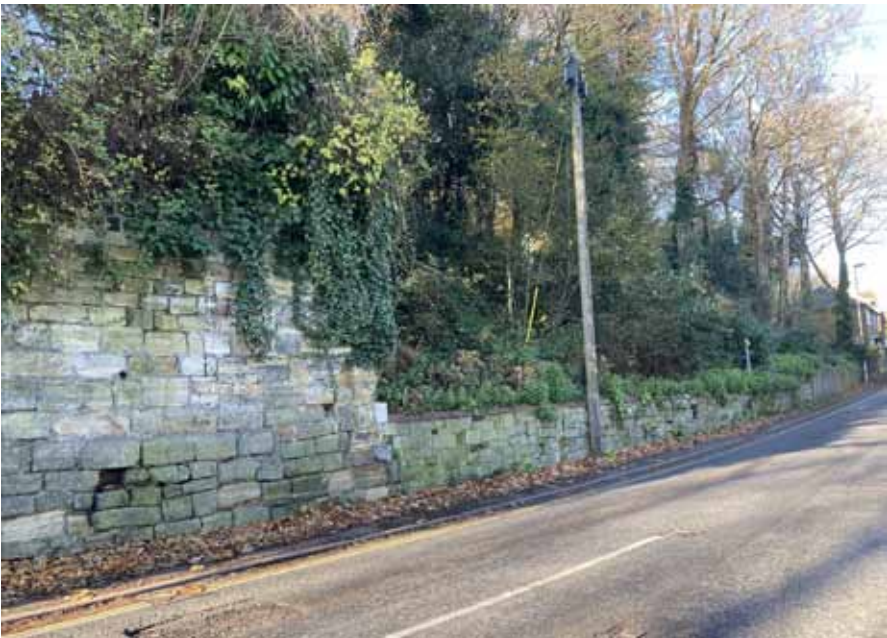
Photograph of wall

Several urgent areas require immediate attention. One particularly concerning area involves a large capping stone on the retaining wall, which is currently supported by an unstable set of bricks. Additionally, several other capping stones appear to be slipping forward. The primary objective of this project is to stabilize these areas and make it safe for pedestrians using the footpath below the wall.

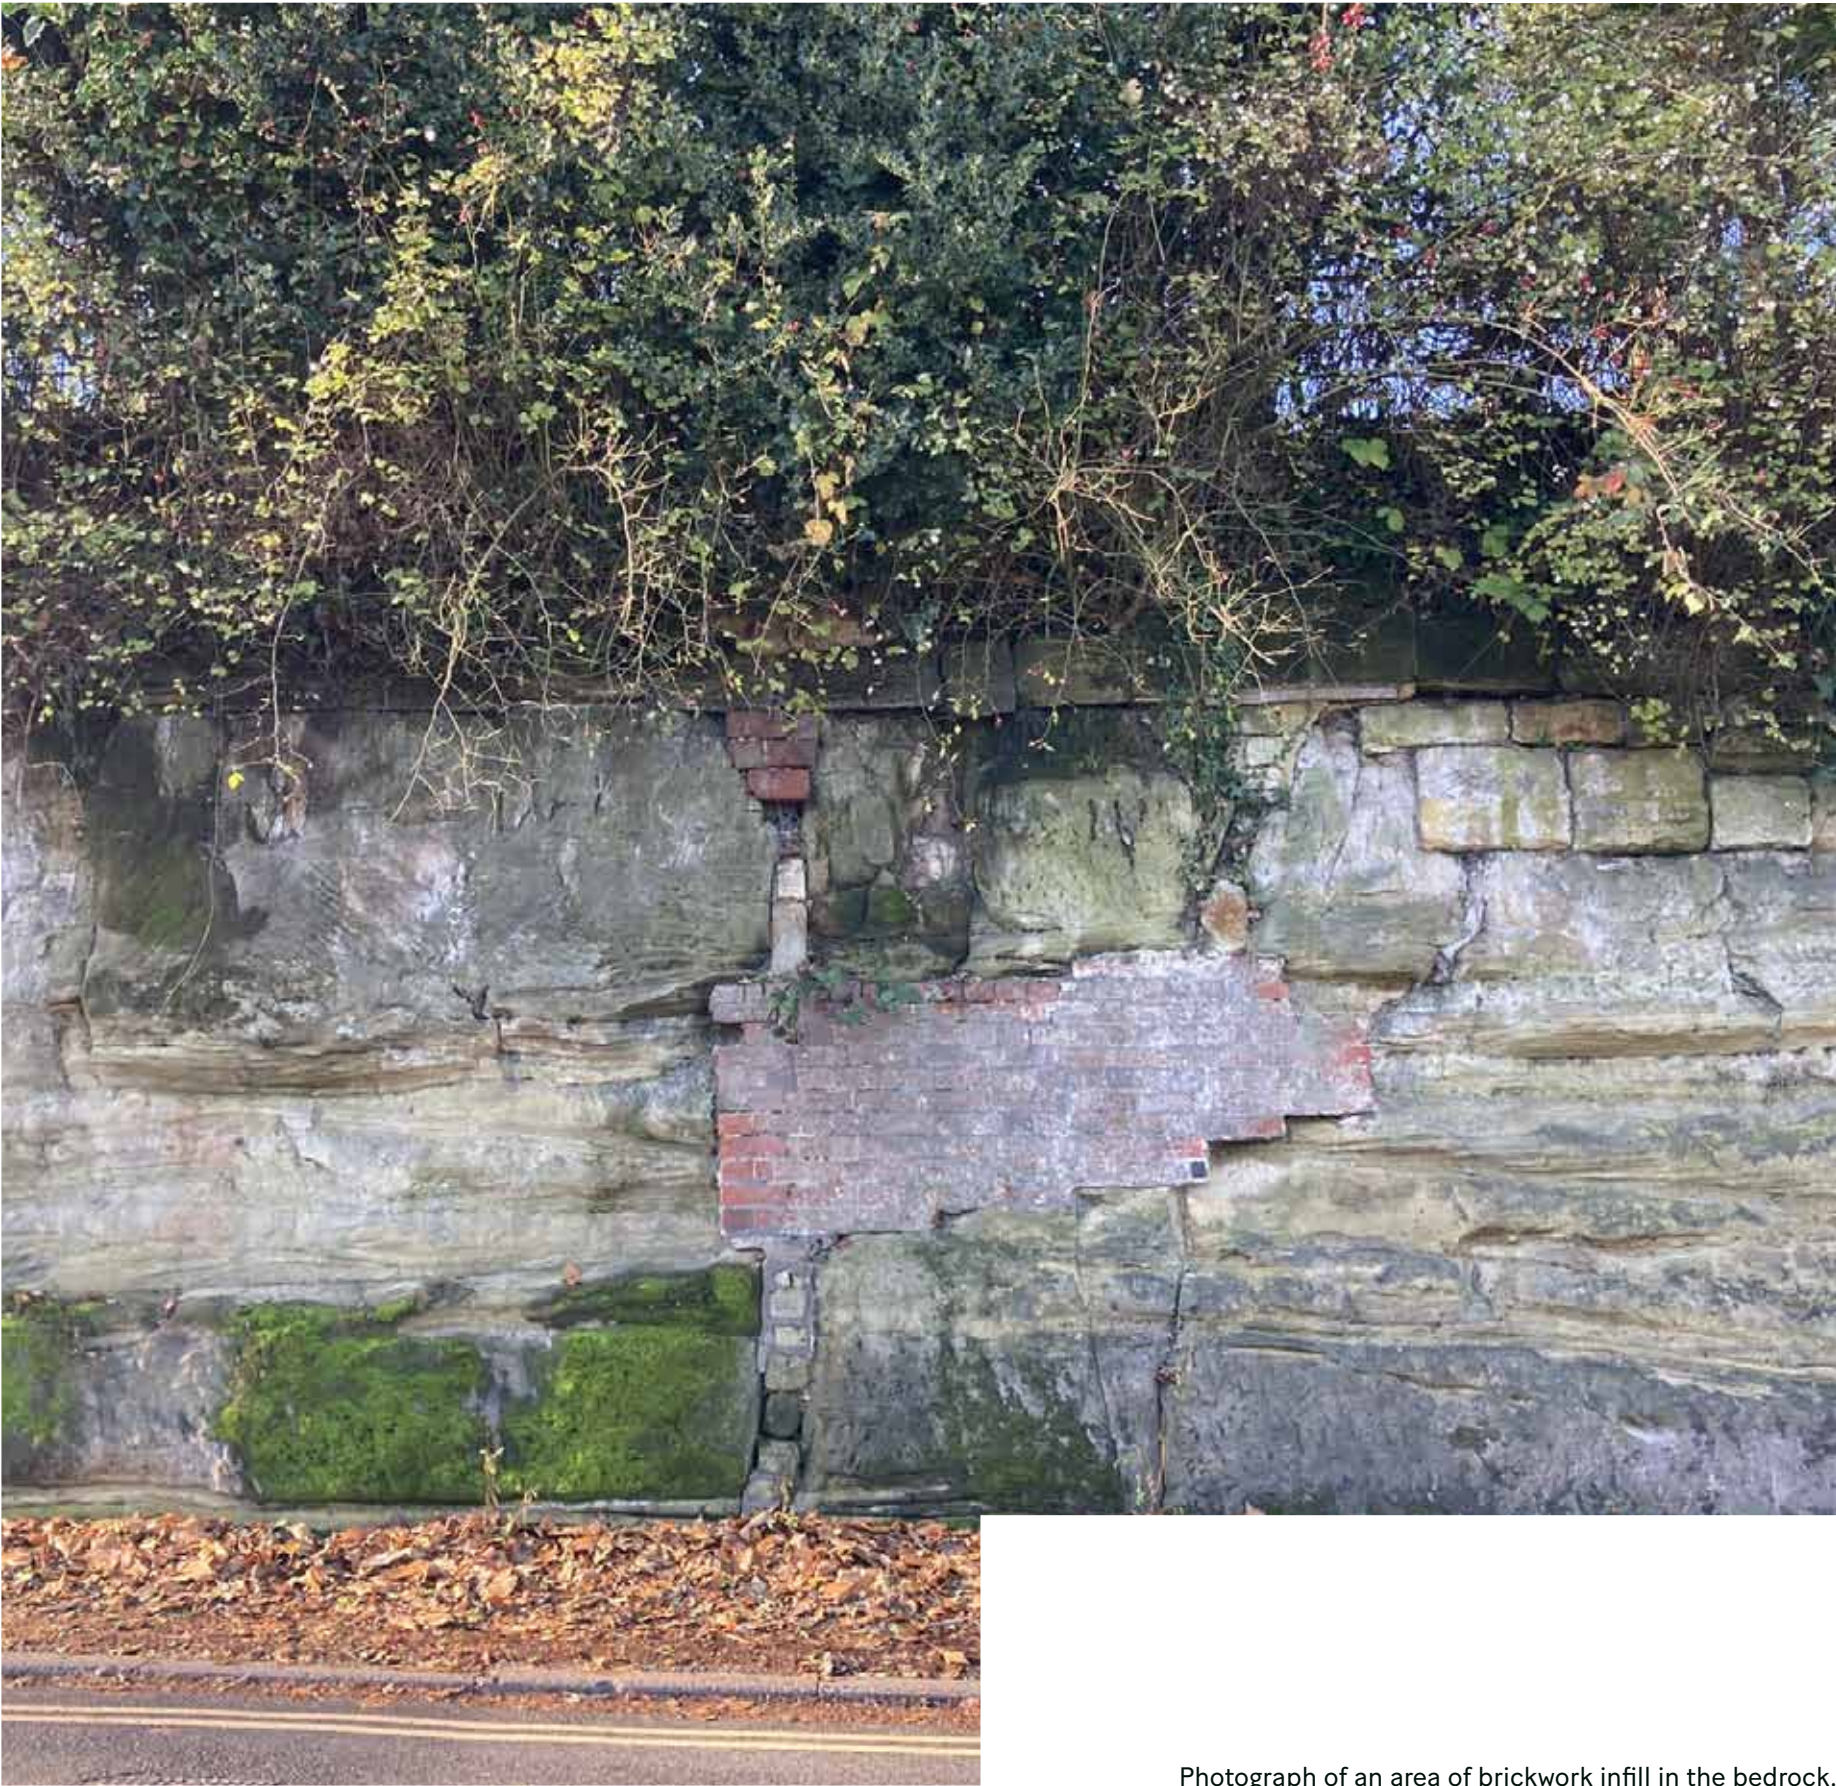
Photograph of an area of brickwork infill in the bedrock.

The wall appears to have been formed out of the bedrock, given the significant level difference between the site and the road and pavement below. Where gaps existed in the bedrock, they have been filled with various types of stone and brick, capped with a row of capping stones along the top edge.

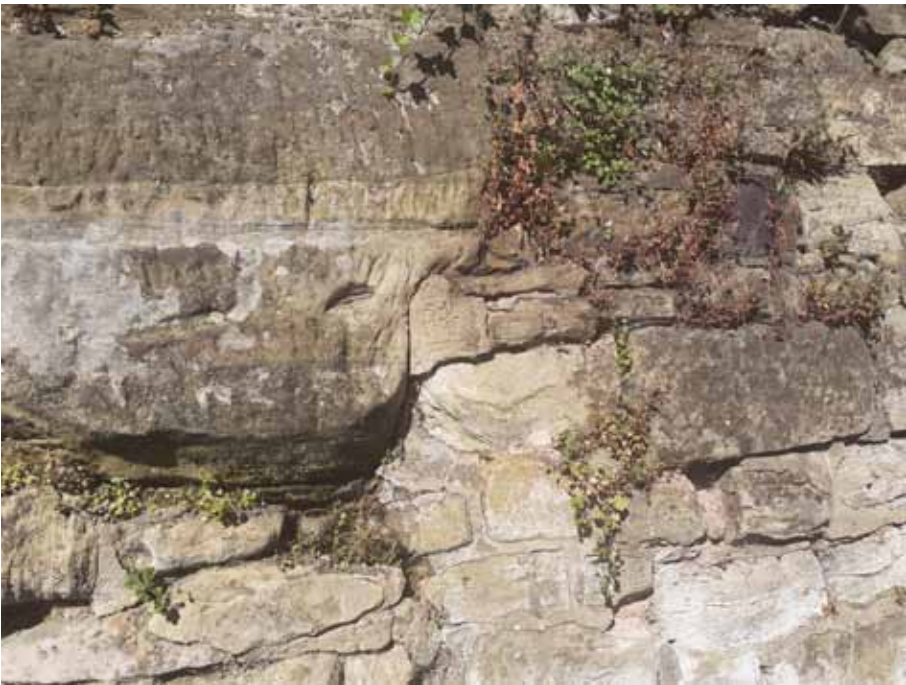
Date Stone in location

The Date stone found within the wall is inscribed with 1775 , although due to the big change in levels between the college site and the road we would pressure that the age of the wall predates the date stone and would have been constructed around the time of the College's construction.

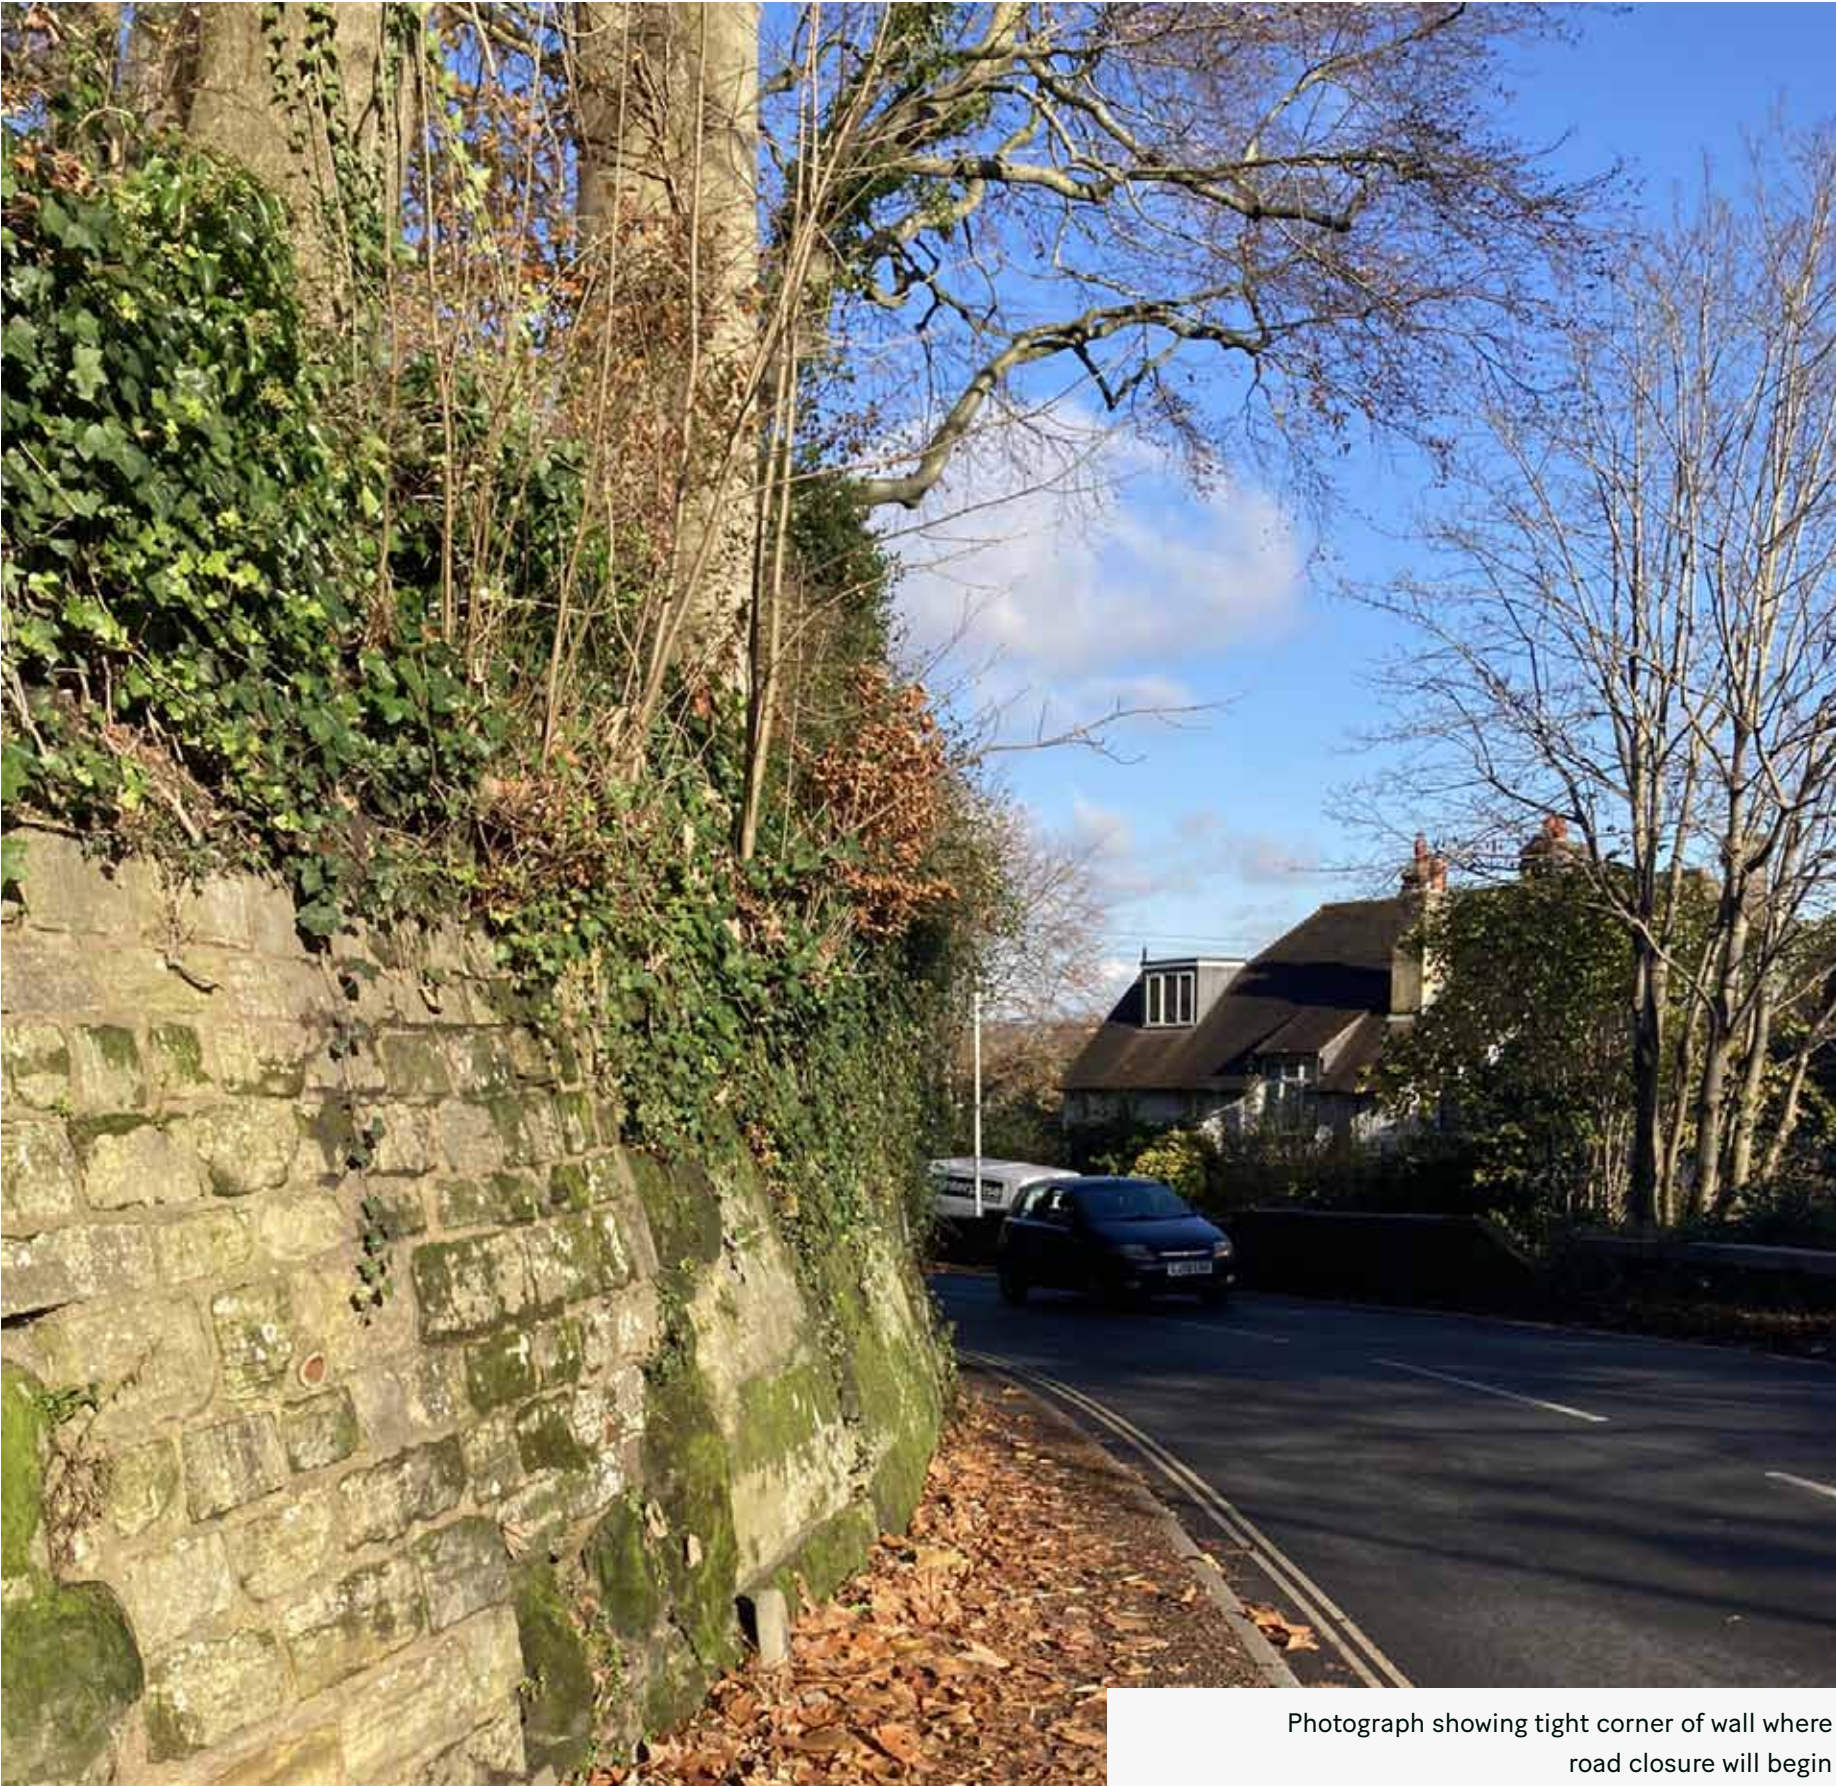
Photograph showing tight corner of wall where road closure will begin
