**19 Gander Hill**

**Haywards Heath**

**West Sussex**

**Biodiversity  
Enhancement  
Strategy**

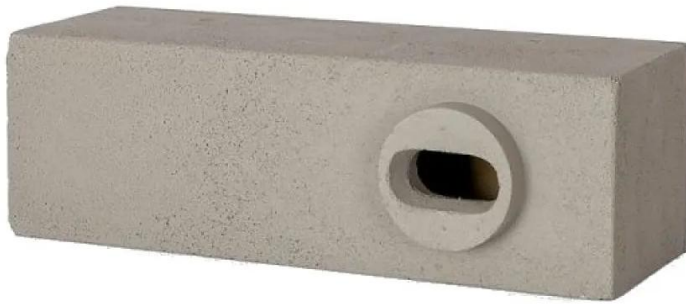
**Figure 2: Pro – UK Rendered build in Swift box**

For the extended dwelling two Pro- UK Rendered Build in Swift box (or Woodstone Build in Swift box equivalent) will be placed on the north eastern aspects at eaves height.

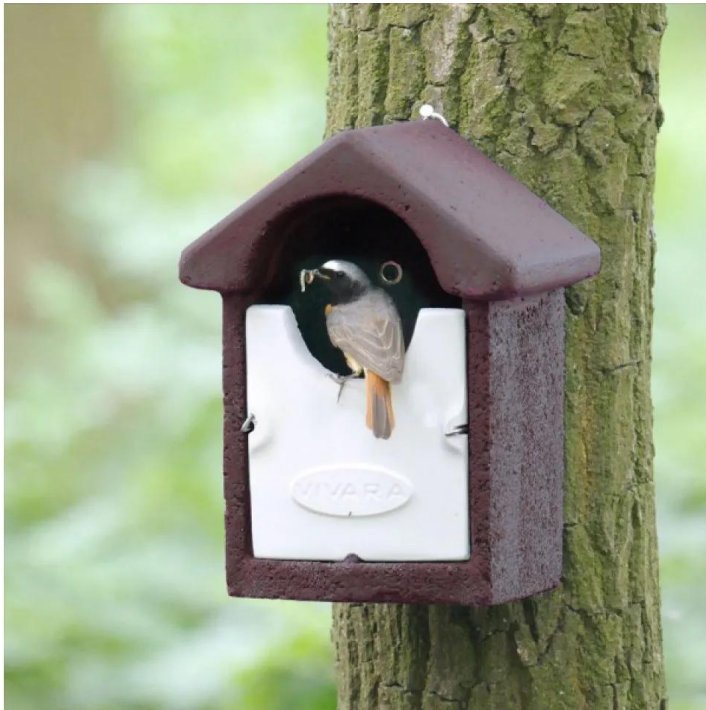
**Figure 3: Vivara Pro Woodstone Barcelona Open Fronted Nest Box**

Open fronted: Vivara Pro Woodstone Barcelona (or equivalent).
