# HB Archaeology & Conservation Ltd

OLD KEYSFORD HALL, TREEMANS ROAD,  
HORSTED KEYNES, RH17 7EA  
(NGR: TQ 38025 27335)

## SUMMARY HERITAGE STATEMENT

Report No. 2025618  
April 2025

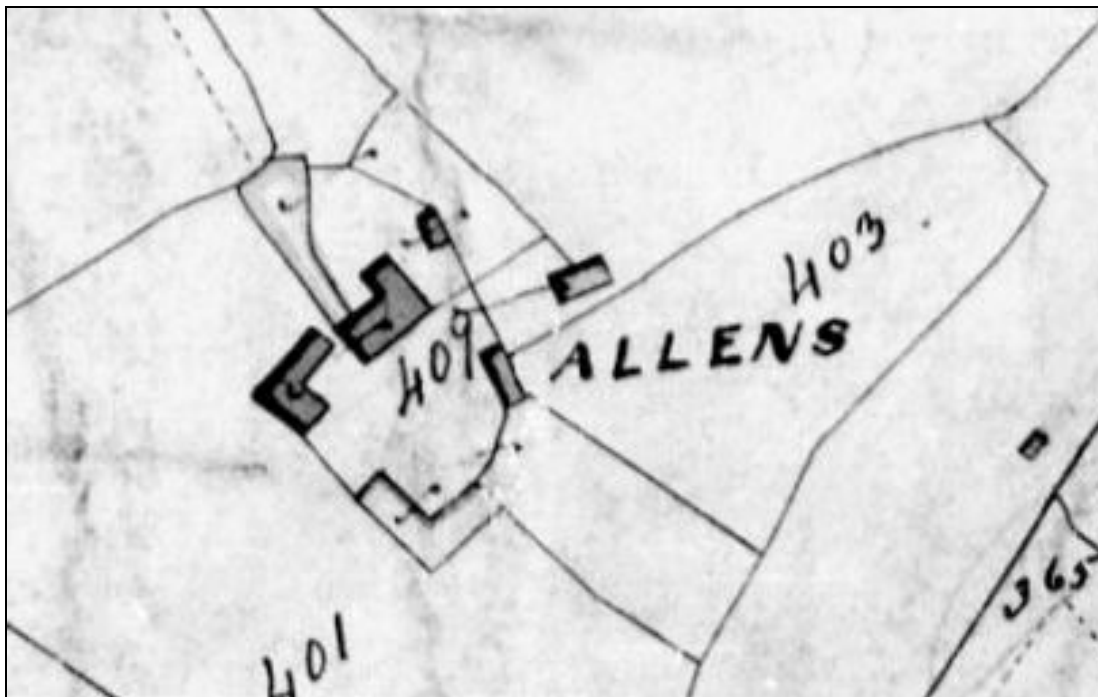
Plate 1: Extract of the Horsted Keynes tithe map, 1845

- 5.1.1 The house is shown to an L-plan arrangement on the tithe map of 1845 accompanied by a series of detached L-plan and rectangular-plan buildings to the north (Plate 1).

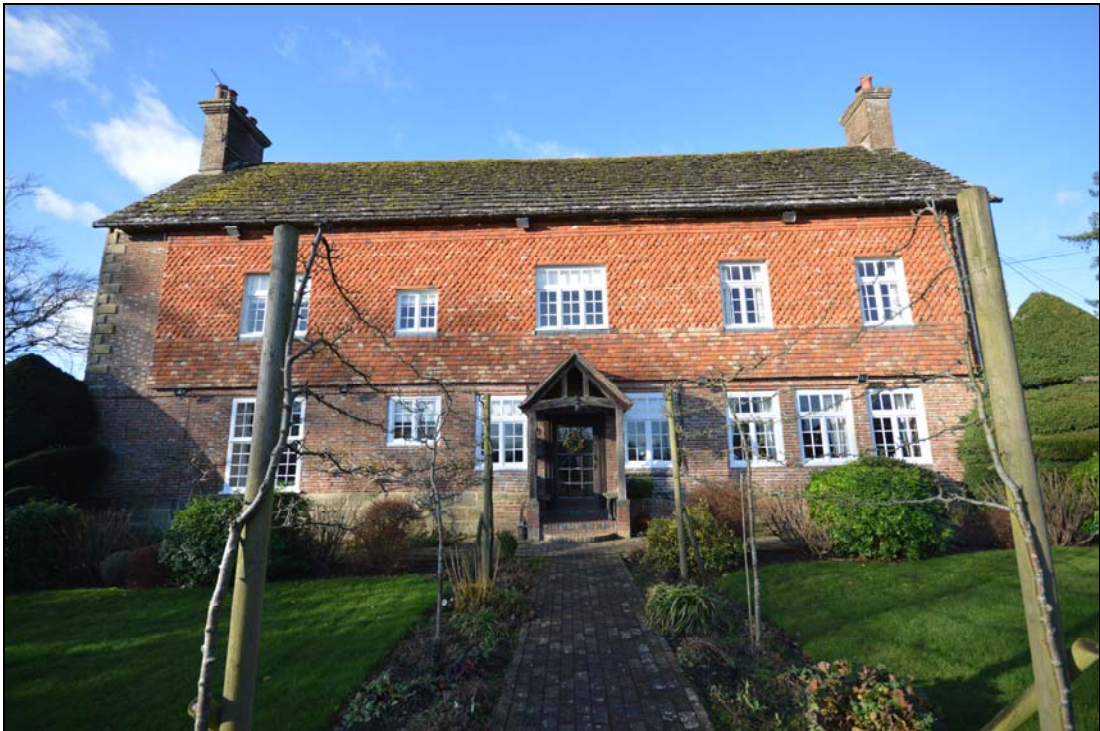
Plate 3: The principal east-facing elevation of the east wing showing the brickwork and the tile-clad timber-frame

- 6.2.2 The building is of composite construction comprising brick laid in Flemish bond with decorative use of over-fired headers, to the ground floors and end walls. The brickwork rises to the eaves at the terminal ends of the building on both side elevations to accommodate substantial internally-projecting, multi-flue chimney stacks (Plate 3). The remainder of the walls are in small-panel timber-frame, either clad in clay-tile to the east-front or exposed with lime-skimmed panels to the rear (Plates 3 and 4). It is probable that the timber-frame had been clad in clay-tile from the outset due to the style, date and status of the building.

windows one above the other lighting the staircase and the closely spaced group of three large windows lighting the high-end parlour (Plate 3).

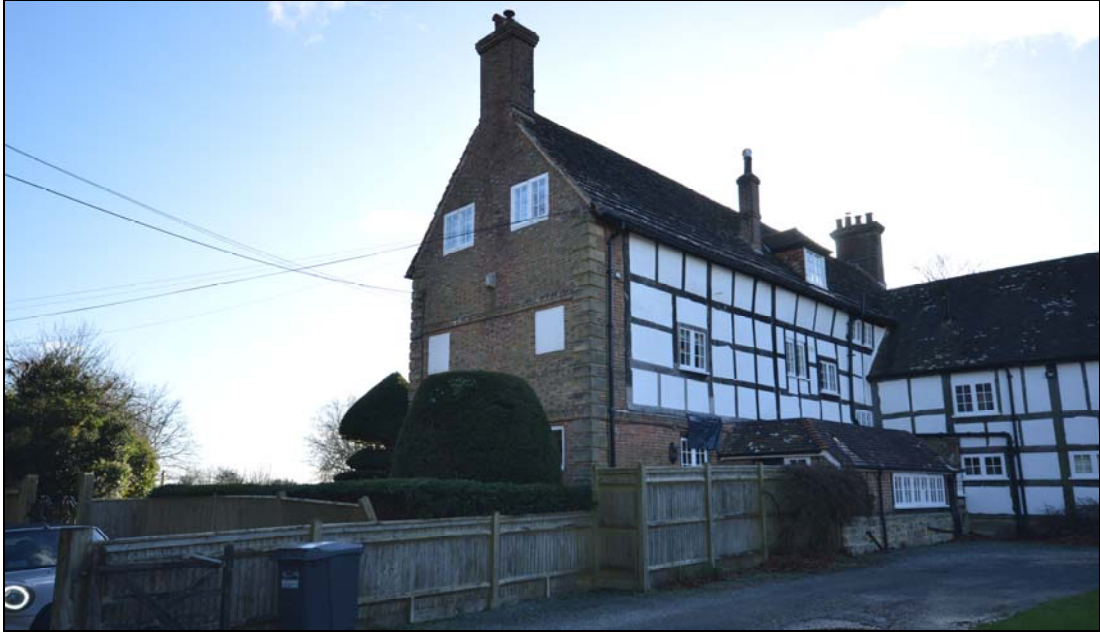
Plate 4: The north and west elevations of the east wing showing the different materials used in the building's constructions and the modern lean-to extensions

- 6.2.4 Windows to the rear are more randomly arranged befitting the less publicly visible elevation. Windows to the north terminal are very regular with those to the first floor rooms now blocked: this may be due to their position within closets that may have been added as an early refinement. Indeed, the doors to the closets are particularly fine examples of early 18<sup>th</sup> century panelled doors; their H-hinges bearing the traces of having been reset in their current locations.

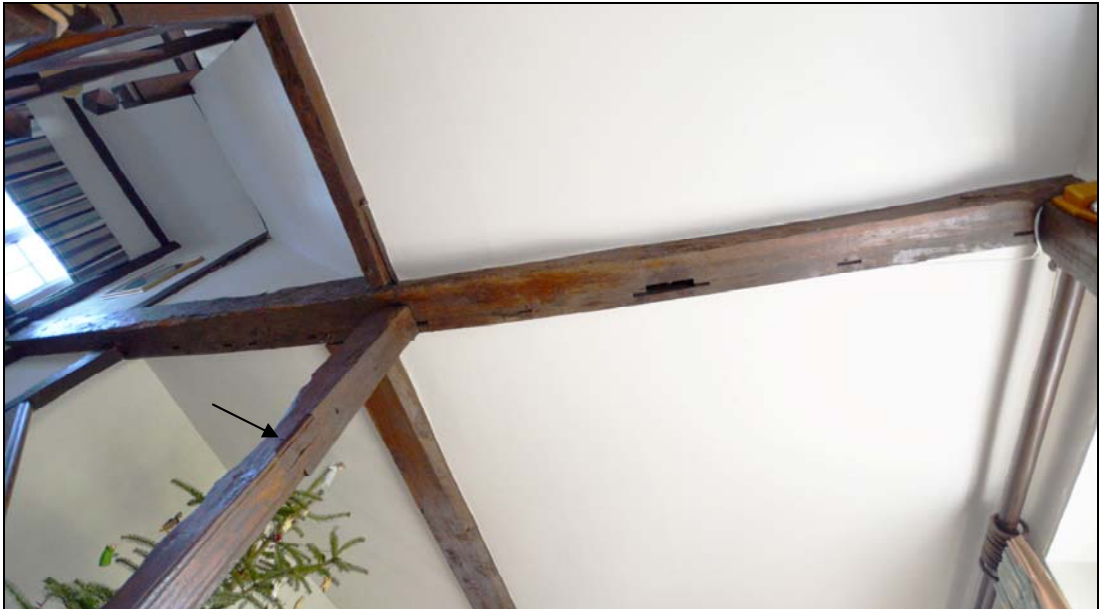
Plate 6: Soffit of the cross-beam between bays 1 and 2 with jointing for a partition and a doorway, the mortise for the head plate of the door can be seen in the post (arrow). Note also that the partition had continued to the west side of the building enclosing the staircase

- 6.2.6 The entrance hall was flanked by a kitchen (now the drawing room), originally served by a large cooking hearth with clock-jack (scars in the bressumer) and a bread-oven. The staircase was accommodated at the northeast corner of bay 1 (the kitchen): whilst it is not uncommon in buildings of this type for the staircase to be separately enclosed rather than being within the hall itself, it is unclear if this is the case here. As it stands, the staircase had been separated from the entrance hall by a partition with an integral doorway situated between the north side of the stairs and the hall proper (bays 1 and 2; Plate 5). The partition and doorway has since been removed and a balustrade created to the north side of the staircase, added to match that already *in situ* to the south (Plates 6 and 7).

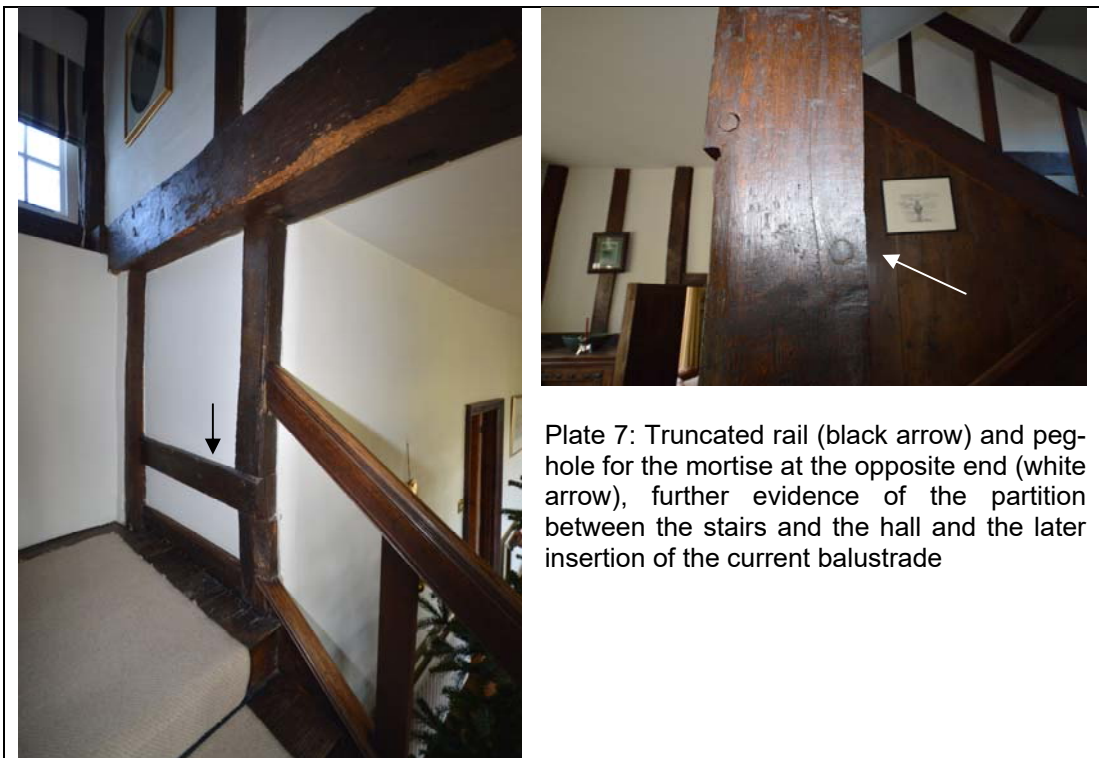
Plate 7: Truncated rail (black arrow) and peg-hole for the mortise at the opposite end (white arrow), further evidence of the partition between the stairs and the hall and the later insertion of the current balustrade

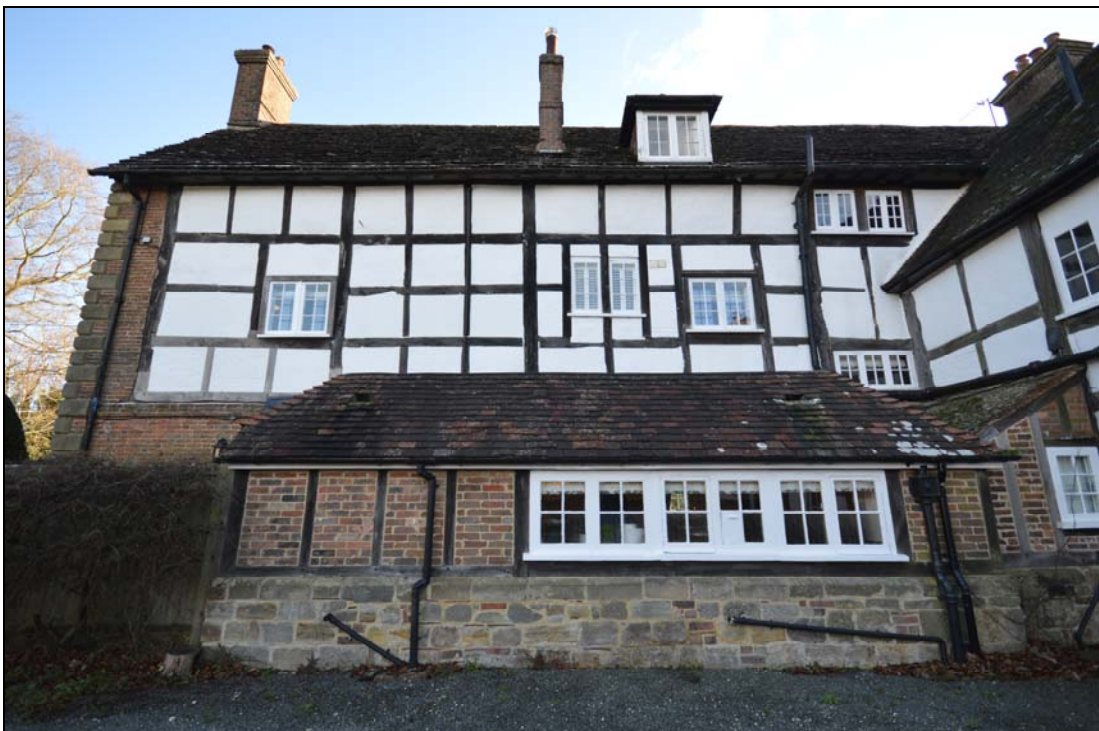
Plate 8: The rear (west) elevation of the wing showing the 20<sup>th</sup> century lean-to extensions

- 6.2.9 The porch and the rear lean-to facilities are all the product of 20<sup>th</sup> century alterations to the group. The lean-tos added, as outlined above, between 1909 and 1938 and extended further to the north between 1938 and 1955, with potential for the entire lean-to group to have been rebuilt at that time. The lean-tos as they now stand are consistent in style, intended no doubt to create a coherent external appearance to the later group (Plate 8).

- 6.2.10 The rear additions are timber-framed with brick-nogged panels raised over low masonry plinths, the latter combining sandstone blocks with brick and tile (Plate 8). The roof is flat-topped, its outer slopes clad in plain clay tile. The substantial six-light window, like those of the main range, is the result of a later 20<sup>th</sup> century programmes of work.

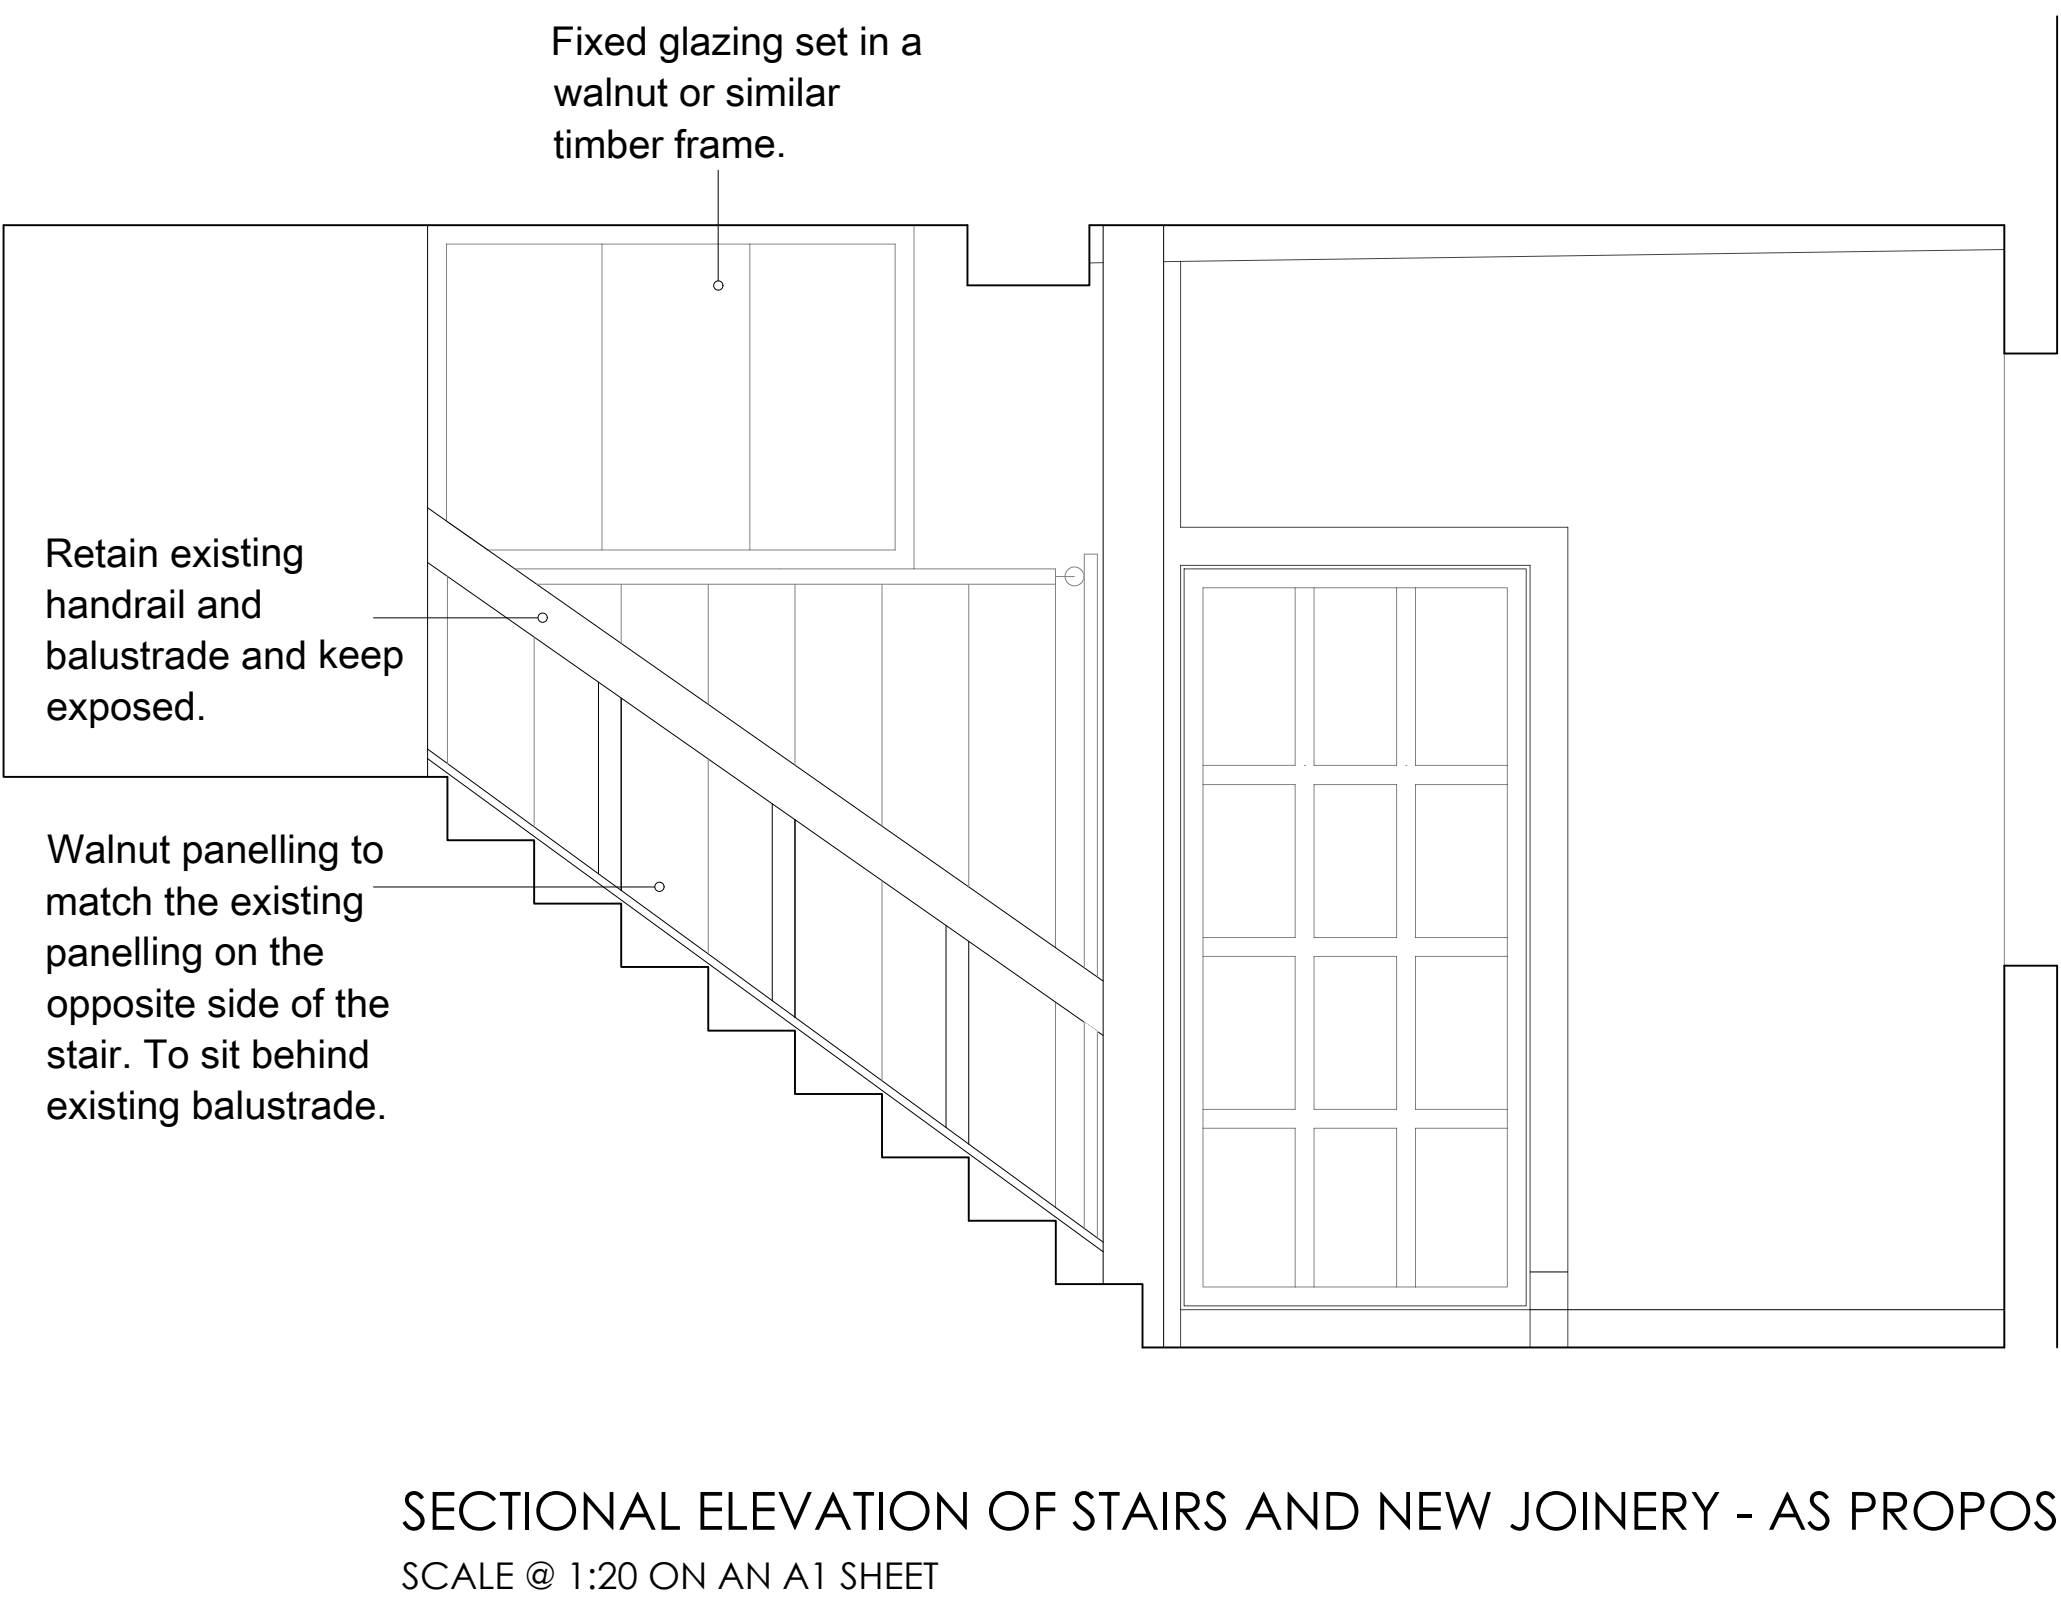
| A. | 04.03.25. | AE. | Allow for plateau rooflight and joinery adjustments. | GB. |

| DRAWING.<br>New Joinery<br>Elevations and Sections<br>As Proposed | | |

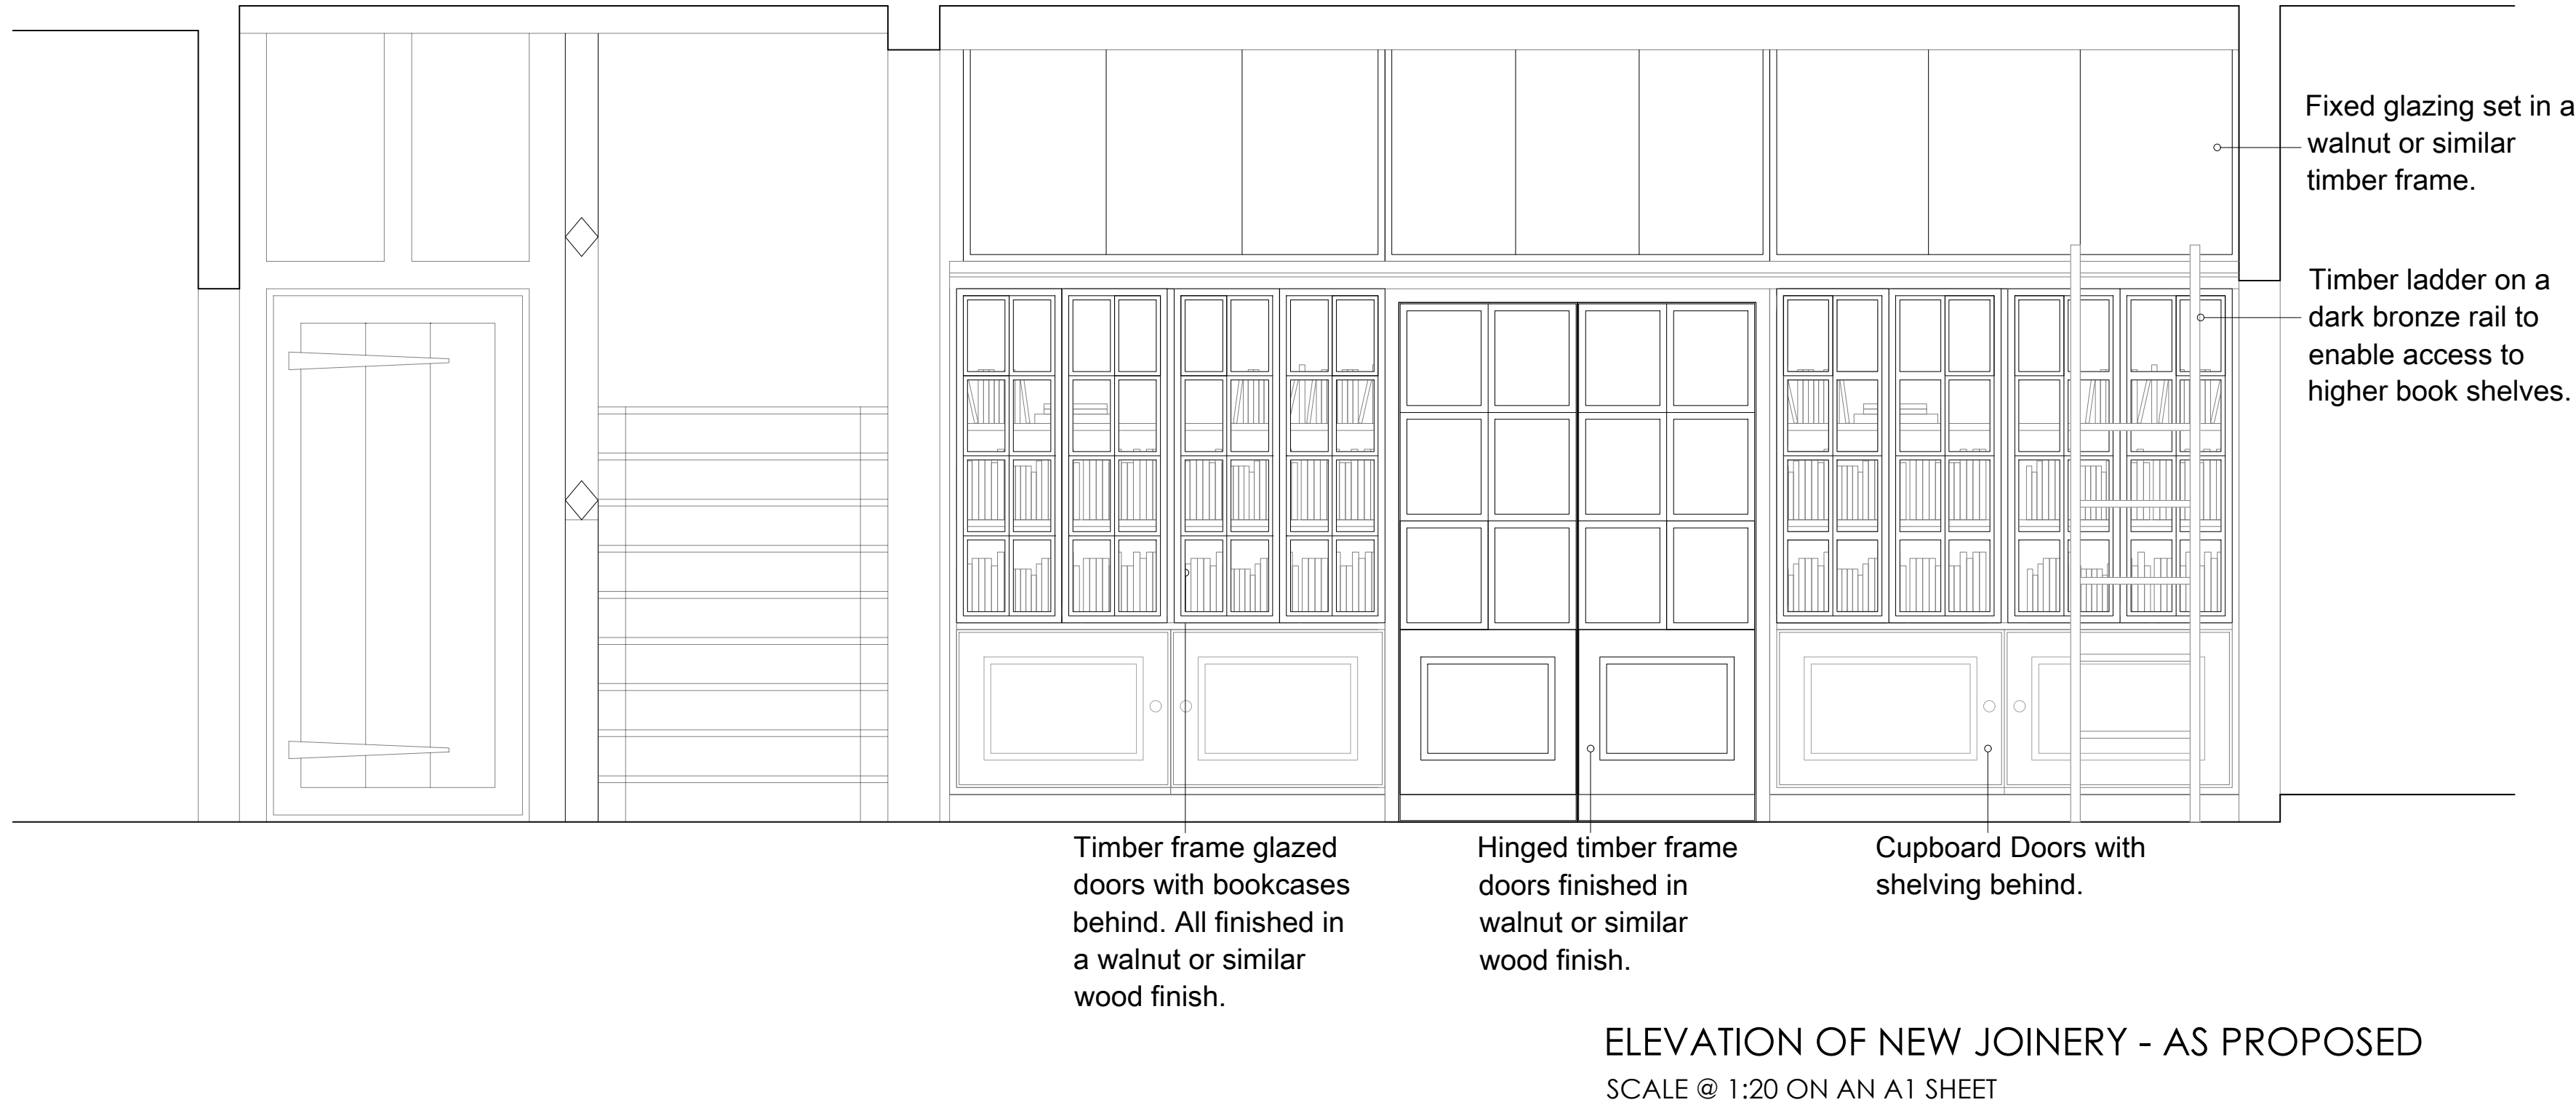
| New Rooflight<br>Part First Floor Plan As Proposed | | |

8.2.7 The final alteration of this light-touch scheme is the removal of the modern ceiling finish within the lean-to outshot and the installation of a plateau rooflight. The two changes will allow a higher degree of natural light to the enlarged kitchen area, and the light can filter through, by virtue of the high-set glazing intended for the new screen, into the main part of the hall.
