Bat Emergence and Re-Entry Surveys (BERS)

49 Queens Road, East Grinstead, West Sussex, RH19 1BG

8th August 2025

“Conversion of a D1 educational building to 24 residential apartments (32 bedrooms) with infilling of existing undercroft areas, associated car parking, landscaping, cycle spaces, amenity areas, 1.1m high metal fence and new ramp”.

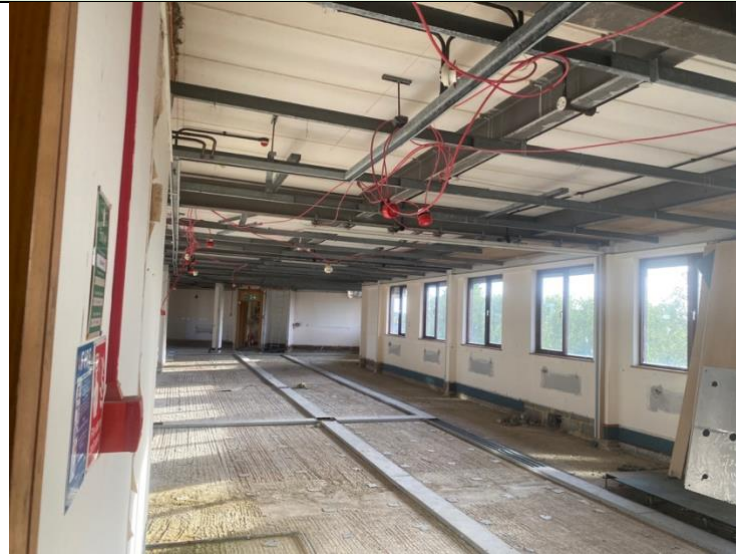
B1: third storey room on northern elevation

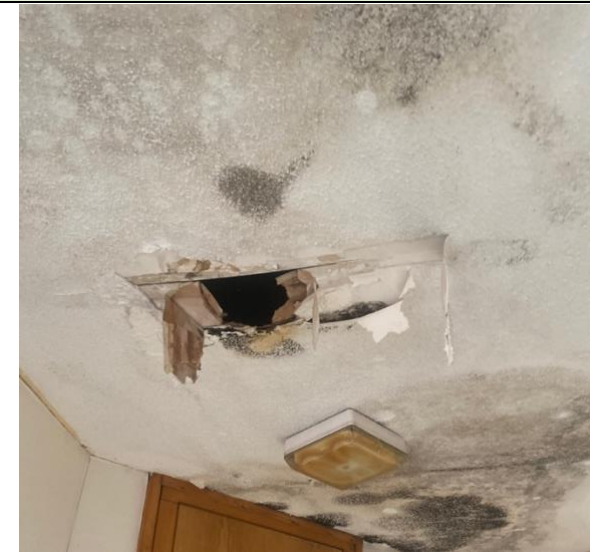
B1: hole in third storey ceiling leading to loft area

The lack of safe access meant the hibernation value of the building could not be fully assessed.

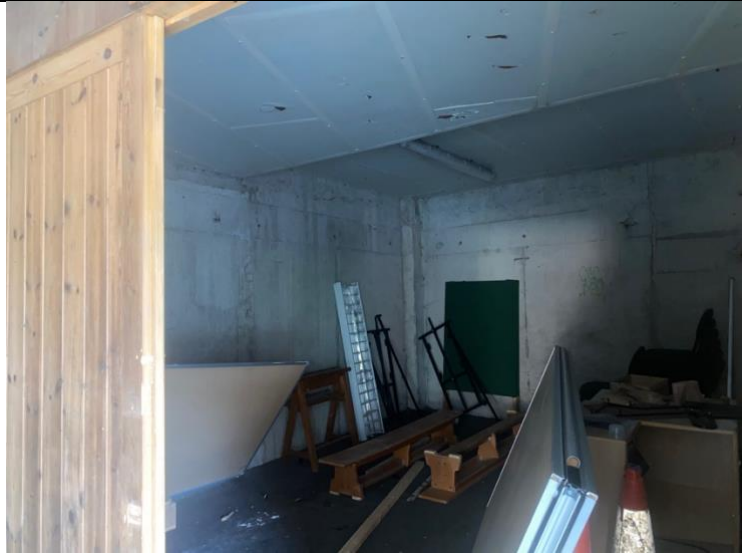
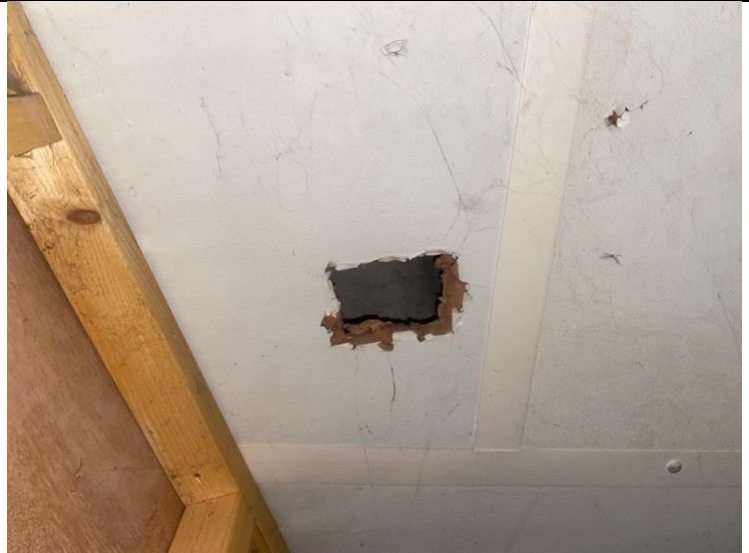
were present in the ceiling panels. These were also assessed as superficial and cobwebs observed over the opening indicating a lack of recent use by bats.

B1: undercroft area, storage room on the northern elevation, holes in ceiling panels		B1: undercroft area, hole in the storage room leading into a superficial void space		
<i>Surveyor and position</i>	Surveyor Position	Name	BERS Experience / Bat Licence	BCT Competency	Elevation
	1 - Lead	Grace McCulloch	1 year	Level 2	Observing southwest
	2	Jen Gibbons	2 years	Level 1	Observing the southeast
	3	Rhianna Dix	12 years (Level 1 bat licence)	Level 2	Observing the south
	4	Unmanned IR	NA	NA	Observing the east elevation of the undercroft area
	5	Lucy Jacobs	3 years	Level 1	Observing the northwest
	6	Jolanta Jurpalova	1 year	Level 1	Observing the north
	7	Zak Hassi	1 year	Level 1	Observing the north
<i>Weather (start/end)</i>	Temperature (°C): 24.5 Relative humidity (%): 51		Temperature (°C): 23 Relative humidity (%): 61

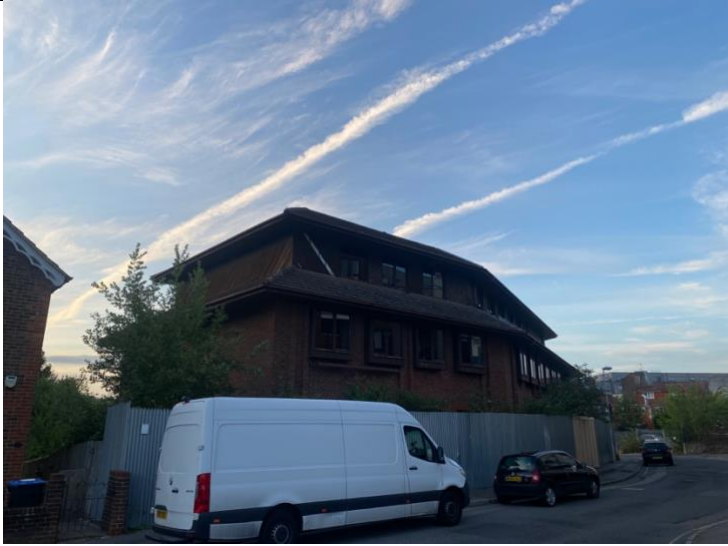
<p><i>IR position 1</i> <i>Nightfox Whisker +</i> <i>Nightfox XB5 PRO</i></p>	<p>Camera position: observing southwestern elevation of B1.</p> <p>No emergences observed. No further bat activity observed in IR review.</p>

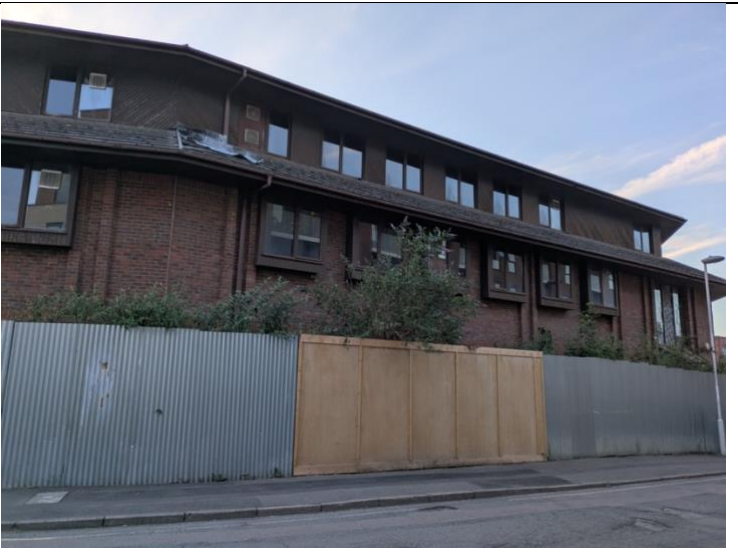
A daytime photograph of a two-story brick building with a dark roof. The building has several windows and a balcony area. In the foreground, there is a fence made of corrugated metal and wooden panels. The sky is clear and blue.

<p><i>IR position 2</i> <i>Nightfox Whisker +</i> <i>Nightfox XB5 PRO</i></p>	<p>Camera position: observing southern elevation of B1.</p> <p>No emergences observed. No further bat activity observed in IR review.</p>

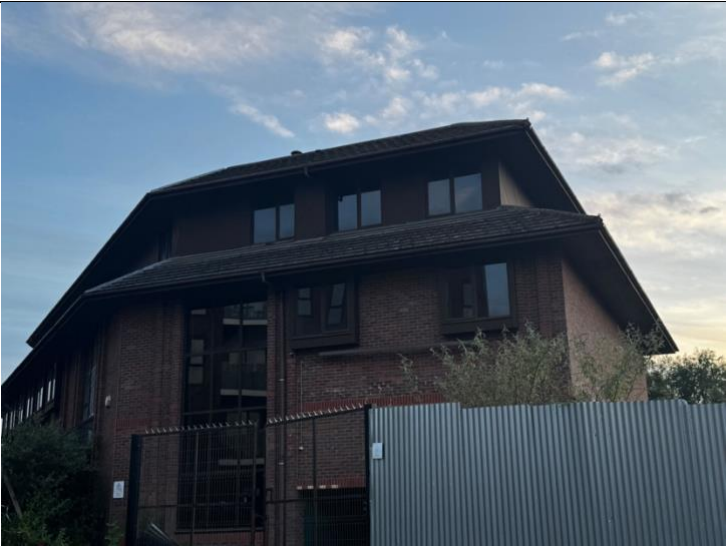
<p><i>IR position 3</i> <i>Nightfox Whisker +</i> <i>Nightfox XB5 PRO</i></p>	<p>Camera position: observing southeastern elevation of B1.</p> <p>No emergences observed. No further bat activity observed in IR review.</p>

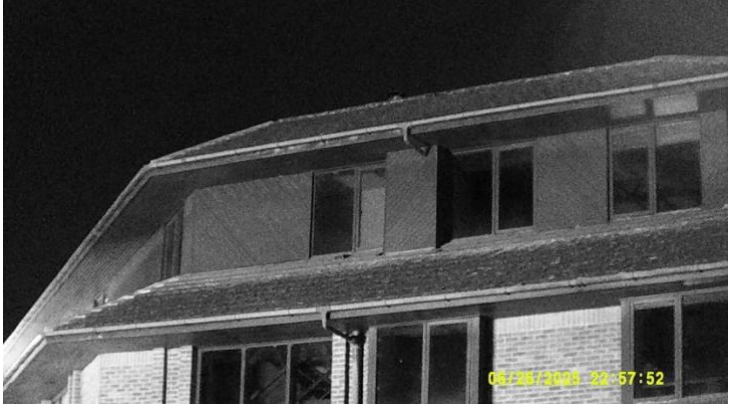
<p><i>IR position 4 (Unmanned IR)</i> <i>Nightfox Whisker +</i> <i>Nightfox XB5 PRO</i></p>	<p>Camera position: observing western elevation of the undercroft of B1.</p> <p>No emergences observed. No further bat activity observed in IR review.</p>

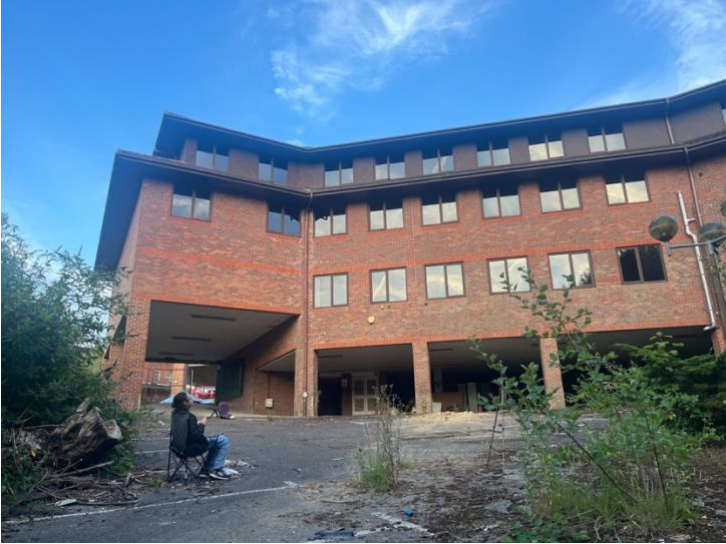
<p><i>IR position 5</i> <i>Nightfox Whisker +</i> <i>Nightfox XB5 PRO</i></p>	<p>Camera position: observing northwestern elevation of B1.</p> <p>No emergences observed. No further bat activity observed in IR review.</p>

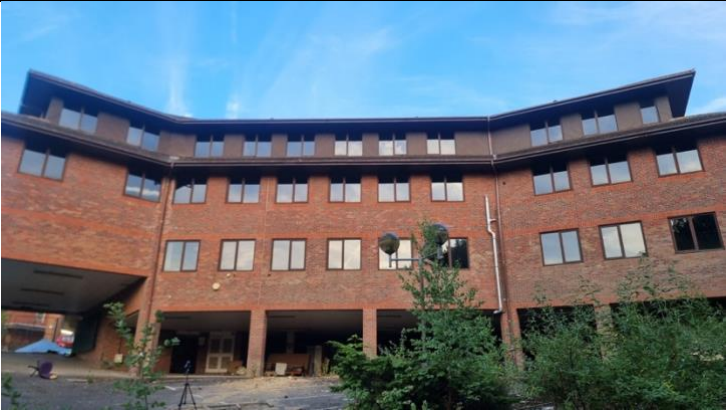
<p><i>IR position 6</i> <i>Nightfox Whisker +</i> <i>Nightfox XB5 PRO</i></p>	<p>Camera position: observing north elevation of B1.</p> <p>No emergences observed. No further bat activity observed in IR review.</p>

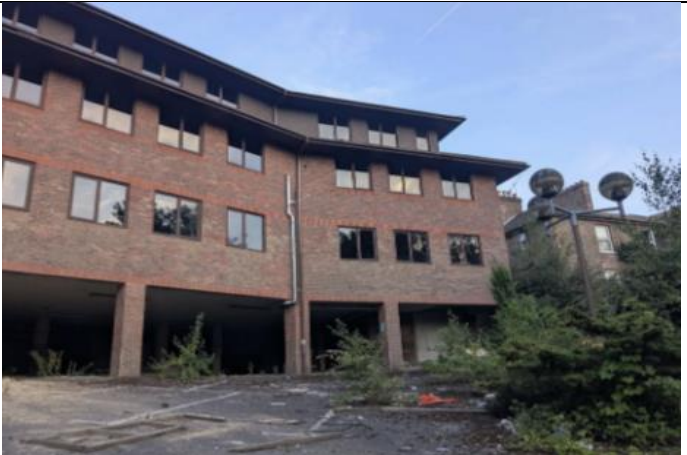
<p><i>IR position 7</i> <i>Nightfox Whisker +</i> <i>Nightfox XB5 PRO</i></p>	<p>Camera position: observing north elevation of B1.</p> <p>Following a potential emergence, the surveyor repositioned their IR to incorporate the undercroft in their field of view. This will be mitigated by full observation of the original elevation in v2 and v3 surveys.</p> <p>No emergences observed. No further bat activity observed in IR review.</p>

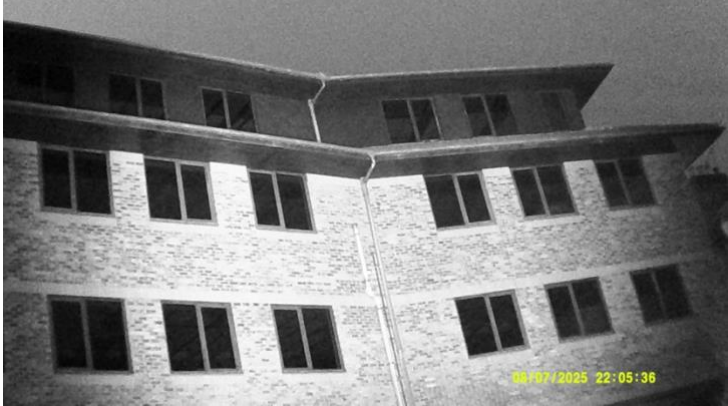
<p>circular pattern over property car park area in the lower northern corner above surveyor positions 5-7. Last bat heard at 21:35 was a common pipistrelle.</p>	
<p><i>IR position 7</i> <i>Nightfox Whisker +</i> <i>Nightfox XB5 PRO</i></p>	<p>Camera position: observing north elevation of B1. No emergences observed. No further bat activity observed in IR review.</p>
