## **APPENDIX C – SITE VISIT PHOTOGRAPHS AND ACCOMPANYING FIGURES**

### Catchment A

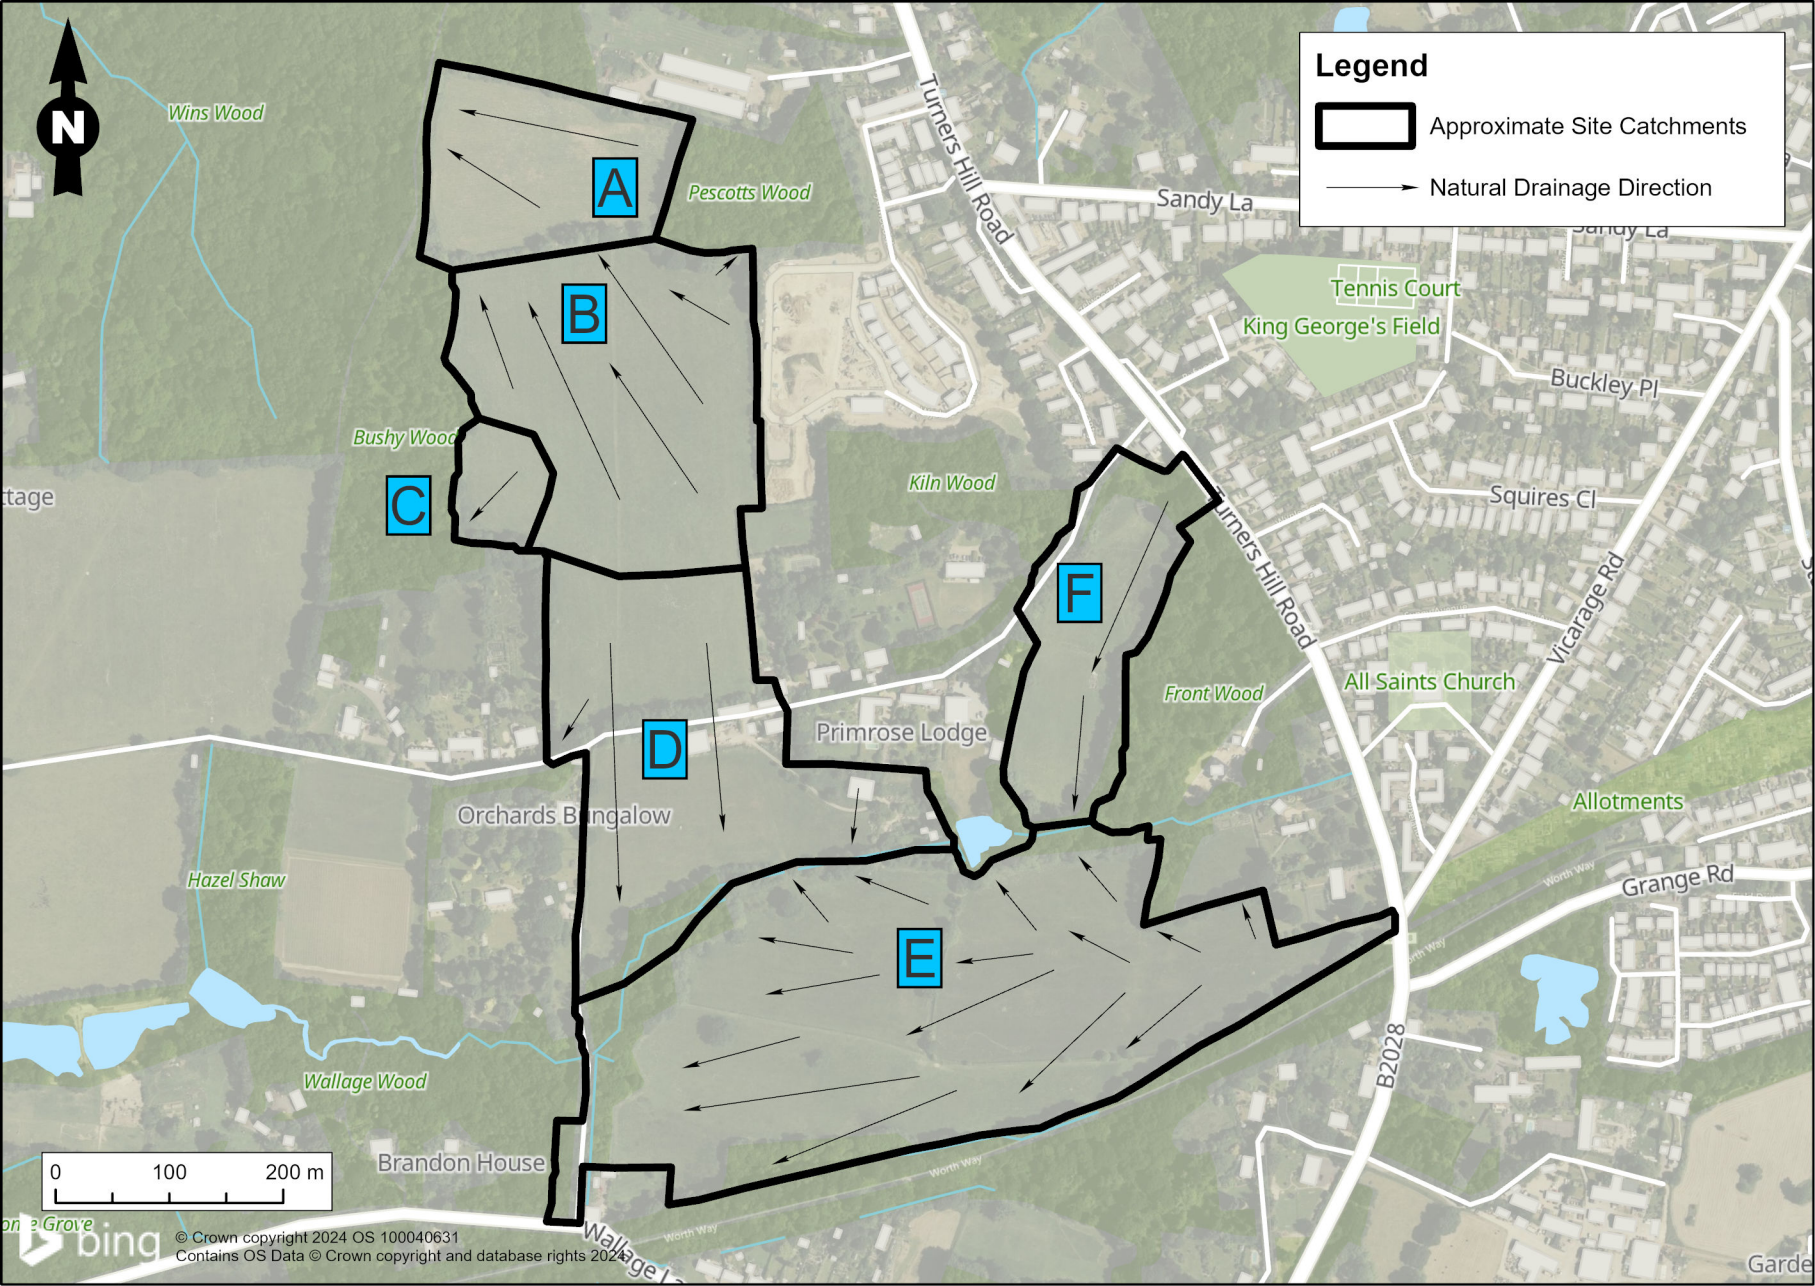
Approximate Site Catchments

Natural Drainage Direction

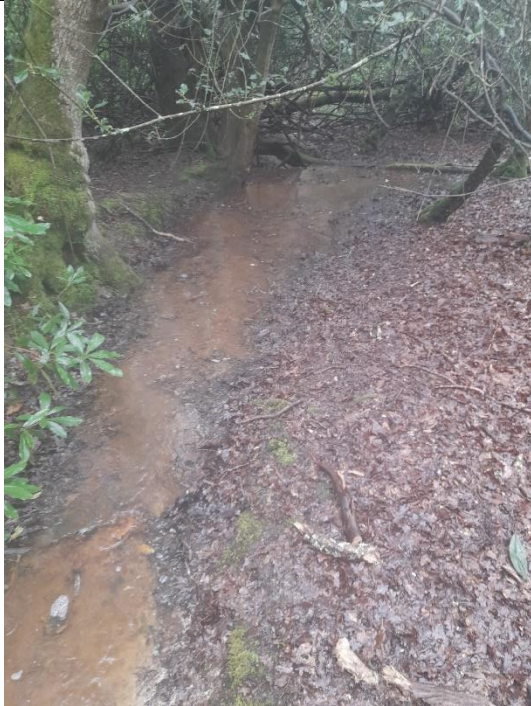
**1.** View of watercourse to the northwest of the site looking west. Watercourse shown to take flows from north of site and direct them westward. Topography visibly sloping from east to west.

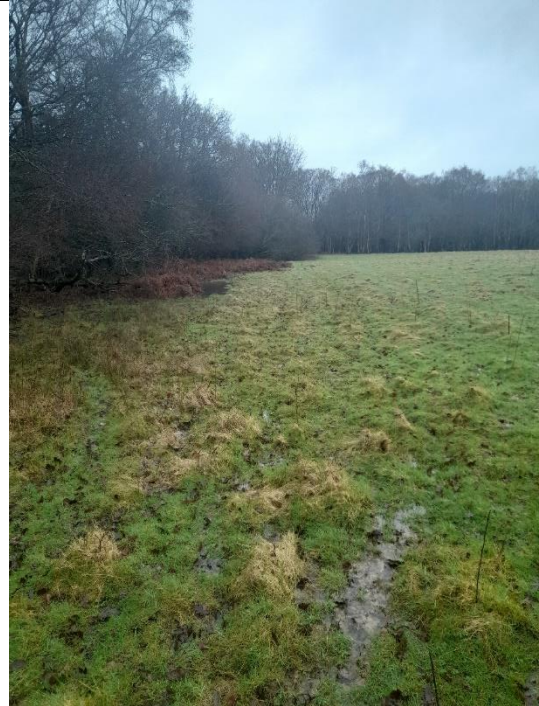
**2.** View of Catchment A looking north along western boundary. Standing water visible in west of site. Topography visibly sloping from east to west.

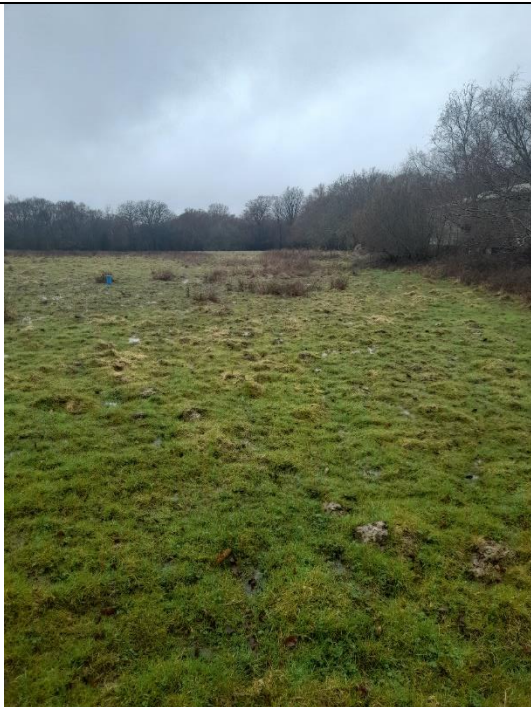
**3.** View of Catchment A in the northeast of the site looking west. Topography typically sloping from east to

west although another low point is present in the northeast corner of the catchment.

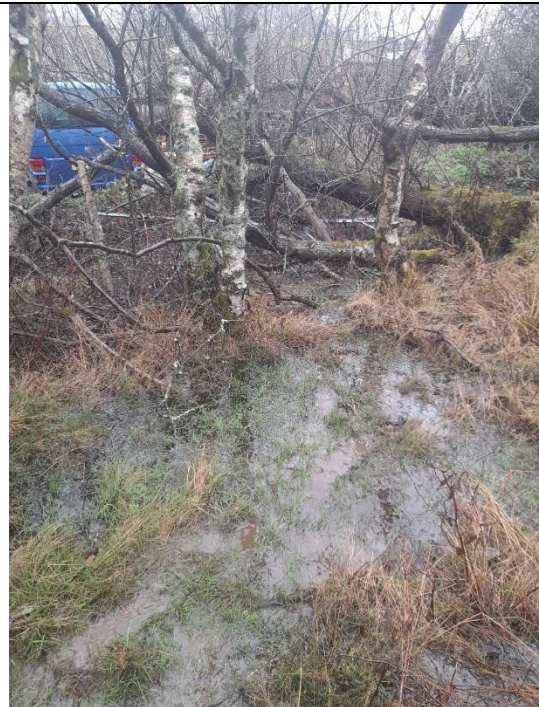
**4.** Surface water flooding in the northeast corner of the site.

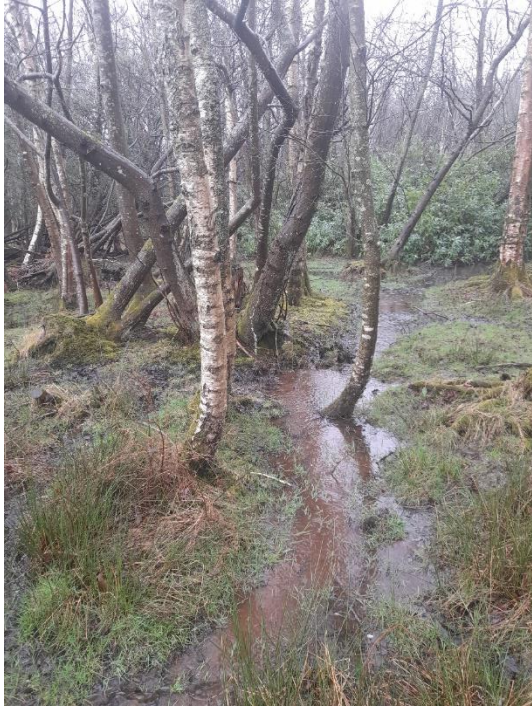
**5.** Surface water flooding in the north of the site. Looking west. Flow observed to be east to west.

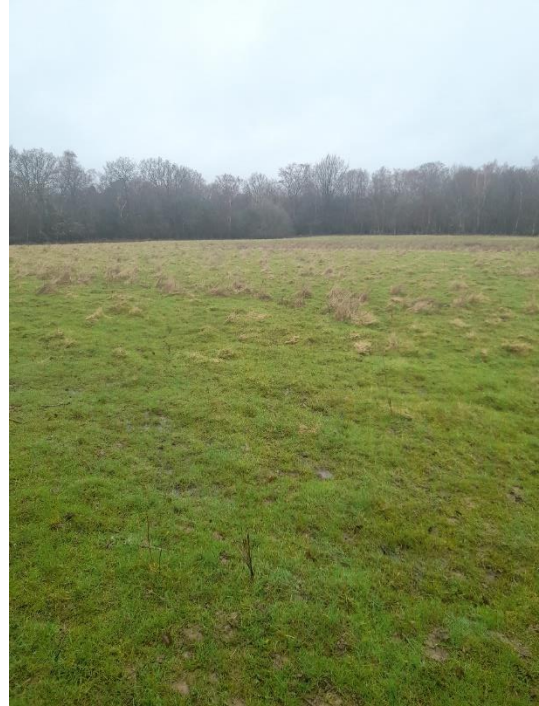
**6.** View of Catchment A looking northwest from the south of the catchment. Land shown to be sloping from southeast to northwest.
