**DESIGN AND ACCESS STATEMENT**  
**HERITAGE STATEMENT WITH IMPACT ASSESSMENT**

**APPLICATION FOR**  
**LISTED BUILDING CONSENT FOR ALTERATIONS,**  
**EXTENSION OR DEMOLITION OF A LISTED BUILDING:**  
**REPLACEMENT OF FRONT DOOR.**  
**RETROSPECTIVE CONSENT FOR THE REMOVAL OF PAINT**  
**FINISH FROM THE BRICK PLINTH TO FRONT BAY.**  
**PROPOSED EXTERNAL FINISH TO BRICK PLINTH TO**  
**FRONT BAY.**

**THE OLD BAKERY**  
**65 – 65A HIGH STREET**  
**LINDFIELD**  
**WEST SUSSEX**  
**RH16 2HN**

DESIGN AND ACCESS AND HERITAGE STATEMENT  
THE OLD BAKERY, 65-65A HIGH STREET  
LINDFIELD, WEST SUSSEX RH16 2HN

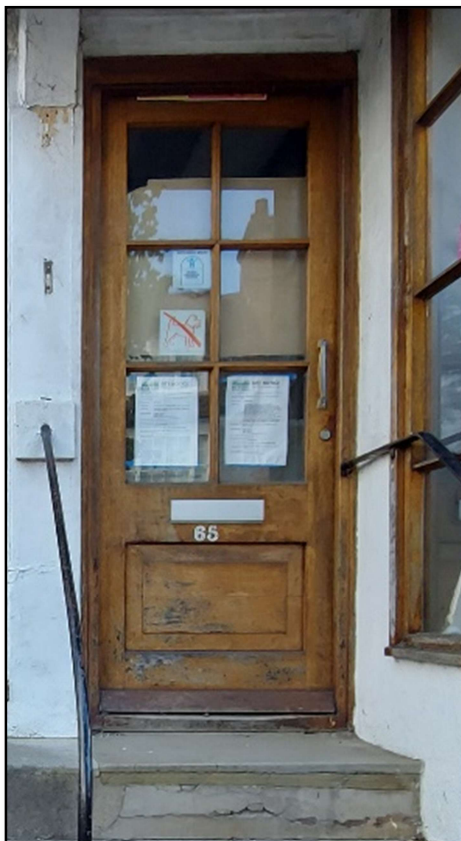
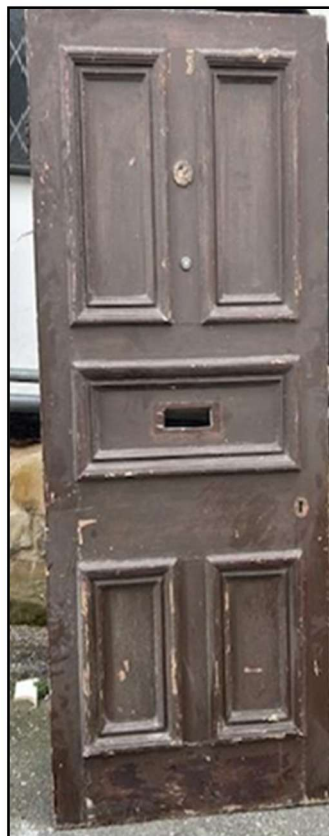
- LEFT: EXISTING DOOR TO BE REPLACED. RIGHT: SALVAGED FRONT DOOR TO BE REINSTATED.

- 2.1.1 Current owner would like to reinstate the timber door that was salvaged from within the property itself, and which the previous owner noted to be the 'earlier' door that was replaced at some point in the past with the existing glazed door.

- 2.1.2 Both doors are not 'Original' but do represent part of the continuous change and adaptation of the building to its adopted use. The glazed door served to promote the use of the building as a bakery allowing for customers to see into the shop, to view goods and gauge the flow of pedestrian traffic over the stepped threshold. Therefore, it acted as a safety measure, as is required for commercial doors to prevent accidents. Whilst the current use of the building as a single-family dwelling, privacy is paramount and sought after, especially taking into consideration its location on a busy road, with a constant flow of pedestrian and vehicular traffic. The replacement of the glazed door with a solid timber door will contribute to providing some privacy and reducing sound transmission.

- 2.1.3 In terms of aesthetics, the use of a solid door would echo the existing adjacent solid door that is currently fixed shut and will not detract from the overall reading of the building. This is as the shopfront with the cantilevered flat roof and signage presents the dominant feature and not the door itself, which is set back within the main elevation.

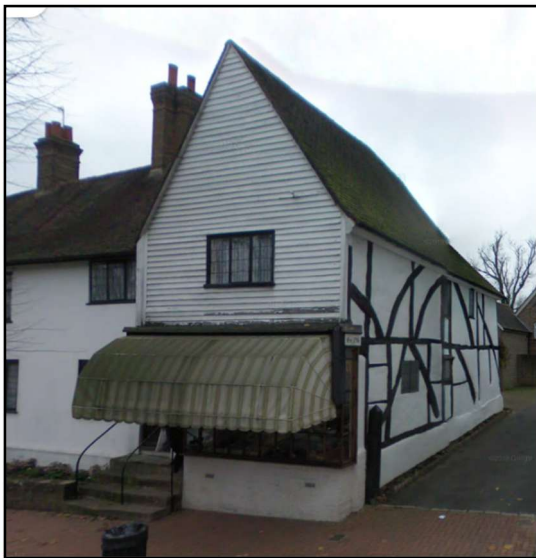
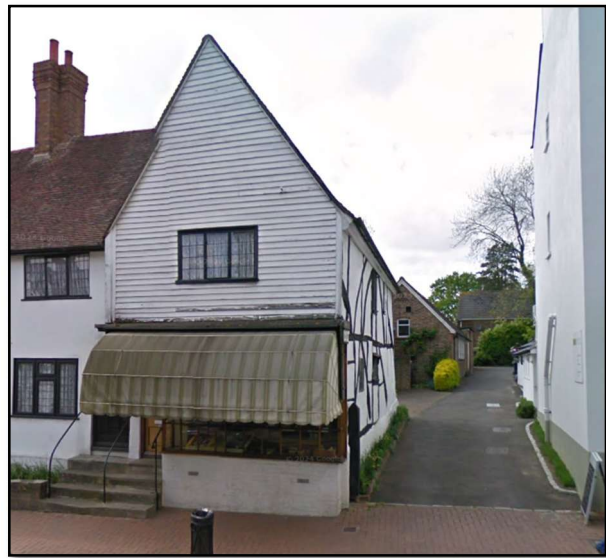
- 2.1.4 The door itself was never meant to be a feature and was almost always concealed by the fabric canopy that was used when the bakery was in operation, and that shielded staff and goods from the glare and heat of the sun. As can be seen from the images below extracted from historic images from Google Street Views.

- GOOGLE STREET VIEW: LEFT 2008 & RIGHT 2009

- 2.1.5 Accordingly, the reinstatement of the solid door that was previously removed by the commercial owner will not have a negative impact on either the reading of the building not on its historic or architectural significance, as the door itself does not contribute to that significance. The glazed door was simply a commercial intervention that facilitated the use of the space as a bakery.

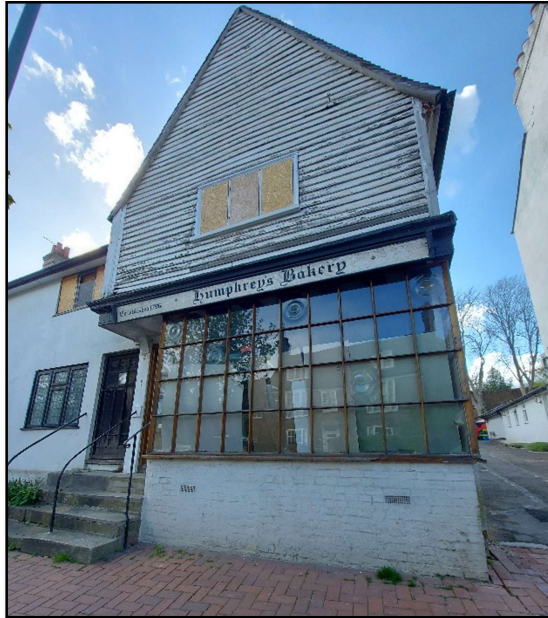
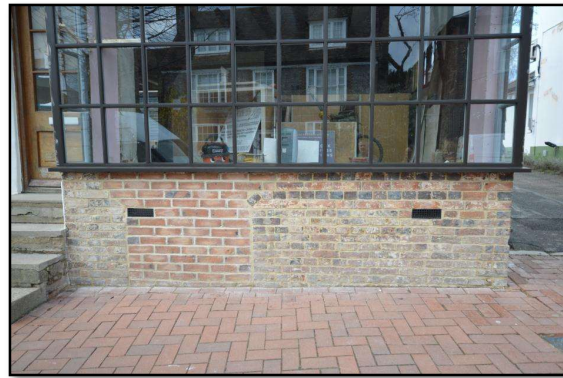
- LEFT: PAINTED PLINTH PRIOR TO THE REMOVAL OF THE PAINT FINISH
- RIGHT: EXISTING CONDITION FOLLOWING THE REMOVAL OF THE PAINT FINISH EXPOSING THE BRICK SUBSTRATE

- 2.2.1 Current owner used a DOFF steam cleaner to remove the paint finish off the surface of the brick plinth. The exposed brickwork is in generally a good condition and has revealed the historic work by previous owners in blocking up the arched air brick and insertion of two brick sized vents. The plinth itself, unlike the rest of the building, was painted rather than rendered

- 2.2.2 The client is requesting consent to retain the brick plinth in its current exposed condition.
- 2.2.3 The intention behind retaining the brick fabric exposed is to improve the passage of the water vapour from the cellar and thus breathability of the fabric, which would help in alleviating the damp conditions within the cellar area.

- 2.2.4 The other reason is aesthetic; the plinth is on a busy pedestrian path and is subjected to flowing water from the driveway and the road. Any paint cover will disfigure quickly. It is to be noted that the building sits on a busy and heavily hardscaped road, subjected to driving rain and water running down from the adjacent drive, down the pavement and splash backs from the road itself. Unlike the rest of the front elevation which is tucked away, set well back from the pavement and protected behind a planting bed.

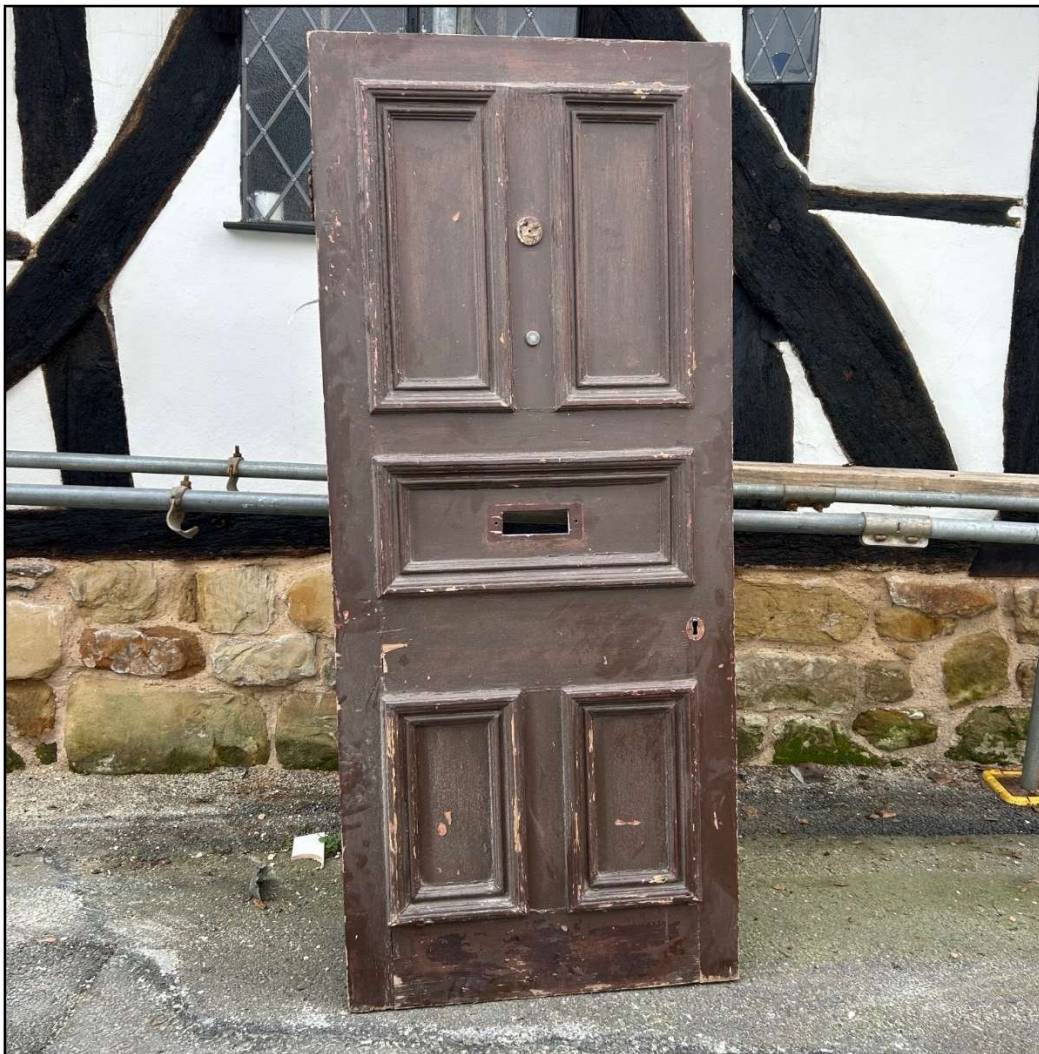
- PHOTO OF THE DOOR RECOVERED FROM THE ANCILLARY RANGE AT THE OLD BAKERY : PHOTO PROVIDED BY THE CLIENT

It is proposed that the front door to the bakery is reinstated to an earlier version. Mrs Kim Wyles the daughter of the previous owner and baker Mr. Wyles has been in touch with the present owner. Mrs Wyles has confirmed that the door salvaged that was initially at the entrance to the bakery in the cross-wing of the building may have been stored with other timber in the ancillary building to the rear of the street front-range. A robust timber door with five moulded panels, the central panel extending across the width of the door and including a letter-box has since been recovered from the ancillary range. Mrs Wyles has supplied photographs, unfortunately they are too pixelated to make out much of the detail other than that the door was certainly to a different form than it is at present, lacking the extent of glazing of the existing modern door as shown on the photos provided above.

The recovered door is stylistically commensurate with a Georgian origin. As the present door is a mid to late 20<sup>th</sup> century addition to the building, its replacement with a more historic alternative will not result in the loss of significant fixtures for this building. The reuse of the robust timber door recovered from the ancillary range will make good use of a salvaged historic fixture of a style that will sit well with the Georgian-style frontage of this important mid-14<sup>th</sup> century cross-wing.

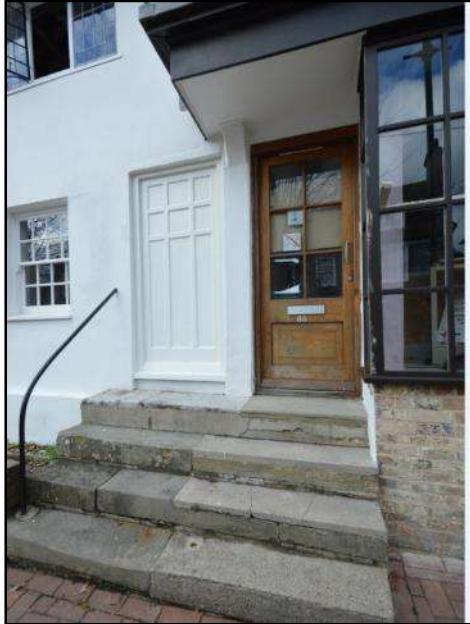
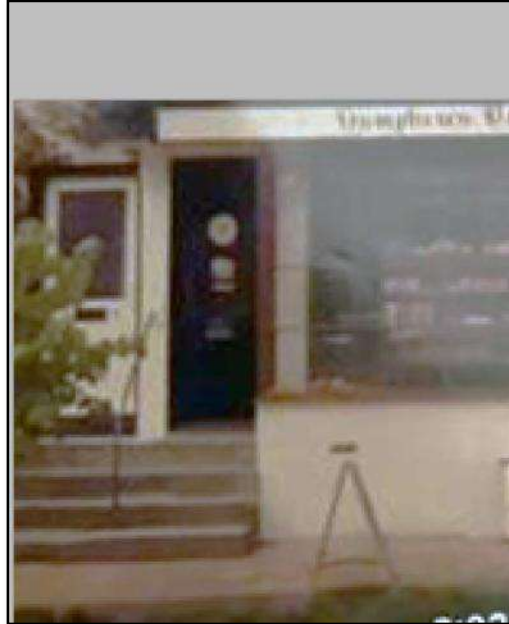
- COMPARISON OF THE EXISTING FRONT DOOR AND ITS PREDECESSOR [PROVIDED BY MRS K.WYLES]

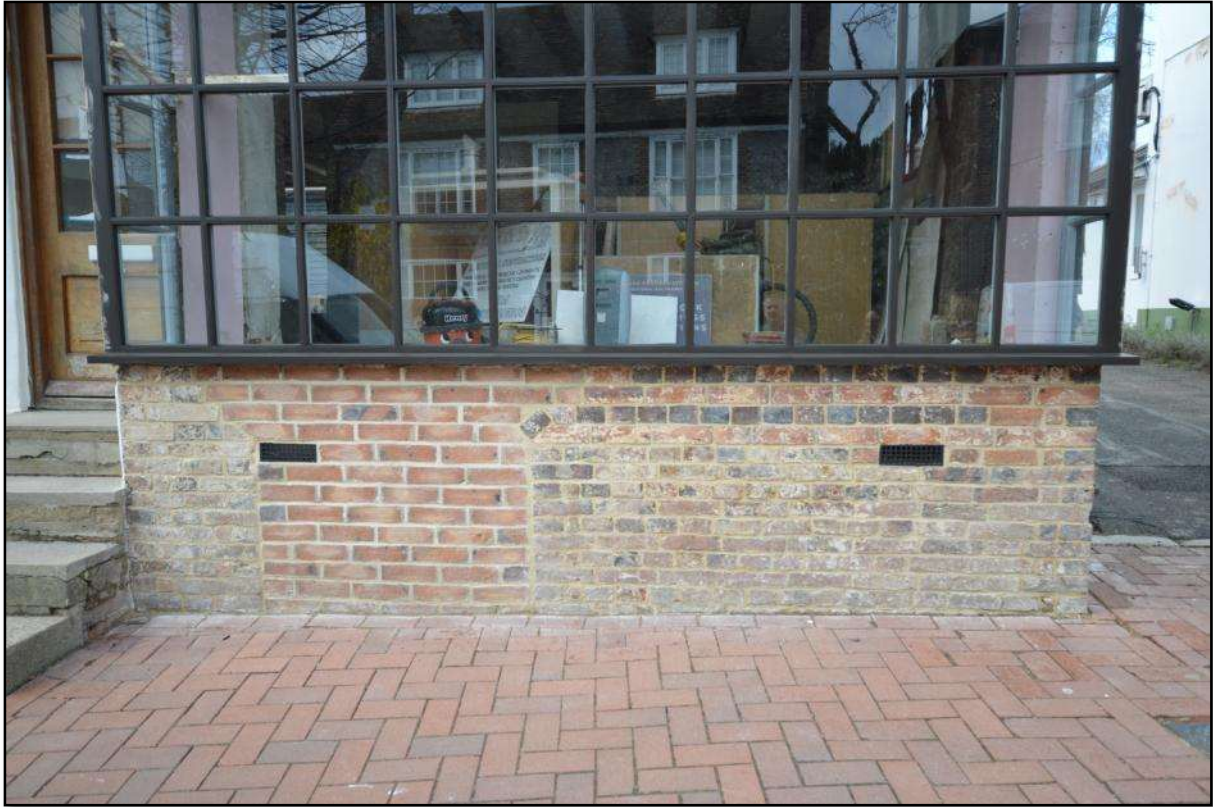
- THE FRONT ELEVATION OF THE FORMER SHOP WITH ITS EXPOSED BRICKWORK

The modern paint finish had been removed from the plinth at the base of the mid to late 20<sup>th</sup> century shop-front window to re-point the brickwork. The newly revealed brickwork illustrates the English bond fabric and form of the plinth itself in addition to the 20<sup>th</sup> century stretcher-bond fabric that had been used to block the light-well to the cellar .

The owner seeks consent for retaining the exposed brickwork instead of repainting it. The benefit of the exposed brickwork is clear in its ability to illustrate clearly the 18<sup>th</sup> or 19<sup>th</sup> century origin of the plinth and its later evolution whereby the lattice screen of the light-well was removed and blocked in brick. The exposed brickwork will allow a greater degree of the building's later historic evolution to remain visually accessible to the public, illustrating its part in its long and complex narrative.
