# Arboricultural Report:

## Arboricultural Implications Assessment (AIA) and Preliminary Arboricultural Method Statement (AMS)

Site Address: 4 Farlington Close, Haywards Heath, West Sussex, RH16 3EH.

Ref: aiams1/4fc/26

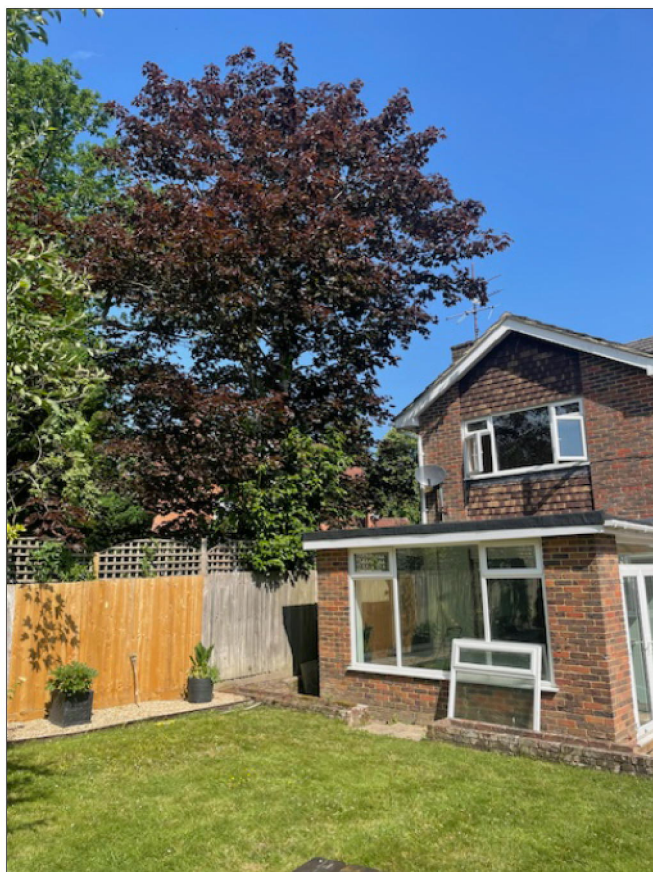
be similar in age. Therefore, roots of the developing tree are likely to have been deflected by the existing foundations that are approximately 1.2m in depth and there is no indication to date, that the tree has caused direct or indirect damage to the property.

Fig. 1: View of existing rear extension to be demolished and re-constructed with T1 (Norway Maple) visible to the left-hand side of the image.

4.3.1 The current proposal will utilise the existing foundations upon which to construct the new extension; therefore, the impacts upon the tree and its root system should be negligible if the recommended protection measures within this report are adhered to. Excavations required within this area highlighted upon the TPP should be carried out using hand tools, from inside the footprint of the building to protect against damage

to any roots that have grown up against the existing foundations, prior to careful construction of the new extension above. Further details relating to this methodology can be found below at **Appendix 5**.

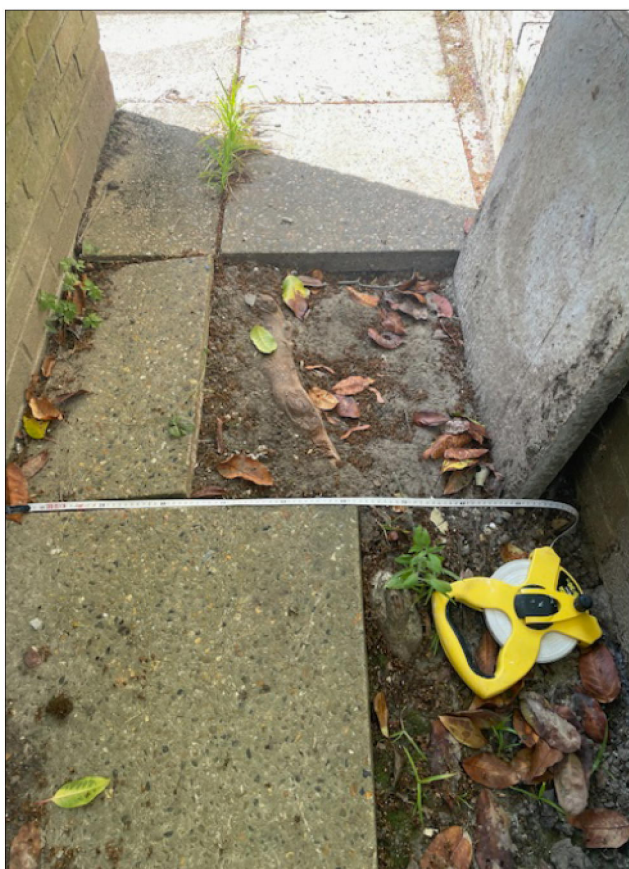
Fig. 2: Roots growing alongside existing structure to be covered with suitable ground protection during demolition and construction phases.

- 4.3.2 Compaction of the soil and subsequent root damage within the RPA of tree no.1 is possible during demolition of the existing conservatory and construction of the new extension, primarily through footfall and the passage of light machinery. Therefore, I have recommended the installation of suitable ground protection within the blue hatched area shown upon the TPP. In this case, heavy duty wooden boarding over a non-compressible substrate such as woodchip would be appropriate. Further details relating to ground protection can be found at **Appendix 3**.

5.3 **Ground Protection:** I recommend installing some ground protection (refer to TPP1\_4FC\_26) at the location indicated upon the TPP, to ensure that roots

belonging to tree no.1 which have grown into the site are not damaged during construction by the regular movement of operatives and light machinery.

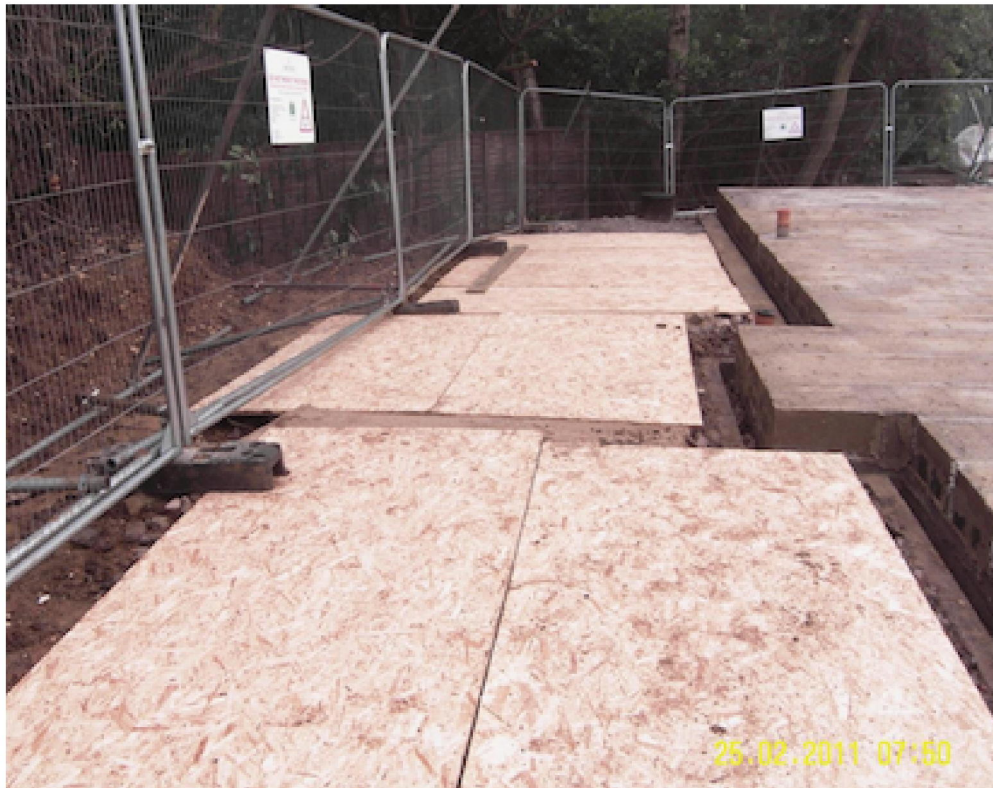
Fig. 1 Heavy duty boards over sharp sand and wood chip

Installing heavy-duty OSB boarding over a depth (min. 50mm) of sharp sand and/or wood chip between the tree protection fencing and the foundation line of new development is effective in protecting roots, which grow in the soil beyond the position of the fencing.
