**Tree Survey and Arboricultural Impact Assessment  
In Accordance with BS 5837:2012**

| Project No<br><b>11612</b> | <b>Ockley Park S5 - 16d, Hassocks, RH15 9HR</b> | | |
| Client: | | Circet UK Wireless | |
| Date of Report: | 24/04/2025 | Revision: | Original |

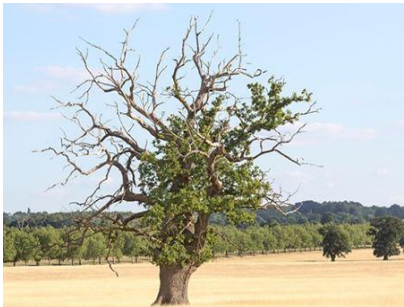
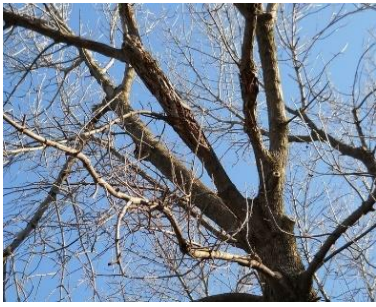
| Name: Deadwood | |
|---|---|
| <b>Symptoms/damage type and cause:</b> | This relates to dead branches in the crown of the tree. In most of cases, this is caused by the natural ageing process of the tree or shading due to its close proximity to neighbouring trees. However, in some situations, it may be related to fungal, bacterial or viral infection. |
| <b>Consequence:</b> | Depending upon the location and mass of dead wood removal of the affected tissue may be necessary to prevent harm to persons or property as the wood will become unstable as it decays and in some circumstances is likely to fall from the tree with little or no warning. |

| Name: Deadwood | |
|---|---|
| <b>Control:</b> | Detailed monitoring should be undertaken on those trees showing signs of excessive deadwood production to identify the underlying cause. |

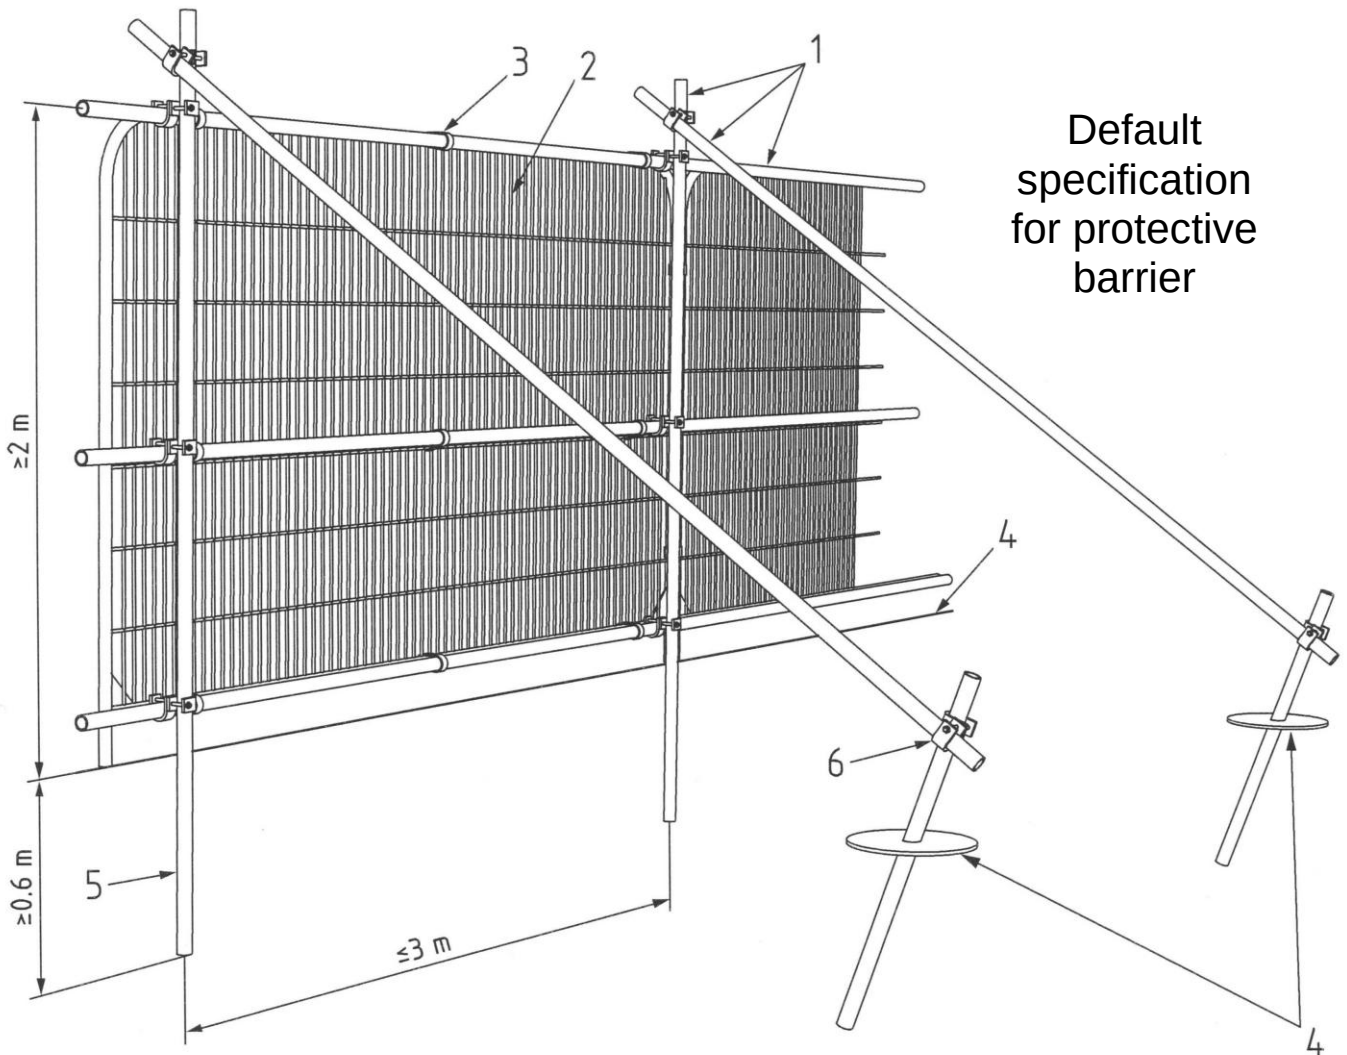
3. BS 5837:2012 Figure 2: Default specification for protective barrier

- 1 Standard scaffold pole
- 2 Heavy gauge 2m tall galvanised tube and welded mesh infill panels
- 3 Panels secured to uprights and cross-members with wire ties
- 4 Ground level
- 5 Uprights driven into the ground until secure (minimum depth 0.6m)
- 6 Standard scaffold clamps

- 4.6.1 Protective fencing will be erected at the location shown on the attached drawing no. 11612-D-AIA prior to the commencement of construction. It will not be removed until completion of the development.

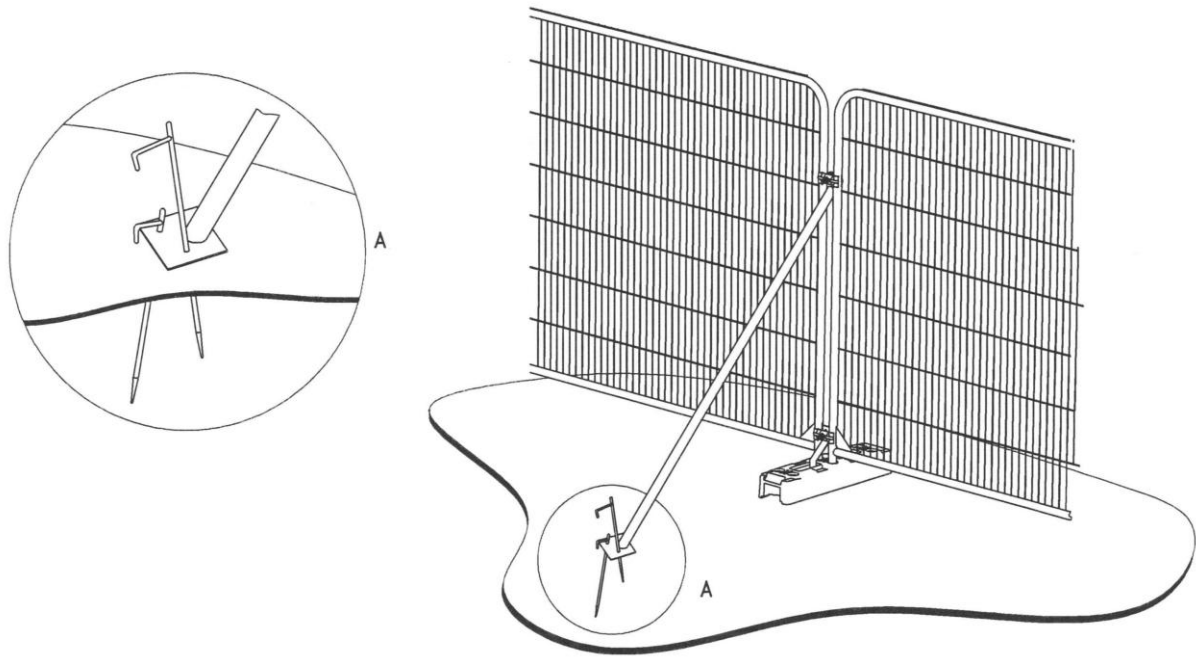
a) Stabilizer strut with base plate secured with ground pins

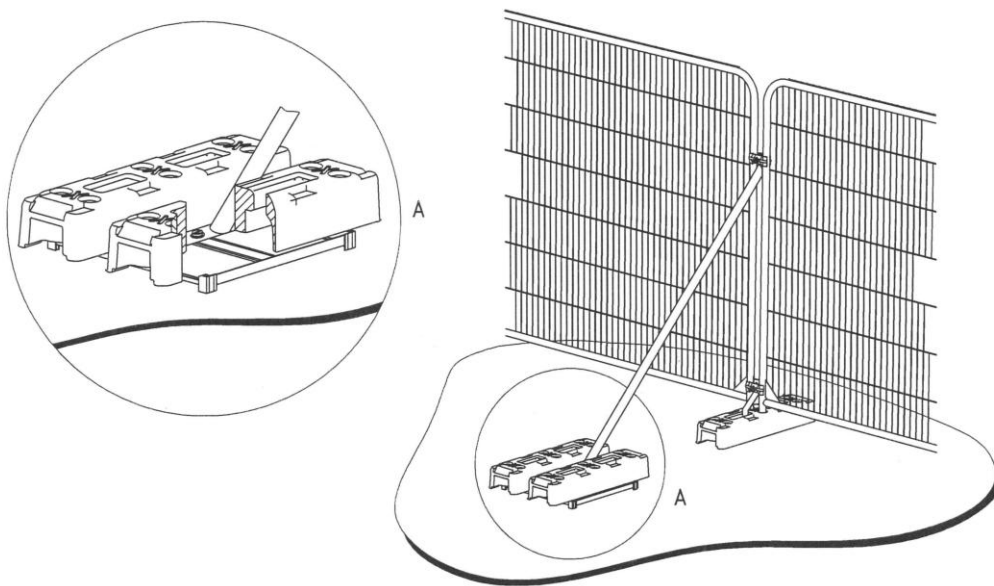
b) Stabilizer strut mounted on block tray

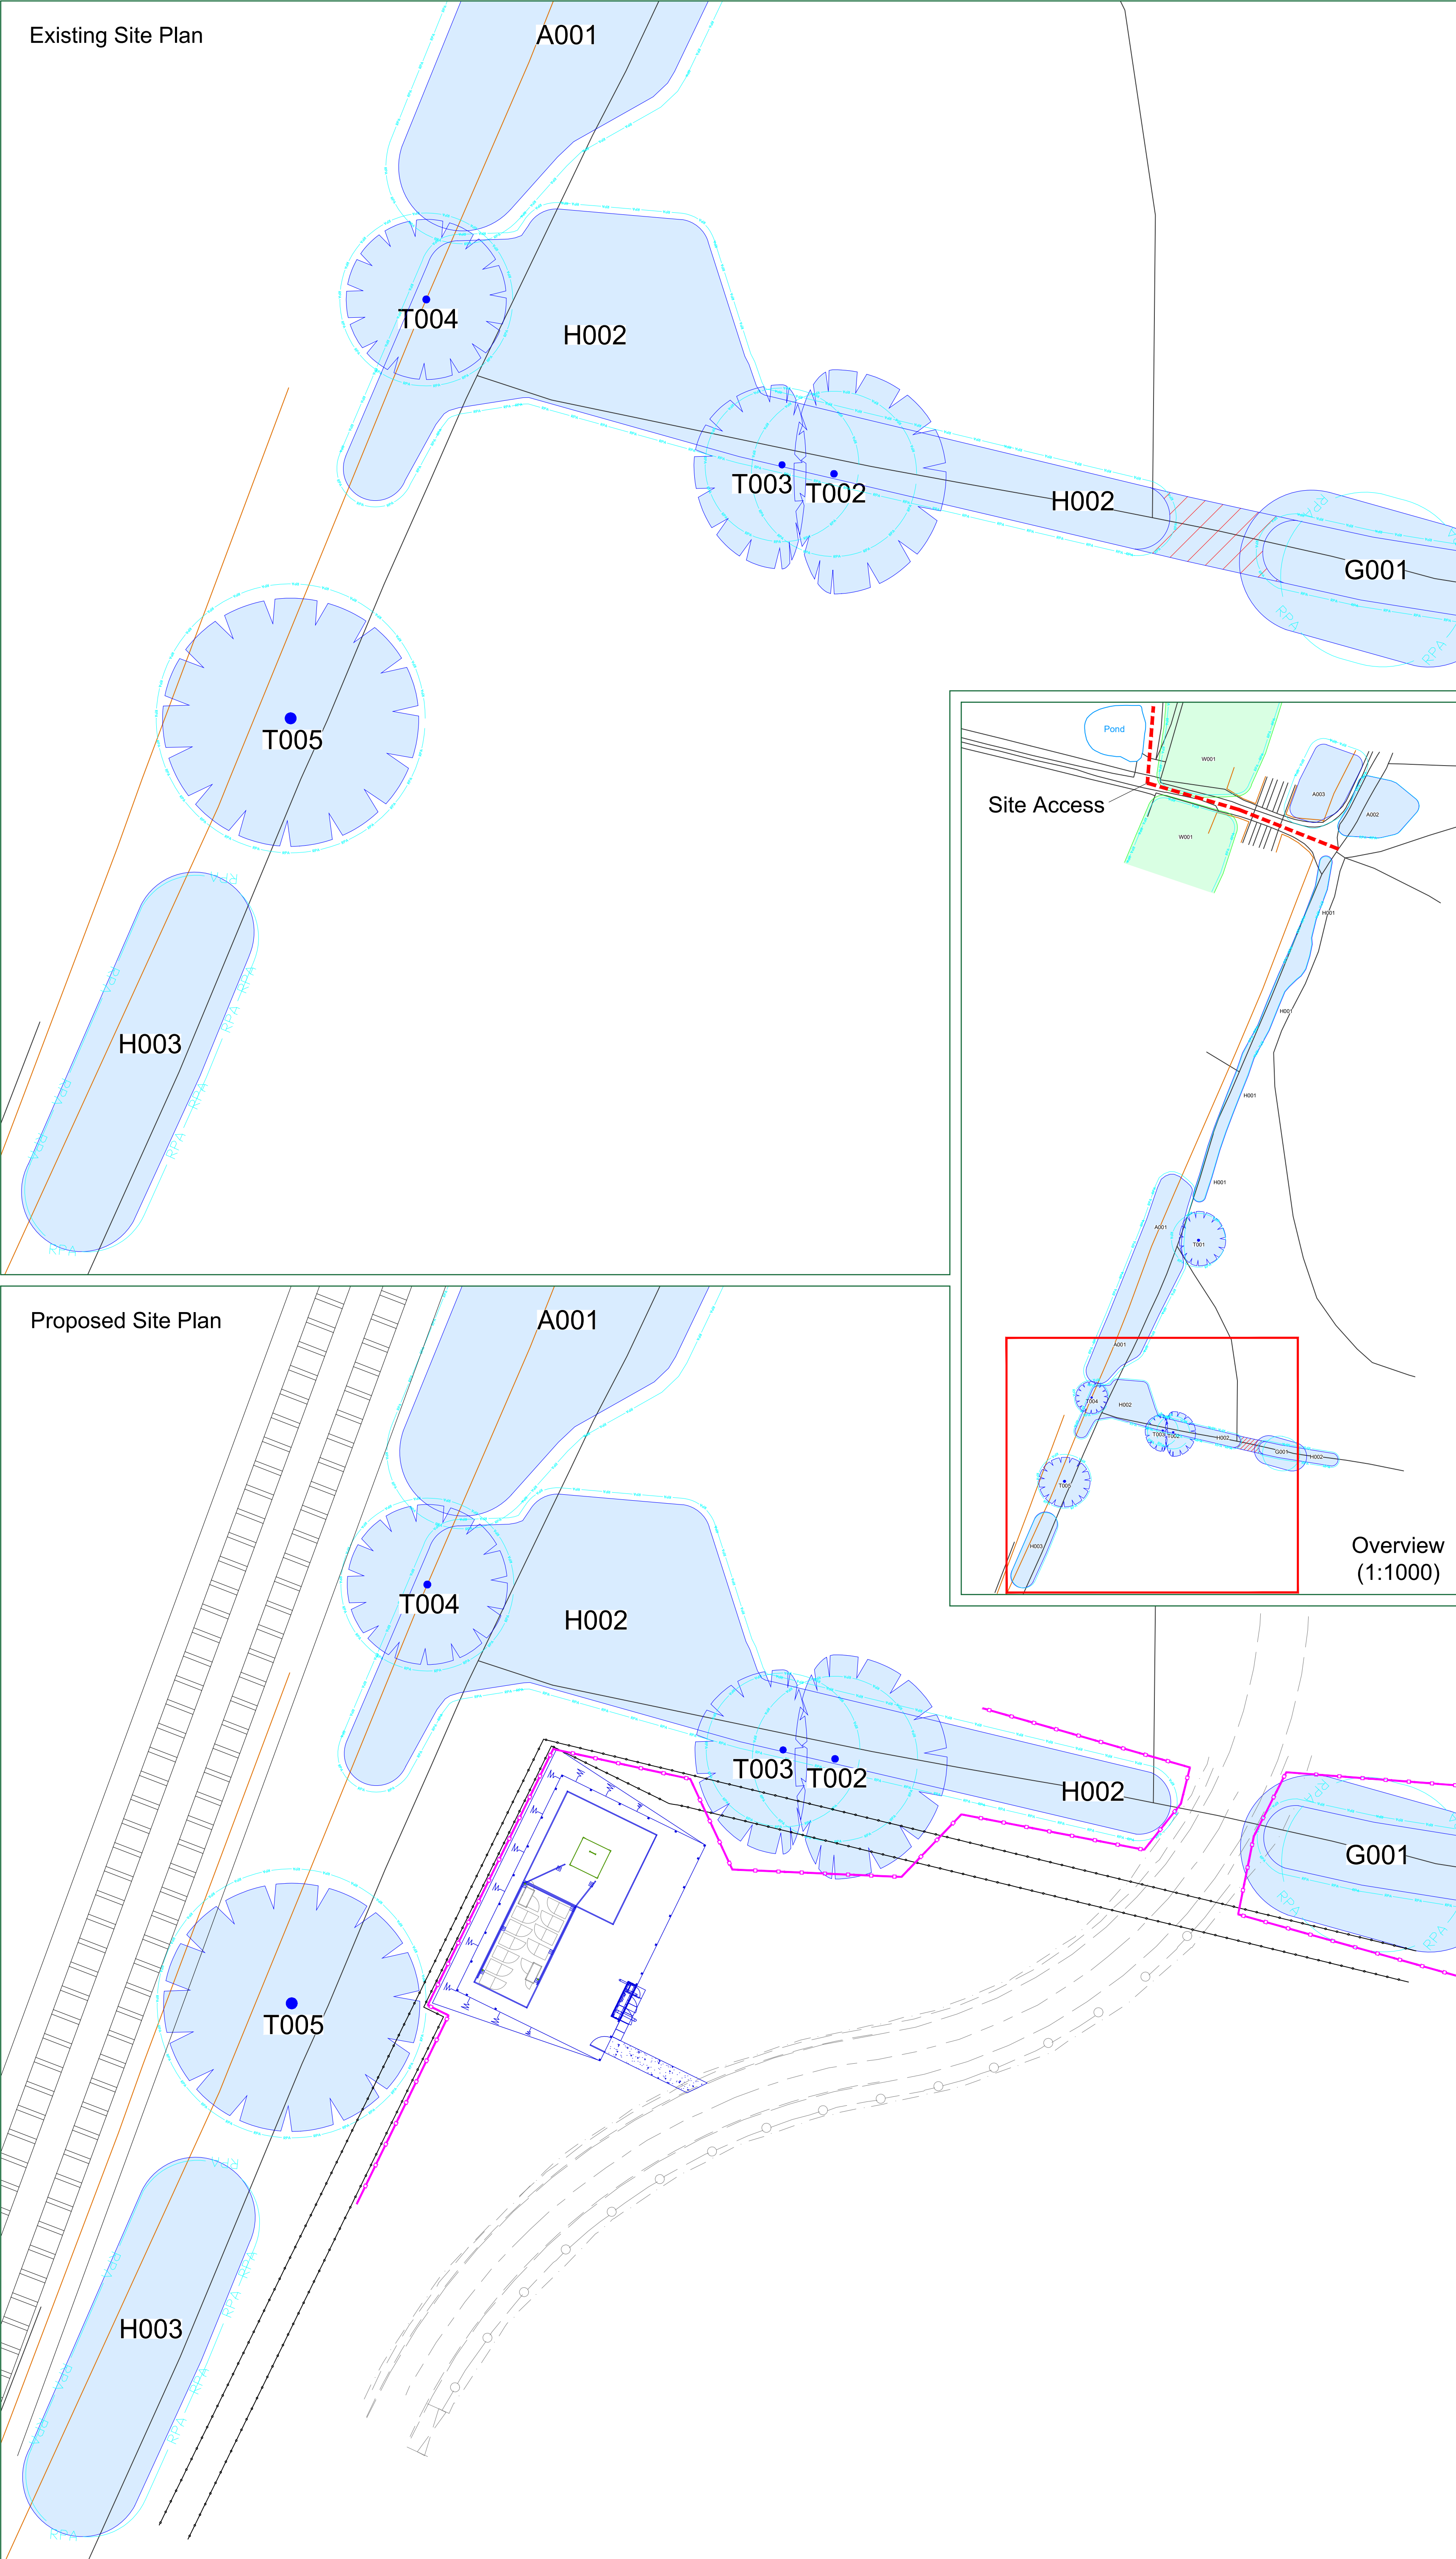
Haydens Drawing

- 4.1.2 The proposed access is partially encumbered by the Root Protection Area (RPA) of W001. In this case the RPA is safeguarded by existing hard surfaces. From a purely arboricultural perspective, it will therefore not be necessary to install a temporary load bearing surface to protect tree roots.

- 4.1.3 To facilitate construction access a small section of H002 requires felling. However, the removal of this section of hedge is not allied to this proposal and is required to install the proposed Taylor Wimpey bridleway that finishes north of the site and at the Network Rail bridge. This is shown for reference on the attached drawing no. 11612-D-AIA.

- 4.3.1 Construction of the compound and telecommunication mast's foundations do not encroach RPA of any trees to be retained, as shown on the attached drawing no. 11612-D-AIA. From an arboricultural perspective, no specialised construction or foundation techniques will therefore be required to protect tree roots. However, dependent on the soil type, species and topography, trees may have an influence on the soil beyond their calculated RPA. Given the proximity of the proposed construction to the trees to be retained, it is recommended that a Structural Engineer is consulted to assess the implications of the tree retention on the required foundation design.

The position, condition, and dimensions of the trees are based on a site survey undertaken on 01/04/25
