# BAT HIBERNATION SURVEY REPORT

**Birchgrove Farmhouse, Horsted Keynes, West  
Sussex**

| <b>Reference:</b> | LLD3743-ECO-REP-001-00-BHS | | | |

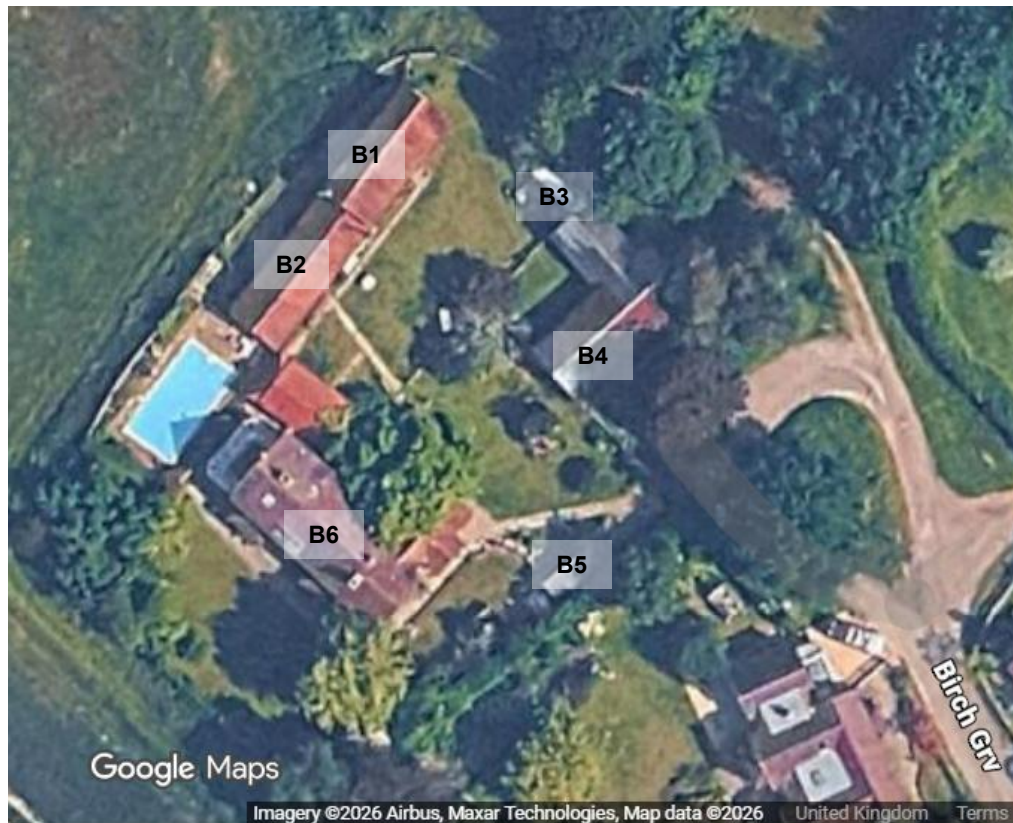
**Figure No. 02 – Building Numbering Plan** ©Google Maps

- 4.1.2 Building B2 is a single storey timber-clad structure with lifted and missing weatherboarding, lifted and damaged roof tiles, and some open eaves. No evidence of bats was recorded within this building during the Preliminary Ecological Appraisal. Building B2 was assessed as offering moderate suitability for summer roosting bats and low suitability for hibernating bats. For full details of the preliminary assessment, refer to the Preliminary Ecological Appraisal (PJC Consultancy Ltd, October 2025).

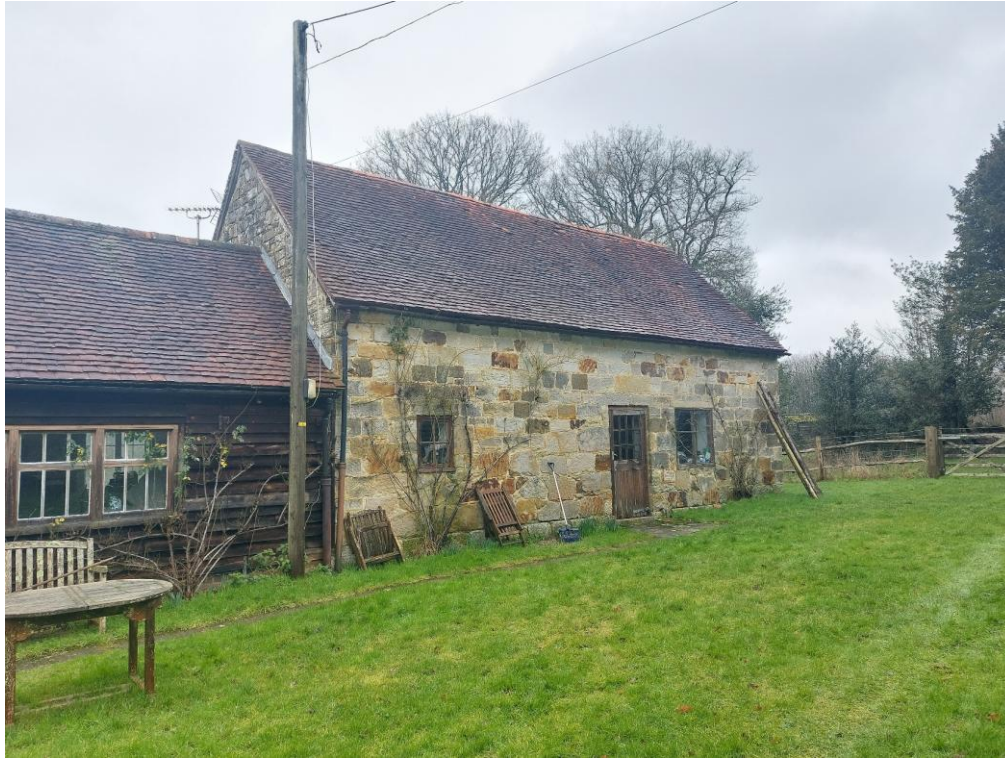
- 4.1.1 A Preliminary Ecological Appraisal, including a daytime bat walkover survey, was undertaken by PJC Consultancy Ltd on the 9th of September 2025. Building B1, a stone-and-mortar barn with a pitched clay tile roof, open eaves, gaps within the stonework and open mortise and tenon joints, was identified as supporting a confirmed bat roost. Bat droppings were recorded scattered throughout the internal elements of the building and DNA analysis confirmed the droppings to be from brown long-eared bat *Plecotus auritus*. Building B1 was also assessed as offering moderate suitability for hibernating bats.

Photograph No. 01 - Eastern aspect of Building B1 (right) and adjoining B2 (left).

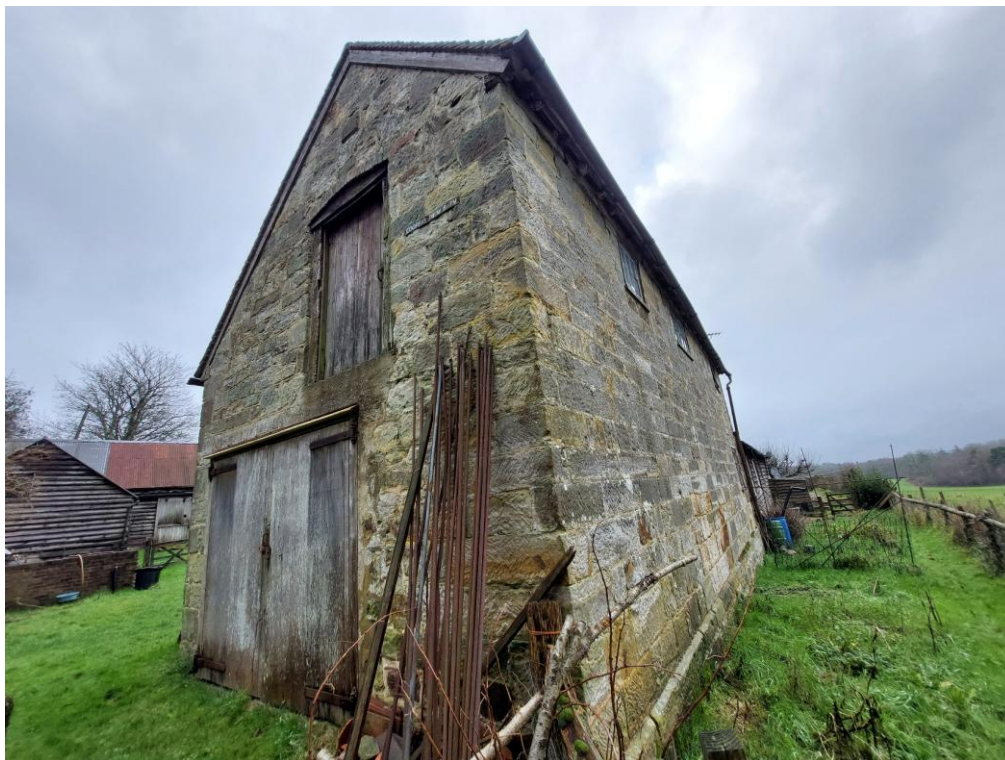
Photograph No. 02 – North and west aspects of Building B1.

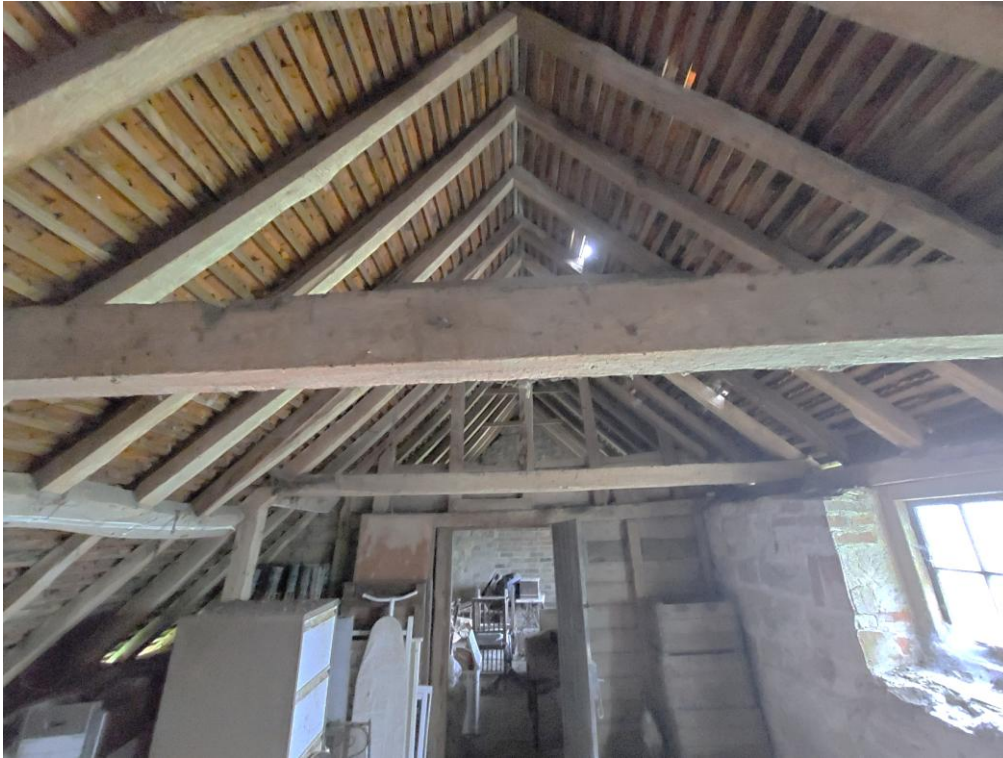
- 4.2.2 Building B1 remained the more suitable structure for hibernating bats, being relatively cool, dark and enclosed internally, with crevice features including gaps in the stonework and mortise and tenon joints, during the surveys hibernating ladybirds and a peacock butterfly were both observed, see Photograph No. 05 & 06 at the back of this report. Building B2 offered more limited hibernation potential, largely associated with lifted roof tiles and weatherboarding. No hibernating bats were recorded within the accessible features of either building.

Photograph No. 03 – Internal Inspection of B1, looking south.

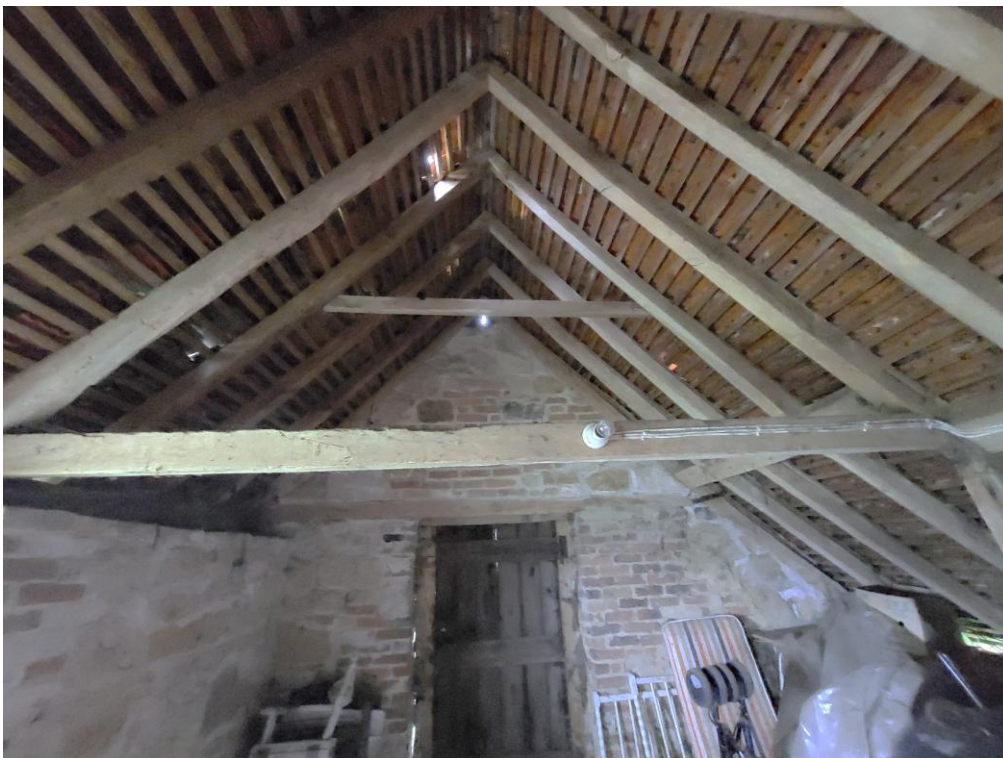
Photograph No. 04 – Internal Inspection of B1, looking north

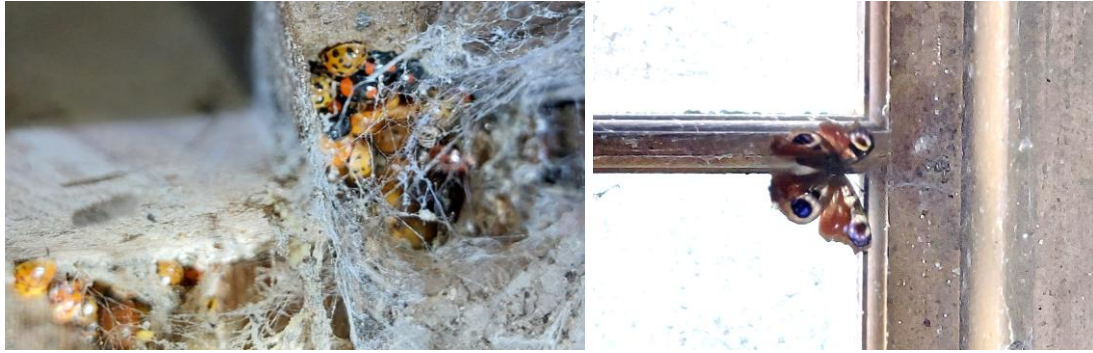
Photograph No. 05 & 06 – Internal Inspection of B1, hibernating ladybirds (left image) and peacock butterfly (right image).
