# Sackville College, High Street, East Grinstead

Preliminary Bat Roost Assessment (PBRA)

A Report for Lee Evans Partnership

October 2025

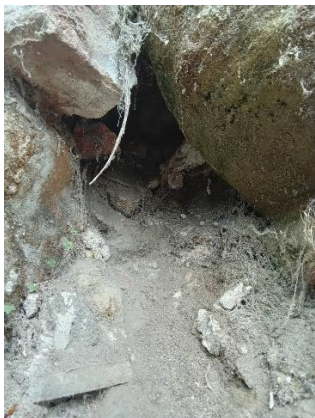
| PRF – 7 | A hole formed by a missing bolder / brick which provides an access point into the wall. The feature extends c.1m backwards behind sandstone blocks and is heavily eroded and dusty. No bats or evidence of bats was recorded. | c.0.75m | | Moderate |

Photo 10: PRF – 7 (W3)

- Prior to the commencement of any works, gaps / cracks / holes to be infilled should be subject to an inspection by a suitably qualified and licensed ecologist with the use of a high-powered torch and an endoscope.

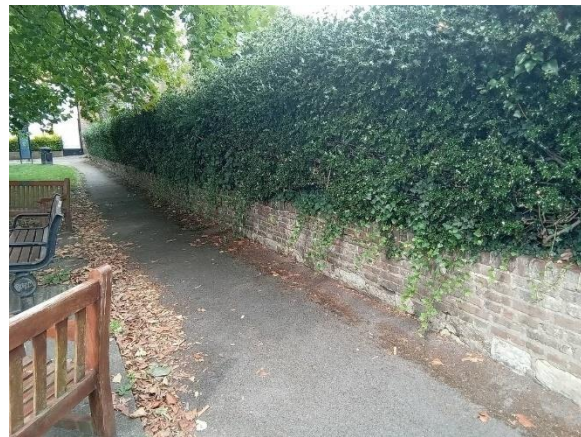
- 5.2.2 W1 is the western-most section of the retaining wall. This section consists of a sandstone wall plinth with a 1m high clay brick wall above. A holly *Ilex aquifolium* hedge is present along the entire length c.2m high. The wall is generally in good condition with occasional areas of missing mortar. It was considered that this area of the wall had **no suitability for roosting bats** due to its height and lack of suitable crevices.

Photo 1: Section of wall denoted W1

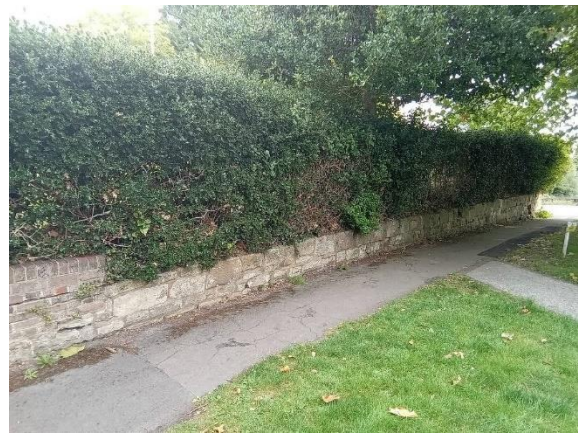
- 5.2.3 W2 consists of stone blocks. This area of wall is a continuation of W1, and the holly hedge continues along the entire length of W2. W2 is varied in height starting at c.0.5m at the western end and extending to c.2m at the eastern end due to the topography of the surrounding landscape. Two PRFs were noted within this section of the wall as described in Table 2 below.

Photo 2: Section of wall denoted W2

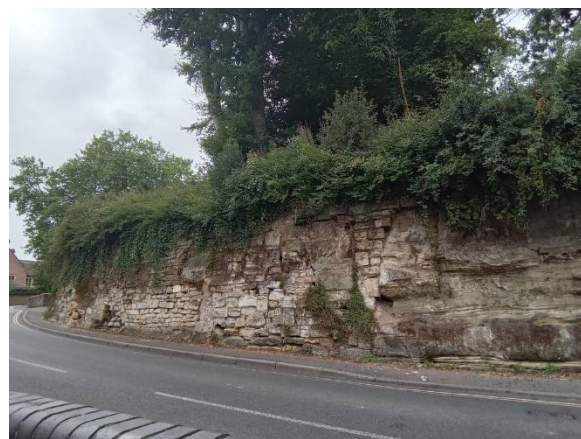
- 5.2.4 W3 also consists of stone blocks. W3 is a continuation of W2 however the height of W3 extends to c.4m high. Overhanging vegetation largely in the form of ivy *Hedera helix* and bramble *Rubus fruticosus* agg. is present at the top of this section of the wall. Five PRFs were recorded within W3 as described in Table 3 below.

Photo 3: Section of wall denoted W3

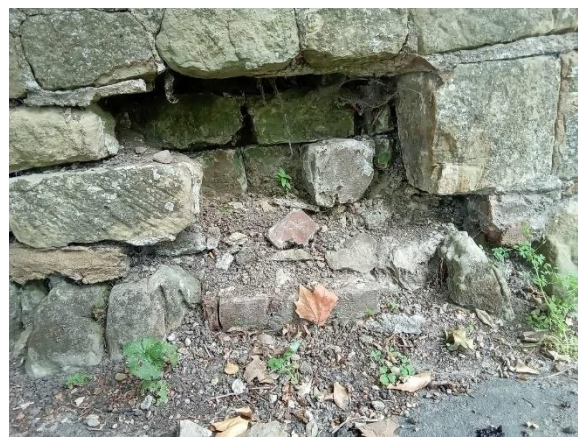
| PRF Ref | PRF Description | Height from Ground | Photo | Level of Suitability |
|---|---|---|---|---|
| PRF – 1 | <p>There is an area of missing block work c.0.75m x 0.75m towards the eastern end of the section. Several gaps between bricks are present within the broken area of the wall. Two cavities are present, the first goes straight up c.30cm and is free of cobwebs and detritus. The second extends c.1m to the west and is also free of cobwebs and detritus.</p> <p>The feature provides access between the double row of stone and appears to be in use by wildlife, likely birds. No bats or evidence of bats was recorded.</p> | c.0.5m | | Moderate |

Photo 4: PRF – 1 (W2)

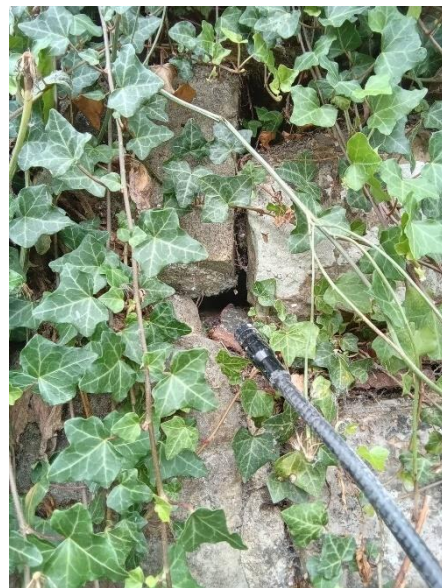
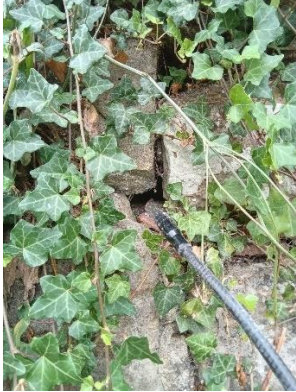
| PRF Ref | PRF Description | Height from Ground | Photo | Level of Suitability |
|---|---|---|---|---|
| PRF – 3 | A 10cm x 5cm gap between a piece of brick / slate within ivy cover. Feature extends c.10cm deep and c.20cm high behind the second row of brick. An opening is present at the top of the feature which reduces its suitability for bats. The feature is currently in use by birds with bird droppings present. No bats or evidence of bats was recorded. | c.1.75m | | Moderate |

Photo 6: PRF – 3 (W3)

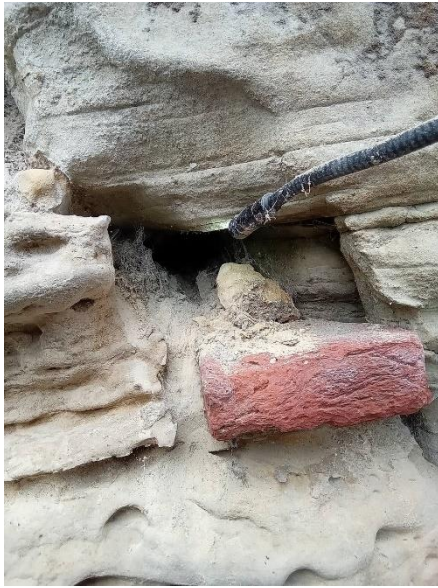
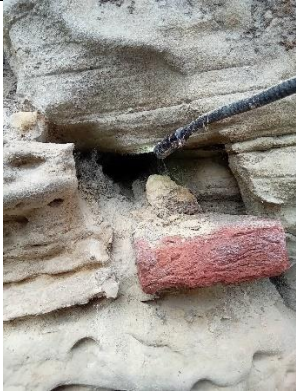
| PRF Ref | PRF Description | Height from Ground | Photo | Level of Suitability |
|---|---|---|---|---|
| PRF – 4 | A hole in the stone with a c.8cm circular entrance which extends c.1m back into the wall. Feature free of cobwebs. No bats or evidence of bats was recorded. | c.0.5m | | Moderate |

Photo 7: PRF – 4 (W3)

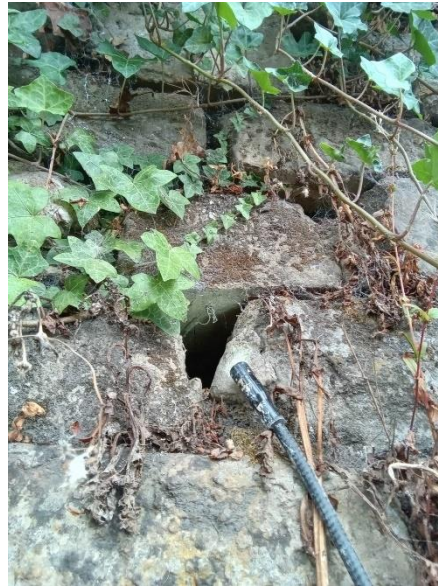
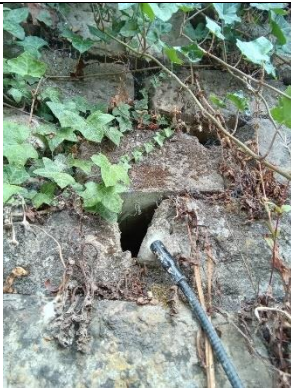
| PRF – 5 | A triangular gap in the brickwork from missing mortar extending c.30cm back. The feature is close to a streetlight which likely results in lighting impacts. The feature is free from cobwebs. No bats or evidence of bats was recorded. | c.2.3m | | Moderate |

Photo 8: PRF – 5 (W3)

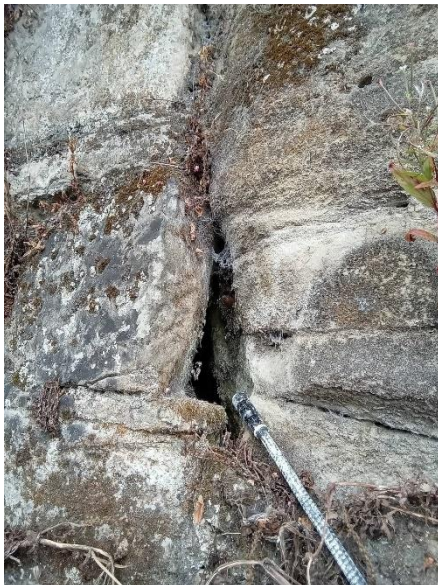
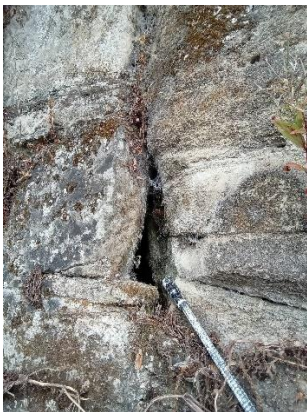
| PRF – 6 | A c.20cm tall x 10cm wide gap which provides access into a cavity behind a block and sandstone bolder. The feature extends c.1m back into the wall. No cobwebs were present, but the feature was very dusty. No bats or evidence of bats was recorded. | c.2.5m | | Moderate |

Photo 9: PRF – 6 (W3)
