# ARBORICULTURAL IMPACT ASSESSMENT

LAR2615-ARB-REP-0140

**Rear Extension and New Porch**

4 Oak Hall Park, Burgess Hill

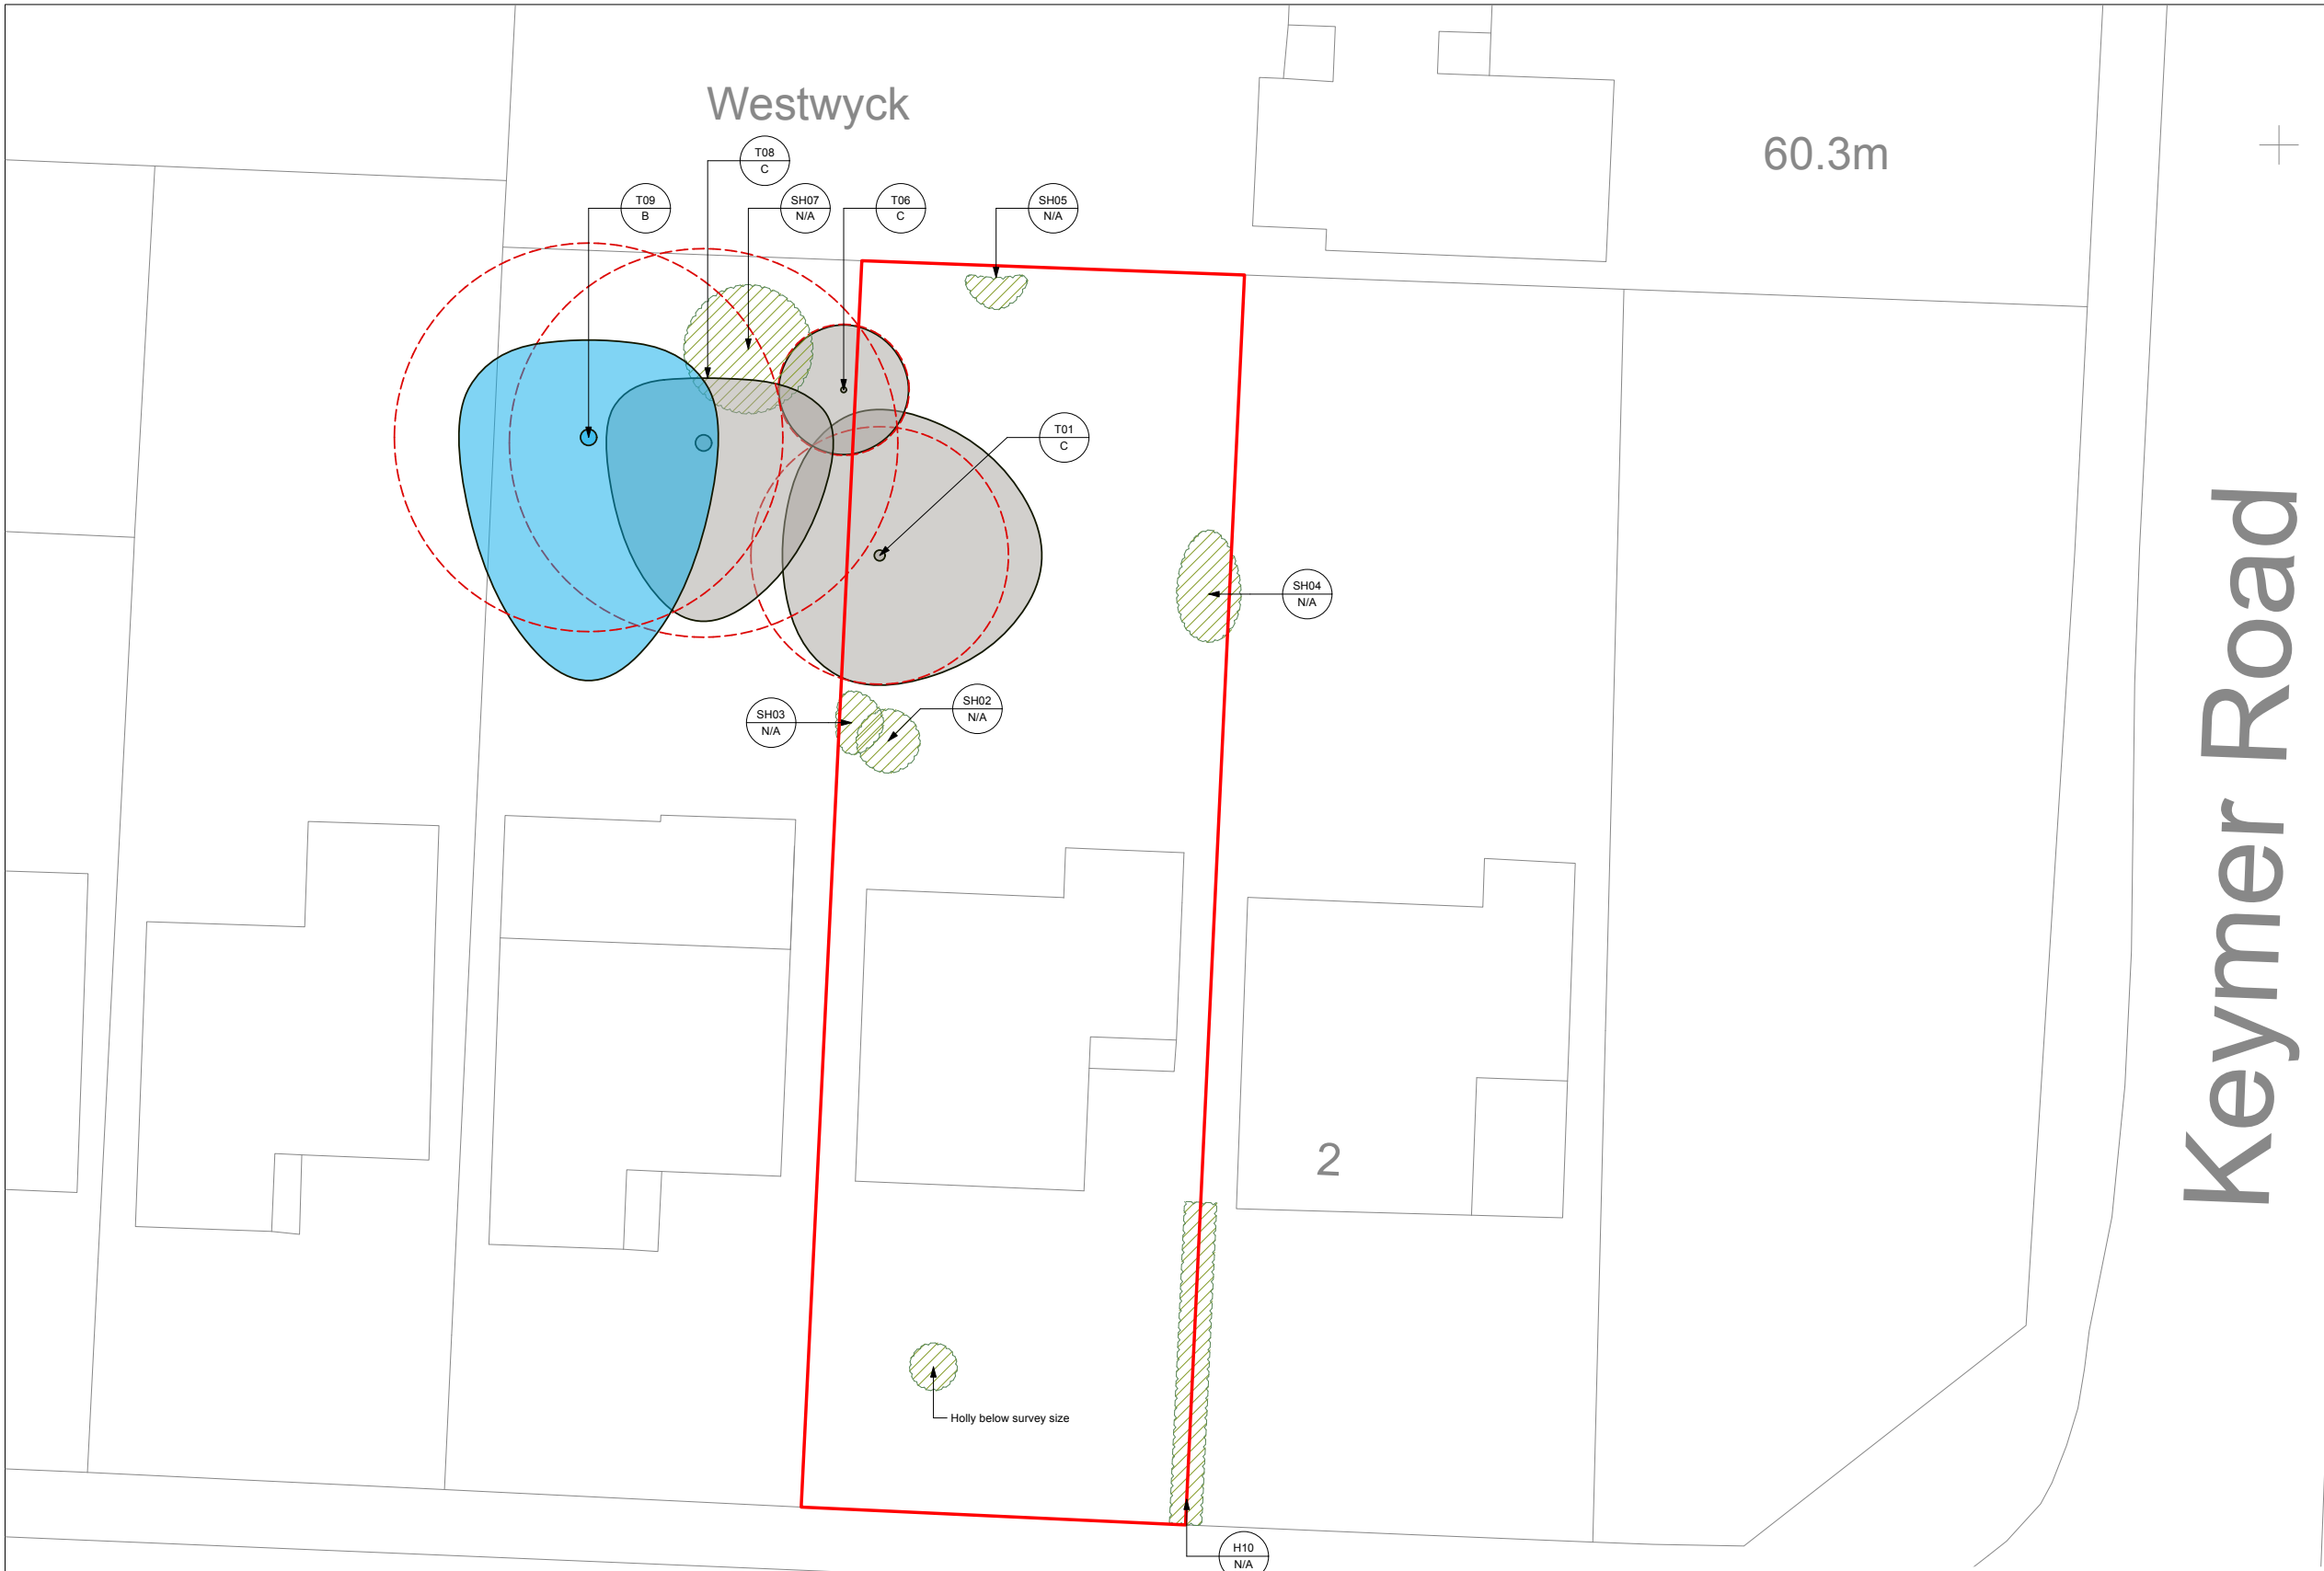
Drawing Title  
Tree Constraints Plan

There were no trees of medium or high quality within the site; however, a mature ash in the adjacent plot was considered of medium quality (category B).

- ▶ LAR2615-ARB-DRA-0101 - Tree Constraints Plan - attached in **Appendix 3**
- ▶ LAR2615-ARB-DRA-0110 - Tree Protection Plan - attached in **Appendix 4**.

All the recorded parameters are included in the Existing Tree Schedule (**Appendix 2**) and shown in the Tree Constraints Plan drawing (**Appendix 4**).

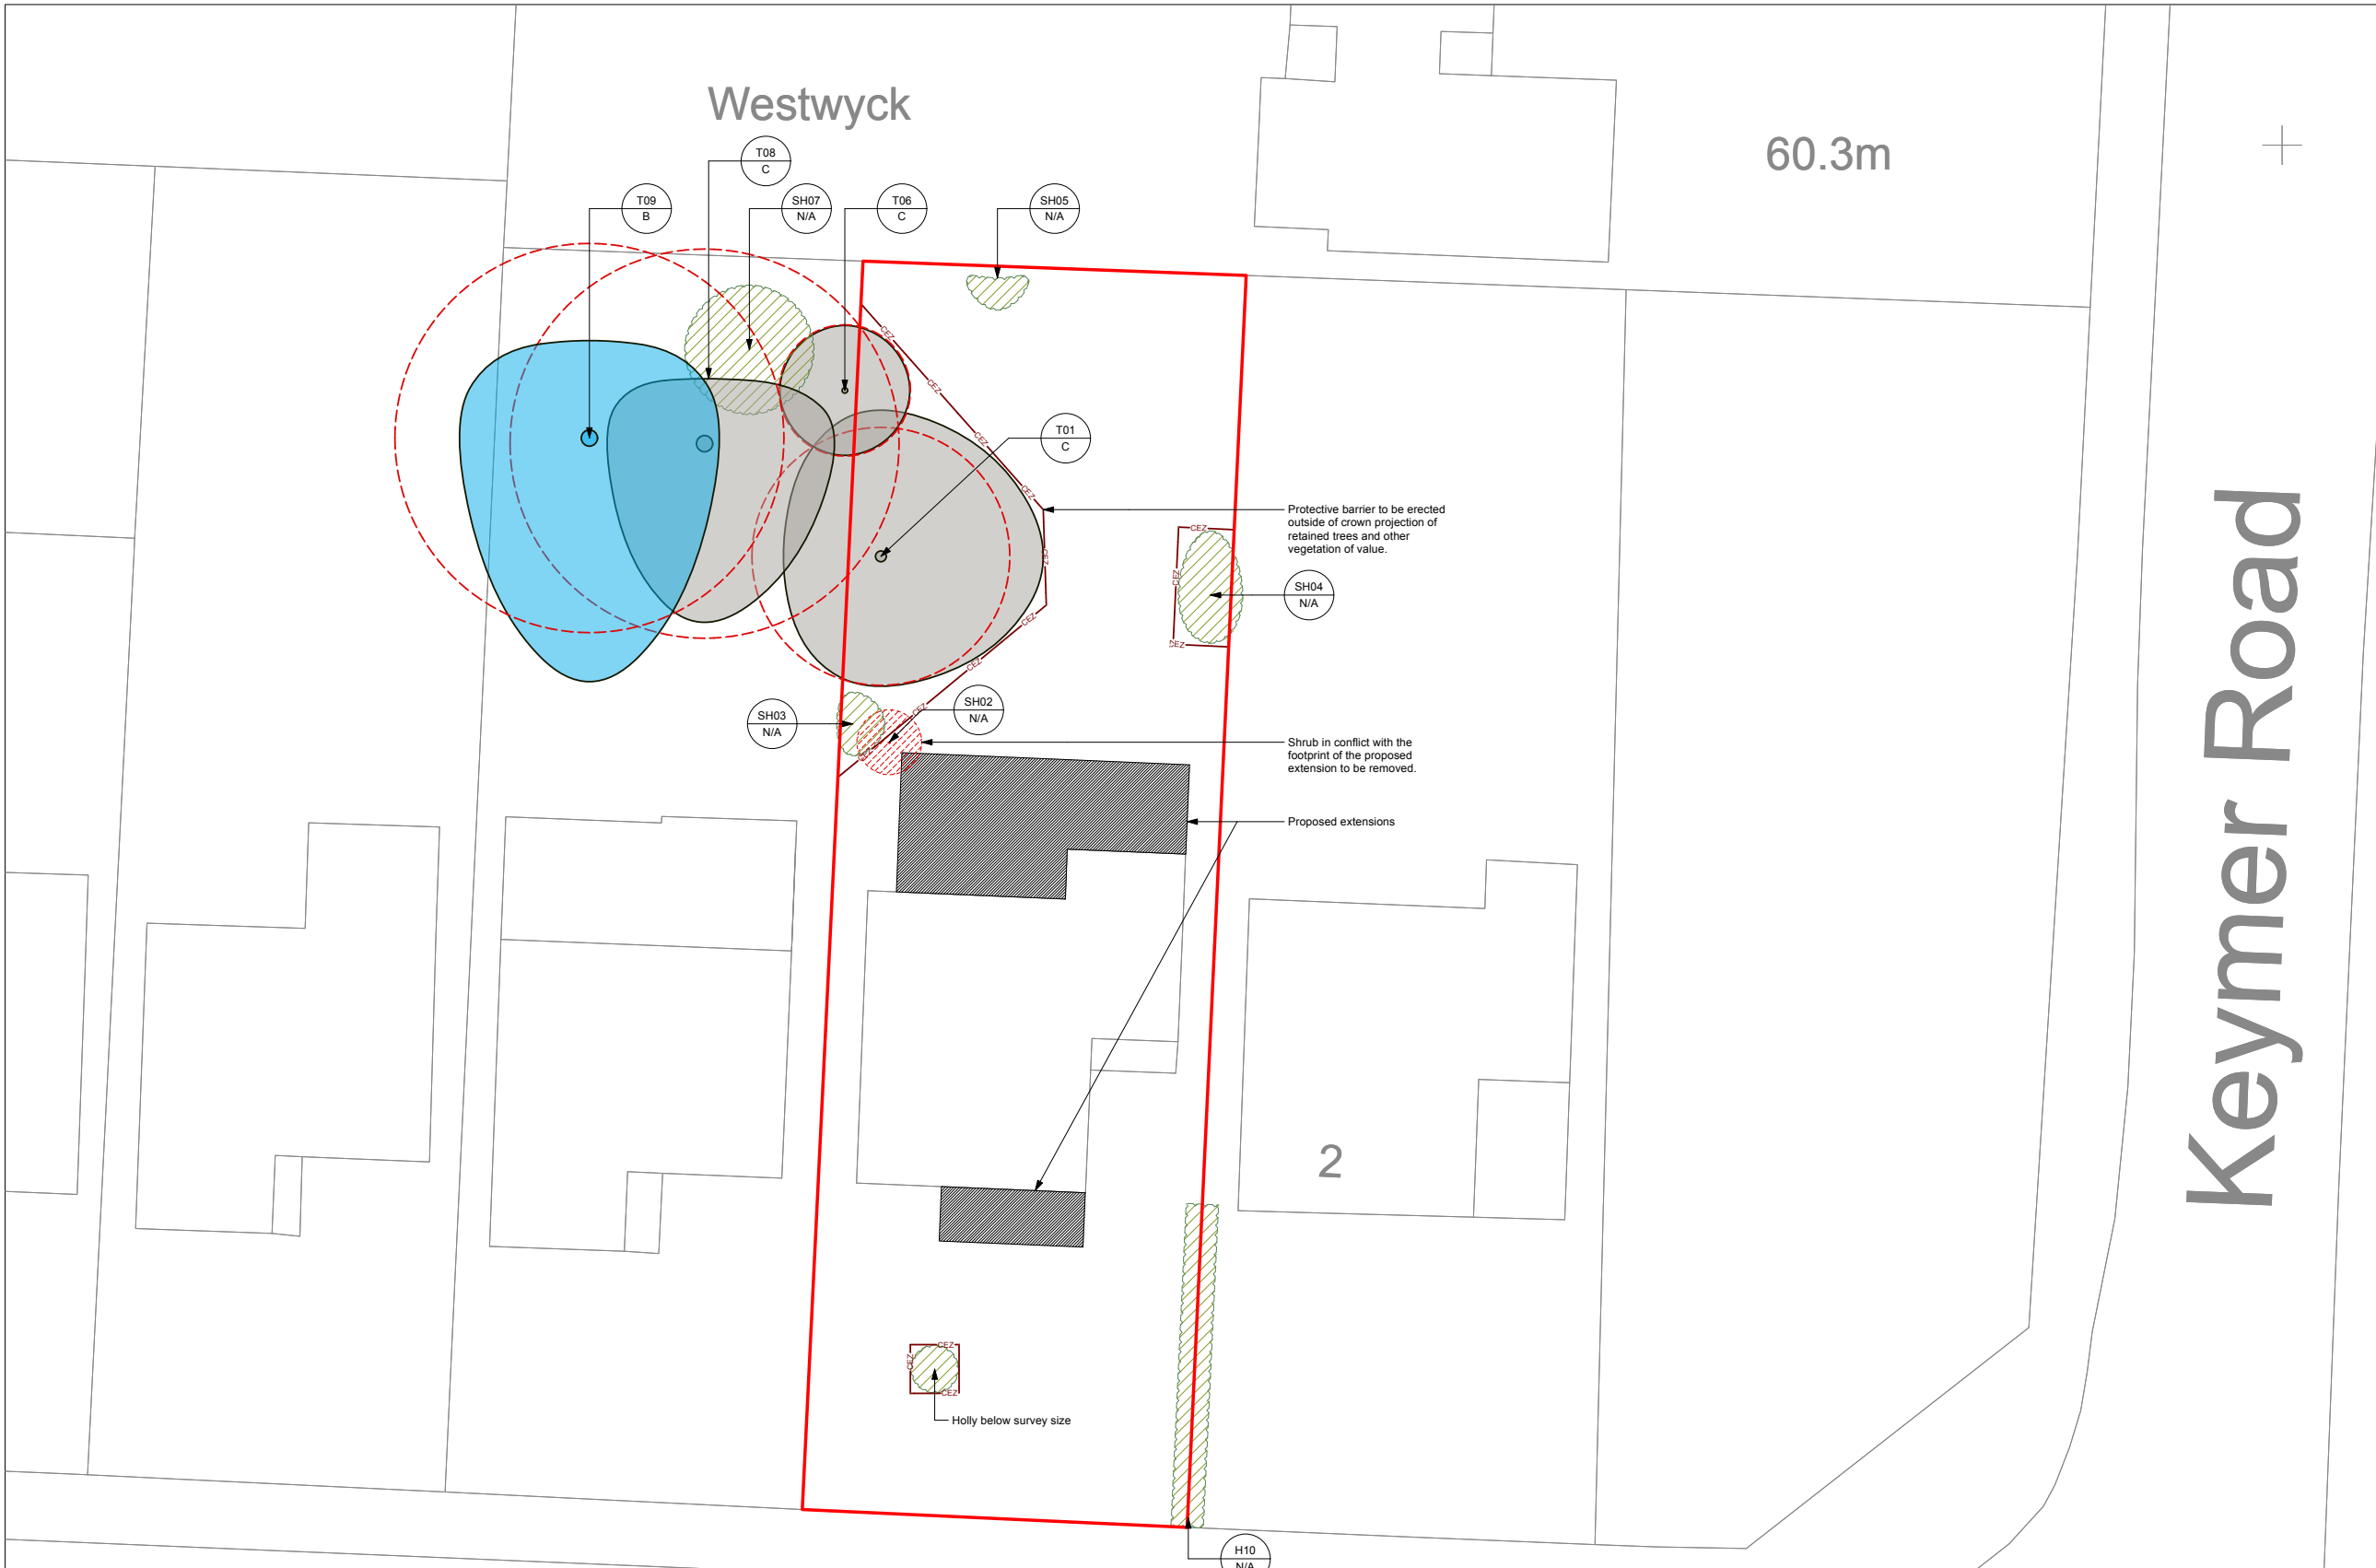
## APPENDIX 4. TREE PROTECTION PLAN (EXTRACT)

Through reference to the architectural proposal, no direct impact on any trees has been identified.

A single ornamental shrub is located within the footprint of the proposed extension and will require removal. It is considered viable to transplant this specimen if desired.

The identified impacts and the associated recommendations are illustrated in the Tree Protection Plan in **Appendix 4**.
