# **BAT EMERGENCE SURVEY REPORT**

**Birchgrove Farmhouse Barns, Birchgrove Lane,  
Horsted Keynes**

| <b>Reference:</b> | LLD3743-ECO-REP-002-00-BES | | | |

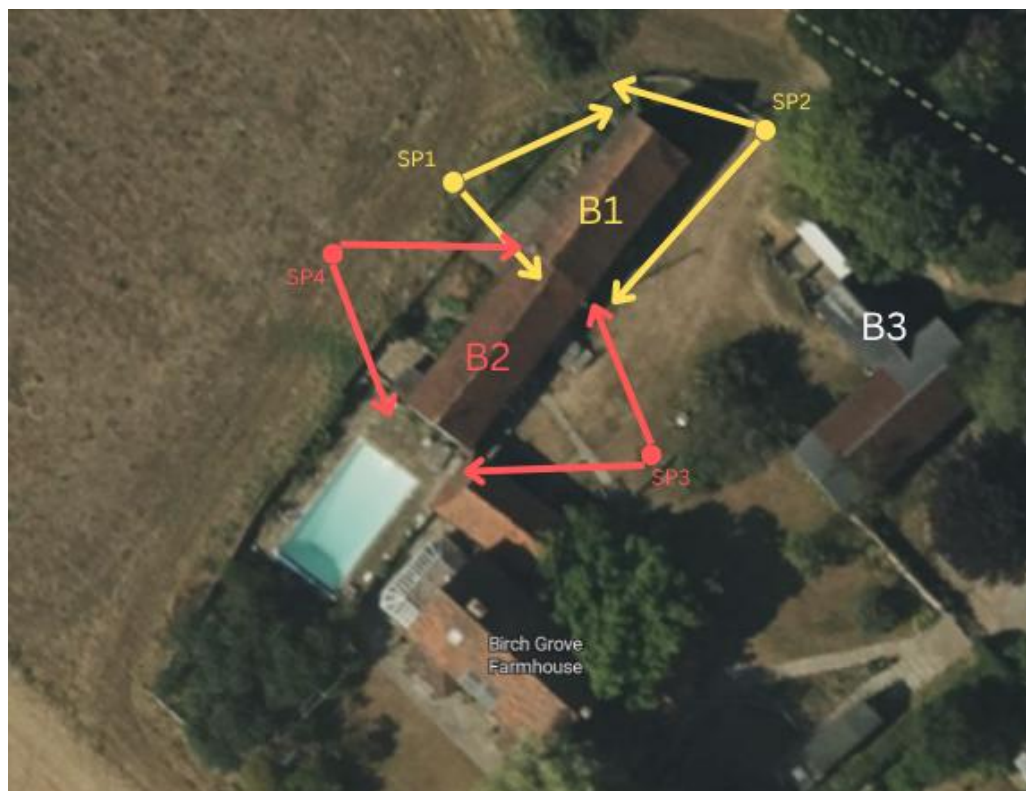
Figure No. 01 – Bat Survey Plan. Building B1 and respective surveyor perspectives (SP1/SP2) are indicated in yellow. B2 and the respective surveyor perspectives (SP3/SP4) are in red.

- 3.1.4 Bats were identified using Echo Meter Touch Pro 2 bat detectors. Two Whisker Nightfox infra-red cameras were also used to aid the surveys (see *Figure No. 02 - Bat Survey Plan*) in line with night visual aid guidance.

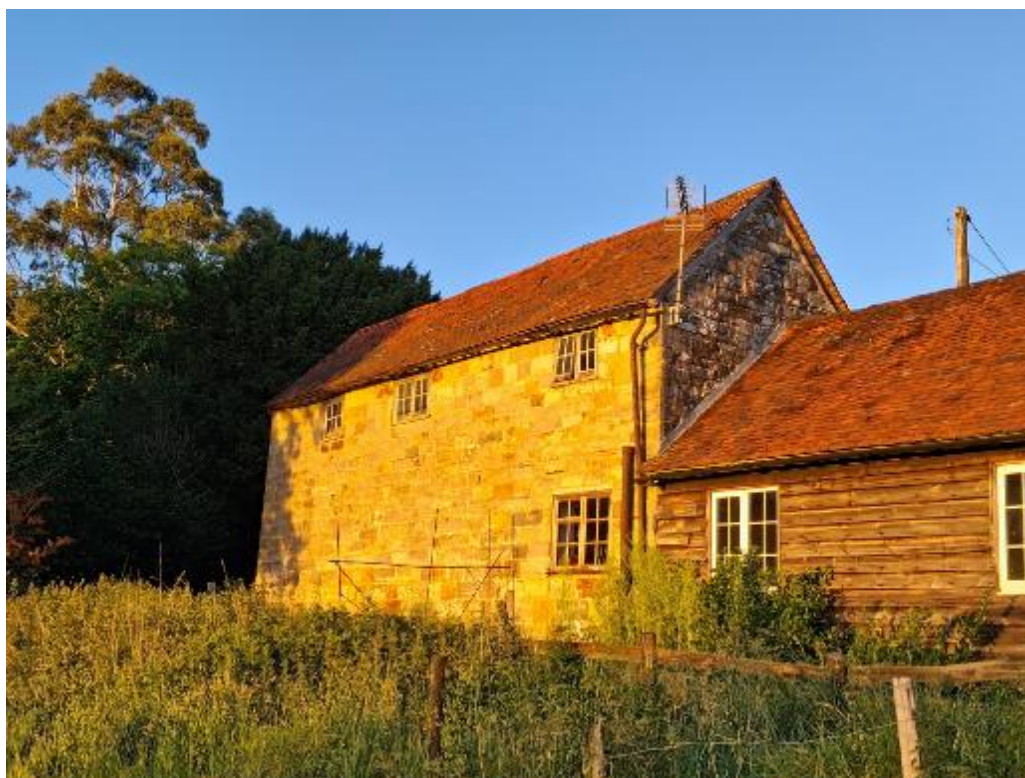
Image No. 01 – B1, northwestern building elevation (SP1).

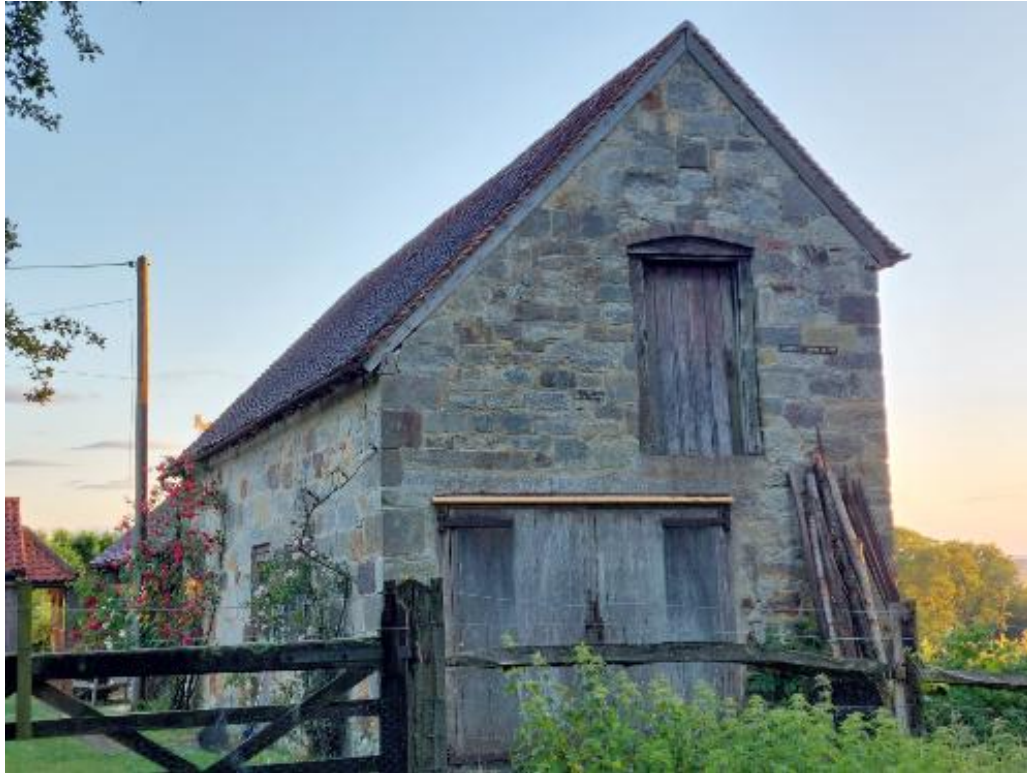
*Image No. 02 – B1, eastern survey perspective (SP2).*

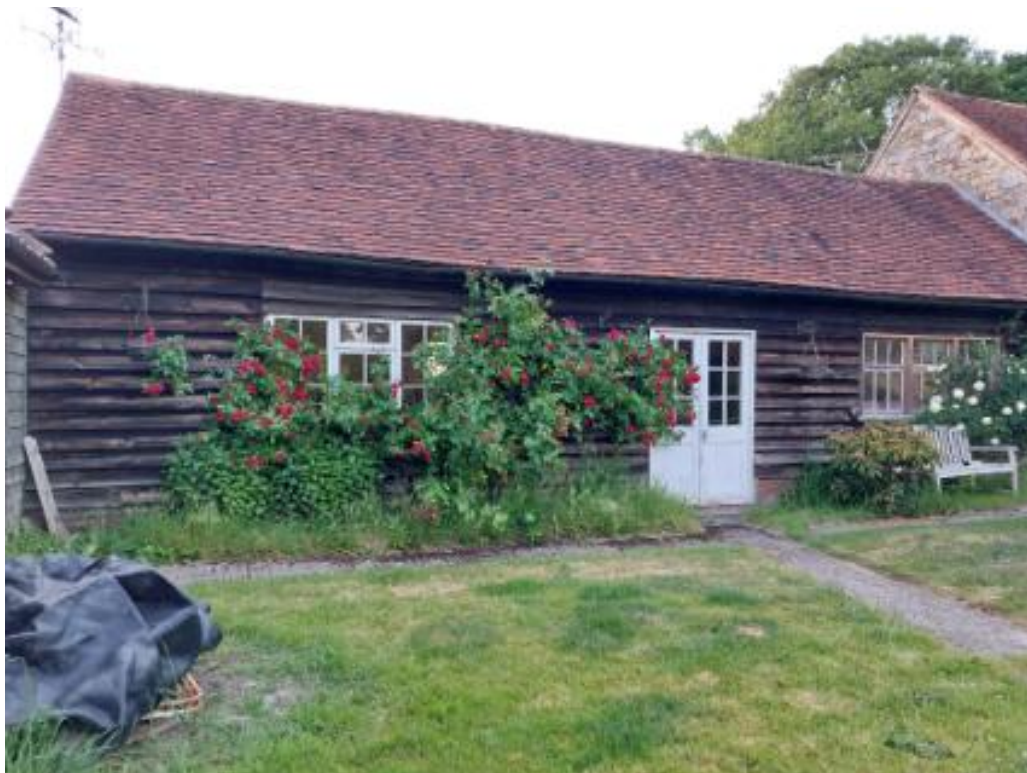
*Image No. 03 – B2, eastern survey perspective (SP3).*

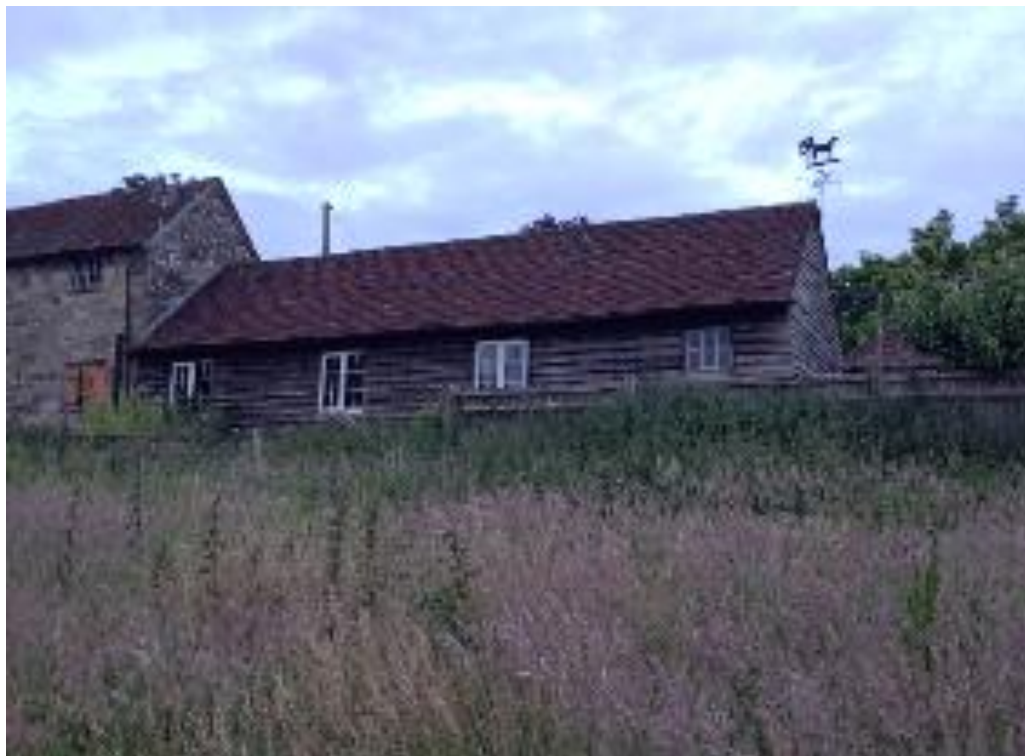
*Image No. 04 – B2, western survey perspective (SP4).*

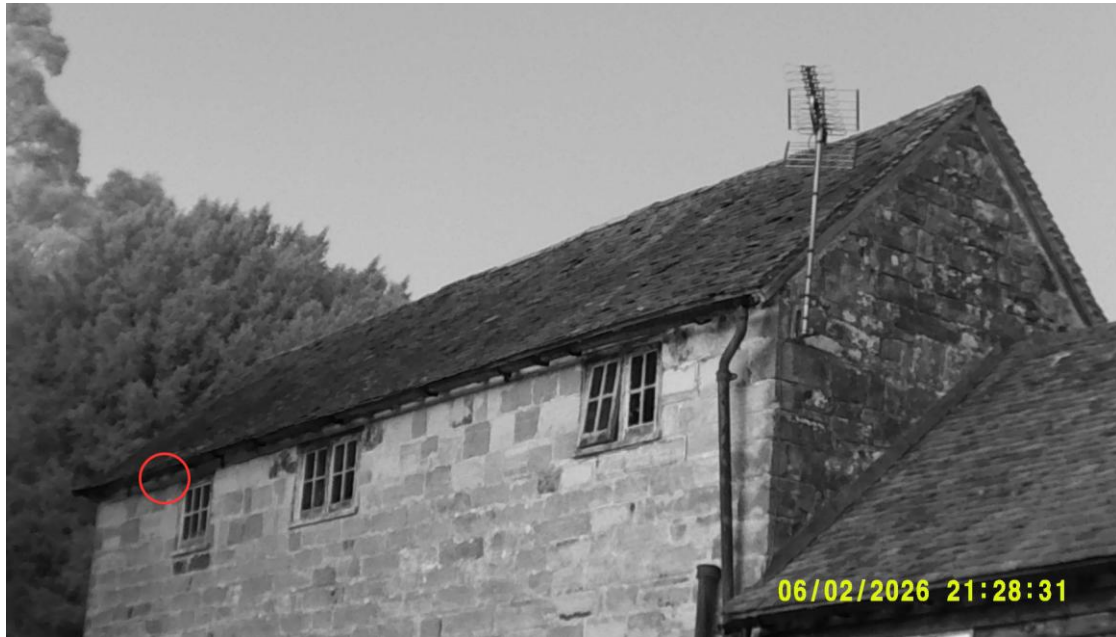
| <b>21:29</b> | <b>N/K</b> | <b>No call. Flew from N to NW corner (access point) of B1. Re-entry.</b> |

*Image No. 05 – B1, northwest aspect. Re-entry at 21:29 on 02/06/2026 between guttering and eaves. Entry point location circled in red.*

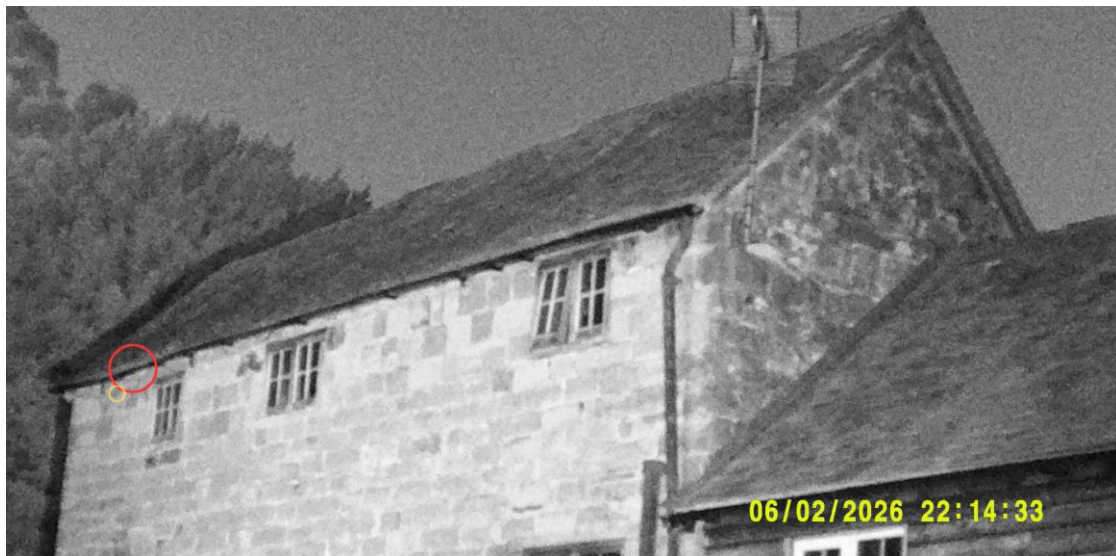
| <b>22:15</b> | <b>BLE</b> | <b>Re-entry NW corner. Roost access point near guttering under eaves.</b> |

*Image No. 06 – B1, northwest aspect. Re-entry at 22:15 on 02/06/2026 between guttering and eaves. Access point circled in red, bat visible faintly, circled in yellow to the left.*

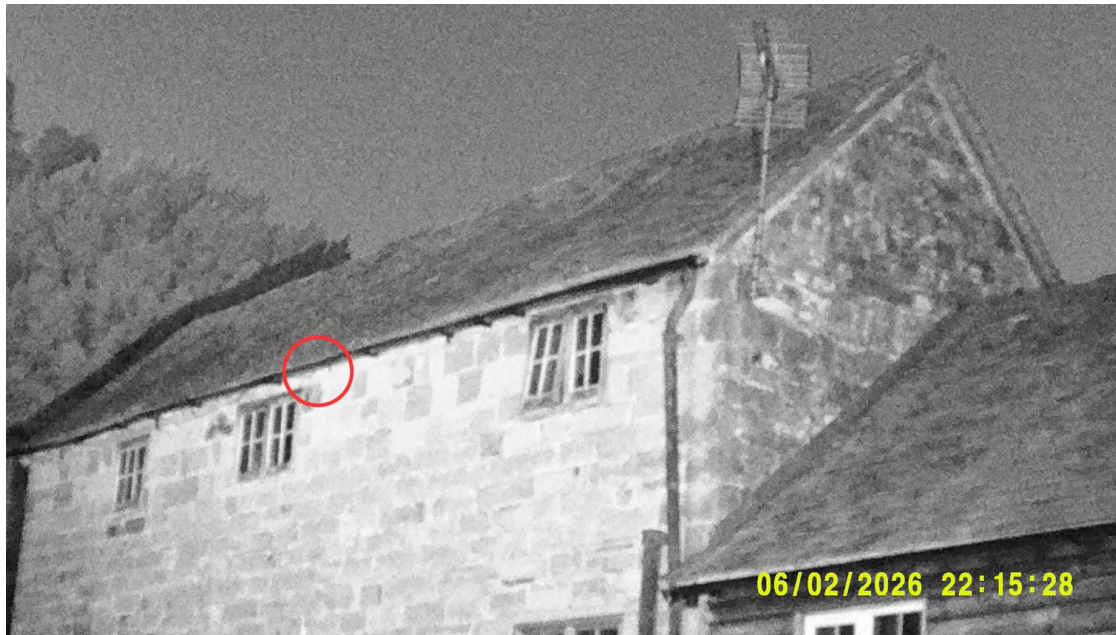
| <b>22:15</b> | <b>N/K</b> | <b>Emergence, middle of building, under eaves. Likely BLE.</b> |

*Image No. 07 – B1, northwest aspect. Emergence at 22:15 on 02/06/2026 between guttering and eaves along a central point. Emergence point circled in red.*

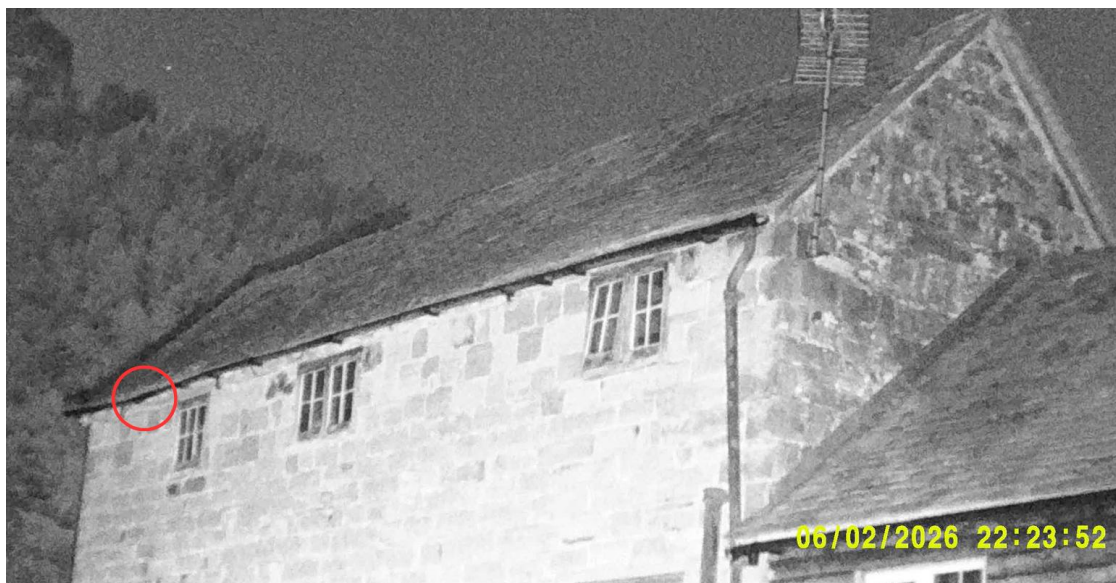
| <b>22:24</b> | <b>BLE</b> | <b>Re-entry near NW corner. Roost access point as above, under eaves.</b> |

*Image No. 08 – B1, northwest aspect. Re-entry at 22:24 on 02/06/2026 between guttering and eaves. Access point circled in red.*

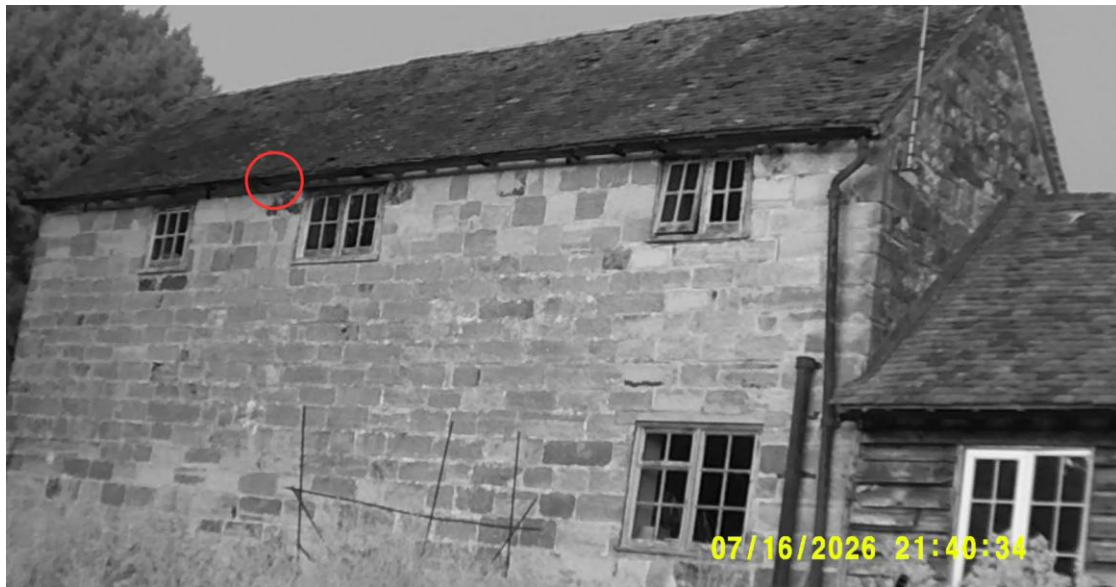
- 4.3.6 During the final survey on B1, low to moderate levels of foraging and commuting activity of common pipistrelle, serotine, and myotis species were recorded in the local area from 21:39 to 22:38. A single emergence of an unconfirmed bat species was recorded from the eaves from the northwest elevation at 21:40. Further detail can be found within *Appendix A – Site Photographs* and *Appendix C – Emergence Points*.

*Image No. 09 – B1, northwest aspect. Emergence at 21:40 on 16/07/2026 between guttering and eaves. Emergence point circled in red.*
