SPICER'S FARMHOUSE, WHITETHROAT LANE,  
BALCOMBE, WEST SUSSEX, RH17 6JN

HISTORIC BUILDING ASSESSMENT, HERITAGE STATEMENT &  
IMPACT ASSESSMENT

Report No. 2025624  
Prepared by Maggie Henderson Ma  
March 2026

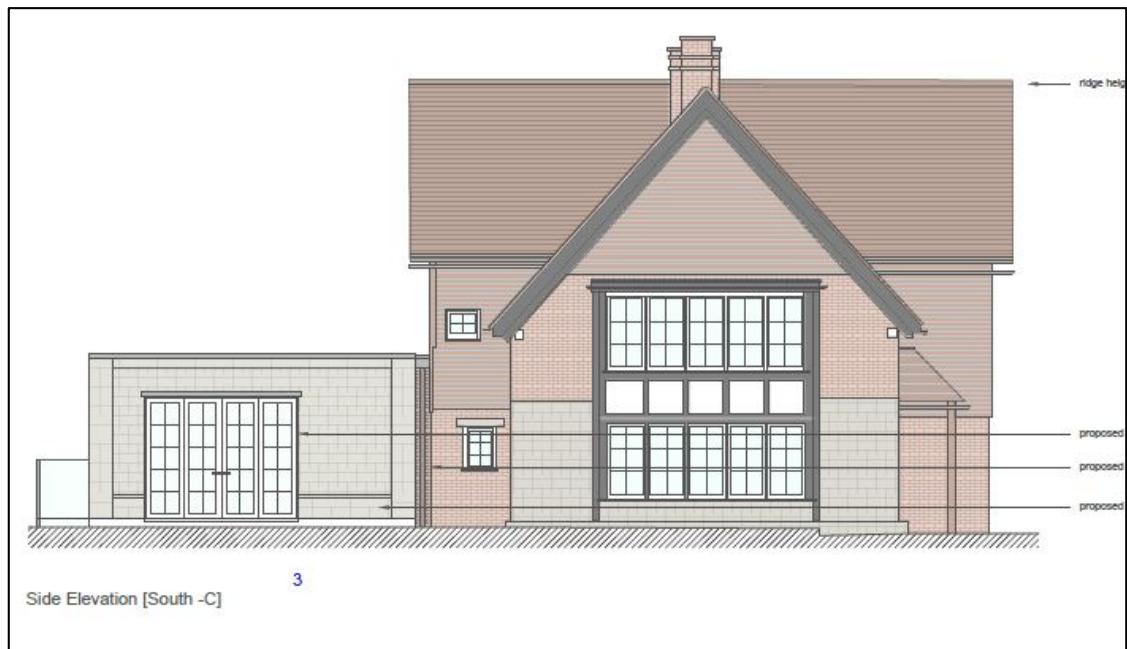
Plate 4: The south side of the house with the proposed west extension shown

- 7.2.13 A set of multi-pane French doors with matching side-lights are proposed for the south side of the extension, again the style of the fittings are intended to sit well with the existing multi-pane fixtures found throughout the house (Plate 4).

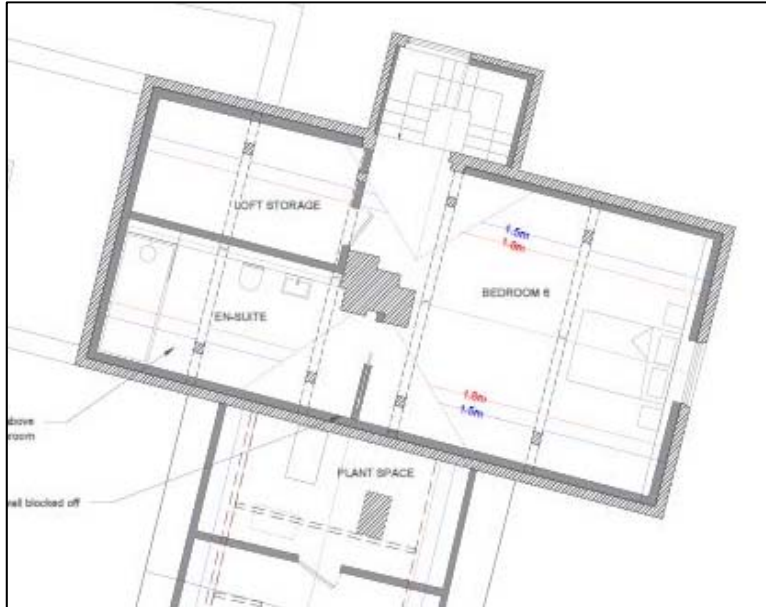
Plate 5: The attic layout as previously proposed

- 7.2.26 The previously proposed installation of a partition and doorway central to the chimney bay has now been omitted from the scheme as it had introduced a division that had never existed within the building, impacting upon the floor plan of the attic as first built. The revised location for the partition is now on the line of the truss to the west of the chimney bay, a more natural position for a division within attics of this type and date (compare Plate 5 and Plate 6).

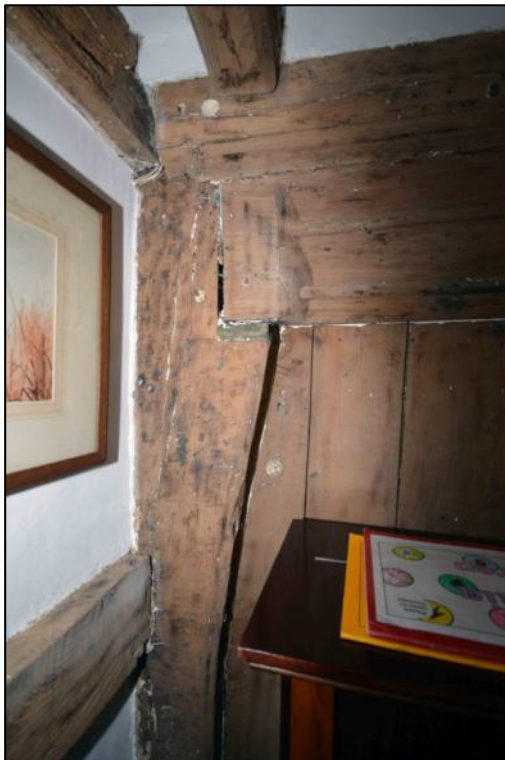
Plate 7: Jowled head to the principal post of the T3 truss where it meets, and carries, the moulded dais beam (west side of the dais partition)

- 8.1.4 Where present, the principal posts are substantial with long swelling jowled heads. The dais partition truss (T3) at the high end of the two-bay hall includes a second set of jowls at ground floor level to support the moulded dais beam (Figure 3; Plate 7). On the first floor, the partition included four curved foot-braces, the two at the centre, their

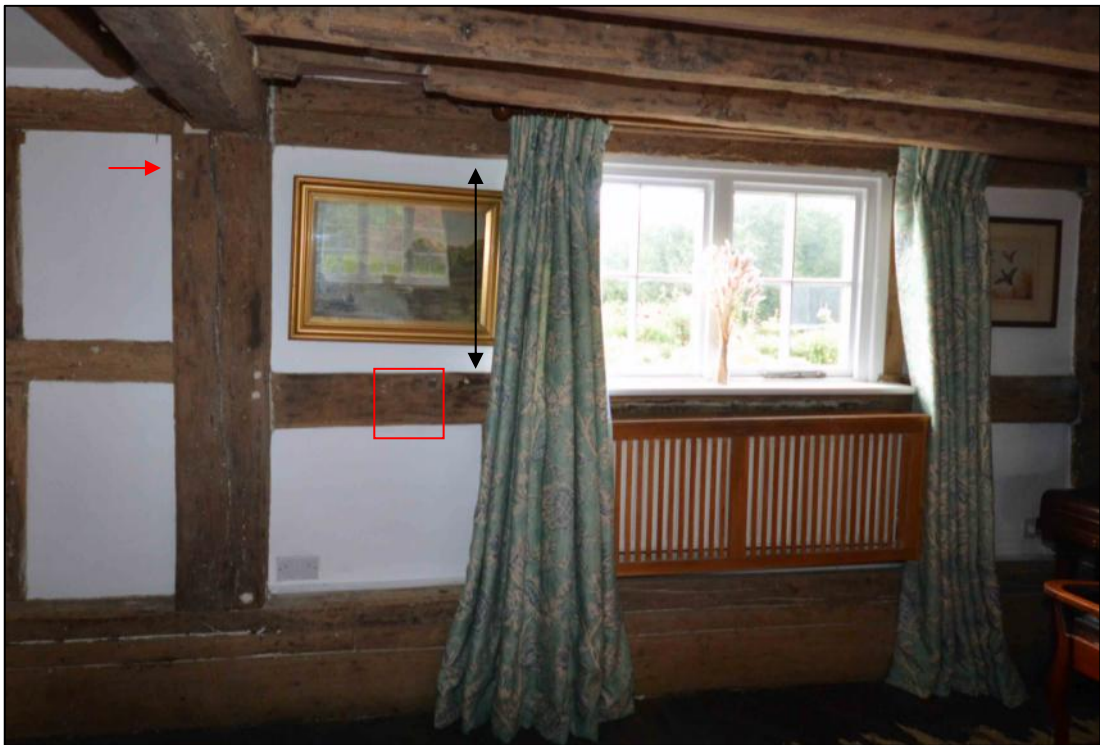
Plate 8: Peg-hole evidence (arrows) for the south jamb of the hall window; note also the double-pegs at the head of the post on its south side, indicative of a doorway head plate or lintel (black arrow). Red square marks the location of the apotropaic mark

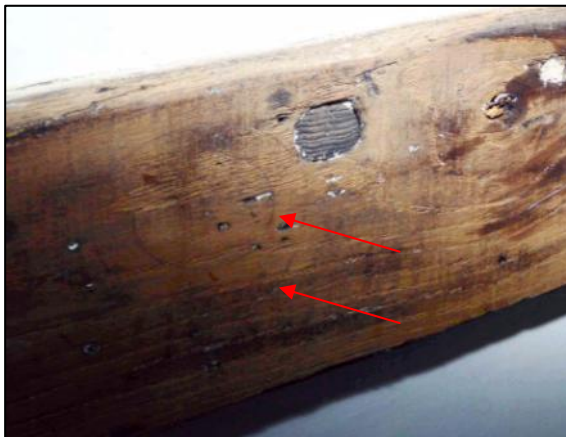
Plate 9: Two concentric compass-drawn circles, an example of an apotropaic mark

- 8.1.8 Two concentric compass-drawn circles on the sill to the south of the (now removed) window jamb are examples of an apotropaic mark, widely believed to be situated in close proximity to openings to ward against evil entering the house (Plate 9).

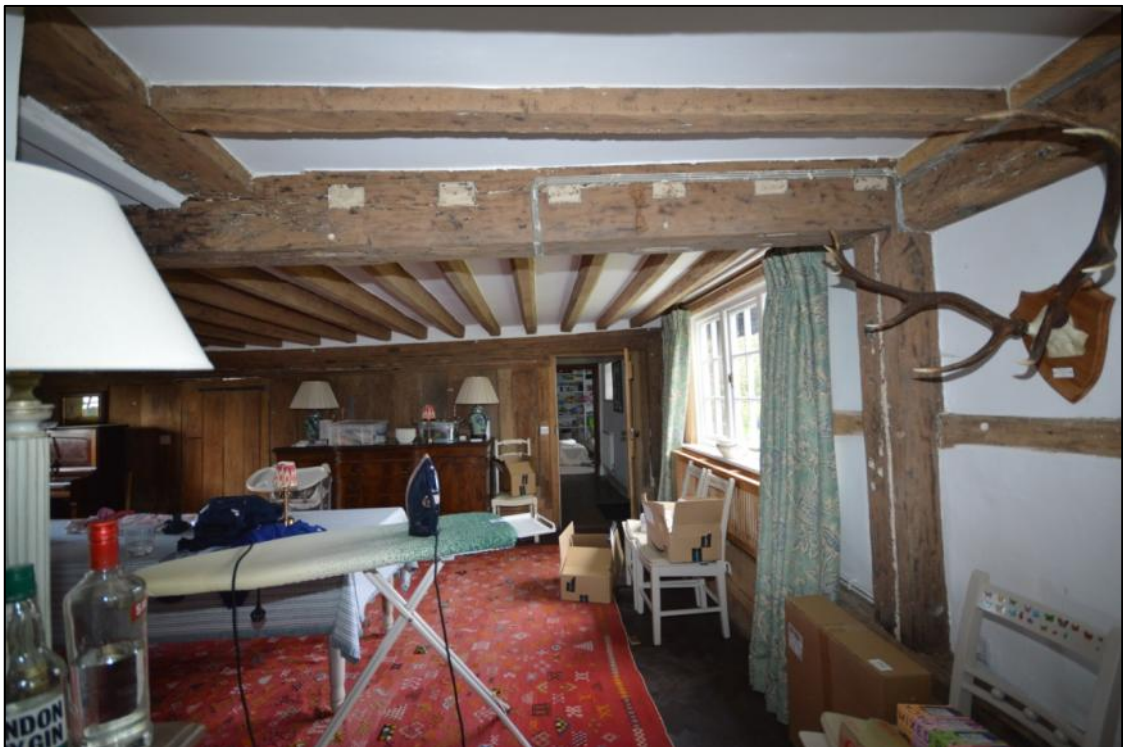
Plate 10: The south side of the inserted cross-beam at the T2 truss, showing the mortises for the original mid-to-late 16<sup>th</sup> century floor at the eastern side of the restricted smoke-bay

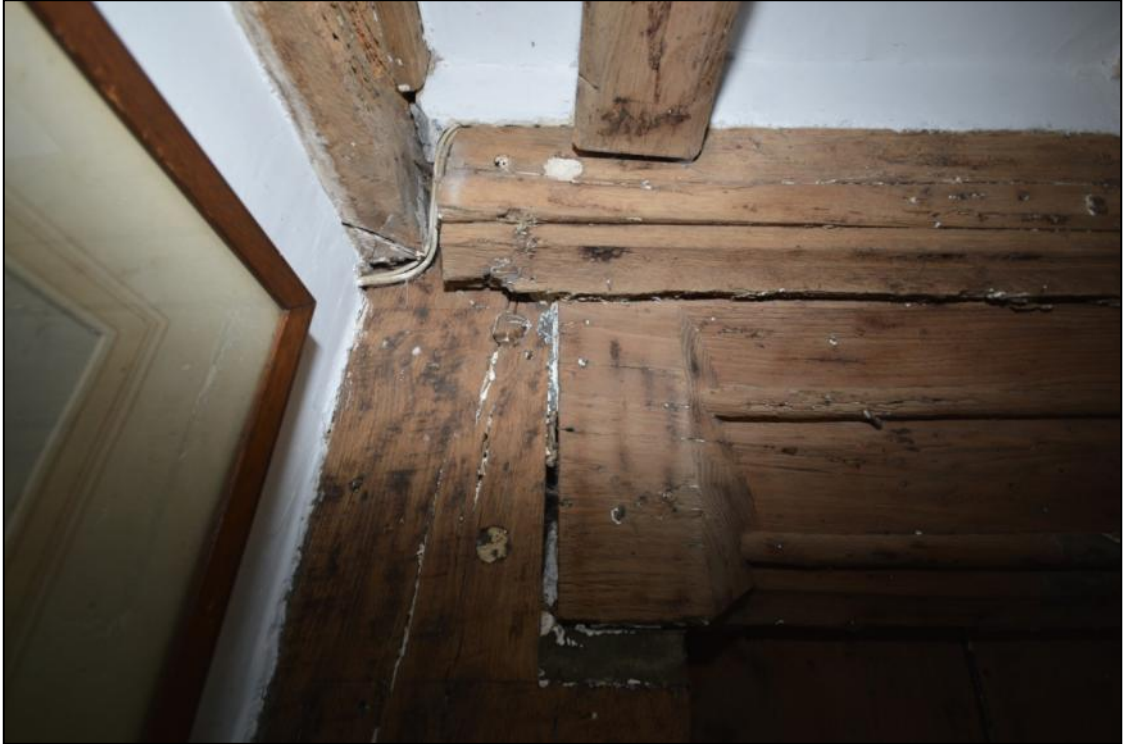
Plate 11: Detail of the western end of the moulded bearer applied over the phase 1 moulded dais beam

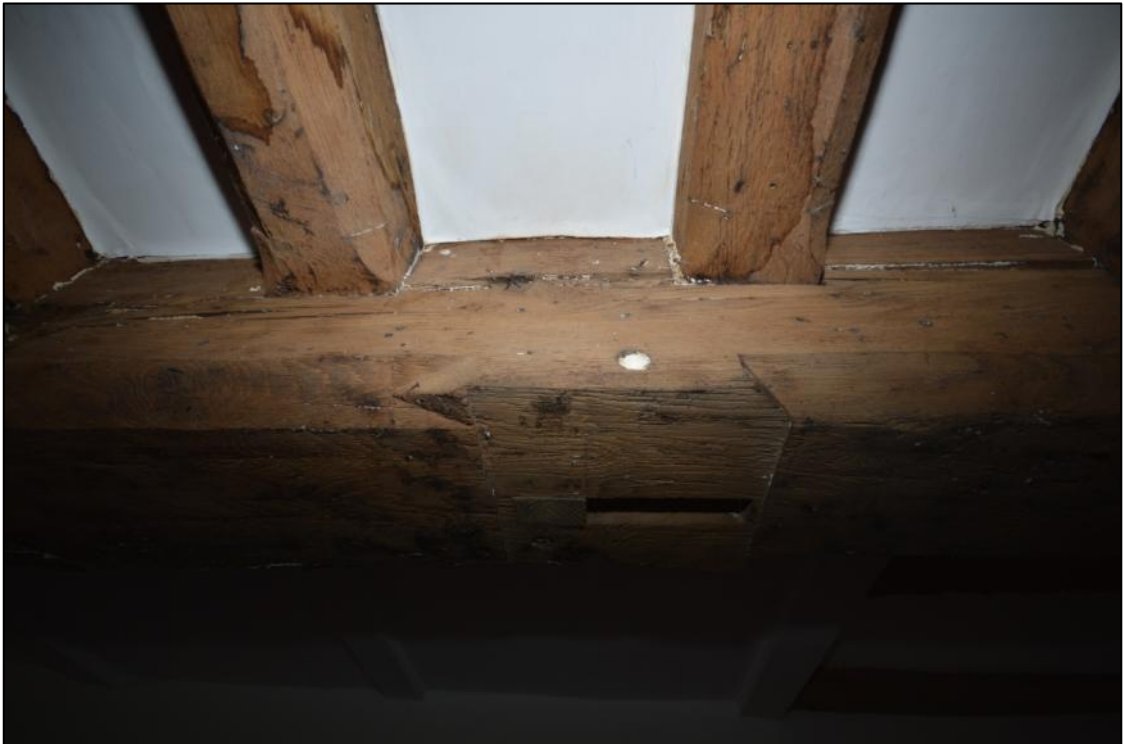
- 8.2.4 The new cross-beam bears chamfered edges and pyramidal-type stops that illustrate the location of the hearth and two doorways that flanked it (Plate 12).

Plate 12: Detail of the chamfer and chamfer stop, and the stud mortise, marking the boundary between the west doorway and the fireplace of the smoke bay

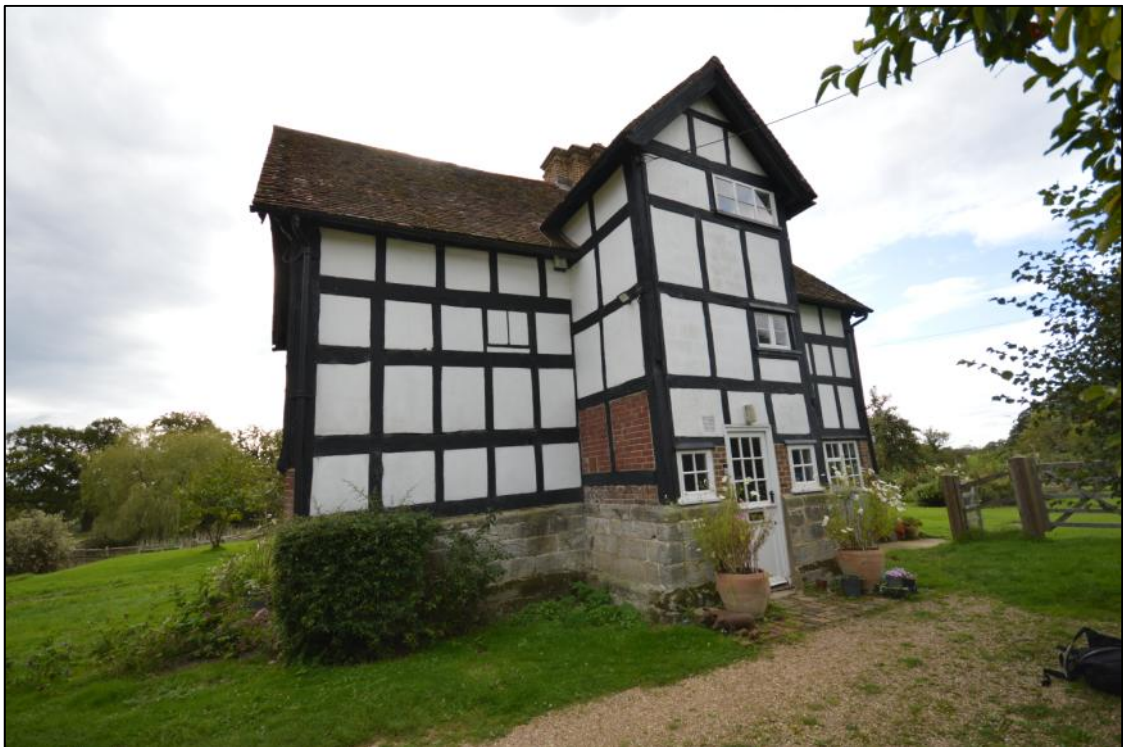
Plate 13: The small-panel framing of the wall construction of the new cross-wing and integral stair turret

- 8.3.5 The wall construction is of small-panel framing type, lacking any sign of bracing (Plate 13). The south side of the south elevation of the wing, at attic level, includes comb-decorated daub, finished with a lime-skim coat. The presence of the decorative finish suggests that the cross-wing was added prior to the insertion of attics into the main range of the medieval house: the combed daub providing visible decoration within the northern first floor room of the earlier range (Plate 14, Plate 15).

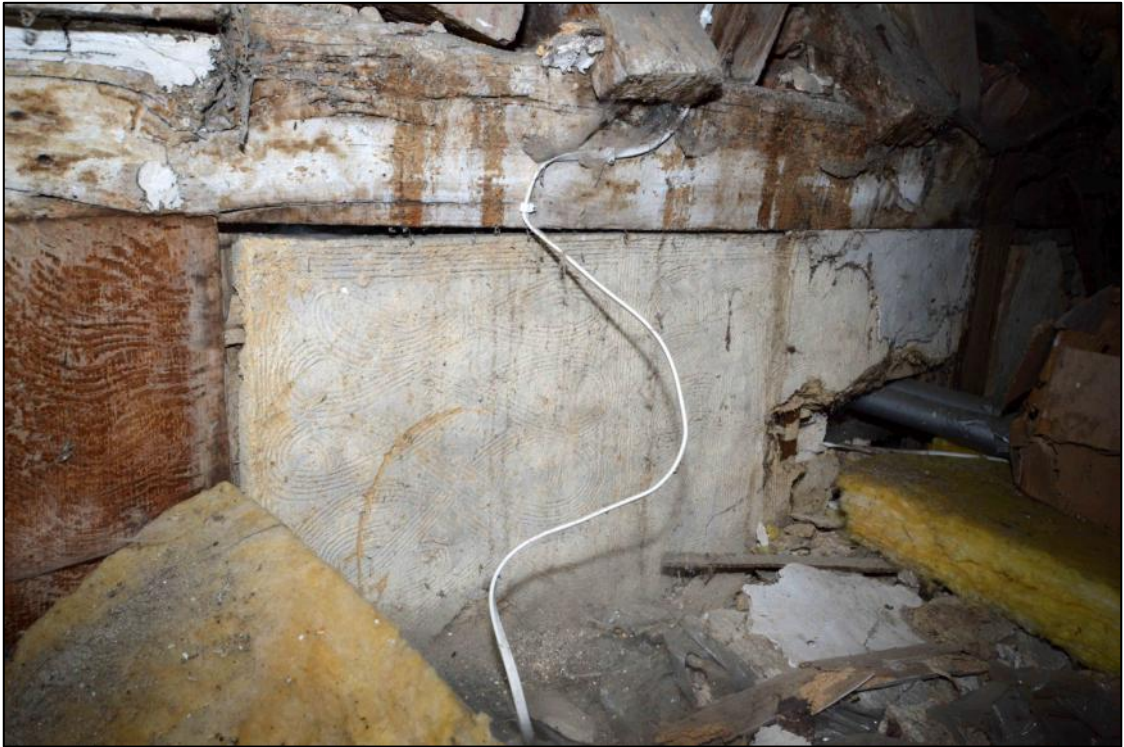
Plate 14: Comb-decorated daub (bay 5) on the south side of the cross-wing visible within the loft over the main range

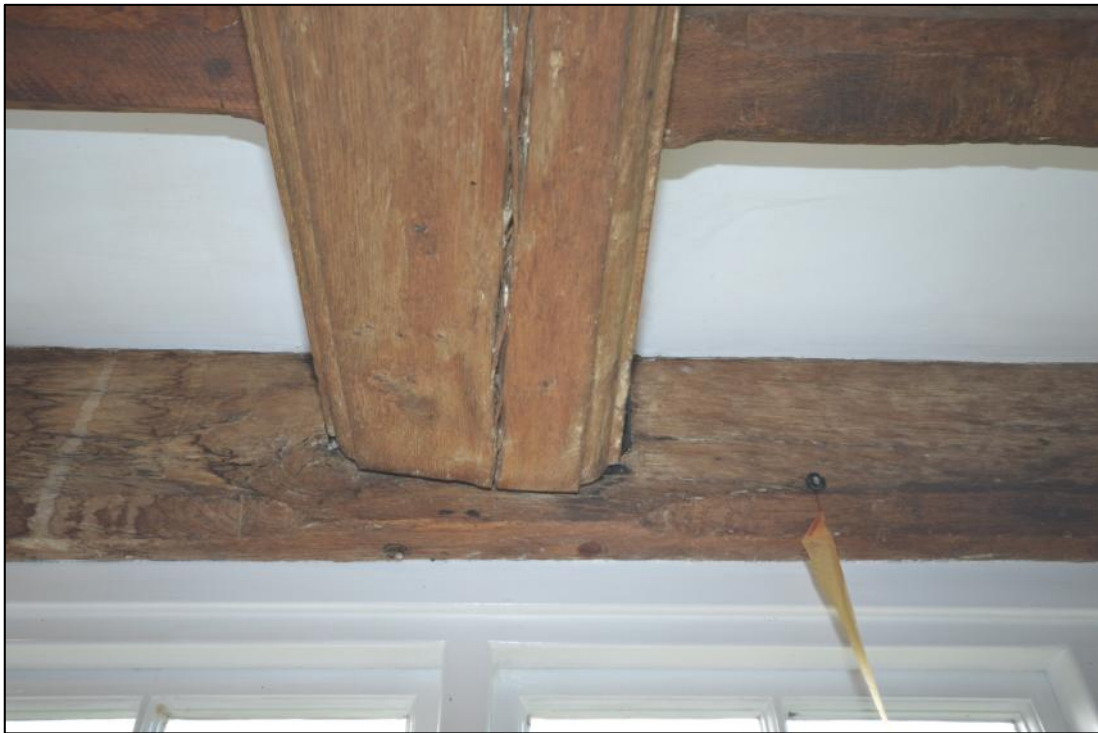
Plate 16: Ovolo moulded girder supporting the first floor in bay 7

- 8.3.7 The two ground floor rooms have central east – west oriented girders with ovolo-moulded leading edges (Figure 5; Plate 16). The north- south oriented joists within the west bay (bay 7), at 110 mm wide (full depth not seen beyond 95 mm) are also chamfered, terminating in step-and-hollow stops (Plate 17). Under-drawn ceiling finishes conceal the joists in the east bay (bay 6) and throughout the first floor rooms.
- 8.3.8 All floor finishes at ground and first floor level are concealed by modern finishes (carpets, tiles). Within the attics, the north – south oriented wide floorboards are visible to the north of the chimney bay (bay 7, Plate 18). The floorboards within the remainder of the attics have been over-boarded in recent years to create a level finish.
- 8.3.9 The attic room remained un-ceiled and open to the roof.

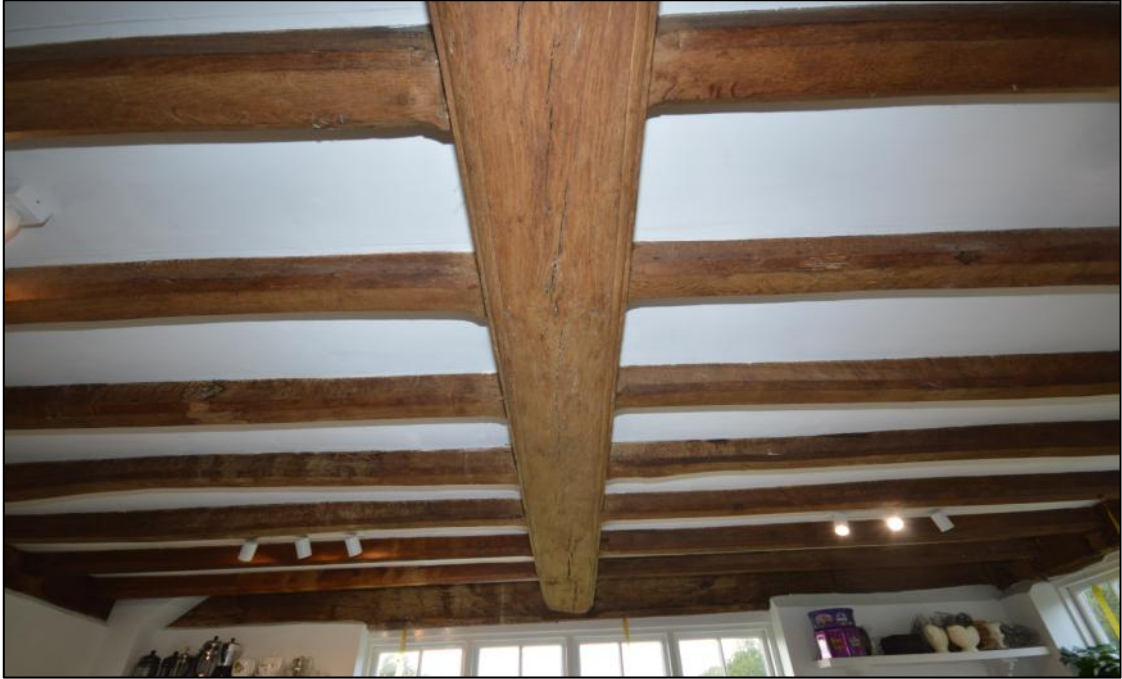
Plate 17: Chamfer and chamfer stops to the joists in bay 7

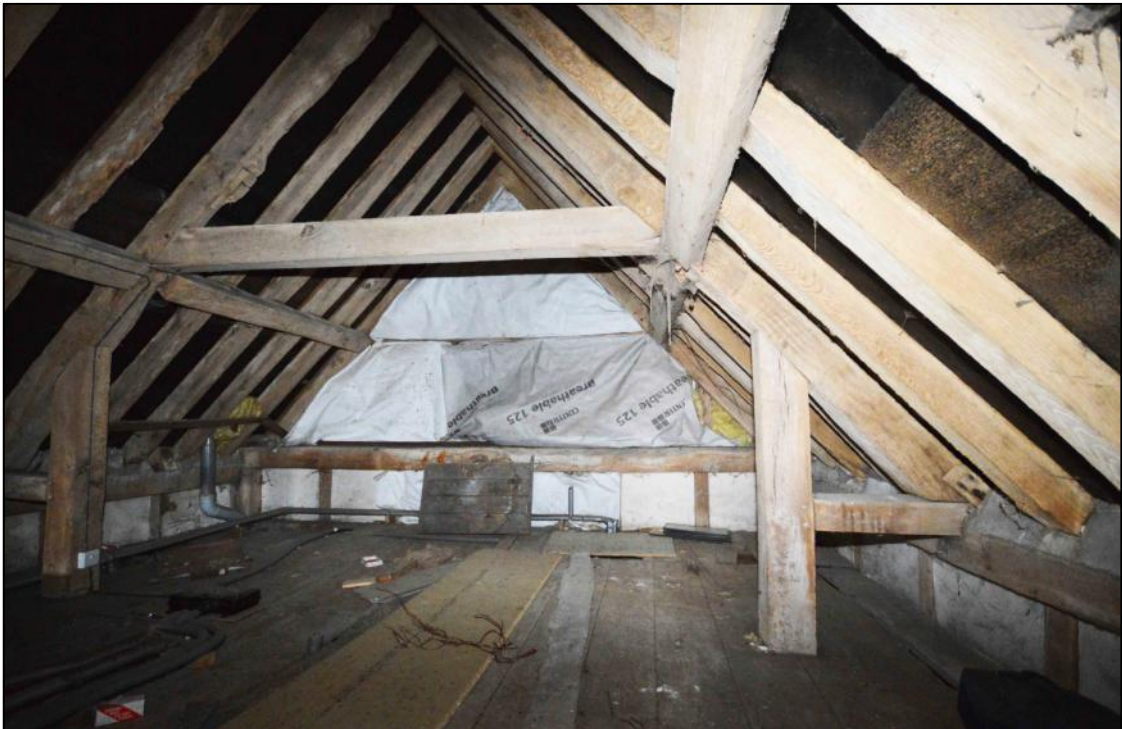
Plate 18: Interior of the attic of bay 7 showing the east-west oriented floorboards

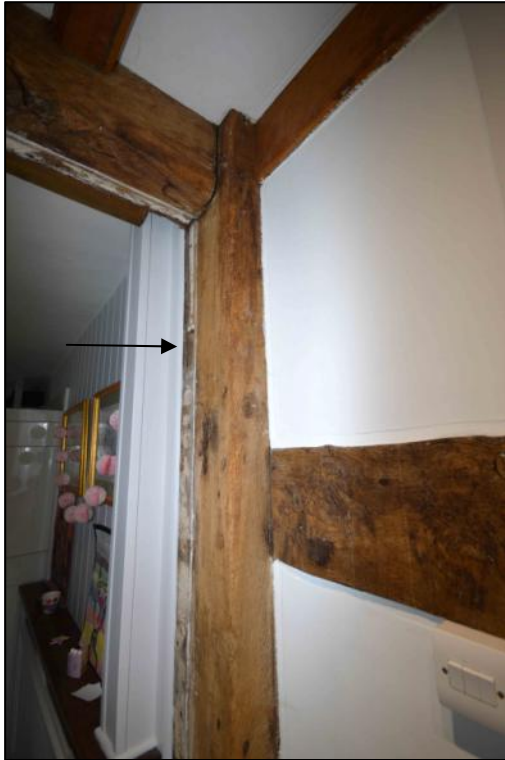
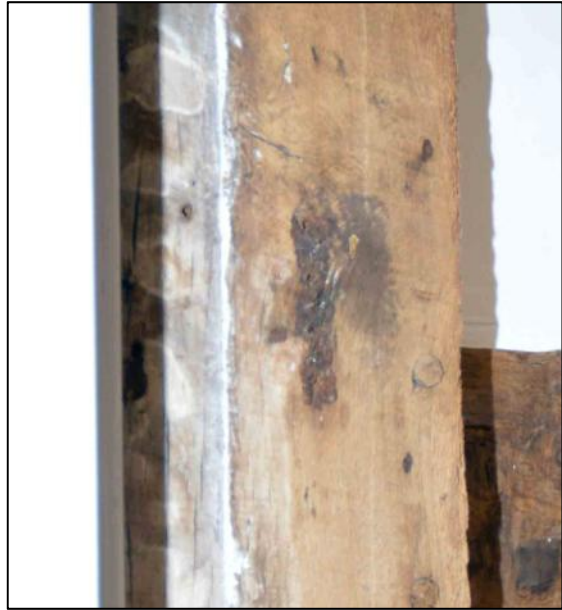
7.2.1 There is clear evidence of a door in the location proposed for the door in the south side of the T6 partition truss, this includes the lack of soffit jointing to the cross-beam, the redundant mortise for a head-plate/lintel and the pressure marks, metal staining and nail-holes for a hinge (Plate 19 and section 8.3.10 below).

- 8.3.10 The rebuilding of the ground floor external walls in mass construction has resulted in a loss of information relating to windows and doorways. Within the building, the presence of jointing to the principal posts and cross-beam soffits provides evidence of original doorways; these include the entrance from the stair turret to the north lobby of the chimney bay, and at the south side of the chimney in the T6 Truss (Plate 19).

Plate 19: The principal south post of the T6 truss showing the mortise for the head-plate of a doorway (black arrow) and detail of scars and stains left after the removal of a hinge (above)

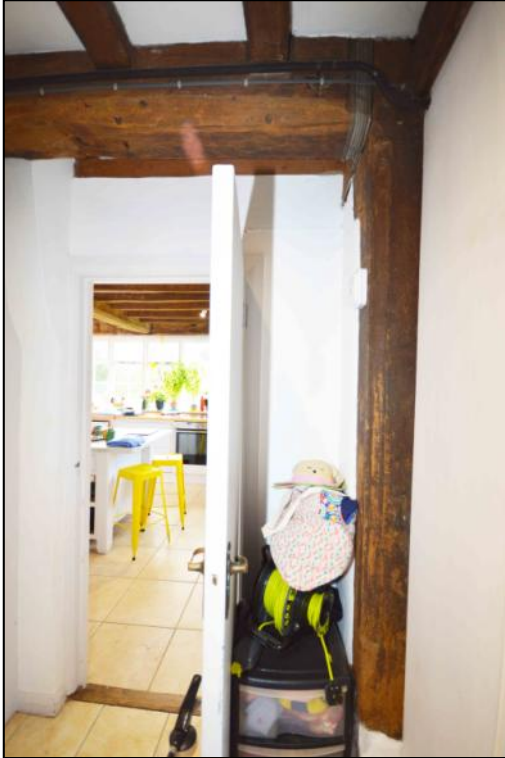
Plate 20: The doorway at the north side of the T7 partition truss, complete with moulded detail in the principal post

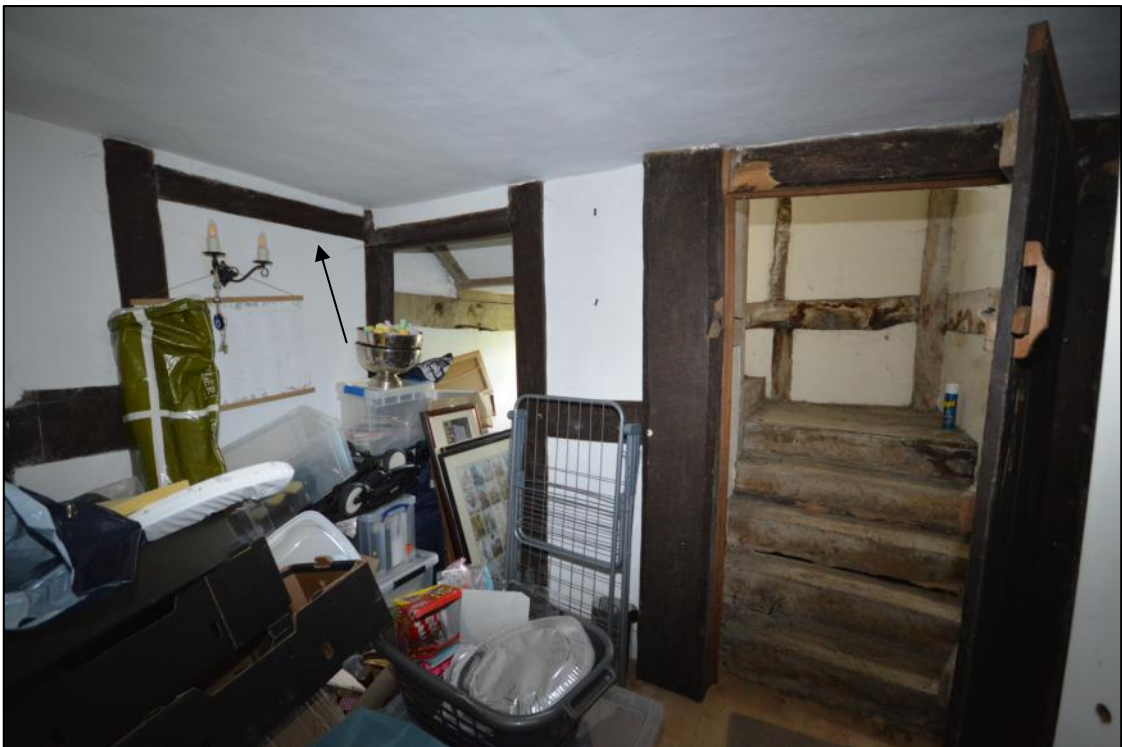
Plate 21: Three original doorways, two on the north side of the cross-wing leading to the closet and stairs within the stair turret and the third, now blocked, providing access to the west chamber (bay 7), indicated by arrow

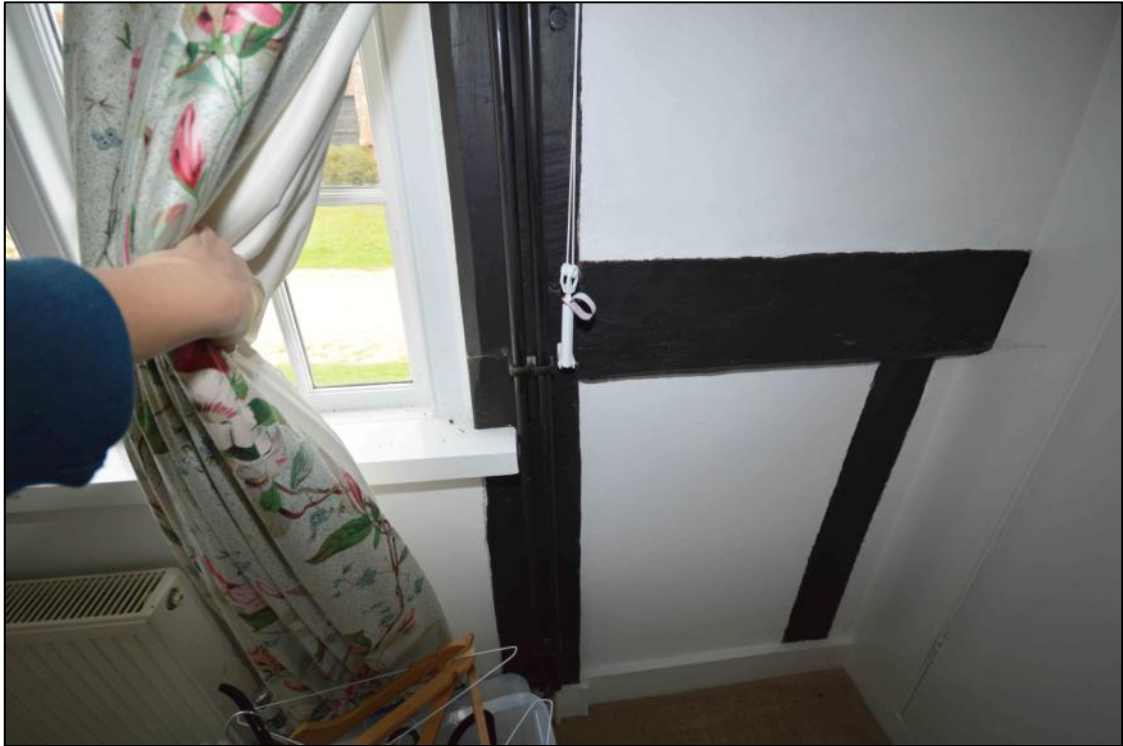
its retained jambs with chamfer and stop detail (Plate 22). Two ovolo-moulded mullioned windows are extant, albeit blocked: these are located in the west wall of the T8 truss and the north wall of bay 5 (Figure 5; Plates 23 and 24). The windows are separately framed to the fabric of the timber-framed wall and in both instances may represent flanking lights adjacent to a larger window, particularly in the west elevation of the building.

Plate 22: Chamfer and stop detail to the south jamb of the east window in the first floor of the cross-wing, indicating the position of the original window

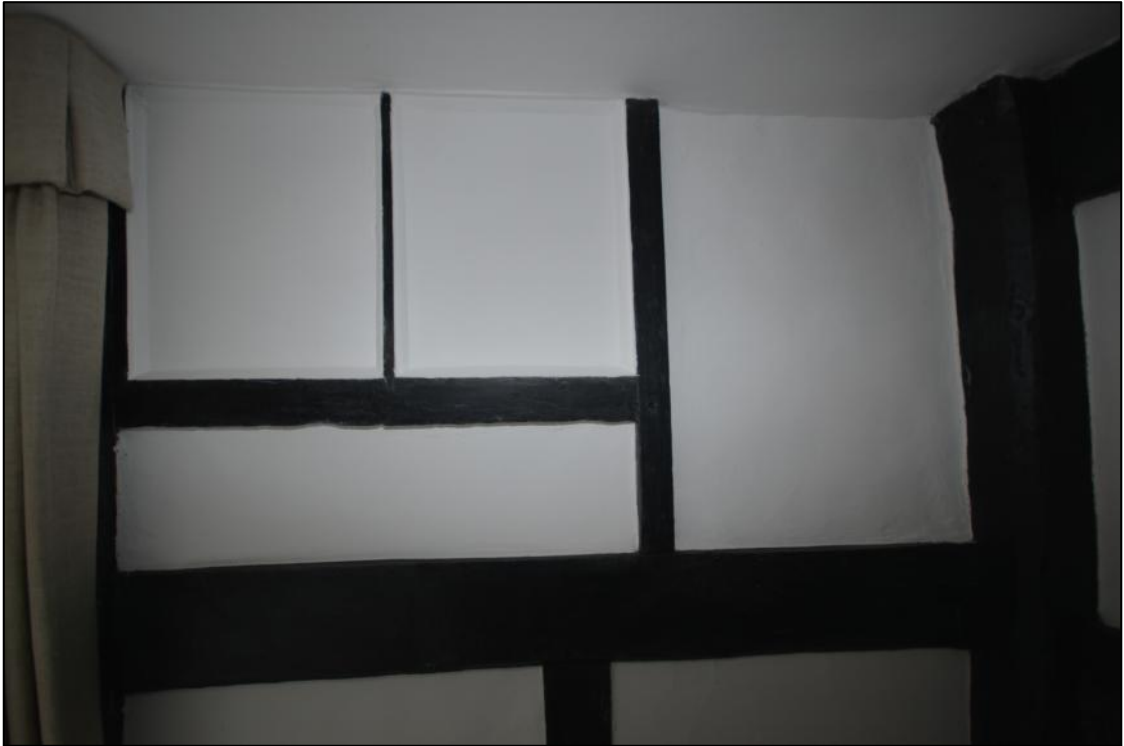
Plate 23: Blocked ovolo-moulded mullioned, two-light window in the west chamber

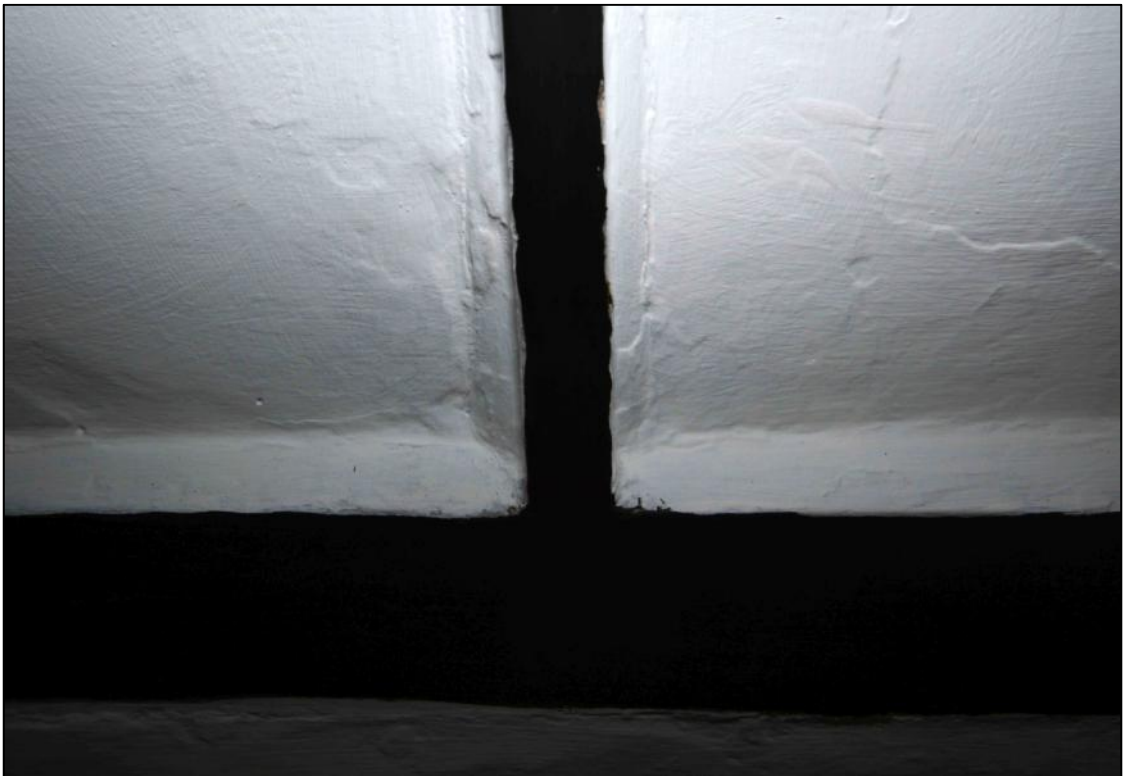
Plate 24: Detail of the ovolo-moulded mullion

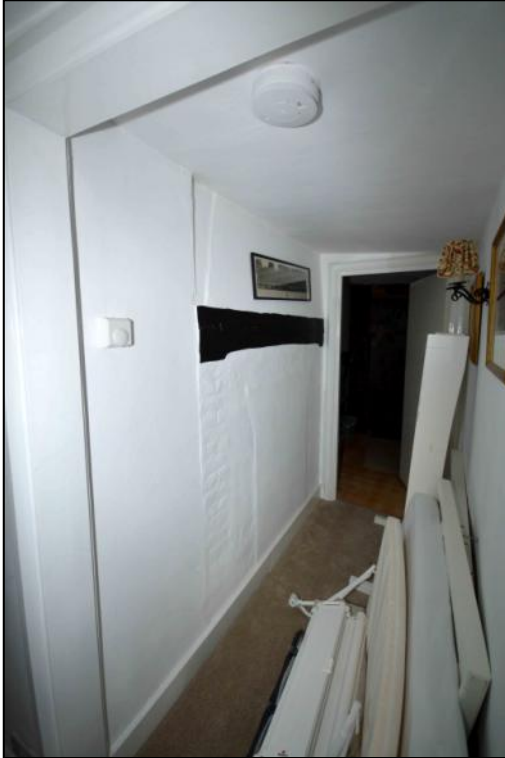
Plate 25: The blocked east fireplace in the multi-flue chimney stack in the cross-wing: note that there are two phases of blocking within the former fireplace

- 8.3.18 The heating system for the cross-wing comprises a mass-constructed, multi-flue chimney stack. The fireplaces have been altered (ground floor west), or concealed (ground floor east), whilst those on the first floor are evidenced by their still *in situ* timber bressumers (Plate 25). Where visible, the chimney stack is in brick, although due to later alterations and render or plastered finishes, it is unclear if any masonry was included as first built on the ground floor as is often the case in buildings of this date and type.

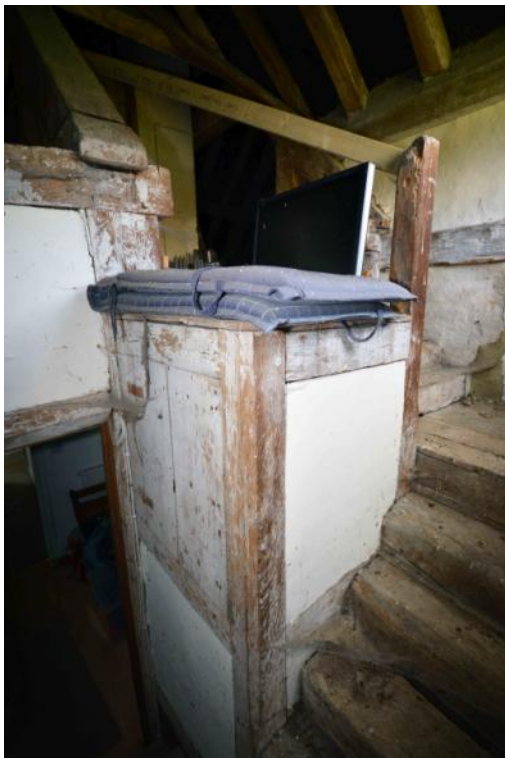
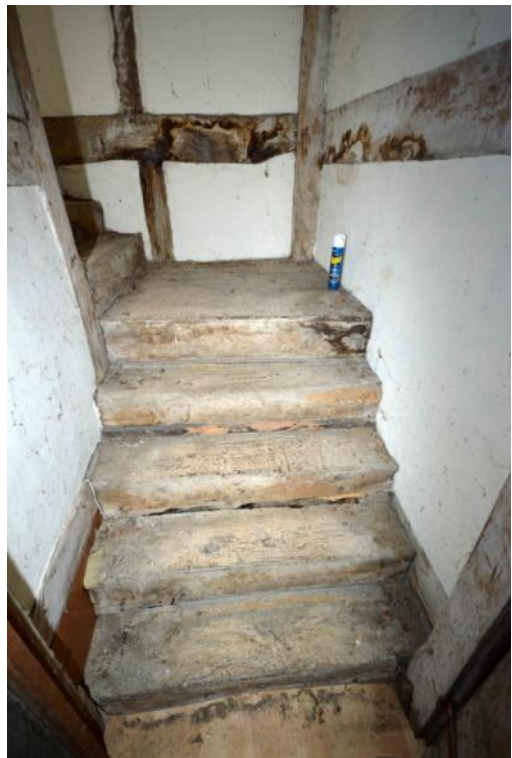
Plate 26: The central well, solid-tread staircase within the stair turret with original cupboard, the door hung on butterfly hinges

- 8.3.19 The cross-wing was provided with its own integral stair turret, projecting northwards from the north elevation of the range adjacent to the chimney bay, extending further to the south of that bay to provide entry to the eastern room of the wing (Figure 5).
- 8.3.20 The staircase has a central well type with integrated cupboards (Plate 26). The door of the cupboard on the flight to the attics is original and is hung on butterfly hinges. The stairs are of solid triangular tread type, and the square-section northwest newel rises into the attic.

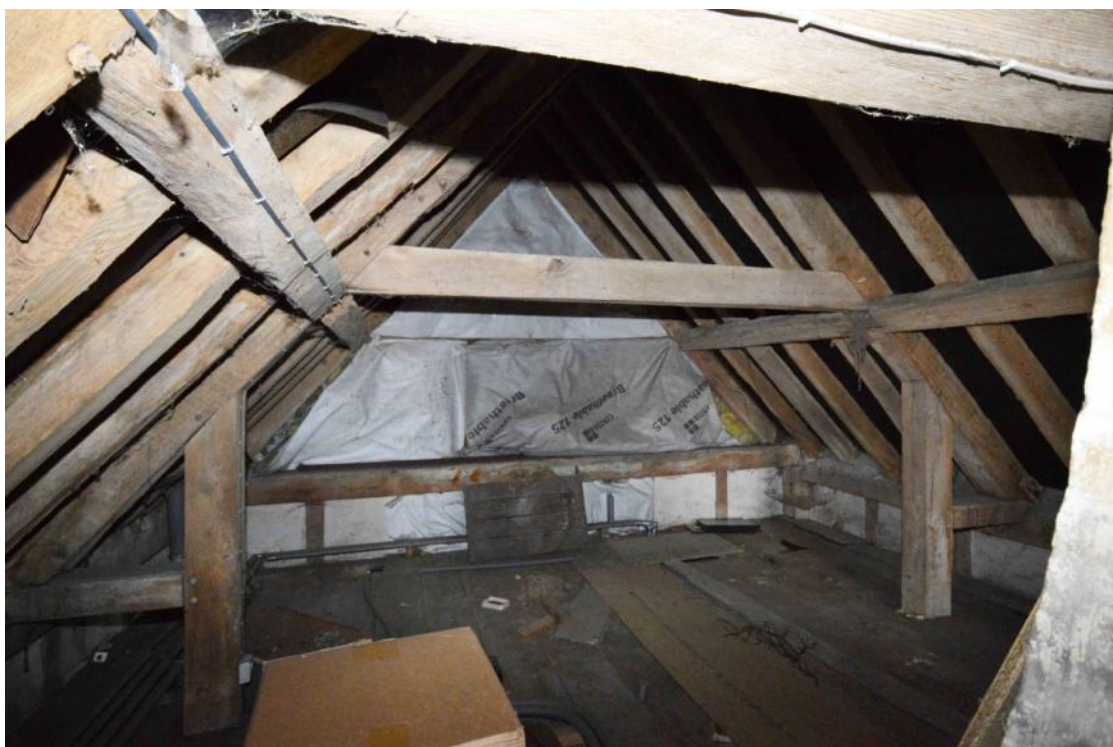
Plate 27: The roof structure with its in-line butted-side-purlins and wide-set queen studs carrying the inner ends of interrupted tie-beams

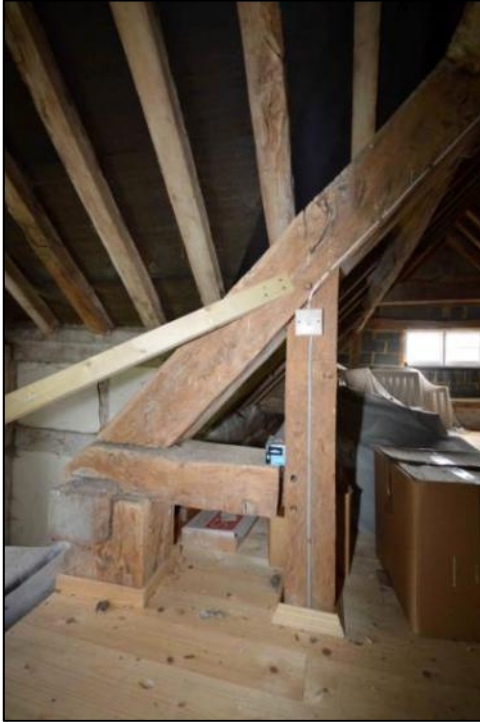
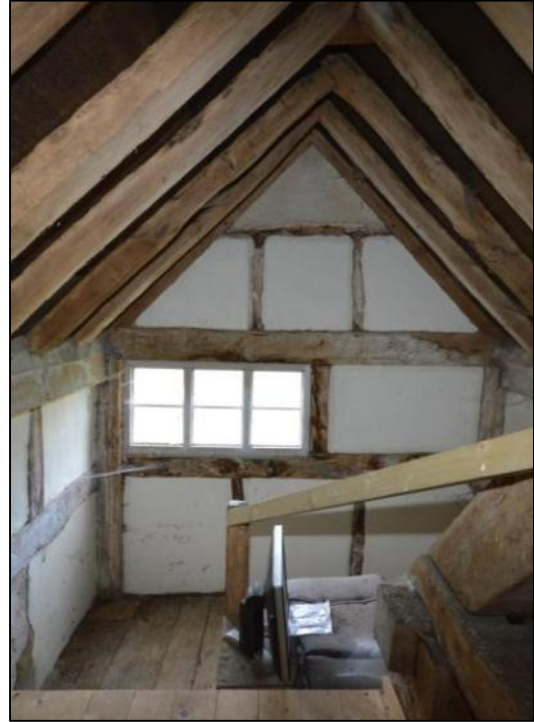
studs: two flanking the window opening (the window since replaced) and one each at the outer sides of the truss rising to meet the principal rafters at their junction with the purlins to add strength to the structure (Plate 29). A single central stud links the lower collar to its upper counterpart. The west gable is currently concealed in plastic sheeting (Plate 27). The stair turret gable is of queen stud type (Plate 28).

Plate 28: Detail of a queen stud and interrupted tie-beam arrangement and view of the queen-stud truss at the gable of the stair turret

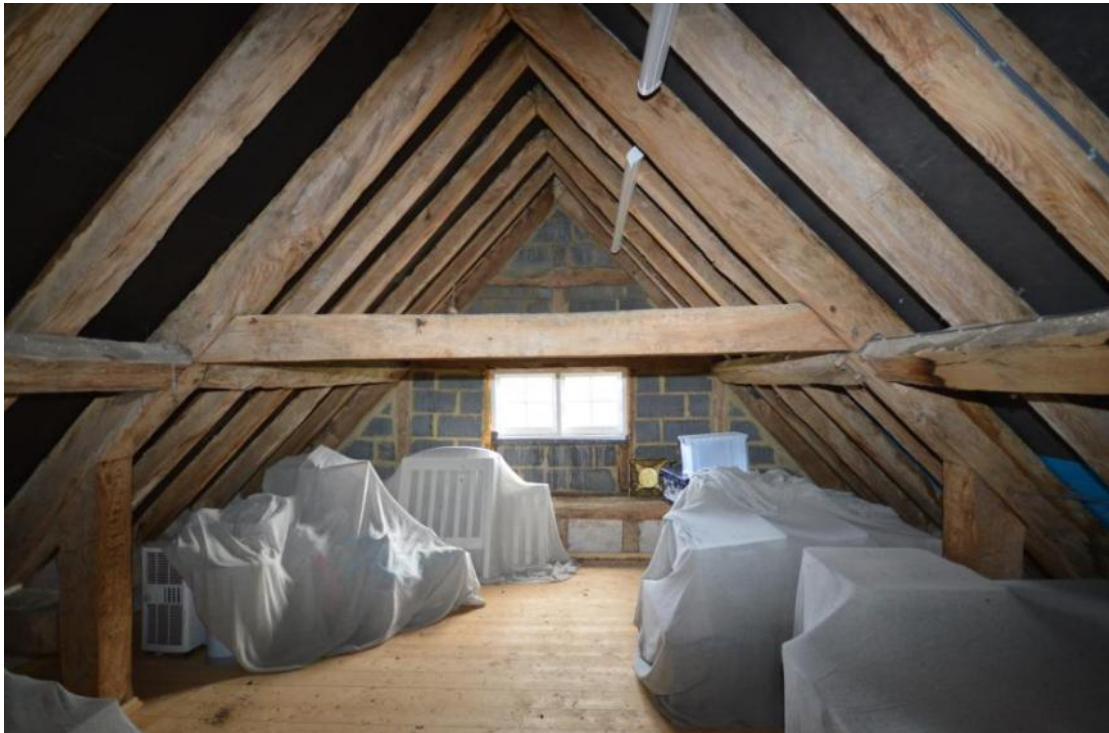
Plate 29: The east roof terminal and general view of the roof

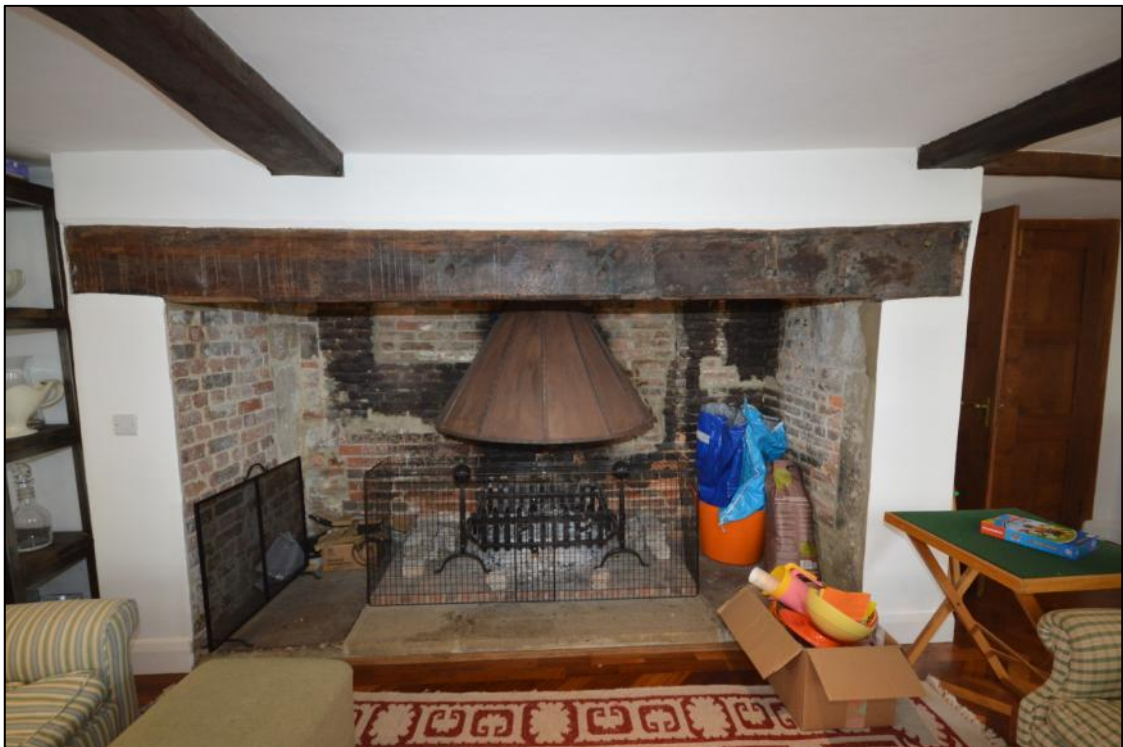
Plate 30: The south fireplace in bay 1 of the main range

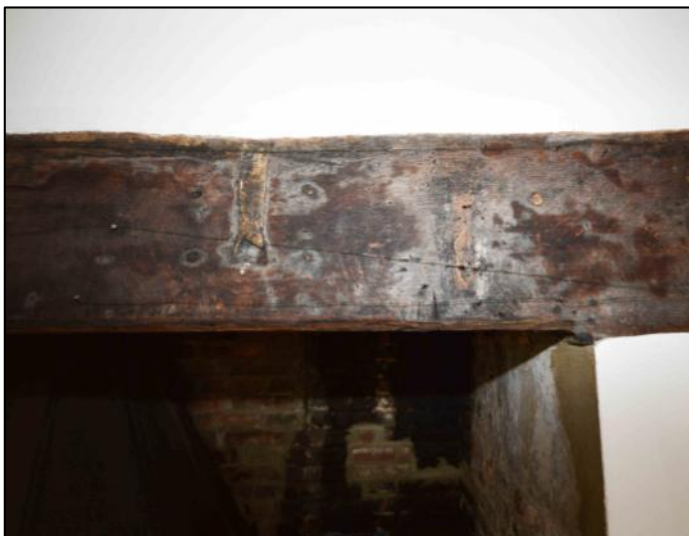
Plate 31: Scars left by the removal of a clock-jack

- 8.4.3 Despite alterations, the south fireplace retains its bressumer and this includes scarring for a clock-jack intended to operate a spit mechanism within the fireplace (Plate 30 and 31). The inclusion of the clock-jack, and indeed the hint of bread-ovens in the jambs of the northern fireplace, indicate a cooking-function for the main range, perhaps building upon the suggestion of an attached kitchen and service suite supplementary to the single-phase high-end cross-wing added at the turn of the 17<sup>th</sup> century.

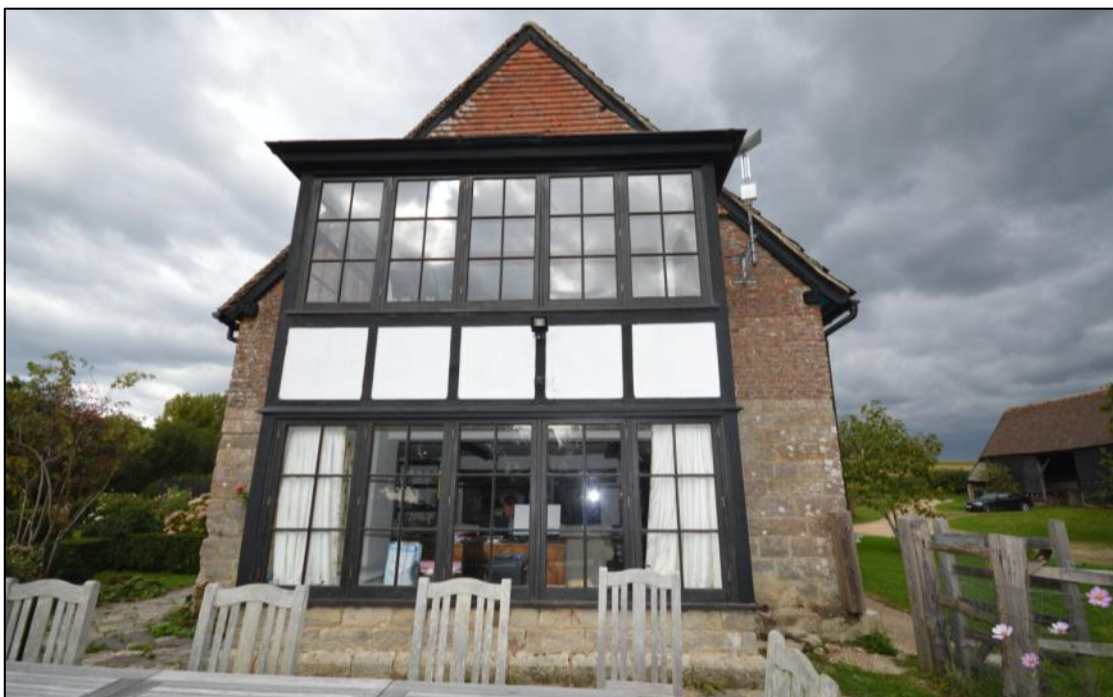
Plate 32: The south end elevation of the main range, the fabric, masonry and brick flanking the late 19<sup>th</sup> or early 20<sup>th</sup> century bay window is commensurate with a mid-to-late 17<sup>th</sup> century origin

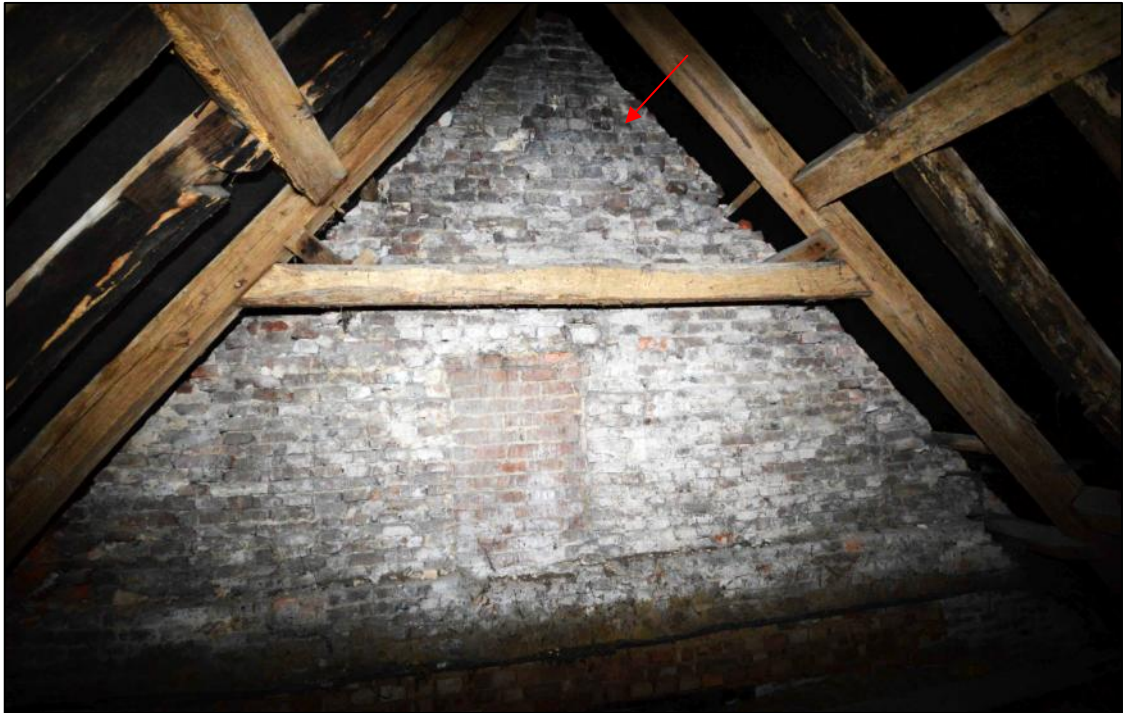
Plate 33: Interior of the south gable with blocked window, note also the off-set for rafters that are no longer *in situ* (arrow)
