SPICER'S FARMHOUSE, WHITETHROAT LANE,  
BALCOMBE, WEST SUSSEX, RH17 6JN

HISTORIC BUILDING ASSESSMENT, HERITAGE STATEMENT &  
IMPACT ASSESSMENT

Report No. 2025624  
Prepared by Maggie Henderson Ma  
March 2026

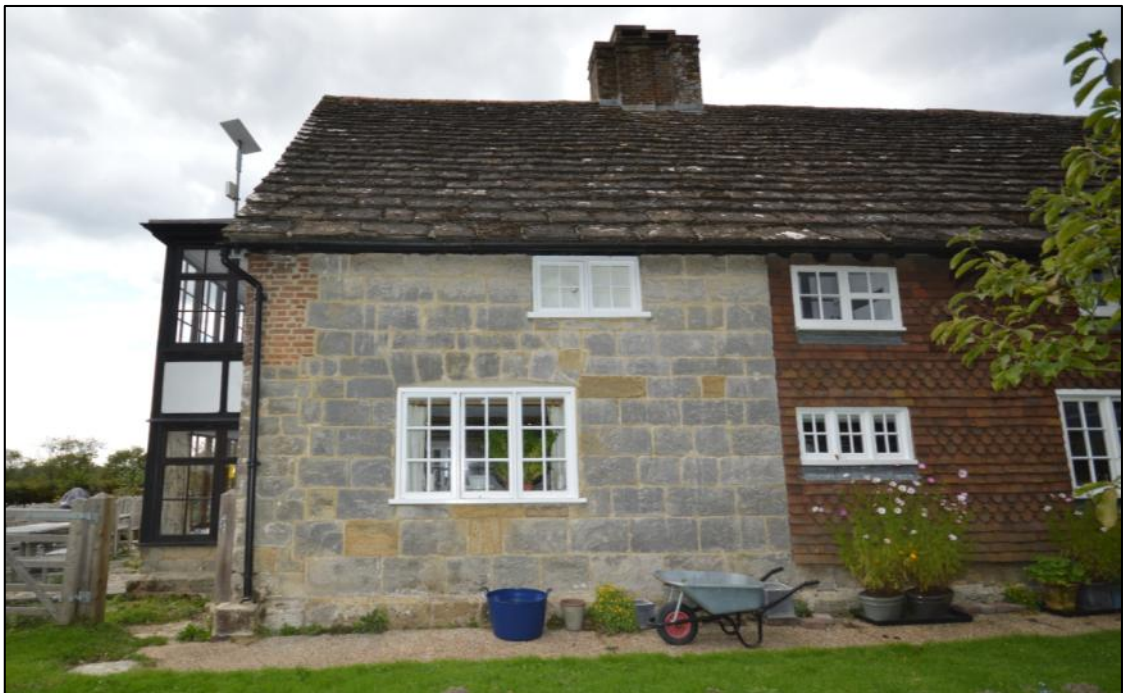
- 8.5.2 It is suggested that the west and east elevations of bay 1 were rebuilt in masonry with a low plinth at this stage; the blocks larger than those utilised for the pre-existing southern end elevation of the building. There is a clear junction between the earlier work and the re-facing of bay 1: with the new work keyed into the existing fabric creating a vertical column of quoins in brick and stone ((compare Plate 34 and 35). The interior of the 480 – 500 mm thick walls are finished in plaster concealing construction details.

Plate 34: The re-faced eastern elevation of bay 1: note the clear junction between it and the earlier southern end elevation of the building

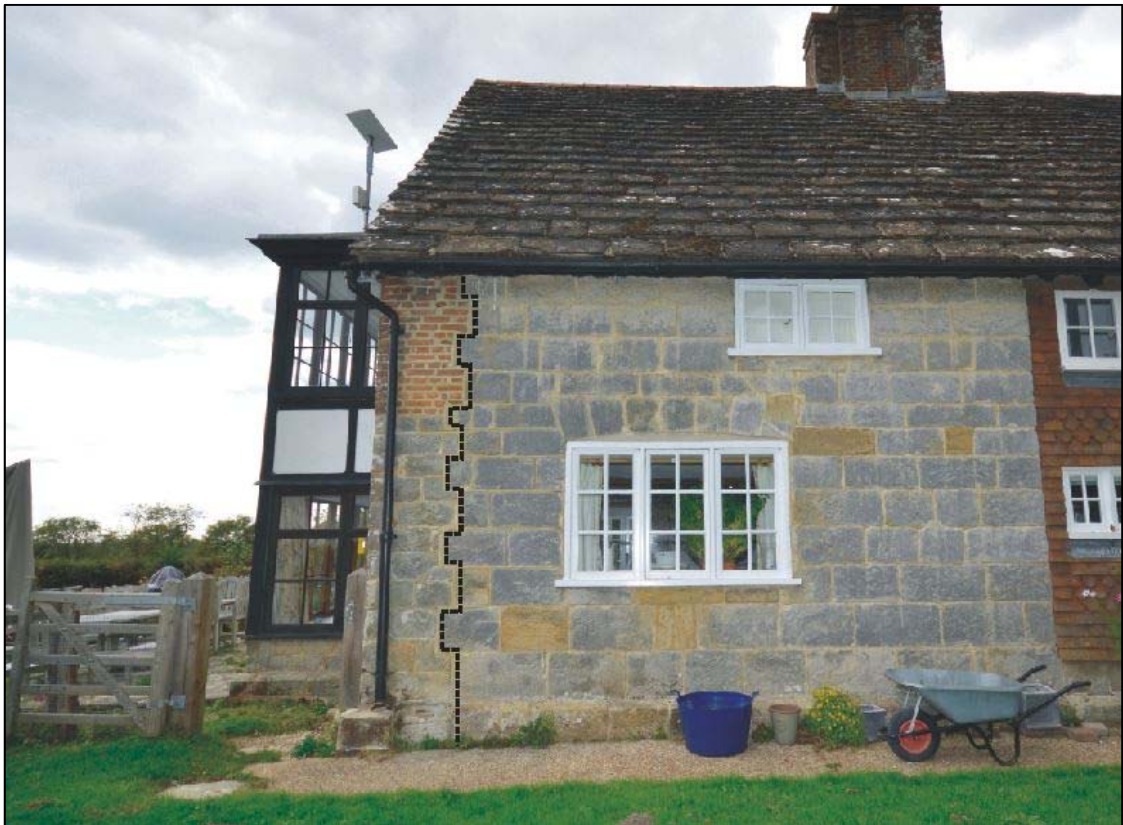
Plate 35: The clear junction between the earlier south end and the re-faced east elevation, compare with Plate 28 above

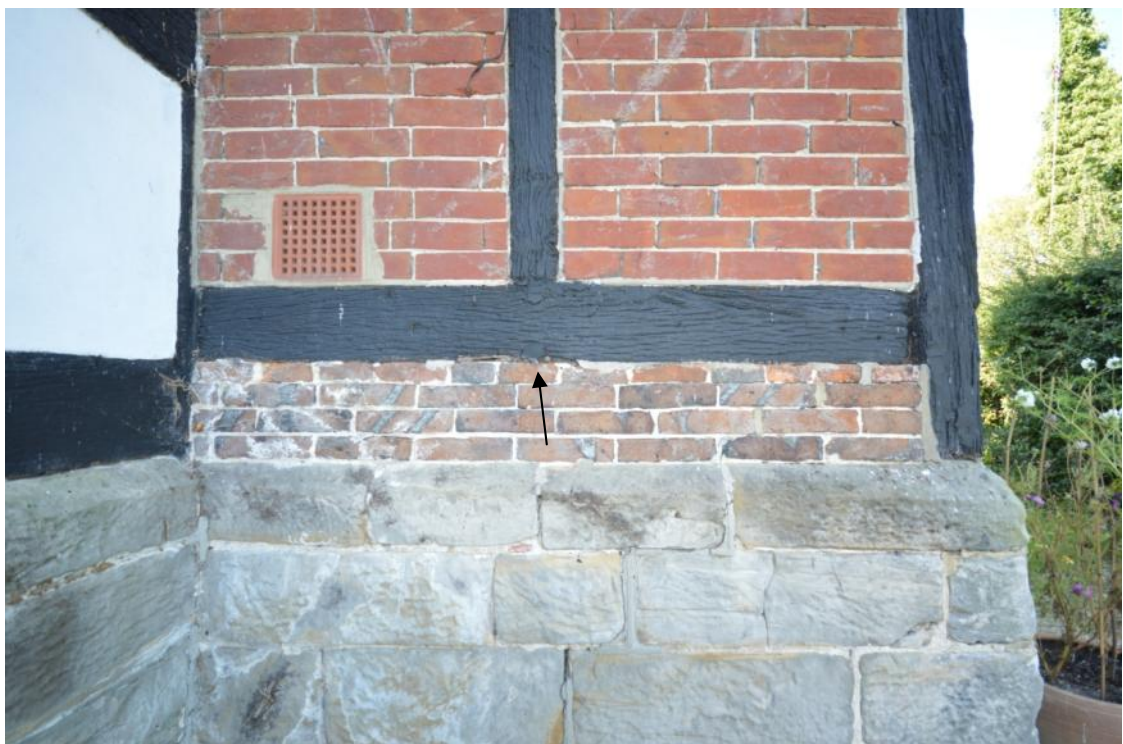
- 8.5.3 The masonry plinth added below the phase 3 timber-frame at the stair turret may date to this phase of construction, although the lack of diagnostic detail means that this is not certain. The masonry, with its chamfered plinth is overlain on the east side by early brick, suggesting that the work was undertaken during the 18<sup>th</sup> century; however, it is not uncommon for early material derived from elsewhere in the property to be reused at a later date (Plate 36).
- 8.5.4 Scotches, or recesses cut into the timber frame are extant on the frame of the turret, illustrating the locations where the building was propped up when the masonry under-building was carried out (Plate 37).

Plate 36: Underbuilt timber frame of the stair tower, with early brick between the new masonry plinth and the timber; note the peg-hole below the stud for a lower stud, removed when the frame was underbuilt (arrow)

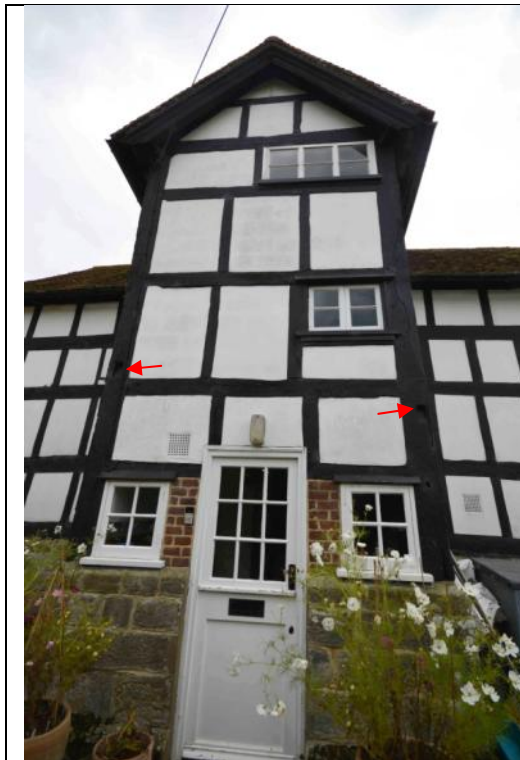
Plate 37: Scotches cut into the two principal posts on the north side of the tower during the under-building of the timber frame (arrows)

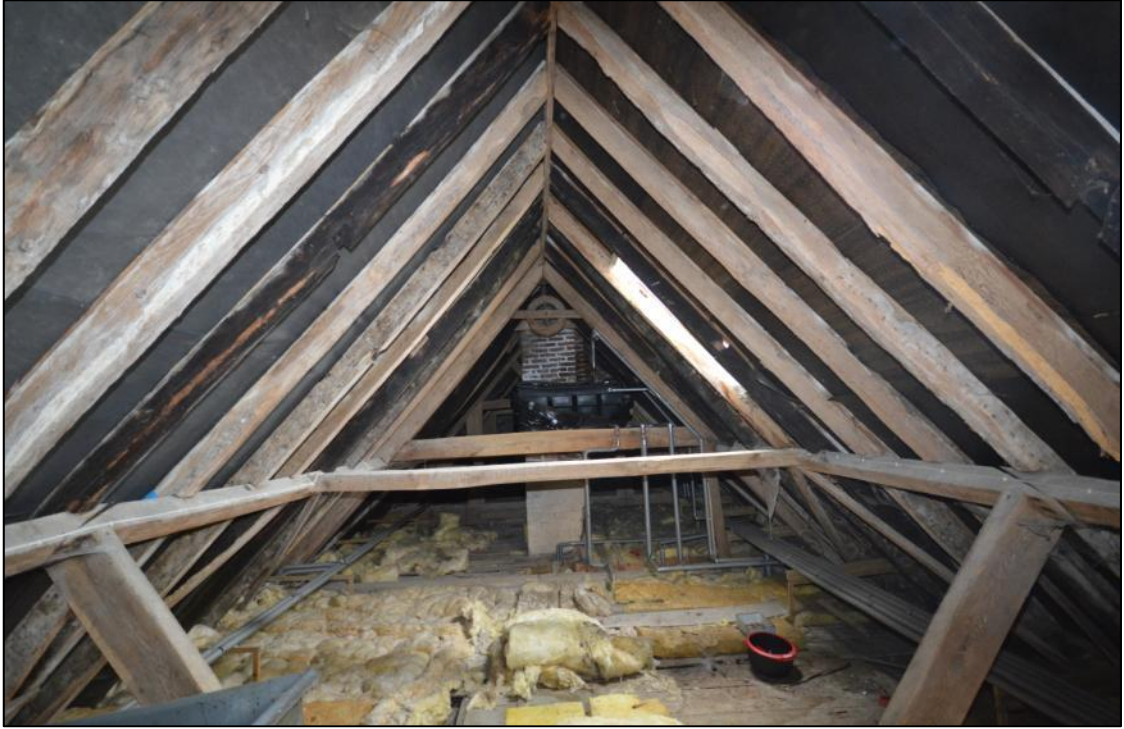
Plate 38: The interior of the roof over the main range with its in-line clasped side-purlins

- 8.5.13 The roof over bays 2 to 4 comprises in-line side-purlins that are clasped by collars or raking struts (Plate 38). The rafters, common and principal, are notched to accommodate the purlins, and where scarf joints were necessary to join short lengths of purlin together across the roof slope they are of simple splayed type, fixed together by nails. Both parts of the composite roof include a quantity of reused material, including rafters with halvings for collars, soot-stained and un-sooted, derived from the medieval roof that the new structure replaced.

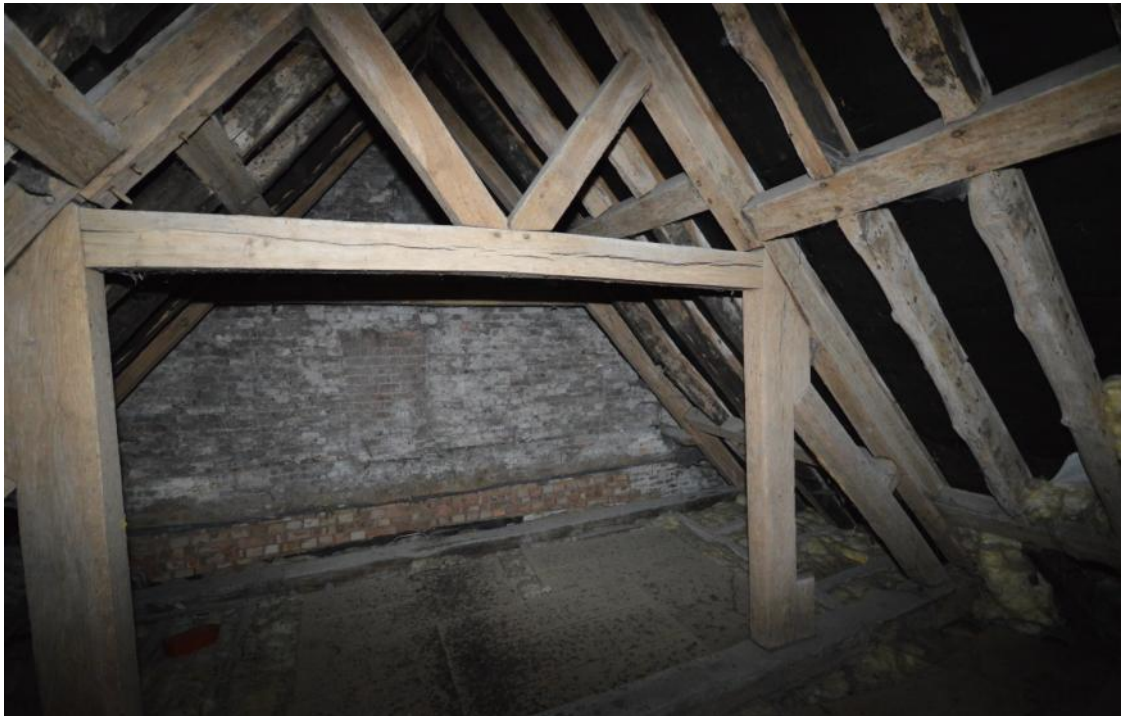
- 8.5.9 The heads of the studs are joggled to accommodate short braces and are linked by a collar-like straining beam. A pair of raking struts rise from the centre of the straining beam to terminate at the soffits of the principal rafter pairs (Plate 39 and 40).

Plate 39: The staggered butt-purlin construction with interrupted rafters and engineered truss over bay 1

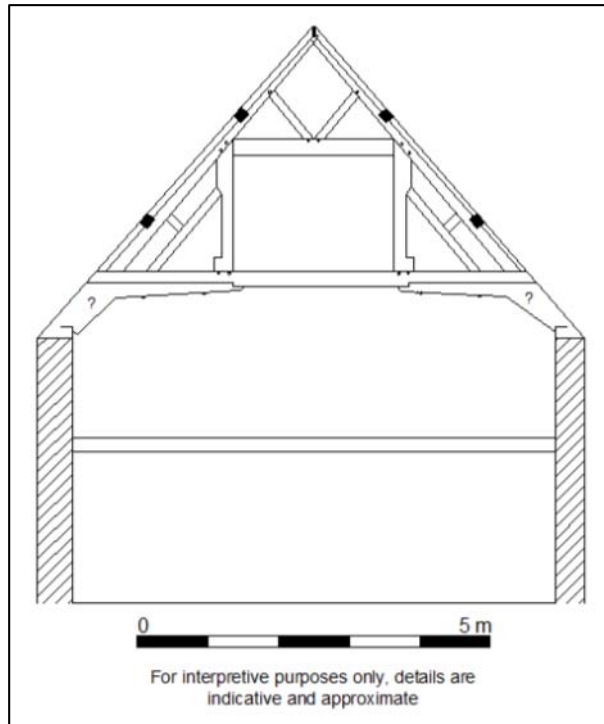
Plate 40: Diagram showing the form of the engineered trusses over bay 1 based on visible fabric

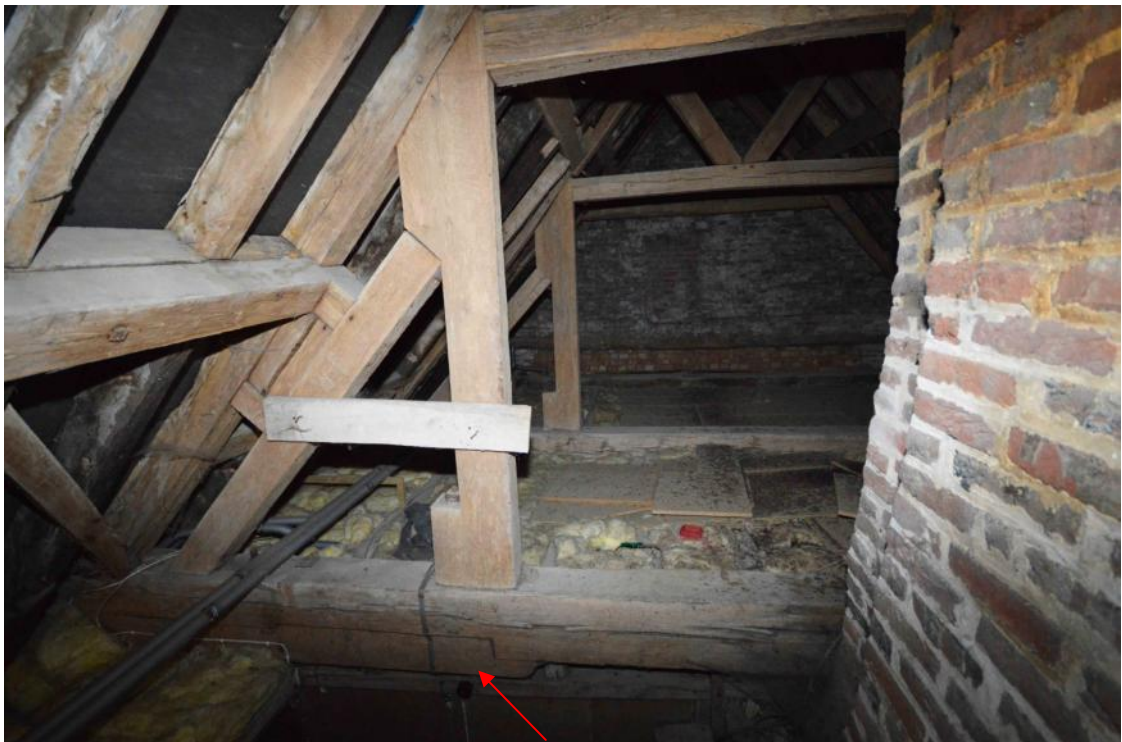
Plate 41: The east side of the T10 truss showing the top of the knee (arrow)

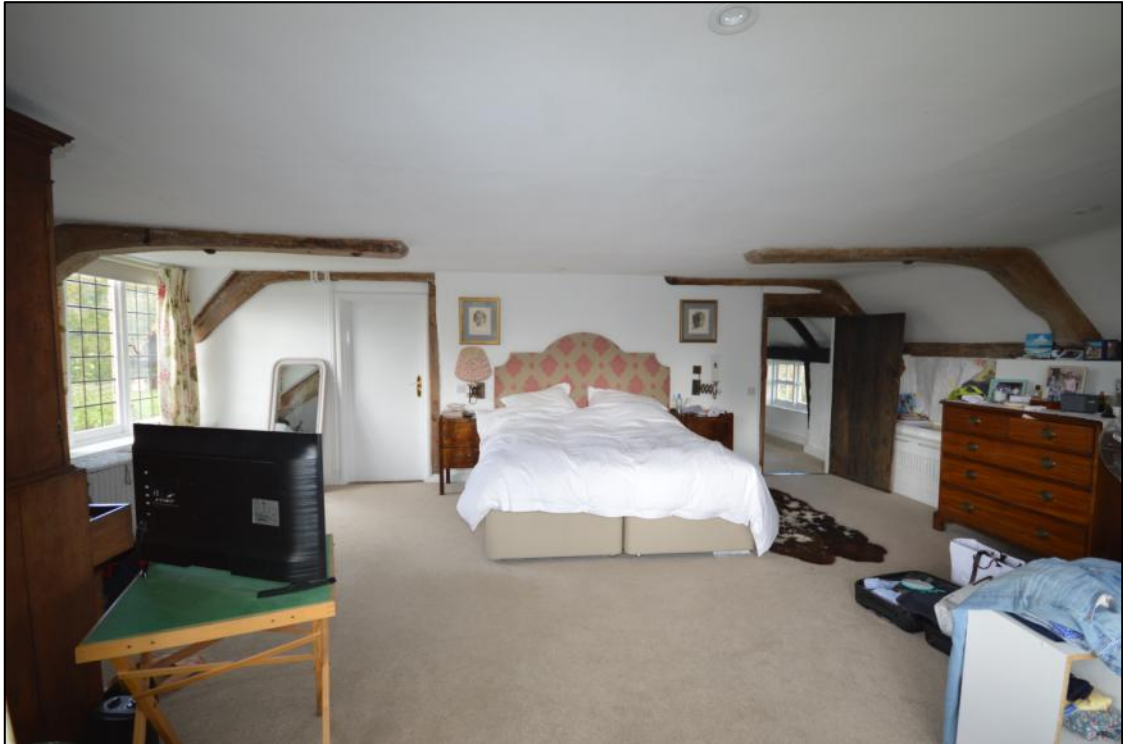
Plate 42: The knee part of the T9 and T10 trusses viewed from the south chamber, supporting the high-set tie-beam and serving as a continuation of the principal rafters

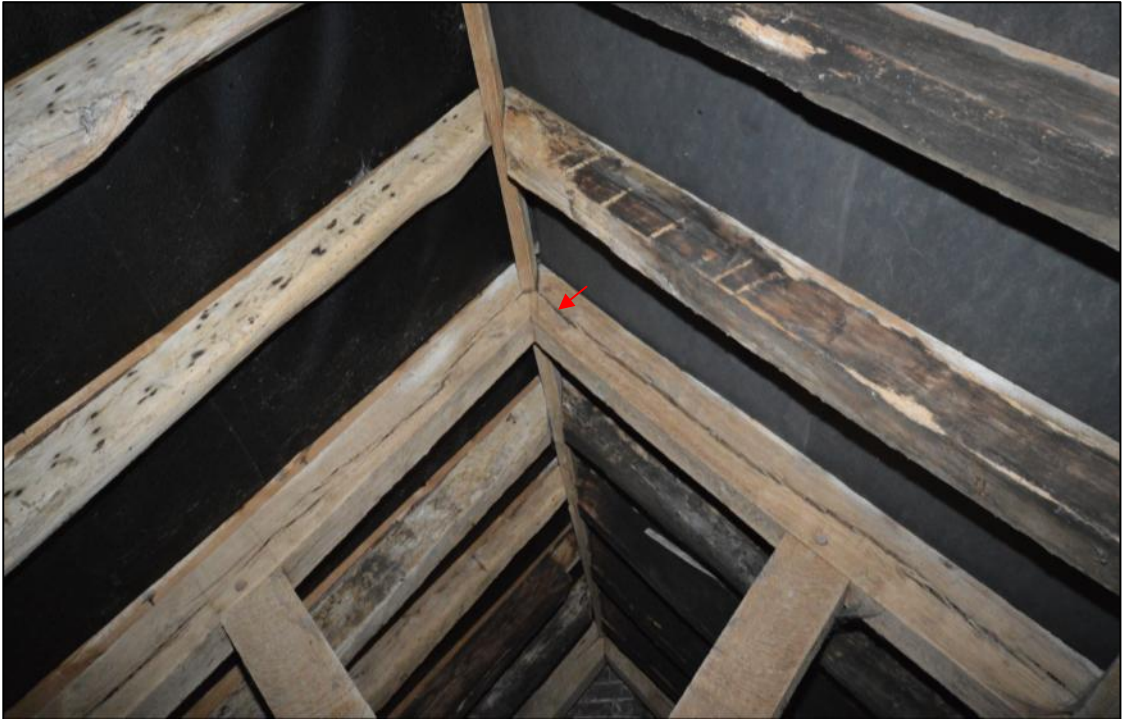
- 8.5.14 The two distinct roof styles are united in the inclusion of a ridge-board at the apex of the roof (Plate 43). The ridge-board is an interrupted version found in 18<sup>th</sup> century roof structures, with the principal rafters of the roof trusses jointed and pegged together interrupting the ridge-board lengths.

Plate 43: The roof over bay 1 showing the principal rafter and ridge-board arrangement, note the peg for the joint at the apex of the rafters (arrow)

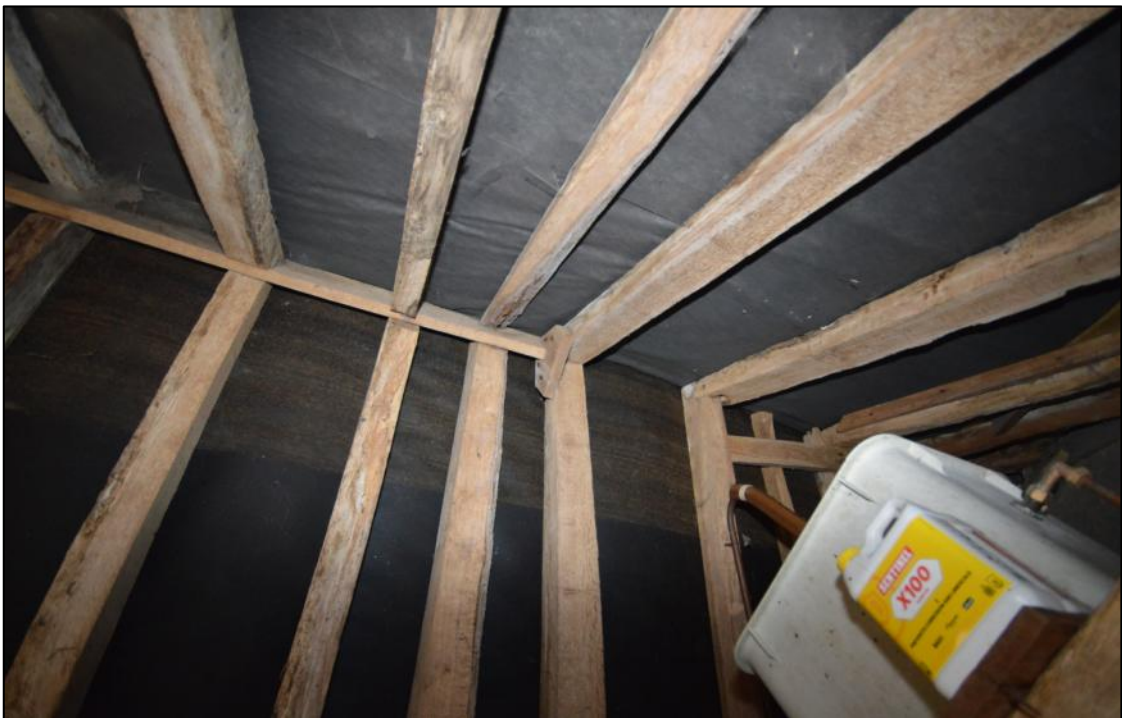
Plate 44: The north end of the roof showing the method of carrying the end of the ridge-board

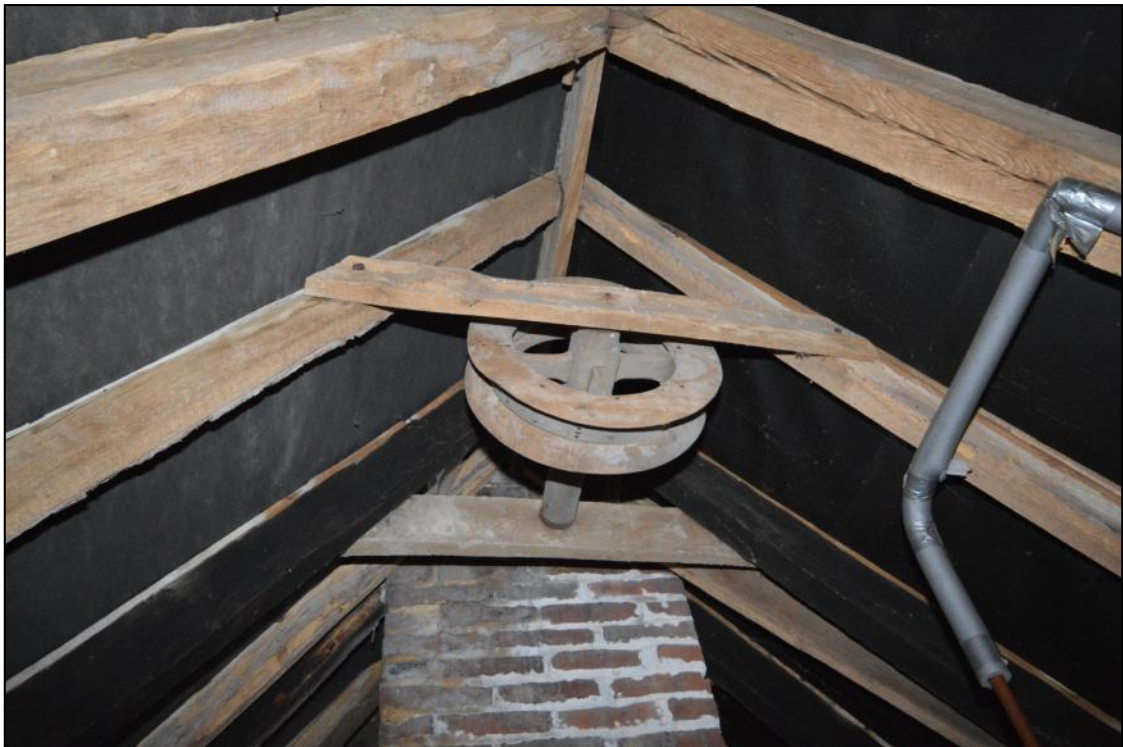
Plate 45: The wooden hoist-wheel nailed to the mid-to-late 18<sup>th</sup> century roof in front of the main range chimney stack

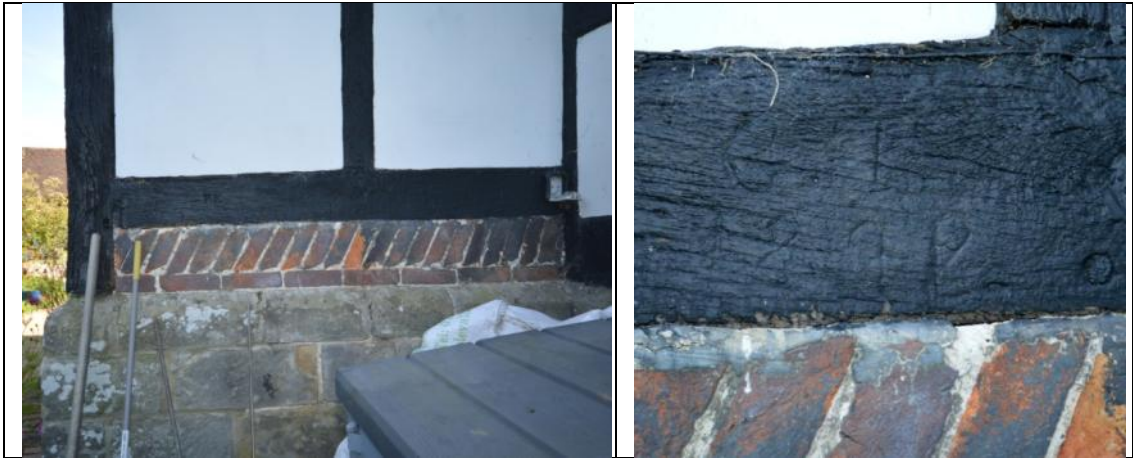
Plate 47: 19<sup>th</sup> century brickwork and dated inscription 1892 on the west side of the stair turret

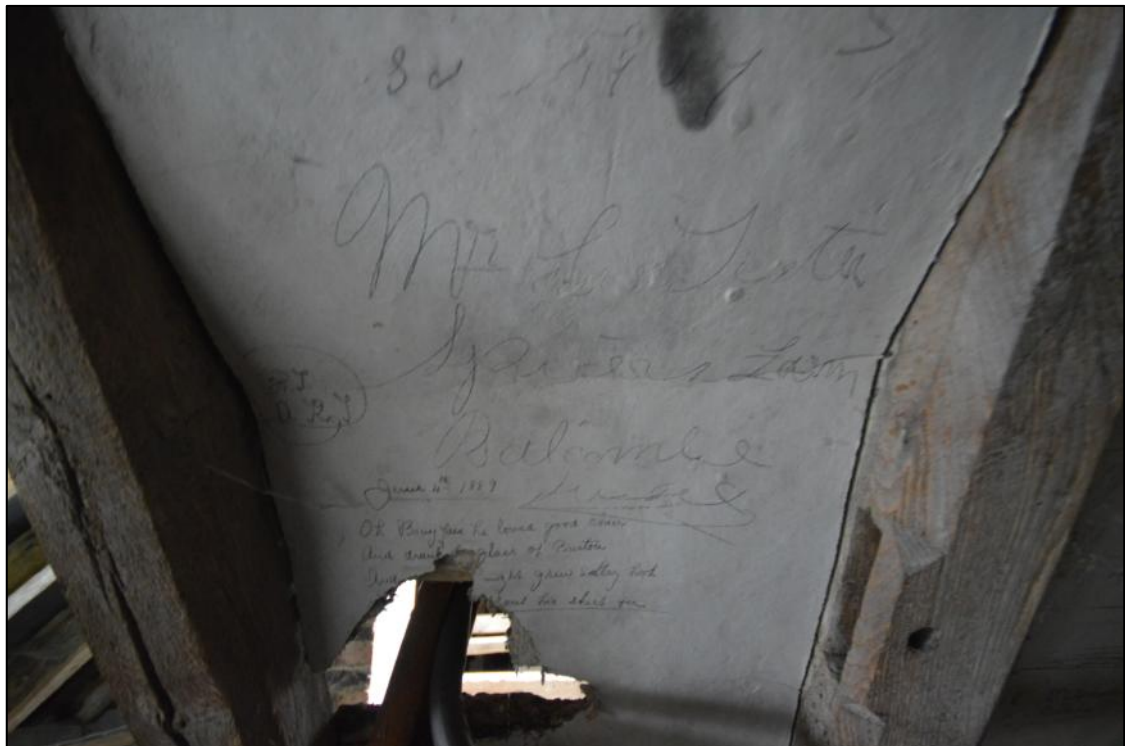
Plate 48: Example of the graffiti dating to 1889 on the south slope of bay 6 in the cross-wing

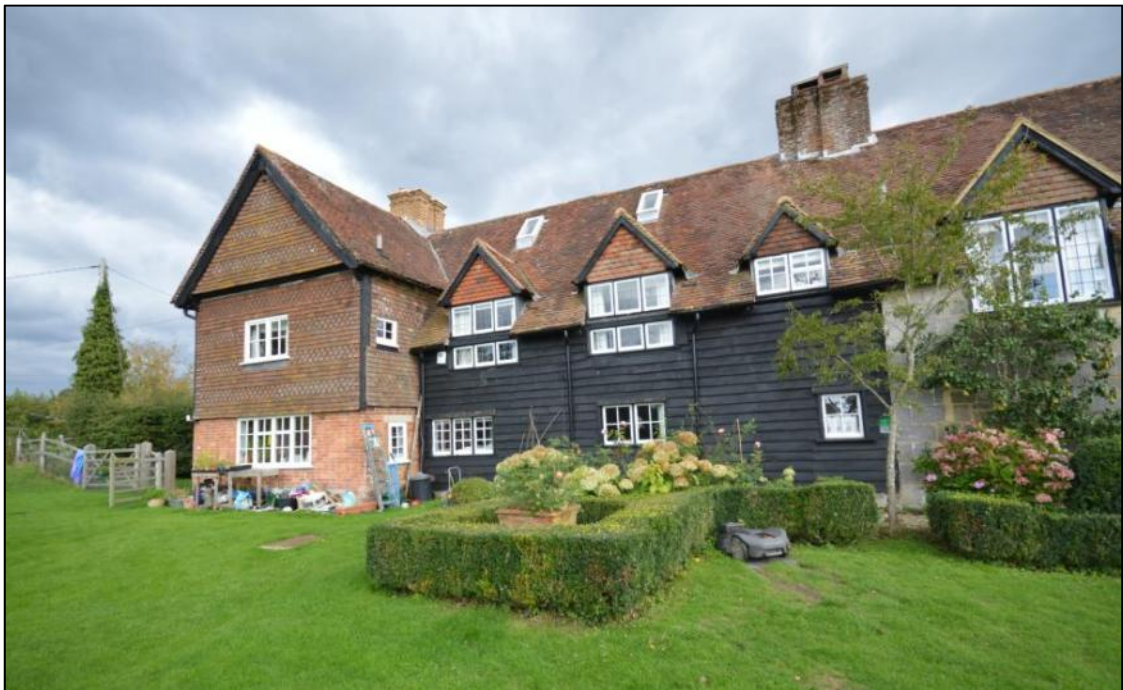
Plate 49: The west side of the property showing the brickwork of the rebuilt ground floor parts of the cross-wing, the weather-boards to the main range and the altered fenestration

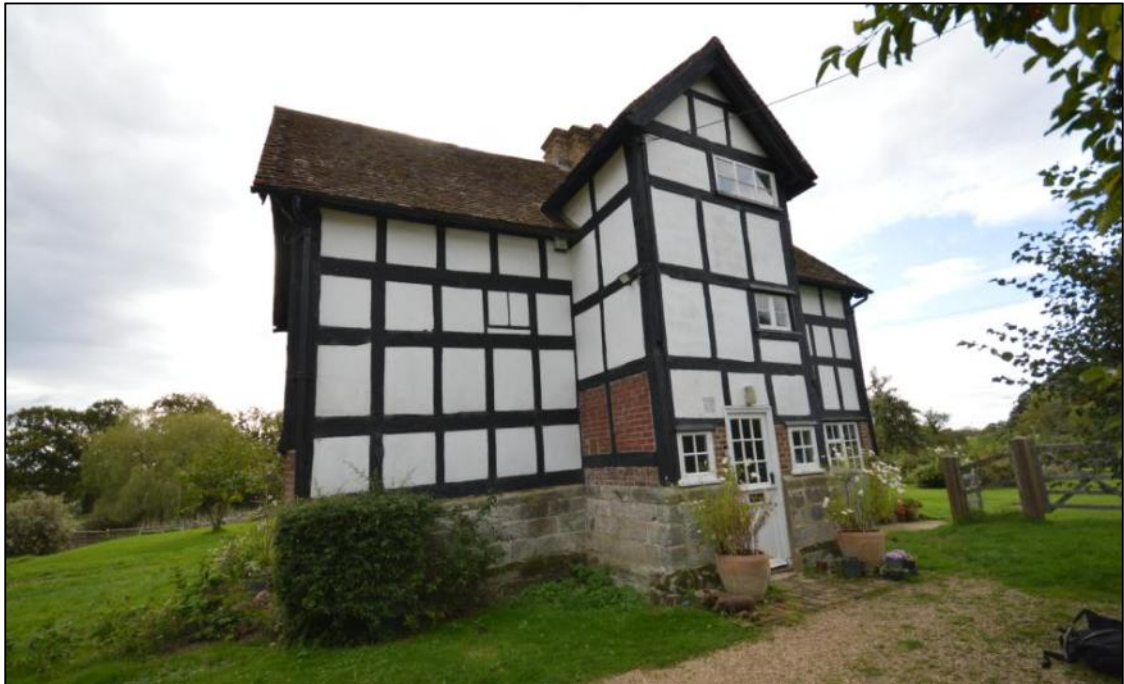
Plate 50: The north side of the cross-wing showing the masonry and brickwork

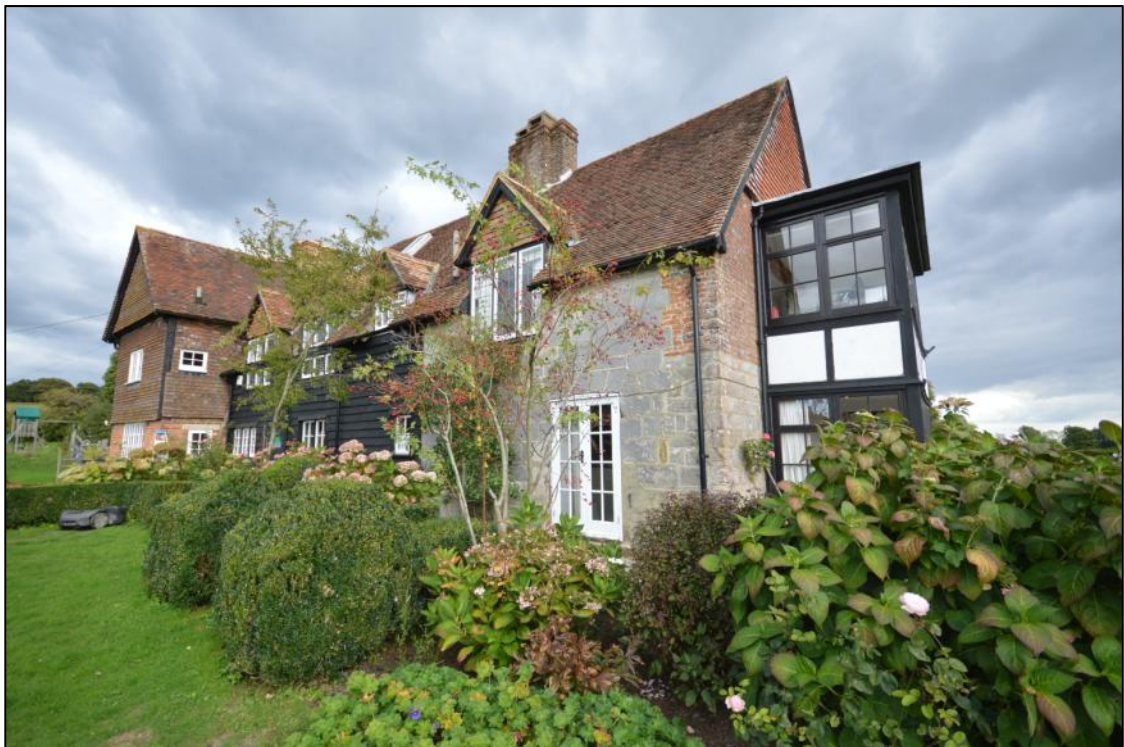
Plate 51: The two-storey bay window added to the south end of the house

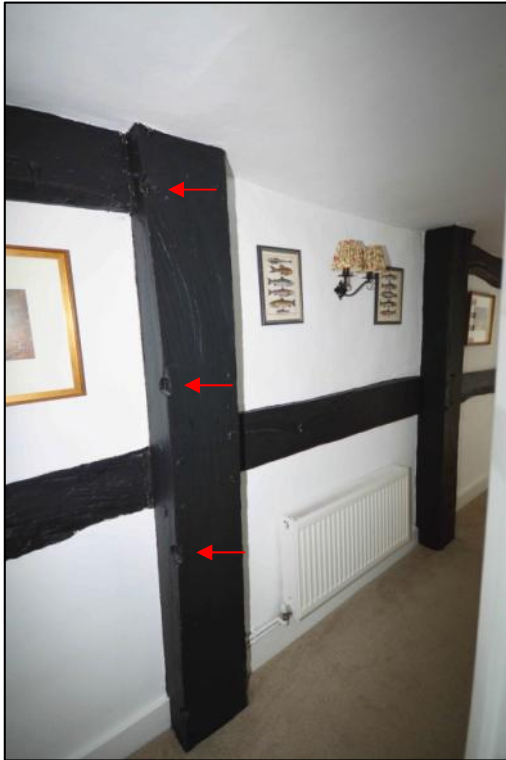
Plate 52: The two principal posts flanking the chimney bay on the south side of the cross-wing, at first floor level, the T6 post includes a series of notches, suggested as fixings for the frame of a doorway/ part of a partition added to the over-length east chamber

- 8.6.12 It is notable that the principal post on the south side of the T6 truss includes a series of regularly spaced notches on its northeast corner (Plate 52). It is suggested that the notches were utilised to frame a doorway in this location intended to provide access to the west room from the new staircase, if not at an earlier stage in the development of the building.

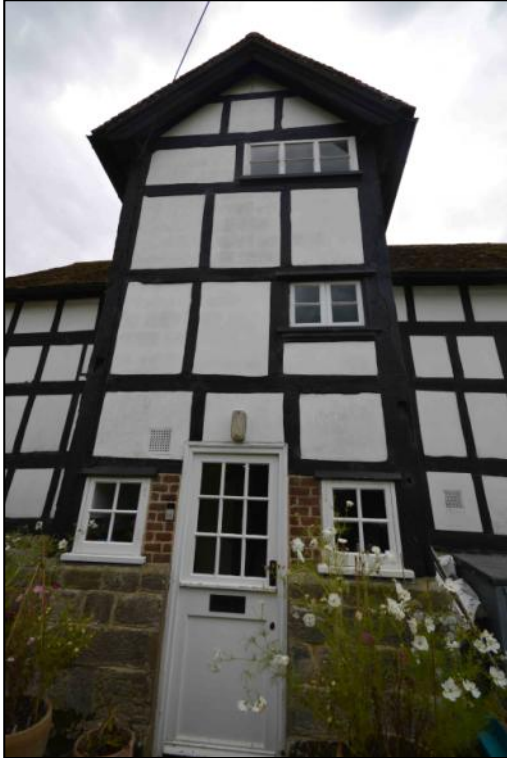
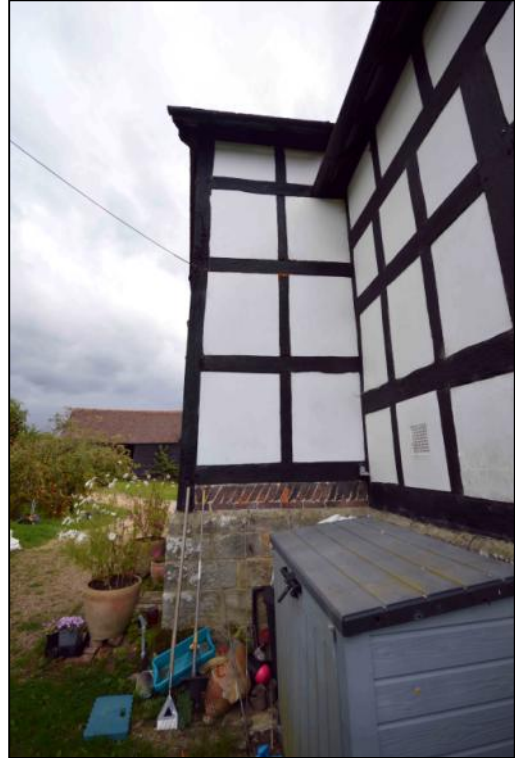
North side of turret showing pressure marks for block-work infill

West side of turret showing expanded foam

Plate 53: Modern intervention into the stair turret, alterations to panel infill and the insertion of a door and windows at ground floor level

8.7.3 There is evidence of replacing the infill of the *in situ* timber frame in block-work this is clear in the east gable of the attic and is suggested in a few areas of the stair turret by virtue of pressure marks defining the blocks through the rendered finish (Plate 53).

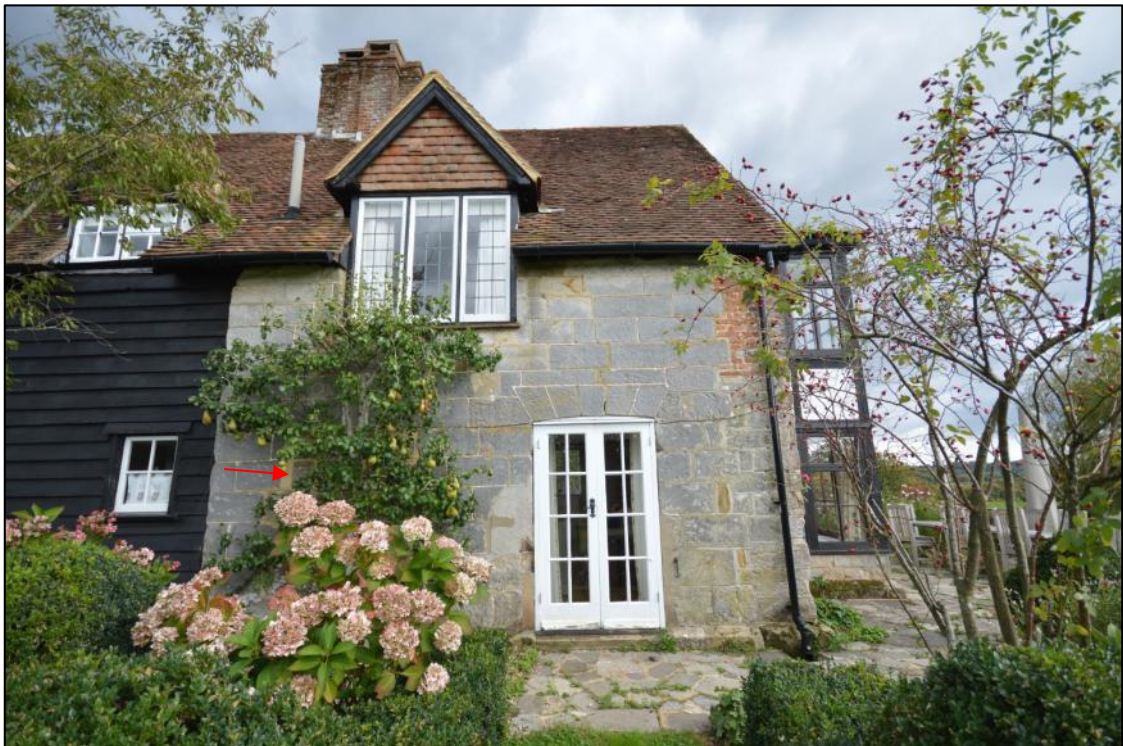
Plate 54: The west side of bay 1, showing the window converted to a doorway and the blocked window to the north of it (arrow)

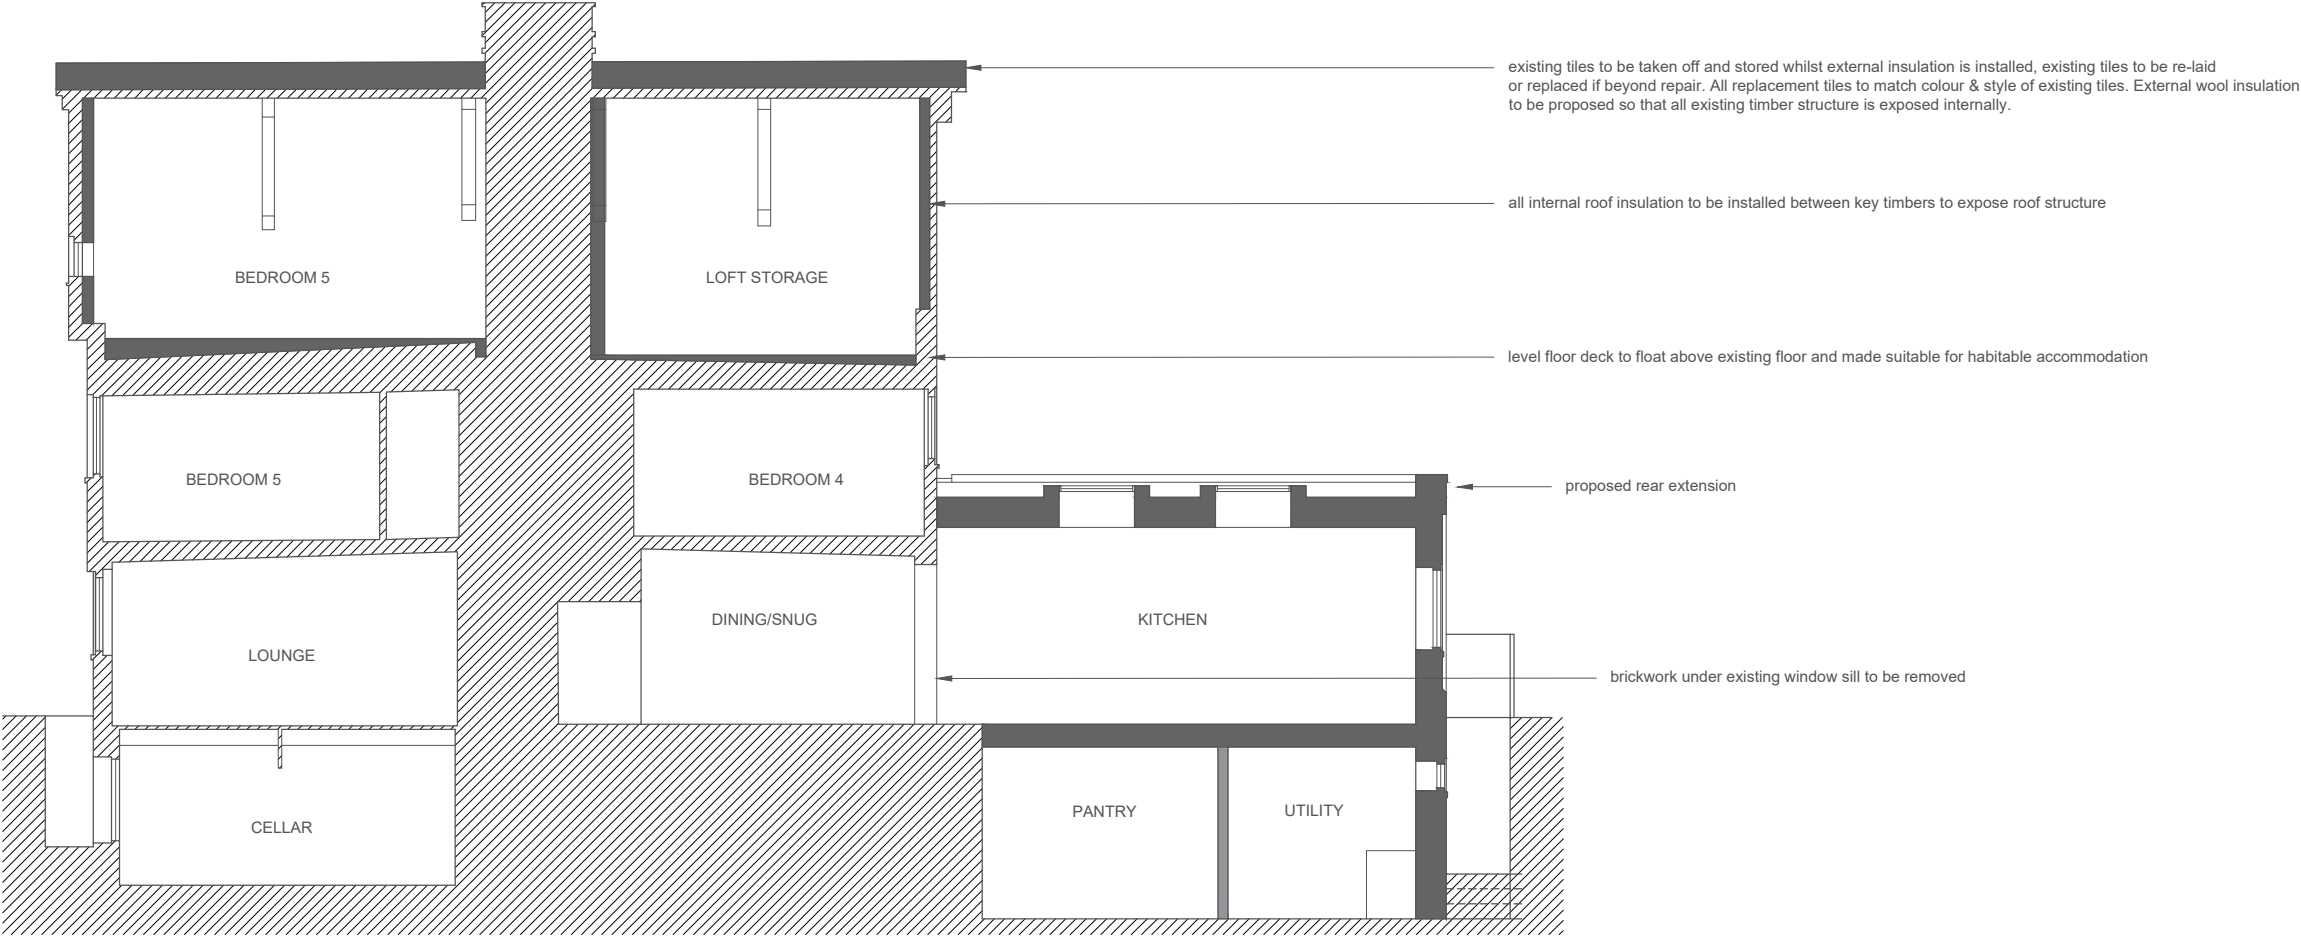
Section BB

existing tiles to be taken off and stored whilst external insulation is installed, existing tiles to be re-laid or replaced if beyond repair. All replacement tiles to match colour & style of existing tiles. External wool insulation to be proposed so that all existing timber structure is exposed internally.
