# Sunte House, Birchen Lane, Haywards Heath, RH16 1RZ

Heritage Statement | June 2025

Robinson Wild  
CONSULTING

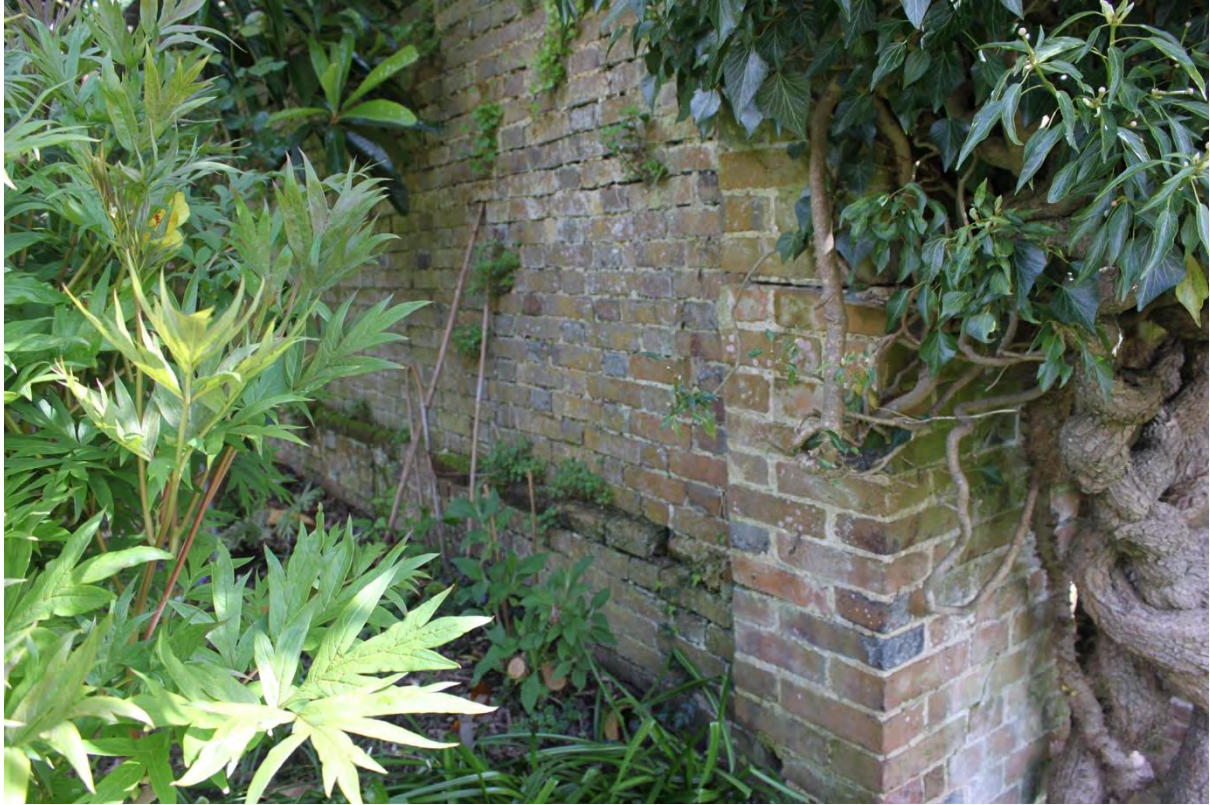
Figure 56: Plate 21 - View of the plinth along the east wall of the formal garden looking northeast

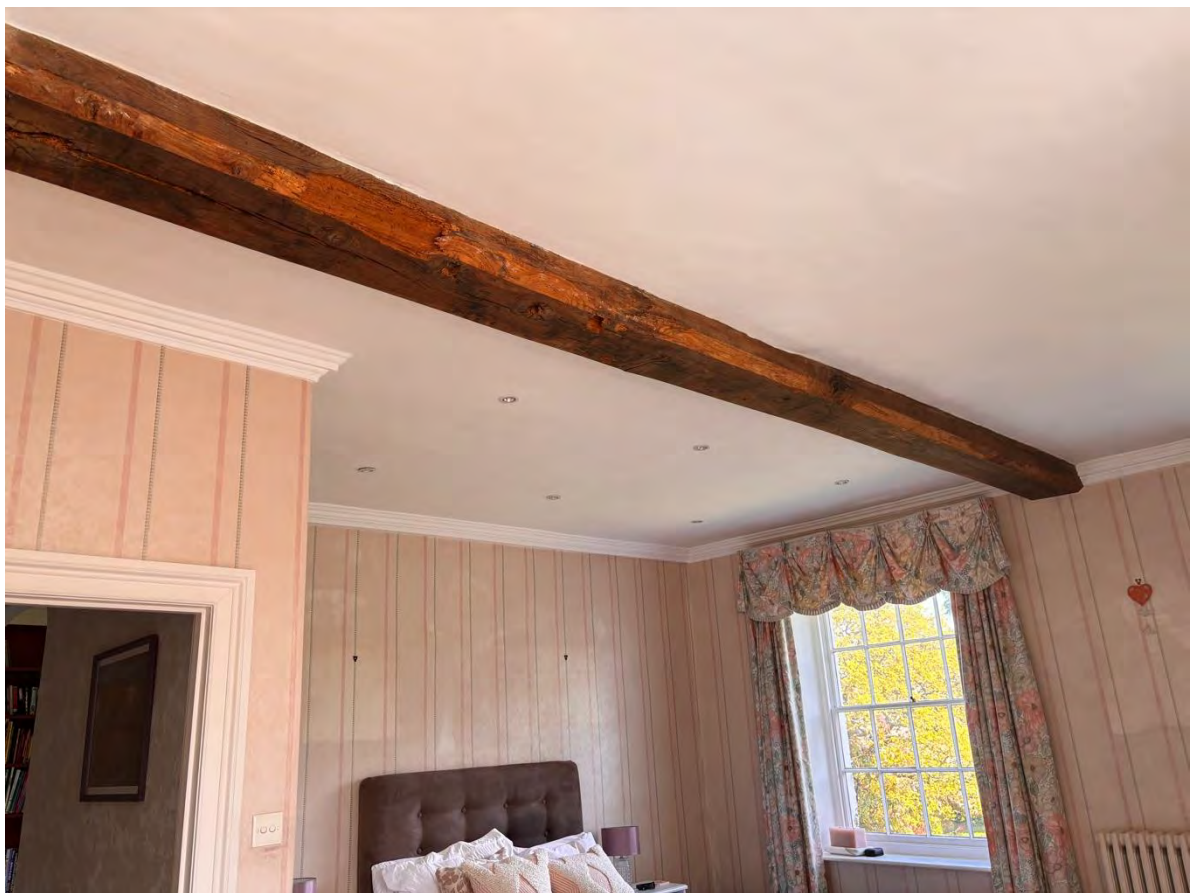
Figure 106: Plate 72 - Beam in the principal bedroom (east).

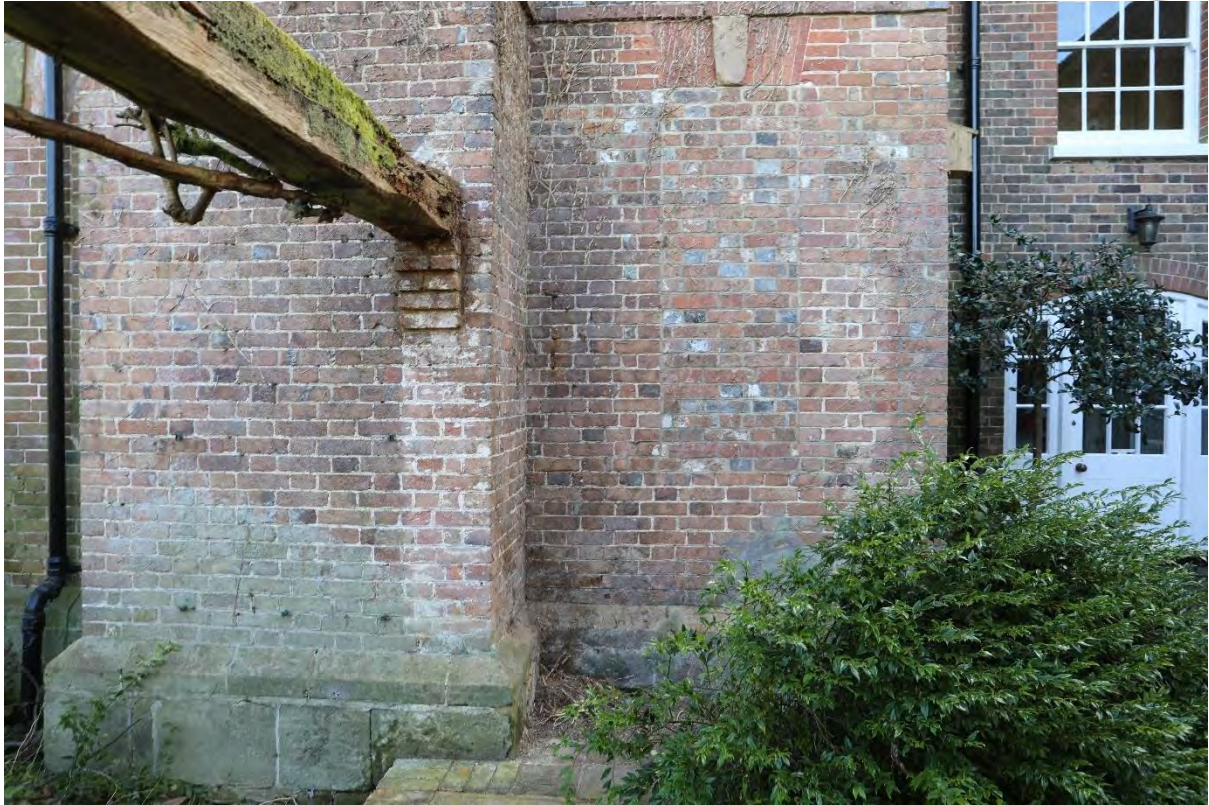
Figure 116: Plate 81 – North elevation, view to the scarring evidencing the historic abutment of the former dairy building, looking south (19.03.25)

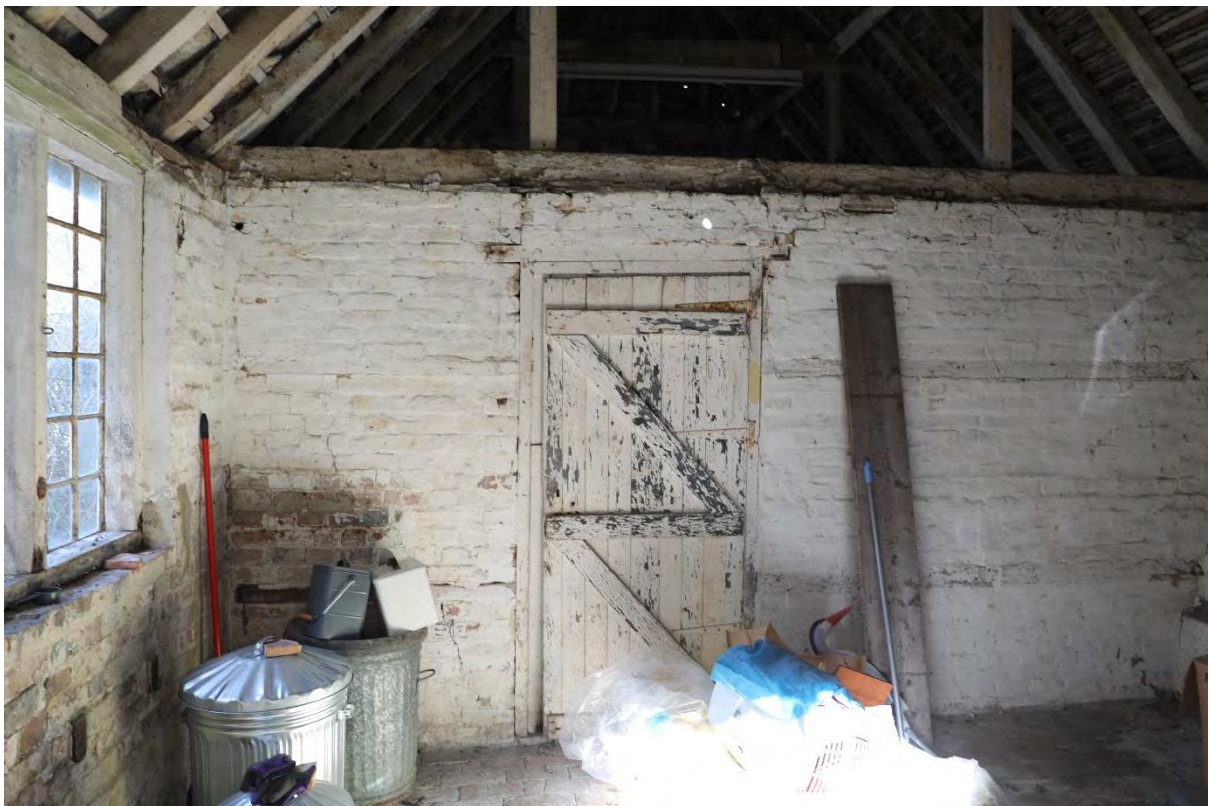
Figure 117: Plate 82 – Former Dairy, view to the brick partition wall, looking north (19.03.25)

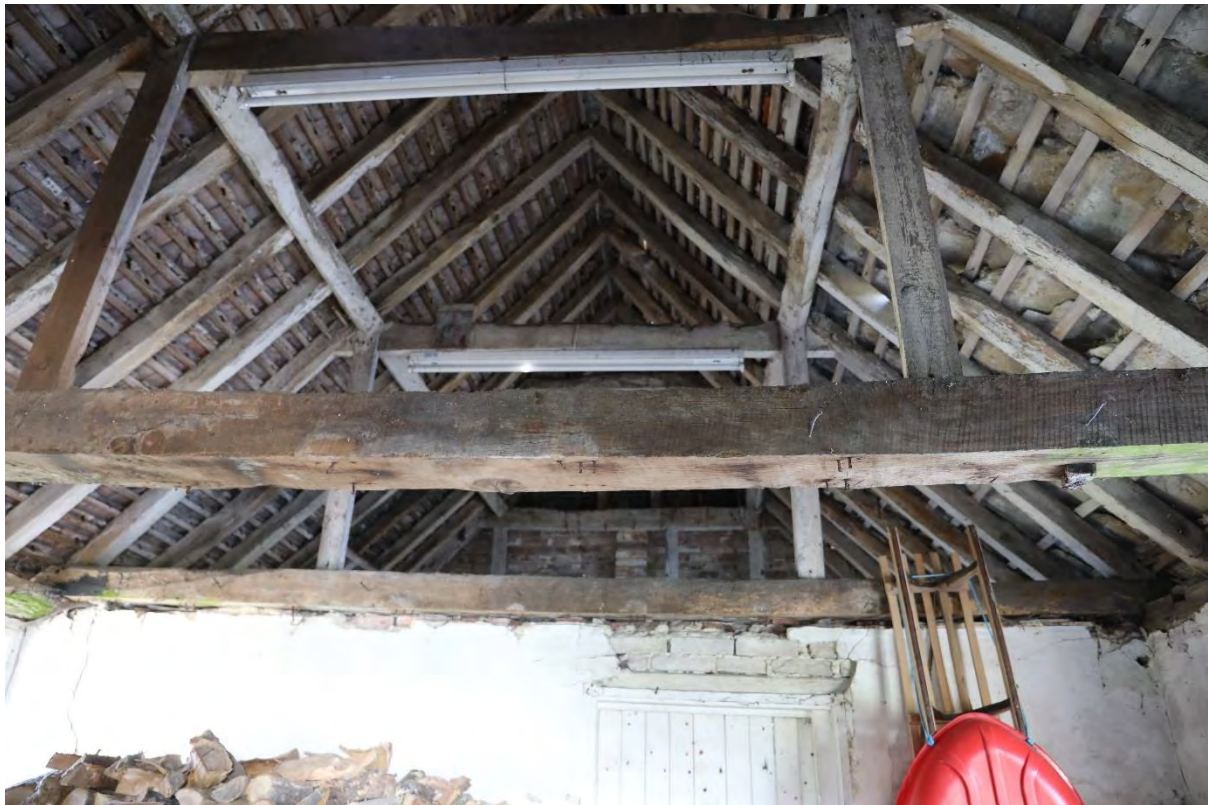
Figure 119: Plate 84 – Former Dairy, view to the timber roof structure (19.03.25)

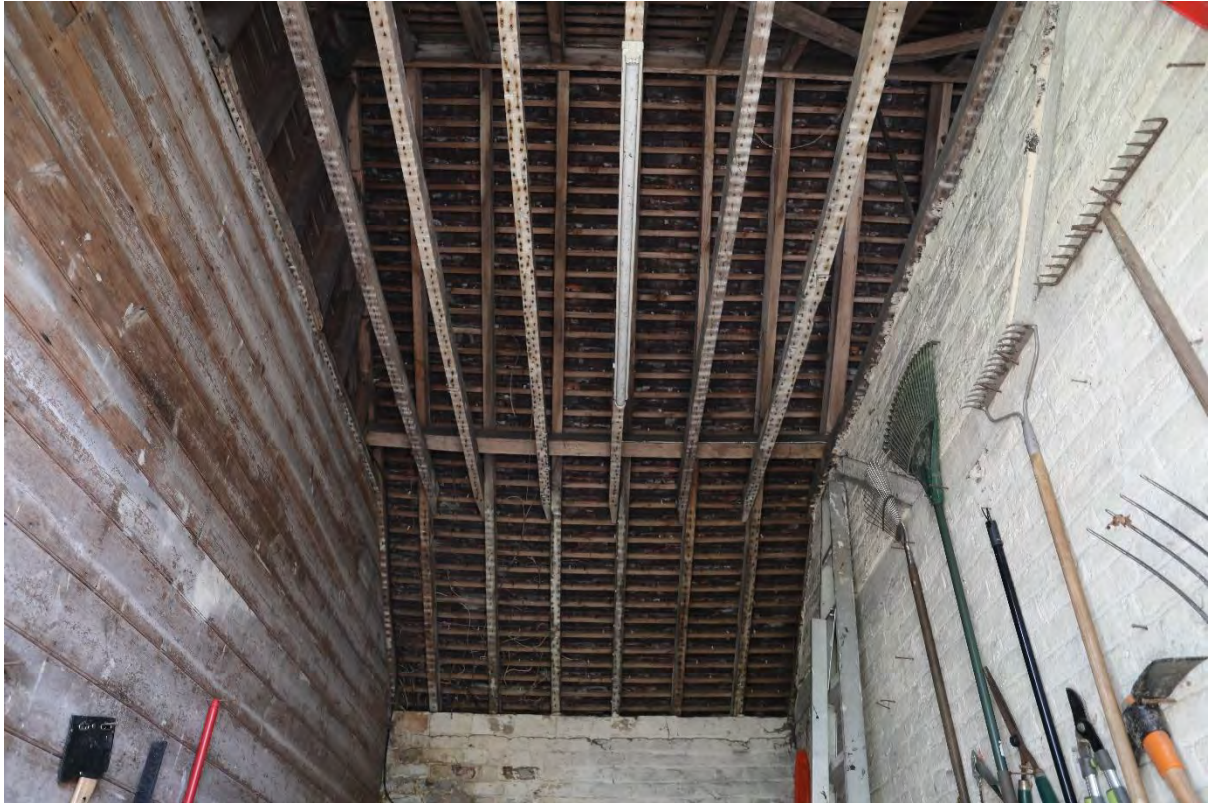
Figure 122: Plate 87 – Toolshed, view to the timber roof structure (19.03.25)
