# An interpretive report on The Friars and Somners, South Street, Cuckfield, Sussex.

July 2024

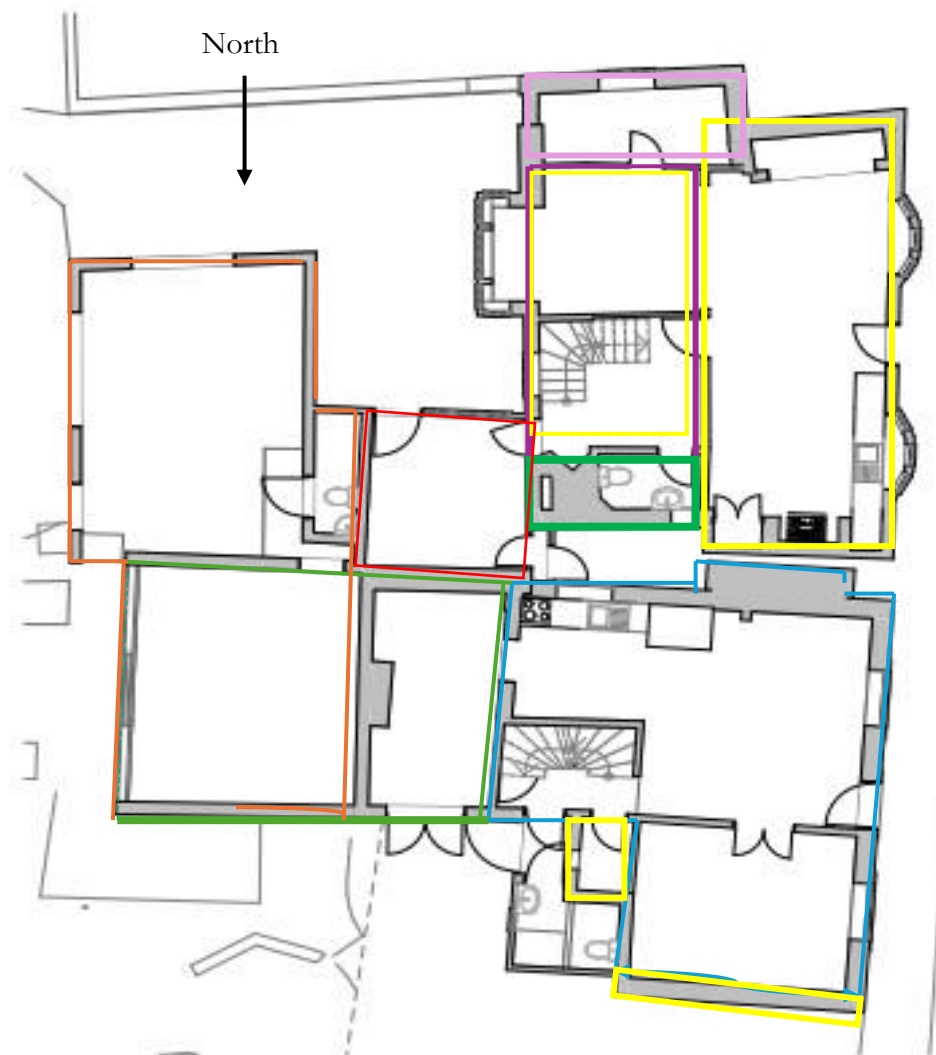
*Figure 1: Colour coded plan showing the phases of development.*

Phase A = Purple ~ *Mid C16 to mid C17.*

Phase B = Blue ~ *Mid C17 to early C18.*

Phase C1 and C2 = Green ~ *Mid to late C18*

Phase D1, D2 & D3 = Yellow ~ *Late C18 to early C19.*

Phase E = Pink ~ *Early C19.*

Phase F = Red = *Mid to late C19.*

Phase G = Orange ~ *Late C19 to early C20.*

Phase H = No colour ~ *C20*

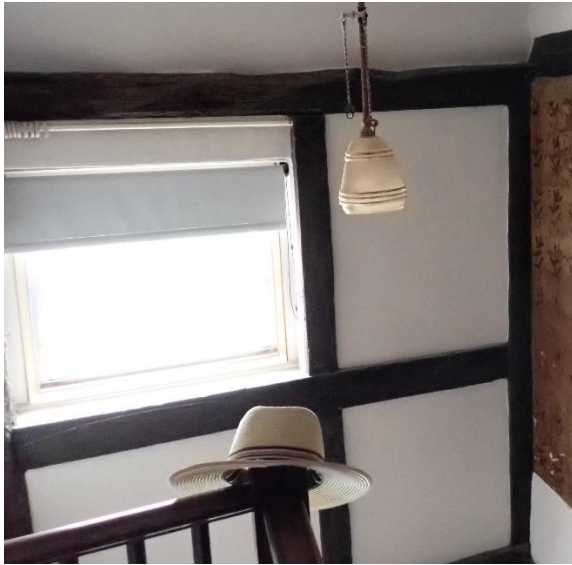
*Figure 3: Small panel framing on the east wall of Bay 1.*

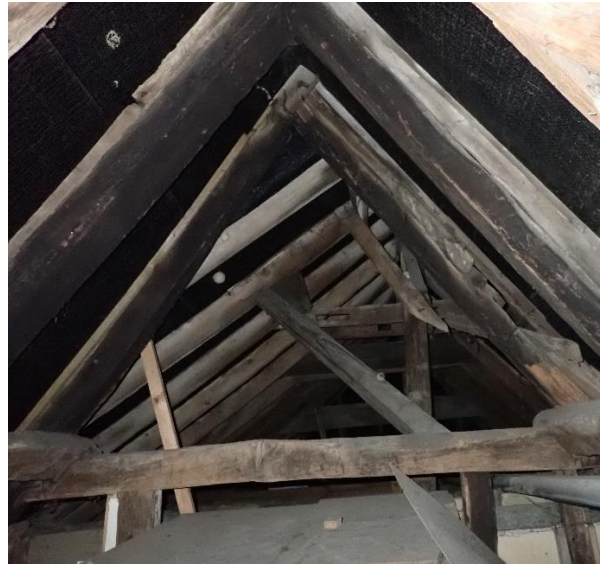
*Figure 4: smoke-blackened common rafters in the foreground, over Bay 1.*

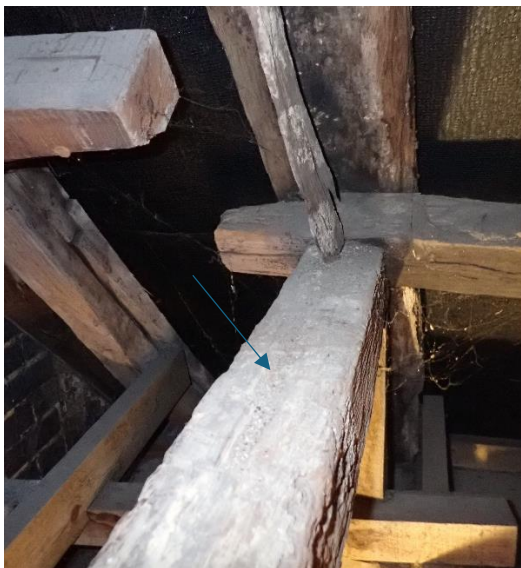
There are a number of inconsistencies with the arrangement, weathering and smoke-blackening of the timbers which require further investigation. It is not clear whether this indicates re-use or evidence of the loss of features.

*Figure 5: collar clasping the eastern side purlin is not faced with the rafter. The side purlin also truncates just to the north of this collar.*

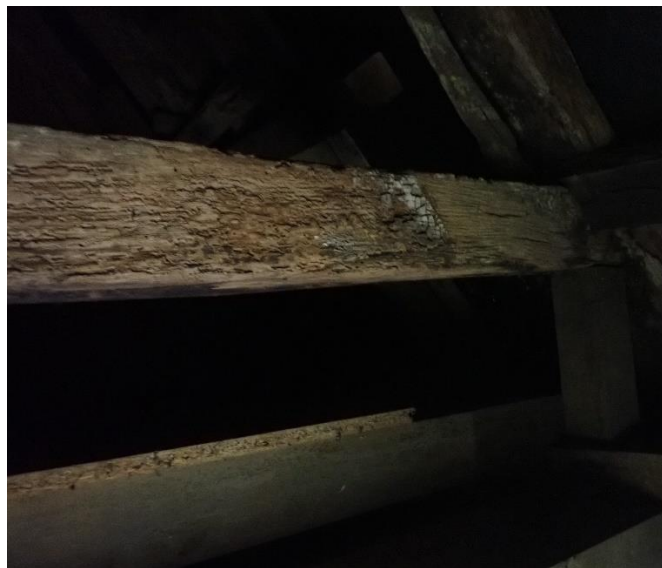
*Figure 6: Significant decay pattern on the collar clasping the side purlin, indicating reuse or built against a feature like a masonry chimney stack.*

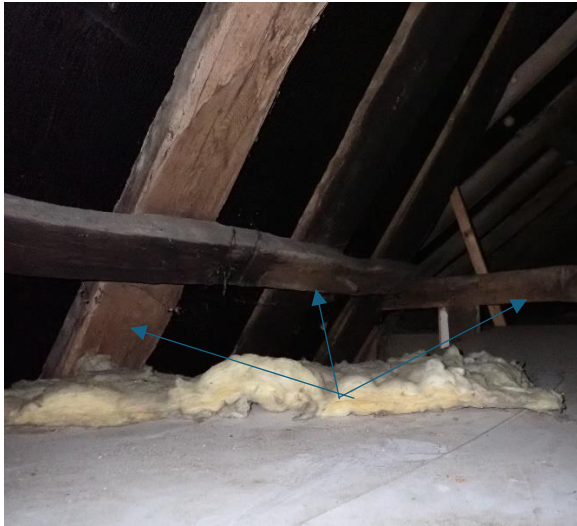
*Figure 7: Mixed pattern of smoke blackened and not smoke blackened rafters, collars and eastern side purlin over Bay 1.*

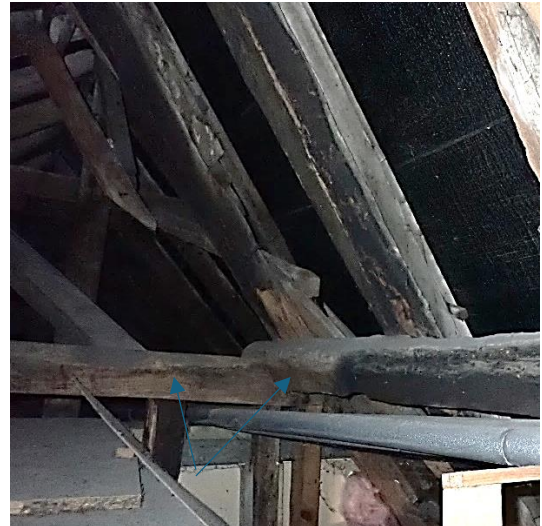
*Figure 8: Mixed pattern of smoke blackened and not smoke blackened western side-purlin and collar.*

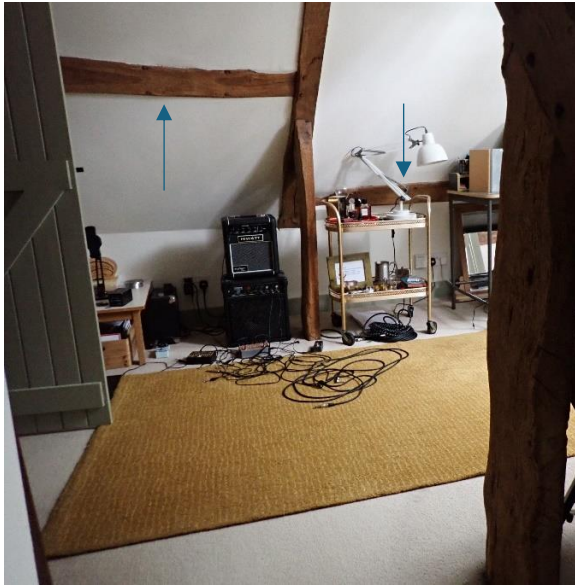
The roof is a staggered and tenoned side purlin with tenoned common rafters over both the main and rear range.

*Figure 10: Staggered and tenoned side purlins.*

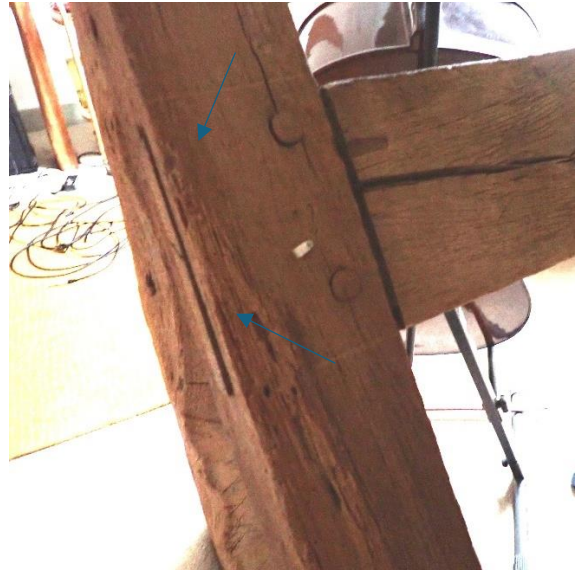
*Figure 11: the principal rafter by the entry to the loft. The lack of framing pegholes indicate that there was no tenoned purlin in this bay, as it was intended to provide access.*

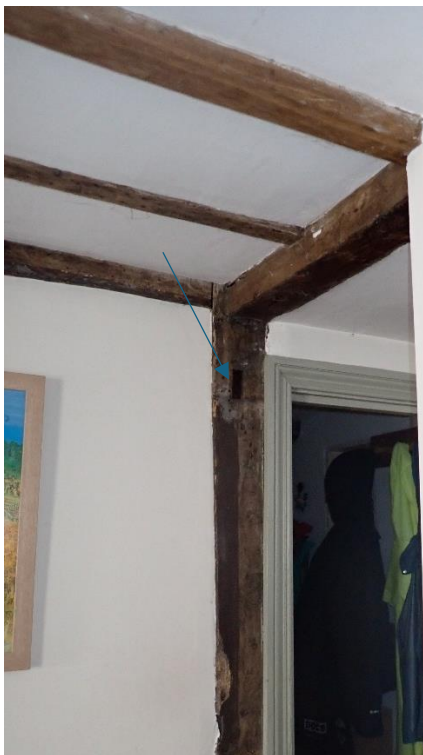
There may have been an entrance lobby/corridor on the ground floor with doorways leading off to the two rooms either side and to the staircase straight ahead. There is evidence for a former bread oven on the outside of the southern chimney stack, indicating that this room was the kitchen.

*Figure 12: empty mortice for a former doorhead. Leading to the staircase.*

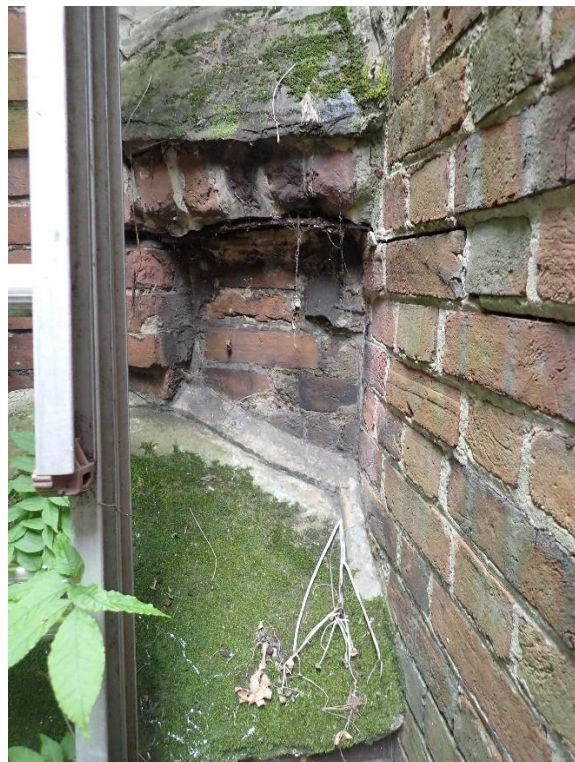
*Figure 13: Blocked up opening for a former bread oven, on the southern chimney stack.*

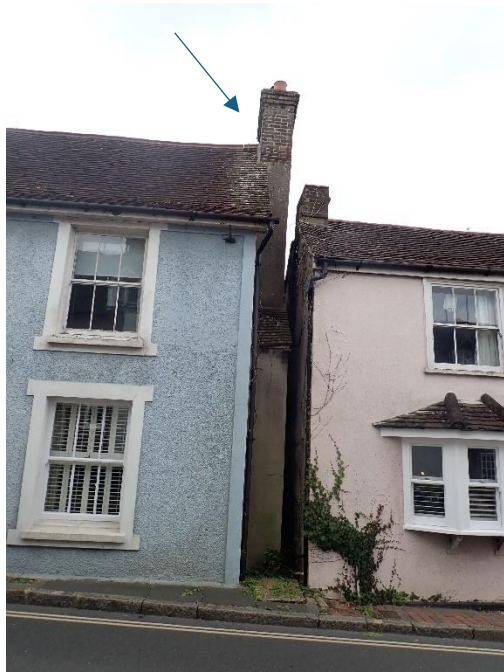
The southern chimney stack currently has three chimney pots indicating three flues. Normally one would be for the ground floor, one for the first floor. The purpose of the third may have been for the loft or for the bread oven, but neither of these is typical and further investigation is required to clarify.

*Figure 14: Chimney stack at the south end with three flues.*

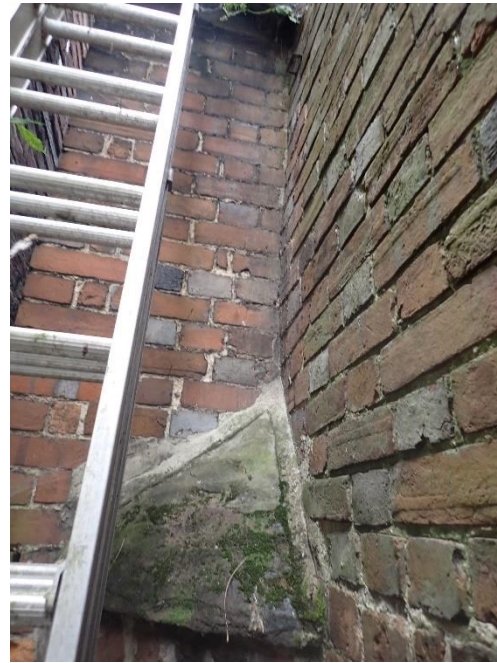
*Figure 15: Brickwork of the chimney and flanking wall.*

The chimney stack on the south is built in brick and is bonded with the flanking brickwork. This may indicate that this flanking wall was also originally built in brick. They may also have been a similar stack at the north end of the main range, but the evidence has been lost. The current stack in this location being Phase D3.

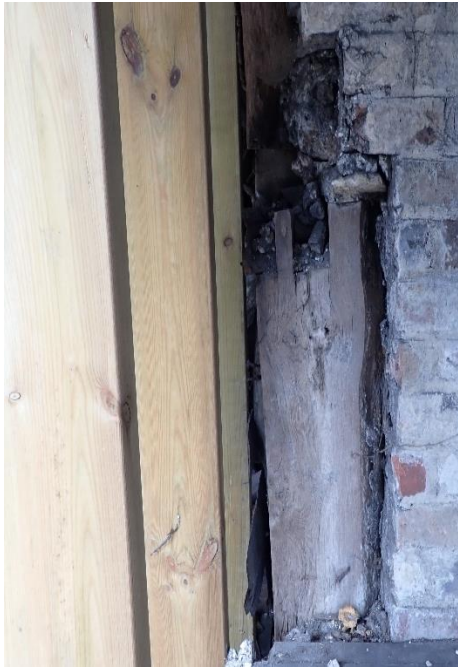
The eaves height was lower than that which survives, as evidenced by the bay posts which are about 1m or so short of the current wallplate. Most of the surviving part of this oak timber-framing is in the westernmost bay.

*Figure 17: Top of a bay post, in the southern wall, on this Phase C1 extension. Now redundant as the wall was lifted higher in Phase E*

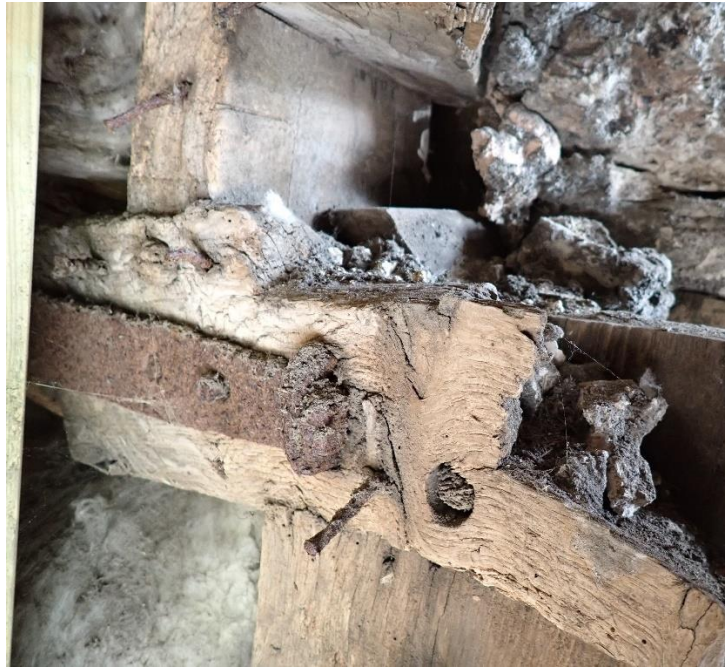
*Figure 18: side view of the same bay post, showing the wall plate with a wrought iron strap.*

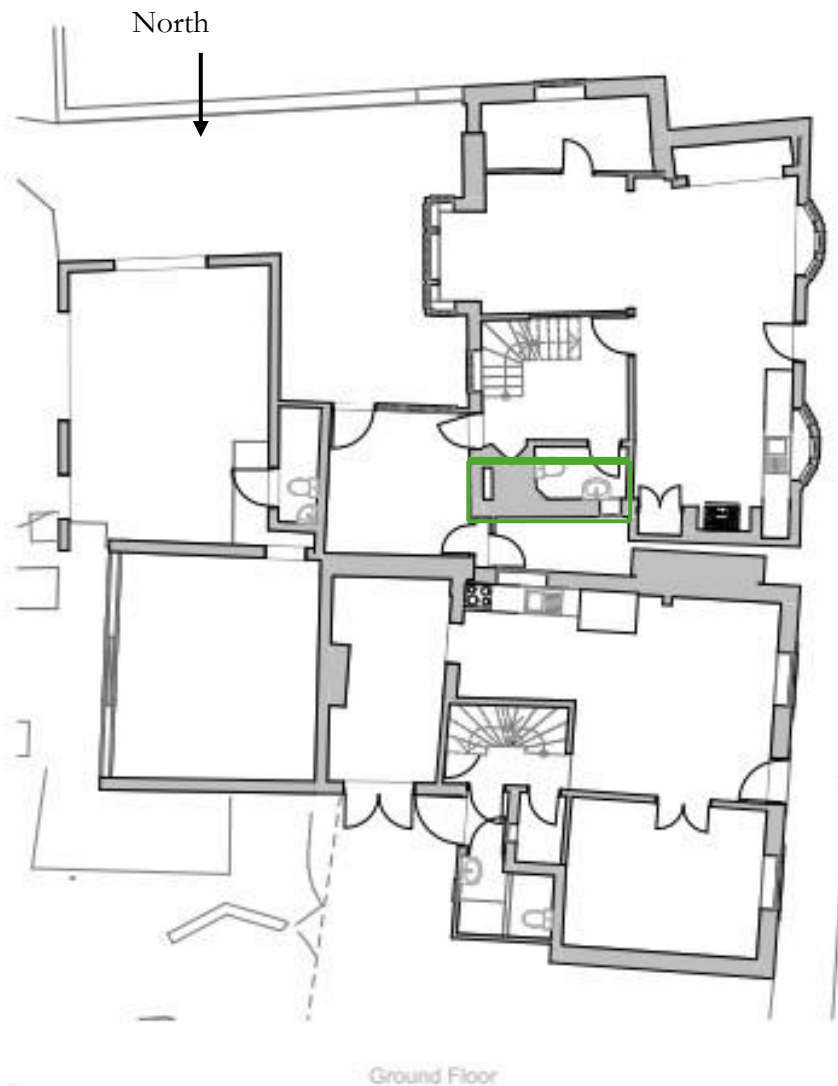
*Figure 19: Annotated plan showing the Phase C2 extension to The Friary.*

The three pairs of common rafters over this northern end of this bay are not smoke-blackened but are oak and are framed with a bridle joint at their apex. The chimney towards the eastern wall is probably contemporary though partly rebuilt.

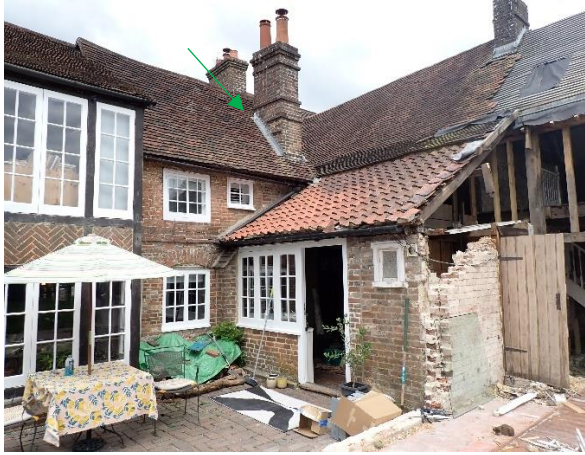
*Figure 20: the Phase C2 extension.*

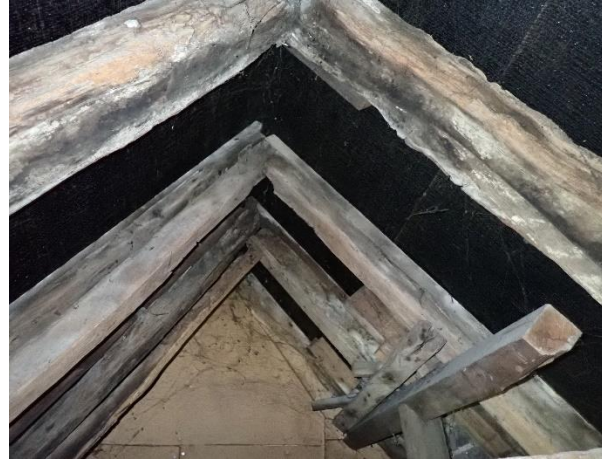
*Figure 21: the oak common rafters over the Phase C2 extension.*

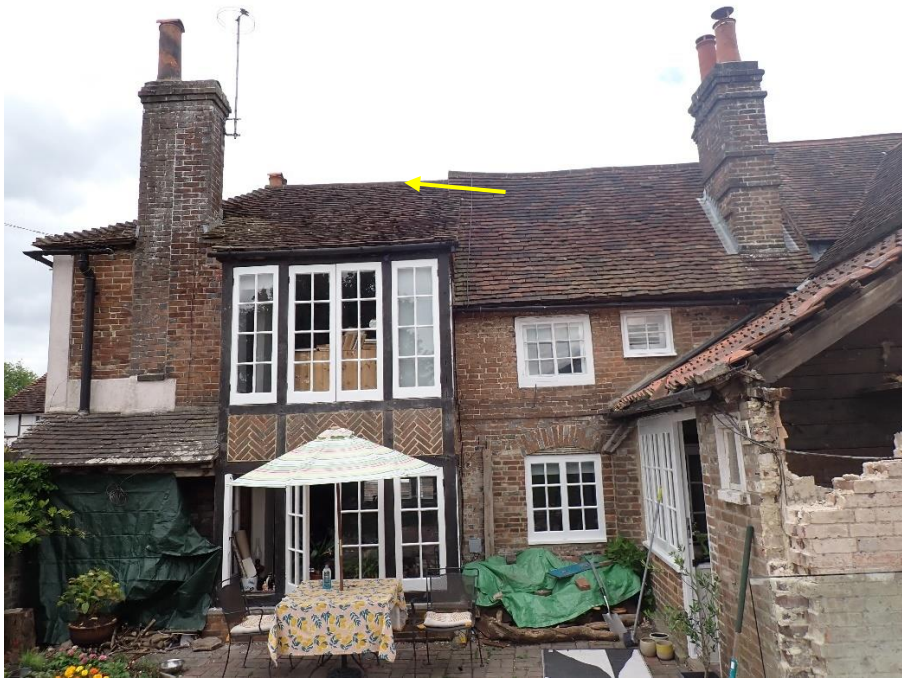
*Figure 23: The raised eaves over Bay 2.*

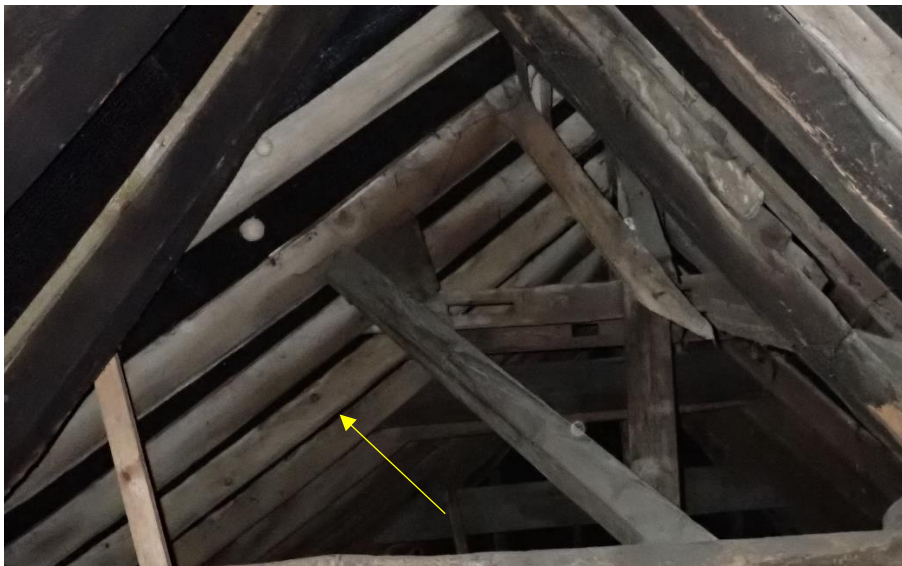
*Figure 24: The new rafters over Bay 2, utilising some reused timbers, evidenced by the redundant mortices.*

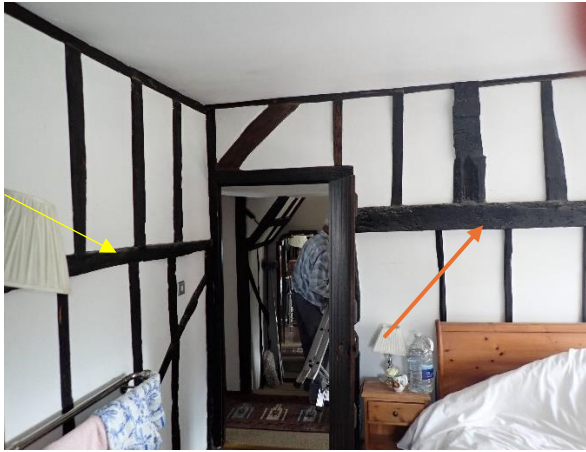
Internally the additional timbers to lift the eaves up are clearly visible.

*Figure 25: The Phase A wallplate and tie beam are arrowed, with Phase D1 timbers above.*

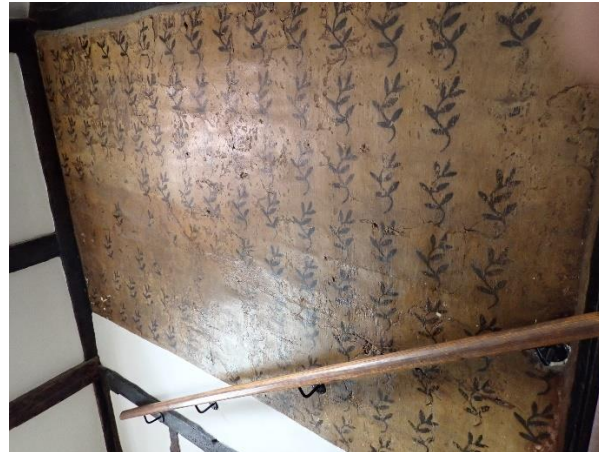
Additional improvements were internal decoration to the chamber of Bay 1. Here a fragment of wall painting survives. This is a regular repeating grid of sprigs on a plain background. It is applied over a lime plaster on laths nailed to stud-framing. It is imitating wallpapers of this period (*Andrea Kirkham, pers comm*).

*Figure 26: Wall painting on the other side of the wall with the orange arrow in Figure 24.*

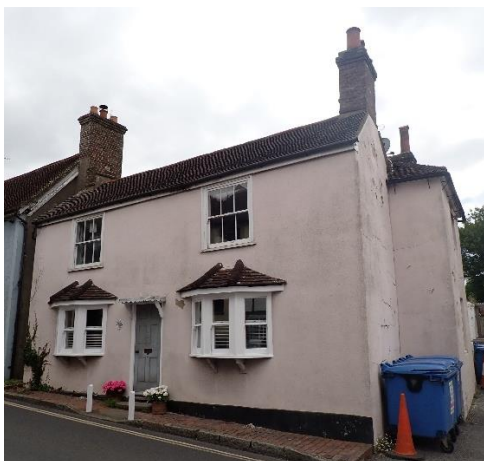
Figure 28: the west and front elevation of Phase D2.

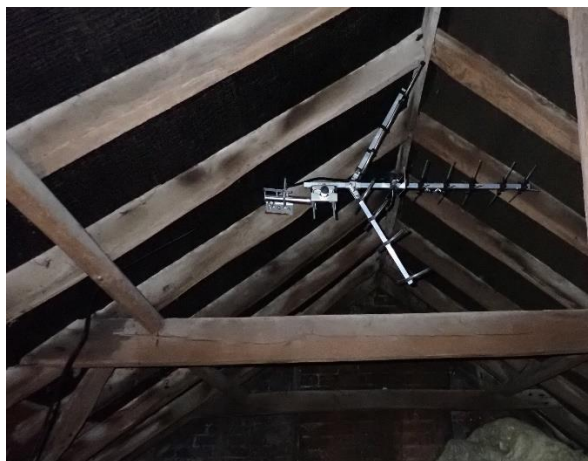
Figure 29: the softwood roof over the front range.

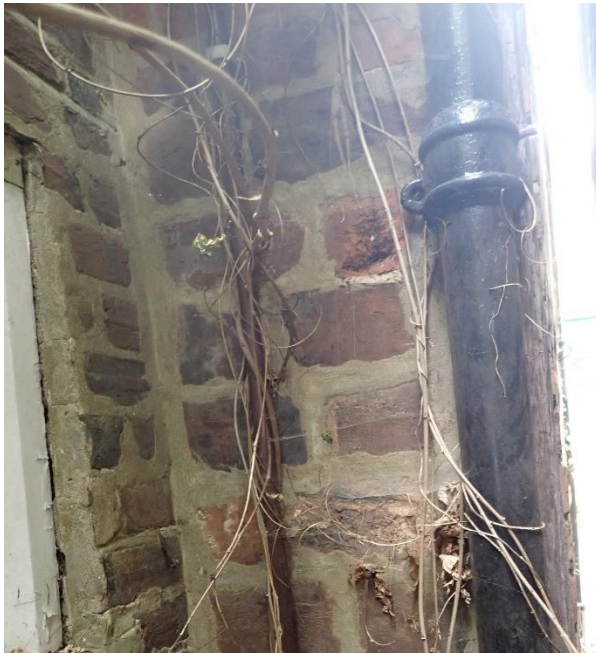
The gabled terminals at each end had two flued chimneys, serving hearths on both the ground and first floors.

*Figure 30: Brick on edge of the northern chimney.*

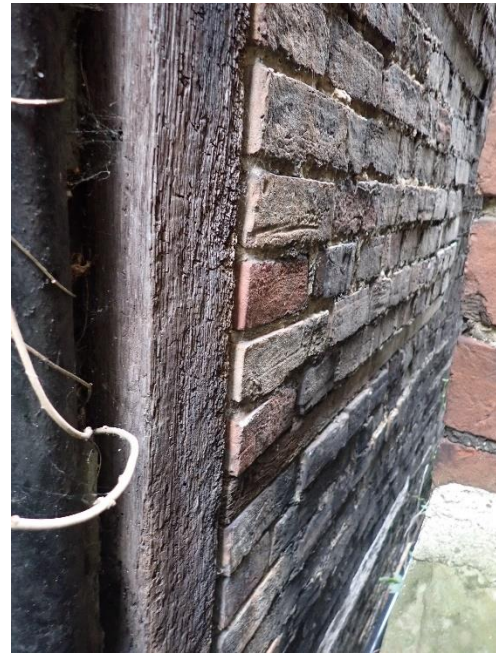
*Figure 31: Northern chimney, bricks laid with faces mis-aligned due to proximity of Somners southern chimney, about 200mm*

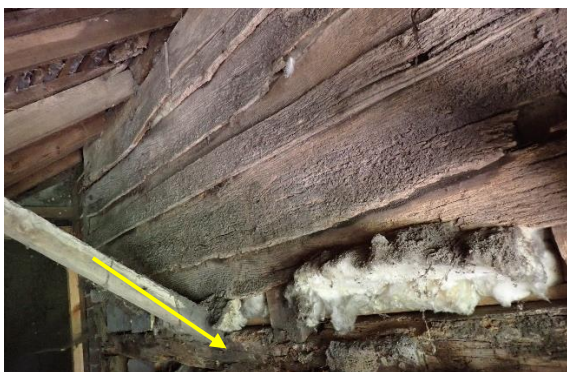
Figure 33: the Phase C1 wallplate (arrowed) with new timbers raising the eaves and weather-boarded, above.

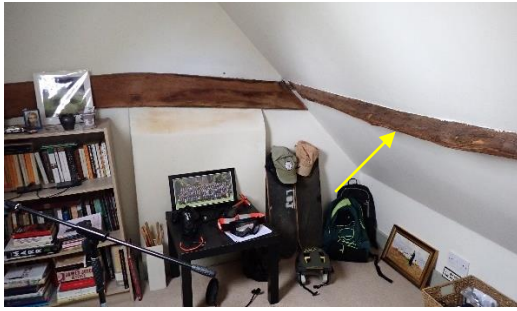
*Figure 34: clapsed side-purlin in Bay 6, at loft level.*

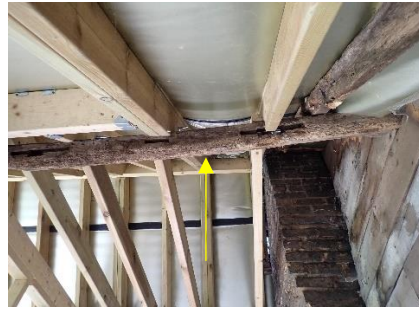
*Figure 35: The purlin extending into Bay 7.*

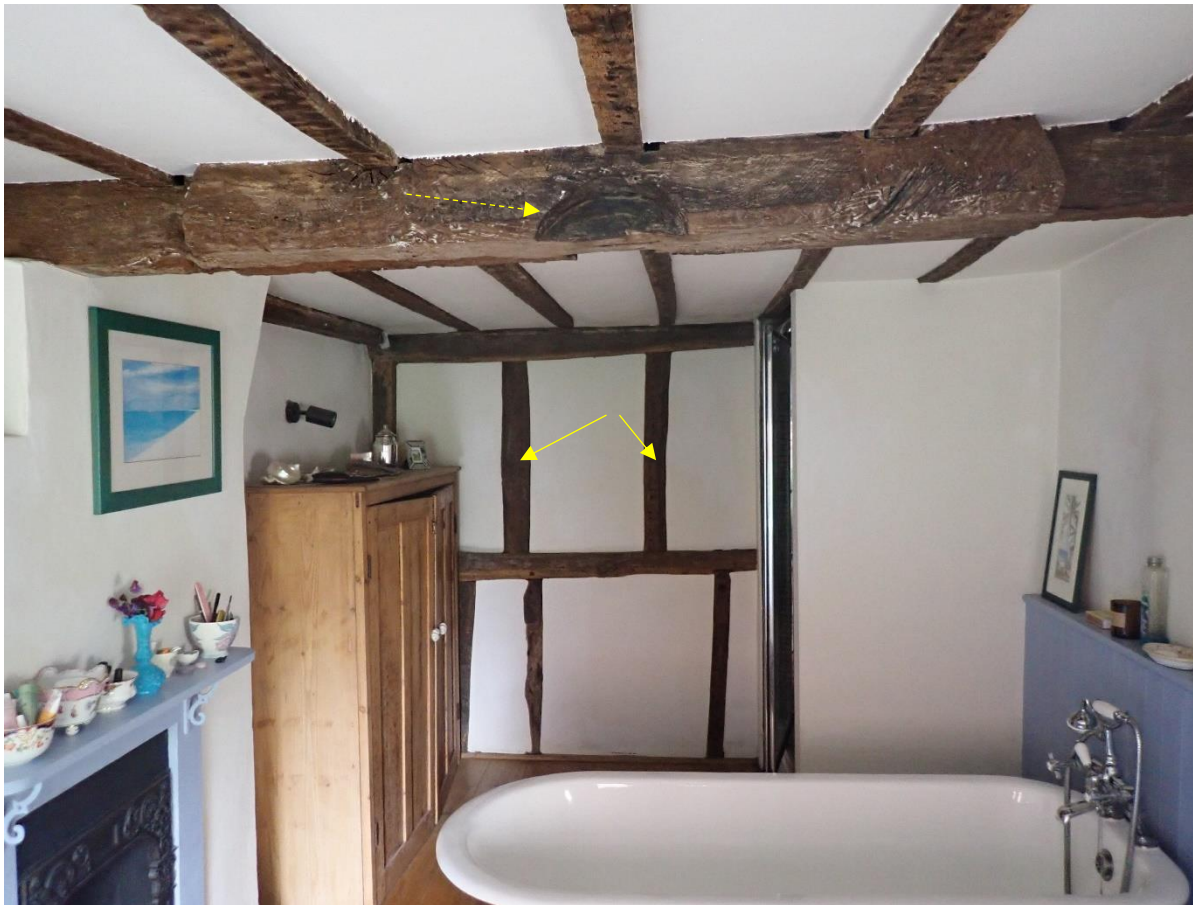
At the first floor level a doorway was created from the Phase B stair landing, into Bay 6. Part of the re-framing of this chamber utilised second-hand timber.

*Figure 36: the new chamber in Bay 6. Note the arrowed timbers in the background, raising the eaves and the central floor beam with its redundant semi-circular housing.*

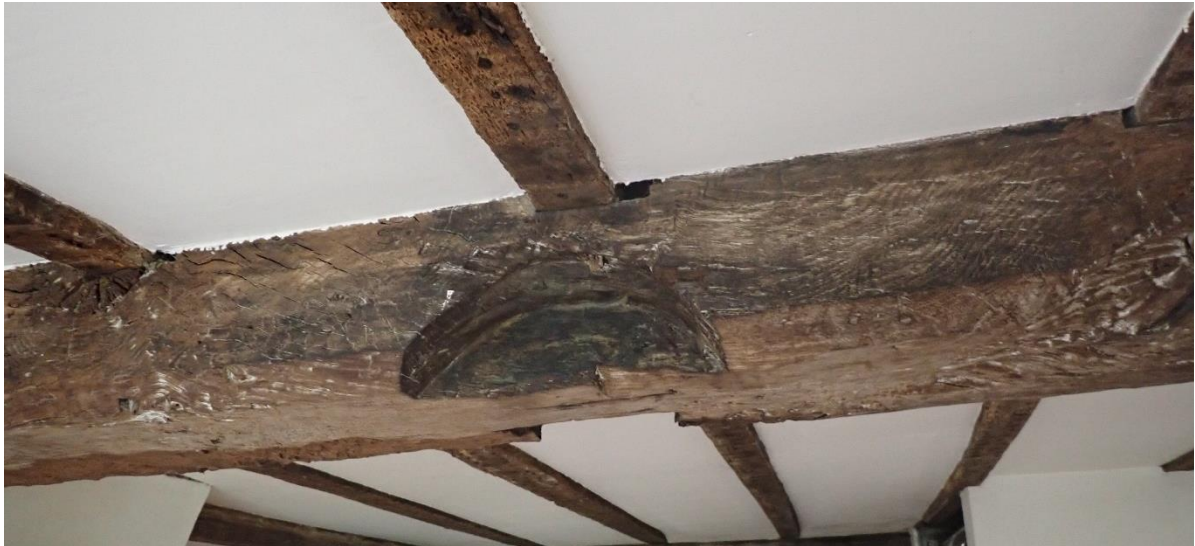
Close examination of this central floor beam shows that it has blackish deposits of grease/oil in the area of the semi-circular housing.

Figure 37: detail of the semi-circular housing.

This shape of housing and staining is consistent with this timber formerly being part of a bell frame. The housing being under the bearing or gudgeon and the semi-circular shape allowing for the movement of the ring of the headstock (or axle) on which the bell rotates. This implies that the timber is currently upside down compared to its earlier use. *It would be fascinating to know if the parish church, which is within 100m has any records of repairs to or a new bell frame during this period.*

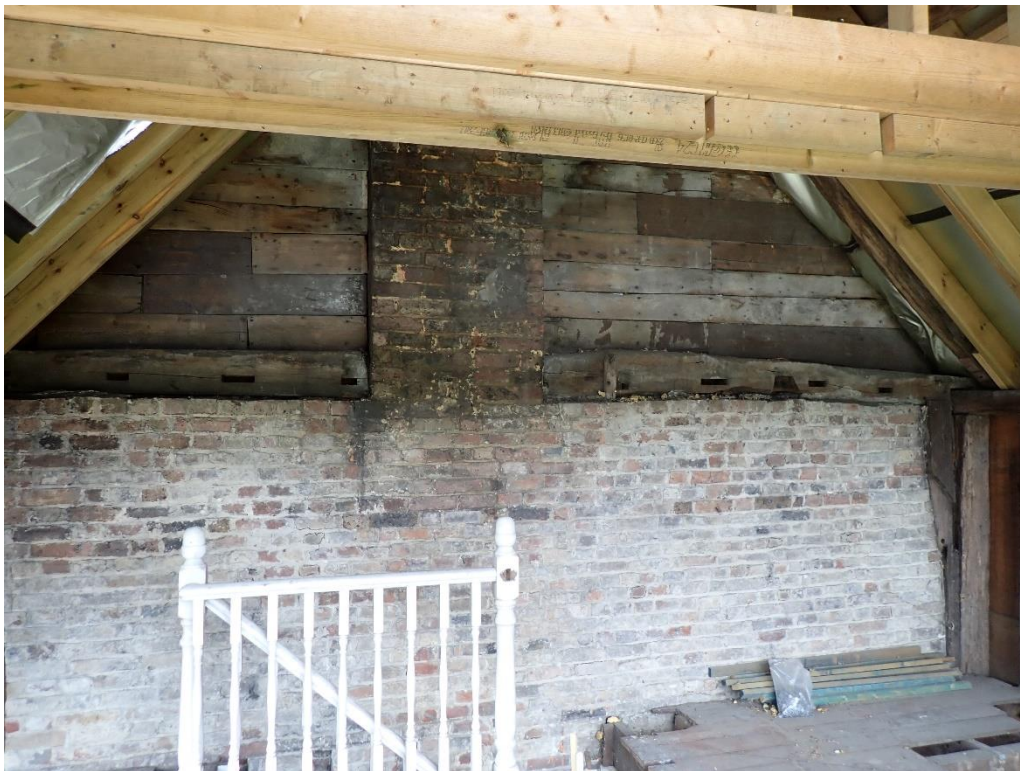
In order to heat this new domestic space a chimney was built up against the timber cross-frame between Bays 6 and 7, and a brickwork partition extended either side of this up to the new tie beam level. The tie beam was a second-hand timber with redundant mortices.

Figure 38: The new brickwork partition, chimney and re-used tie beam between Bays 6 and 7.

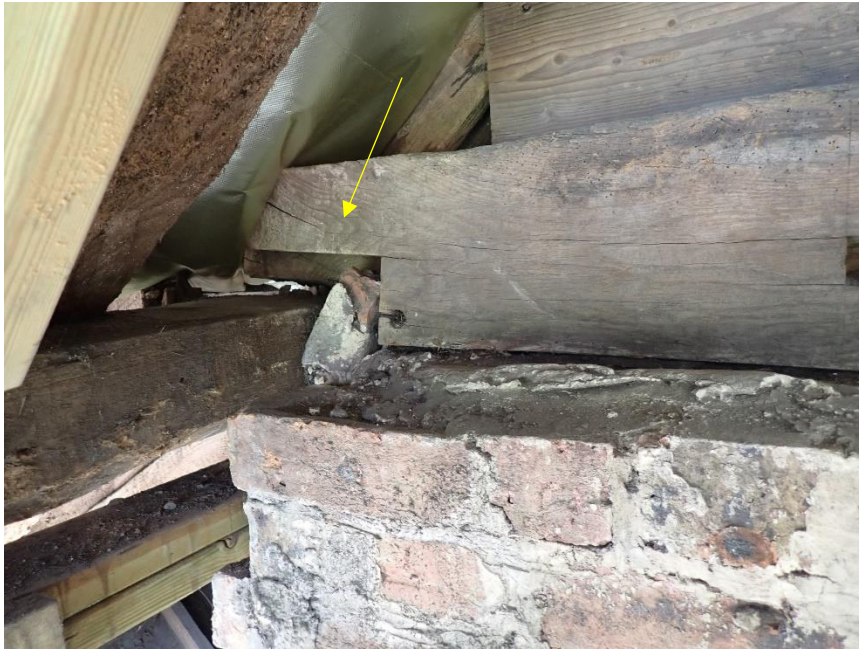
*Figure 39: detail of the lap dovetail joint between the new wallplate and tiebeam.*

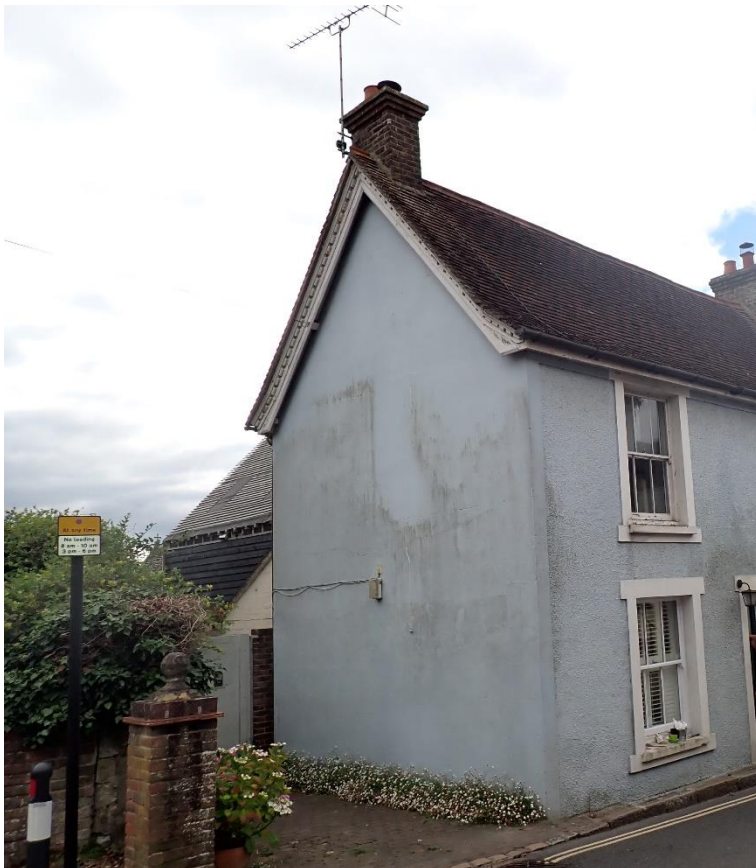
During this phase the northern gable end including a brick chimney of the main, front, range was either rebuilt or added.

*Figure 40: chimney at the north end of the main, front, range.*

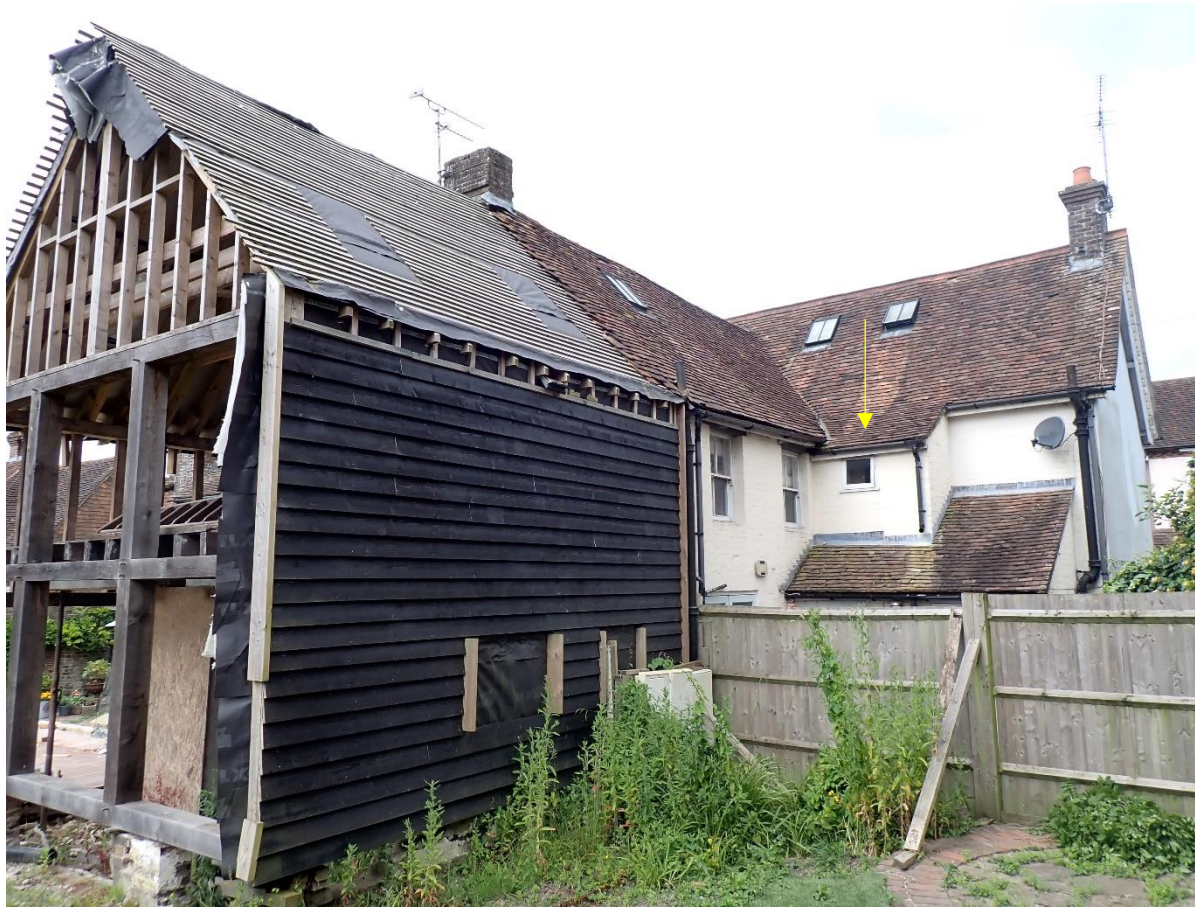
There is a rear two storey outshot added into the angle between the stair range and the main range.

*Figure 41: showing the raised eaves and roof of the rear range (left hand side) and the new outshot (arrowed yellow) to the main range.*

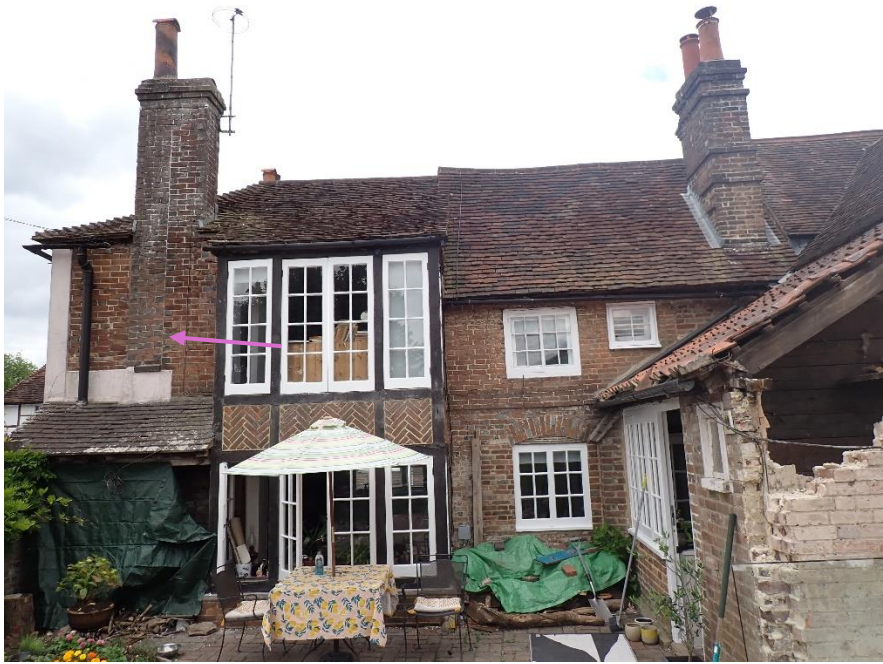
*Figure 43: Additional room and a flue added to the south end of Phase A and D1 of The Friary.*

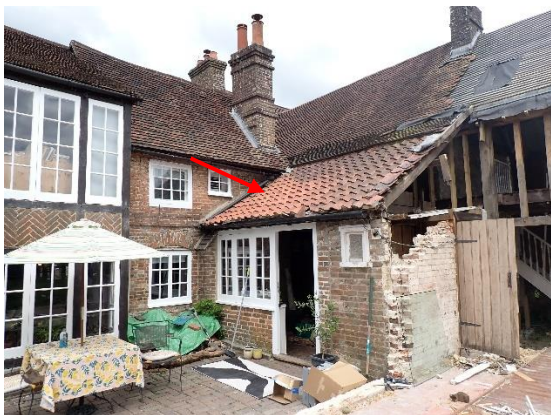
Figure 45: The extensions accessed from *The Friary* and built against *Somners*.

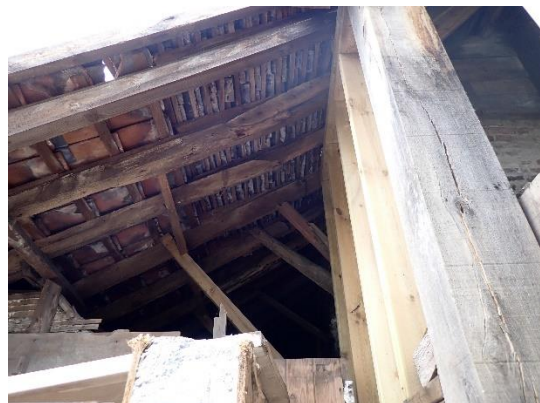
Figure 46: the lean-to roof abutting the framing of *Somners*, on the right hand side.

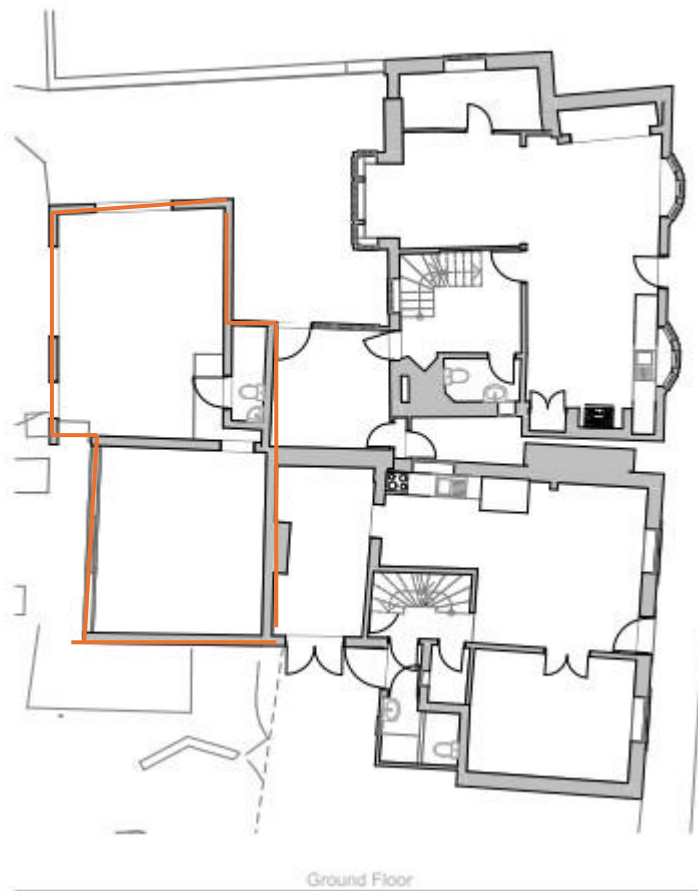
Figure 47: Annotated plan view of Phase G, *Dumbrells*, to the rear of *The Friary* and *Somners*.

A prefabricated timber-framed and corrugated iron building – *probably initially non-domestic* – attached to Phase F, of *The Friary* and incorporating part of Phase D of *Somners*. Late converted to a dwelling and then consent given to its demolition recently.

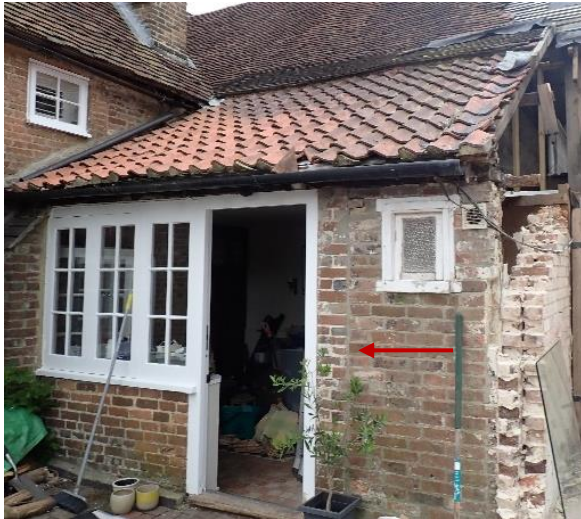
*Figure 48: The only remaining part of this Phase, to the east, identified by abutment in the brickwork*

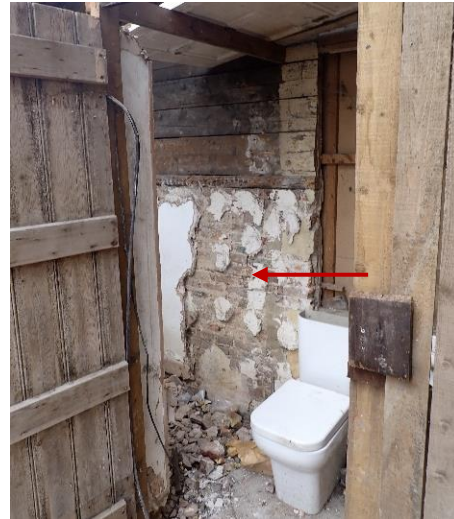
*Figure 49: The end wall of the abutting Phase F.*

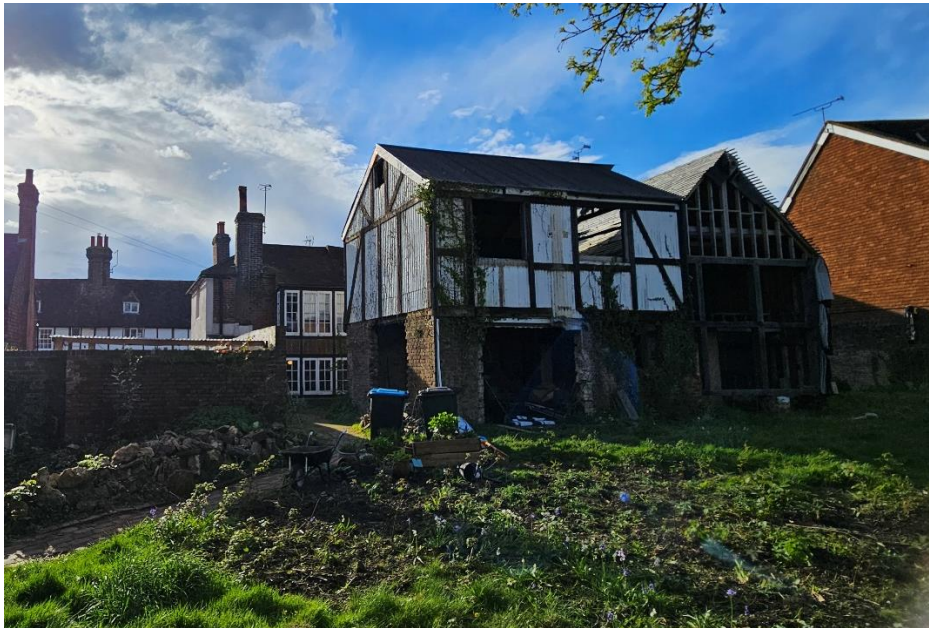
*Figure 50: East elevation (photo courtesy of Jo Saady, April 2024)*

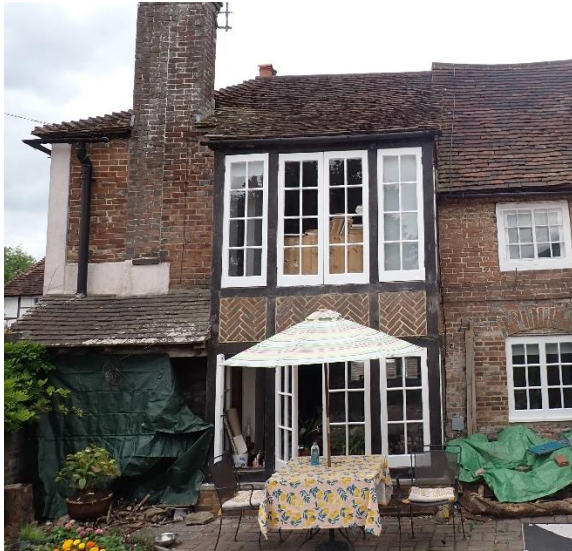
*Figure 51: Bay windows on the rear of The Friary.*
