**SUPPLEMENTARY GEOENVIRONMENTAL ASSESSMENT  
IMBERHORNE LANE - PARCEL B  
EAST GRINSTEAD  
VISTRY  
GEA-21949BA-25-18  
MARCH 2026**

SUPPLEMENTARY GEOENVIRONMENTAL ASSESSMENT  
 IMBERHORNE LANE - PARCEL B  
 EAST GRINSTEAD  
 VISTRY  
 GEA-21949BA-25-18  
 MARCH 2026

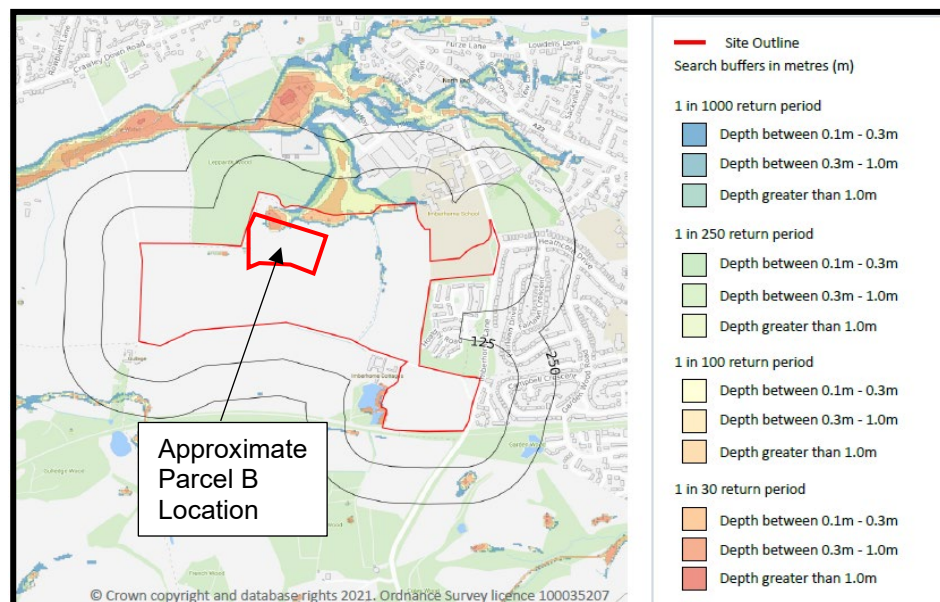
- 2.3.2 Within the Groundsure report appended to the desk study, it was noted that discharges of water or liquid waste of more than 5m<sup>3</sup> to ground or to surface waters would require consultation with the regulator as the site lies within a SSSI impact risk zone for the SSSI known as Hedgecourt.
- 2.3.3 The risk of surface water flooding is considered to be very high with 1 in 30 year chance of flooding with depth greater than 1.0 m within the northern half of the site. This is considered to represent attenuation points within the flood plain of Eden Brook. The risk of groundwater flooding is considered to be negligible and the site is not located within an area at risk of flooding from rivers or the sea. An excerpt of the surface water flood risk mapping is presented in Figure 1 below.

Figure 1- An excerpt from the Groundsure Report highlighting the surface water flood risk on Parcel B

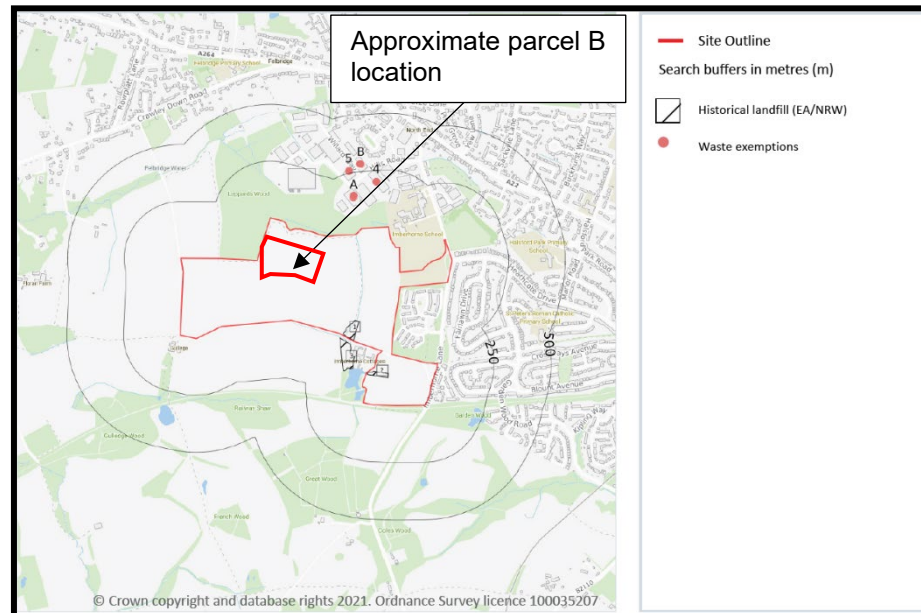
- 2.4.2 Three historical landfills are located between 300 to 500m to the south east of Parcel B. Each of the historical landfills were recorded to have received inert waste material and their licences were surrendered in 1980.

Figure 2- Extract from the Groundsure report included within the Campbell Reith desk study

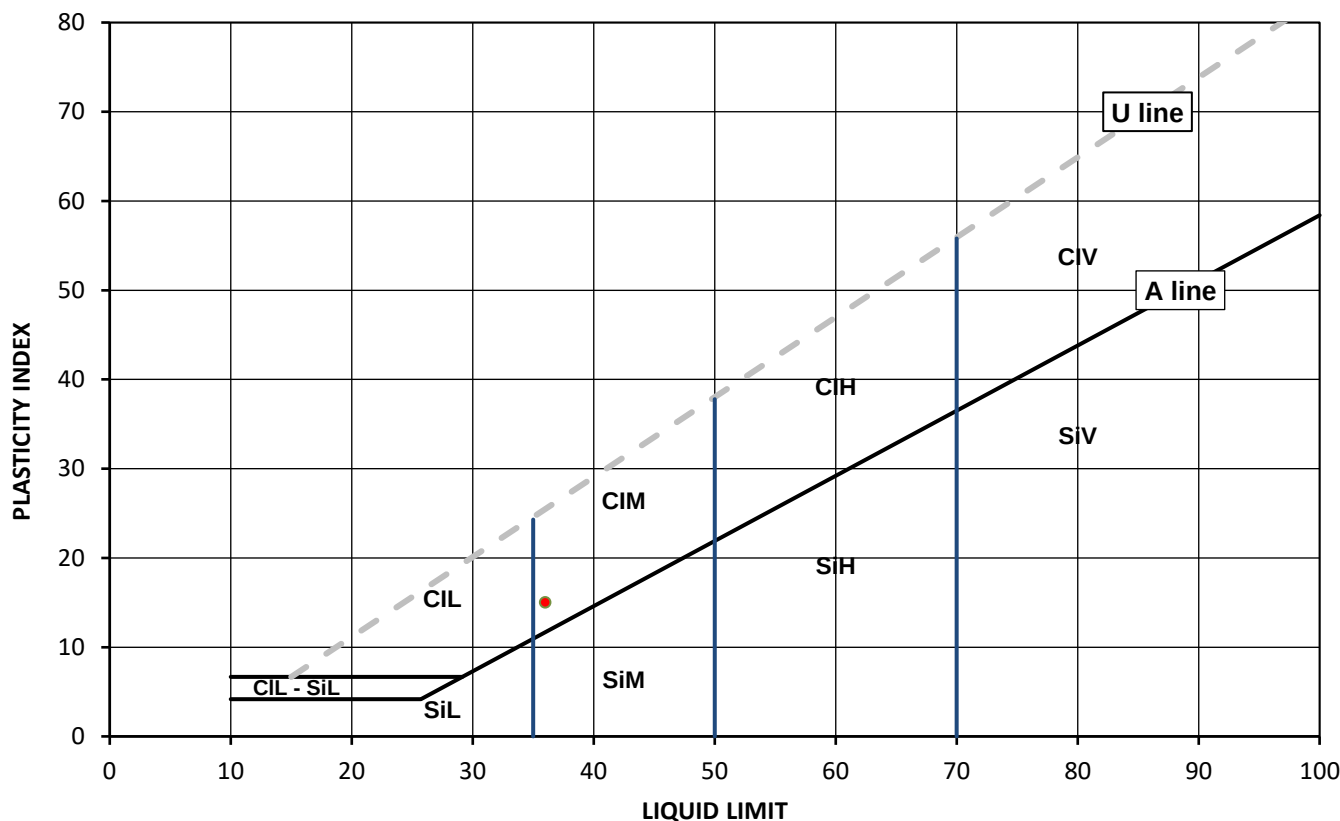
| As Received Water Content [W] % | Corrected Liquid Limit [WL] % | Correlation Factor | Plastic Limit [Wp] % | Plasticity Index [Ip] % | Liquidity index [IL] % # | Consistency index [IC] % # | % Passing 425µm BS Test Sieve |
|---|---|---|---|---|---|---|---|
| 19.3 | 36 | 0.968 | 21 | 15 | -0.13 | 1.13 | 100 |

Legend, based on BS EN ISO 14688 2:2018 Geotechnical investigation and testing – Identification and classification of soil

- 6.1.6 The final foundation depth must be determined using Chapter 4.2 of the NHBC Standards for building near trees and hedges and extending as necessary. Atterberg limits tests have classified the cohesive soils as low volume change potential. The minimum footing depth of 0.9m was determined as at this depth most of soft clay soils near surface would be bypassed.

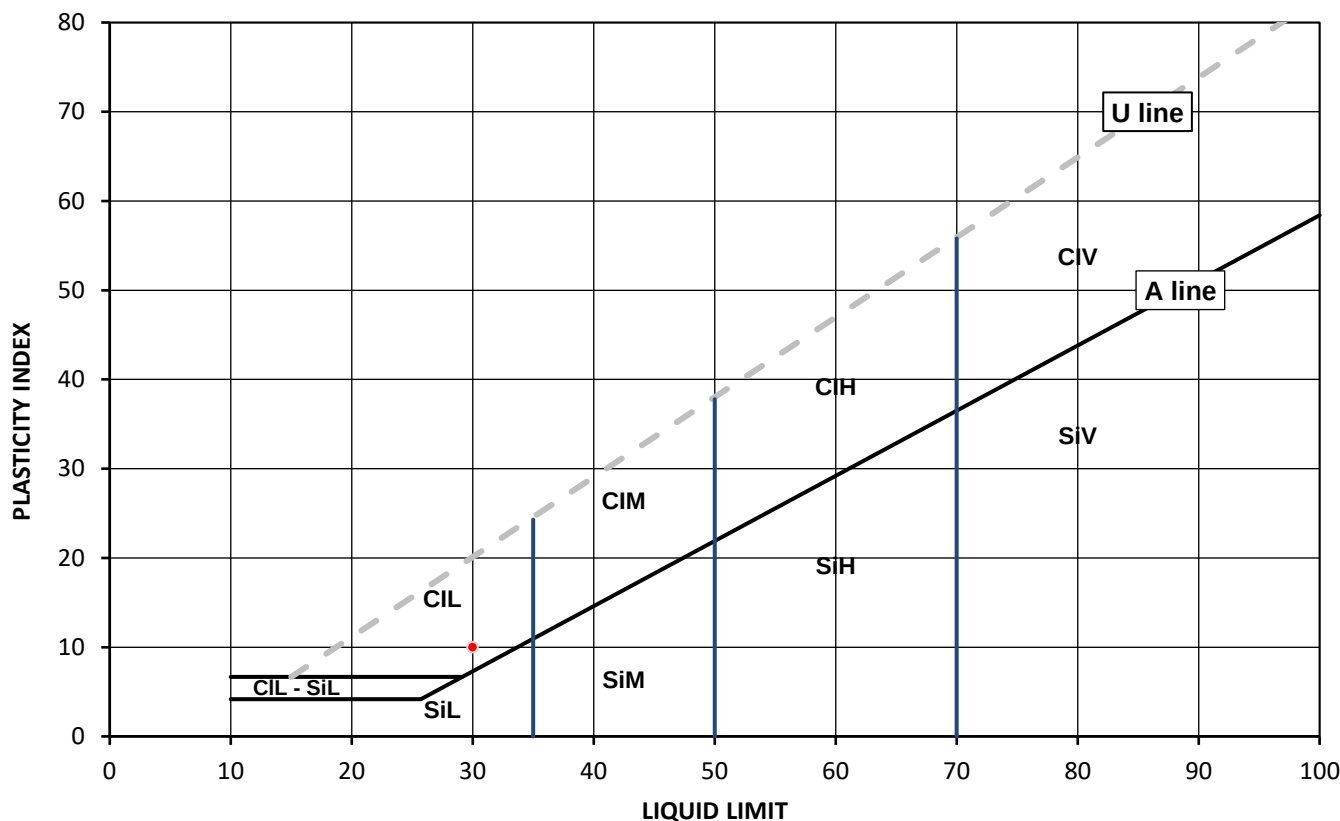
| As Received Water Content [W] % | Liquid Limit [WL] % | Plastic Limit [Wp] % | Plasticity Index [Ip] % | Liquidity Index [IL] % # | Consistency Index [IC] % # | % Passing 425µm BS Test Sieve |
|---|---|---|---|---|---|---|
| 20.6 | 30 | 20 | 10 | 0.10 | 0.90 | 95 |

Legend, based on BS EN ISO 14688 2:2018 Geotechnical investigation and testing – Identification and classification of soil

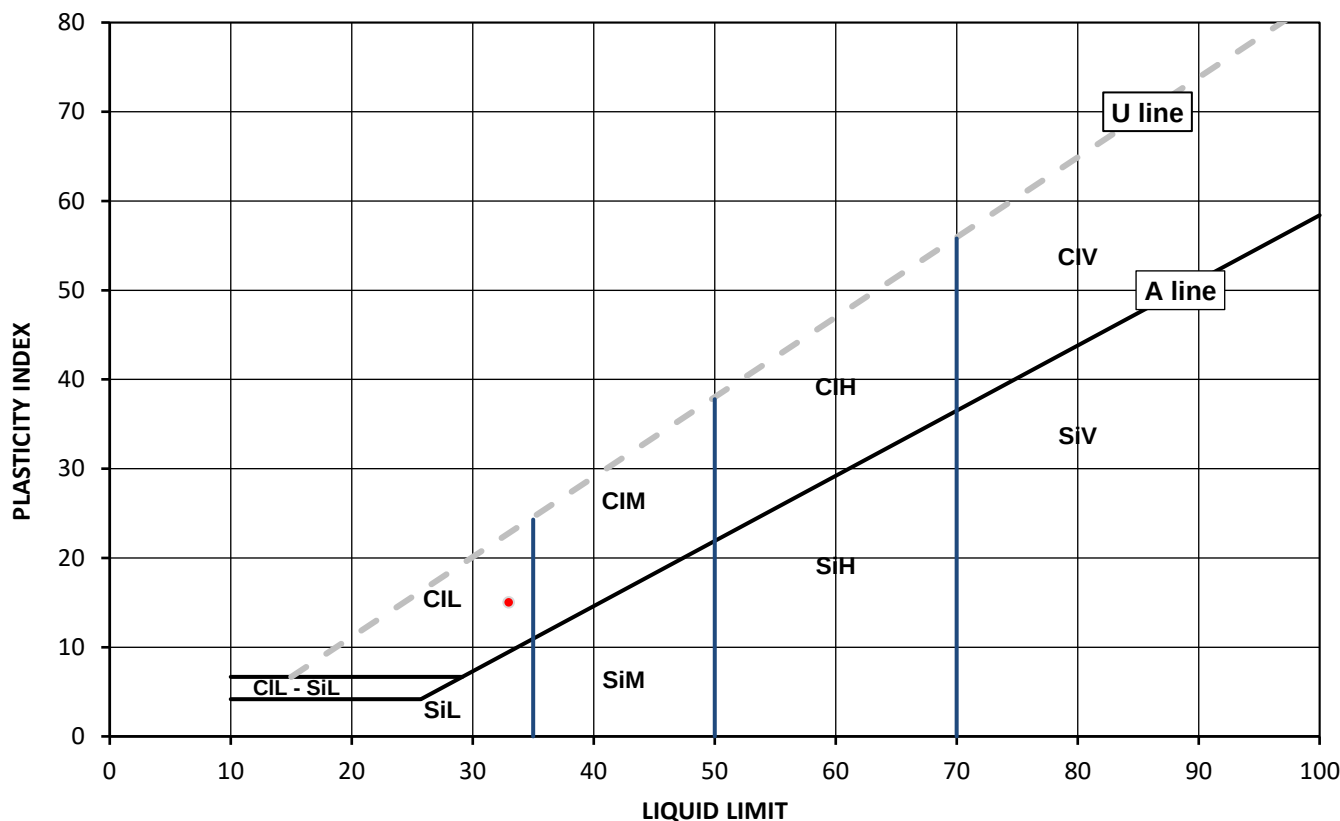
| As Received Water Content [W] % | Liquid Limit [WL] % | Plastic Limit [Wp] % | Plasticity Index [Ip] % | Liquidity Index [IL] % # | Consistency Index [IC] % # | % Passing 425µm BS Test Sieve |
|---|---|---|---|---|---|---|
| 22.8 | 33 | 18 | 15 | 0.33 | 0.67 | 100 |

Legend, based on BS EN ISO 14688 2:2018 Geotechnical investigation and testing – Identification and classification of soil

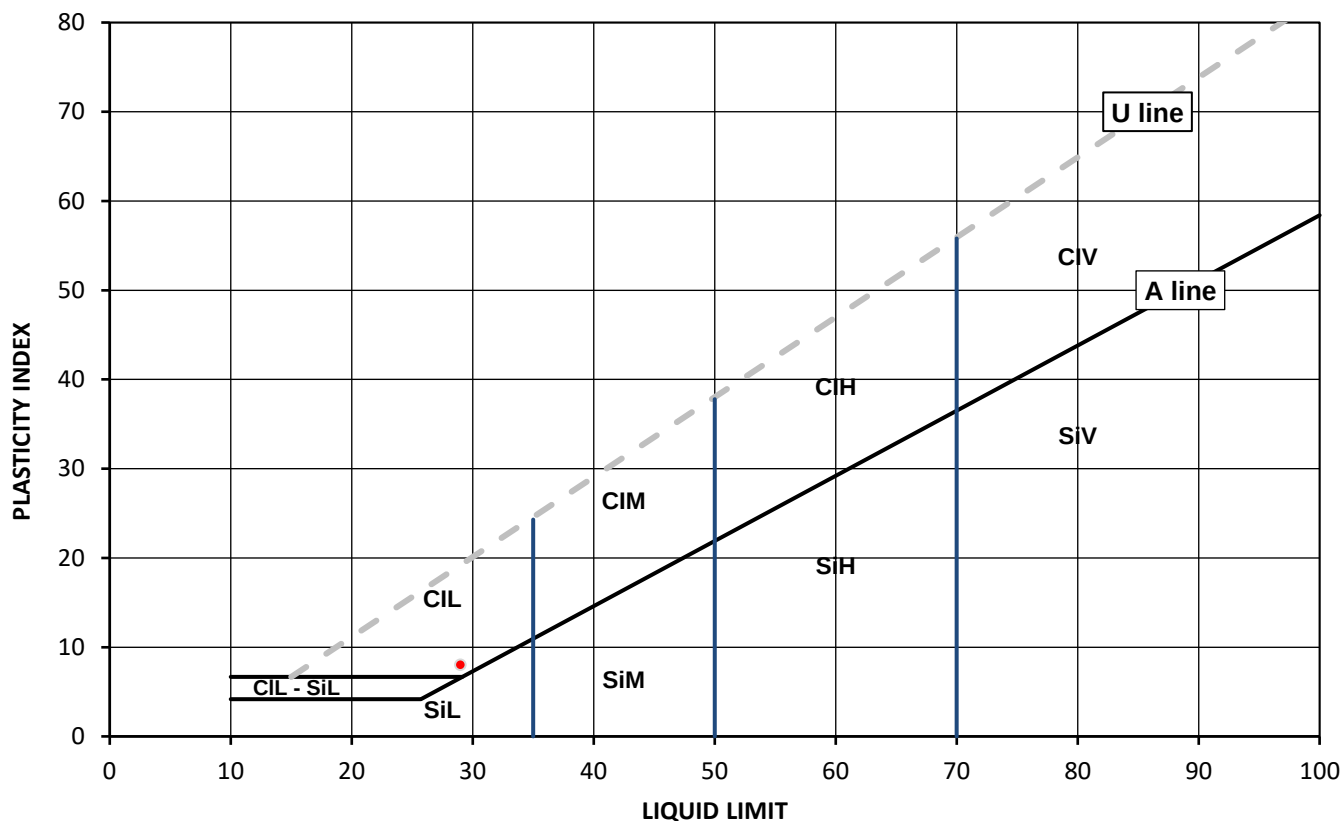
| As Received Water Content [W] % | Liquid Limit [WL] % | Plastic Limit [Wp] % | Plasticity Index [Ip] % | Liquidity Index [IL] % # | Consistency Index [IC] % # | % Passing 425µm BS Test Sieve |
|---|---|---|---|---|---|---|
| 21.7 | 29 | 21 | 8 | 0.13 | 0.88 | 100 |

Legend, based on BS EN ISO 14688 2:2018 Geotechnical investigation and testing – Identification and classification of soil

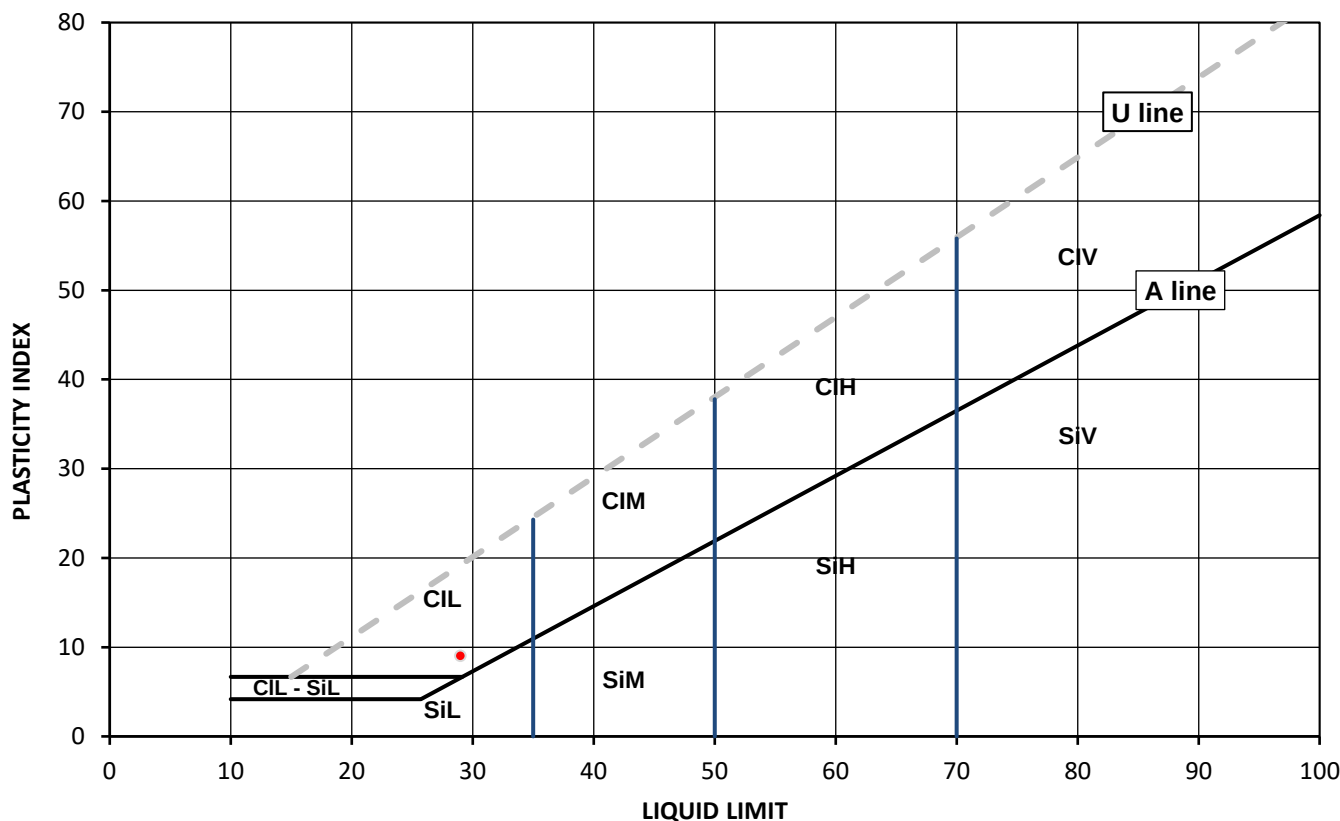
| As Received Water Content [W] % | Liquid Limit [WL] % | Plastic Limit [Wp] % | Plasticity Index [Ip] % | Liquidity Index [IL] % # | Consistency Index [IC] % # | % Passing 425µm BS Test Sieve |
|---|---|---|---|---|---|---|
| 13.2 | 29 | 20 | 9 | -0.78 | 1.78 | 100 |

Legend, based on BS EN ISO 14688 2:2018 Geotechnical investigation and testing – Identification and classification of soil

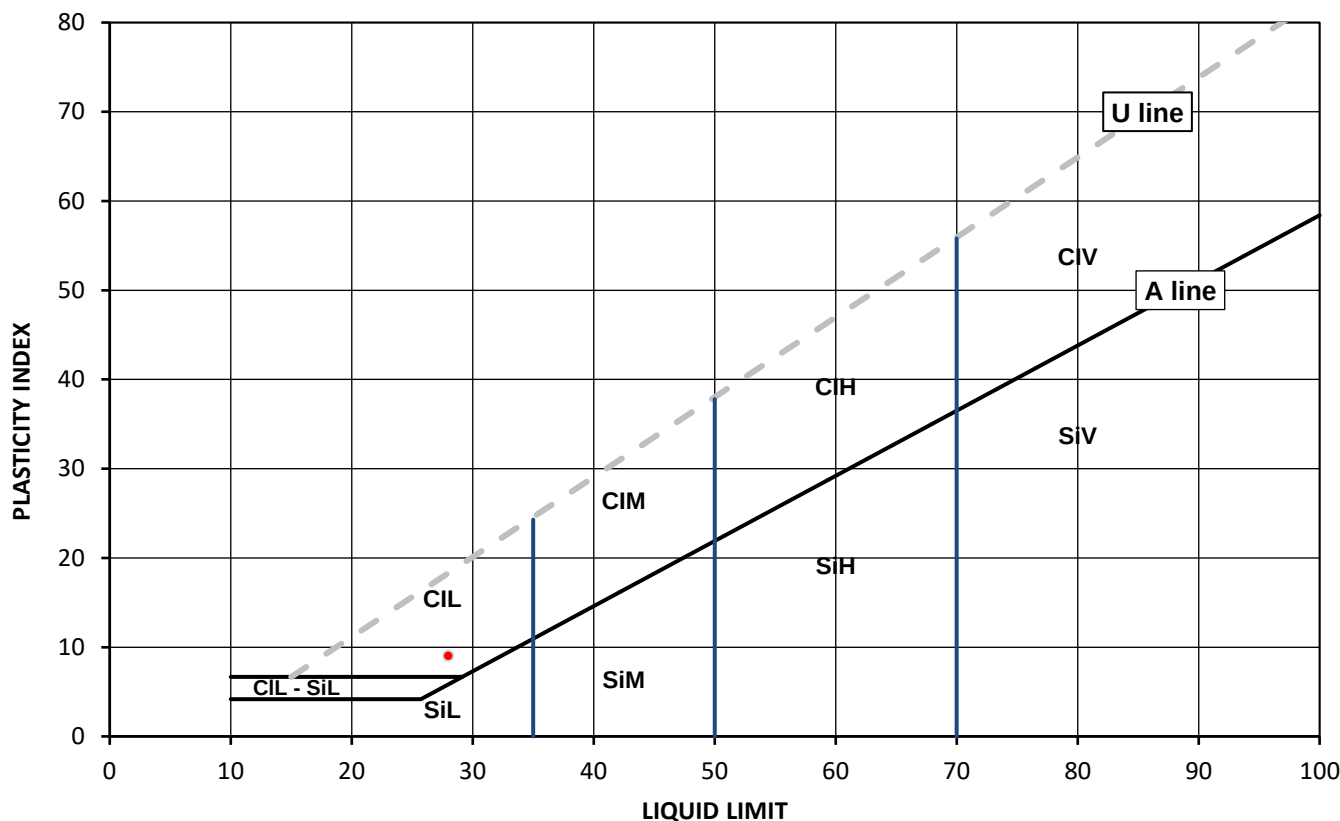
| As Received Water Content [W] % | Liquid Limit [WL] % | Plastic Limit [Wp] % | Plasticity Index [Ip] % | Liquidity Index [IL] % # | Consistency Index [IC] % # | % Passing 425µm BS Test Sieve |
|---|---|---|---|---|---|---|
| 17.2 | 28 | 19 | 9 | -0.22 | 1.22 | 100 |

Legend, based on BS EN ISO 14688 2:2018 Geotechnical investigation and testing – Identification and classification of soil

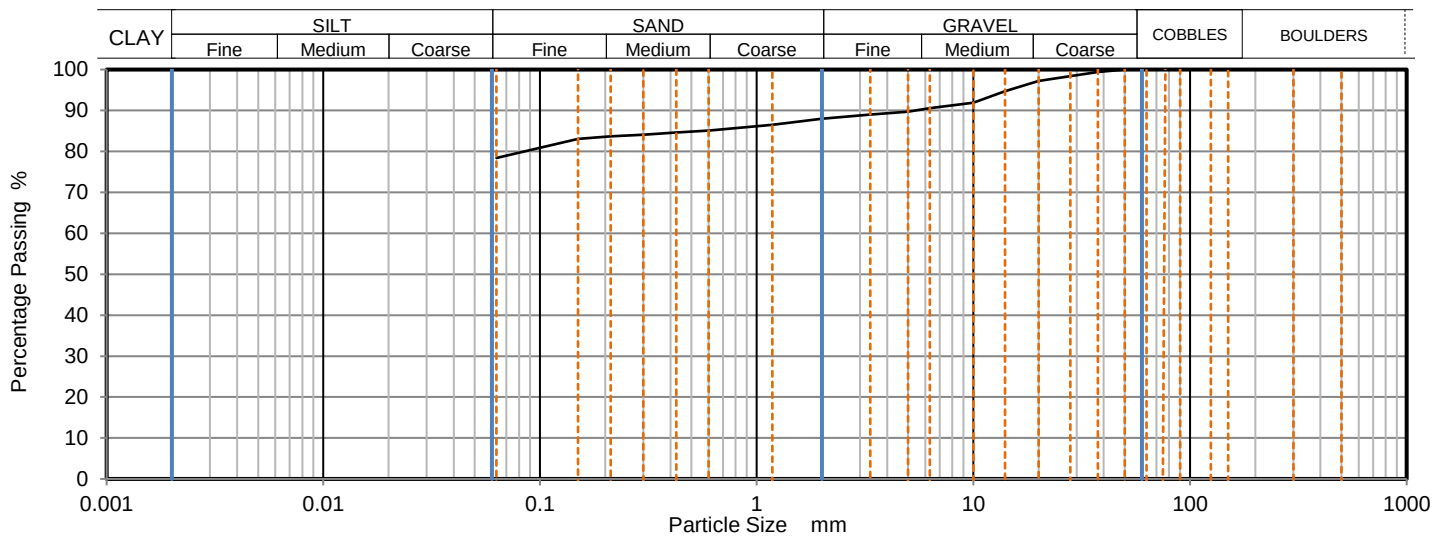
Laboratory Reference: 420403  
Hole No.: Parcel B MTP101  
Sample Reference: Not Given  
Sample Description: Light brown slightly gravelly slightly sandy SILT  
Sample Preparation: Sample was whole tested, oven dried at 107.8 °C and broken down by hand.

Depth Top [m]: 1.50  
Depth Base [m]: Not Given  
Sample Type: B

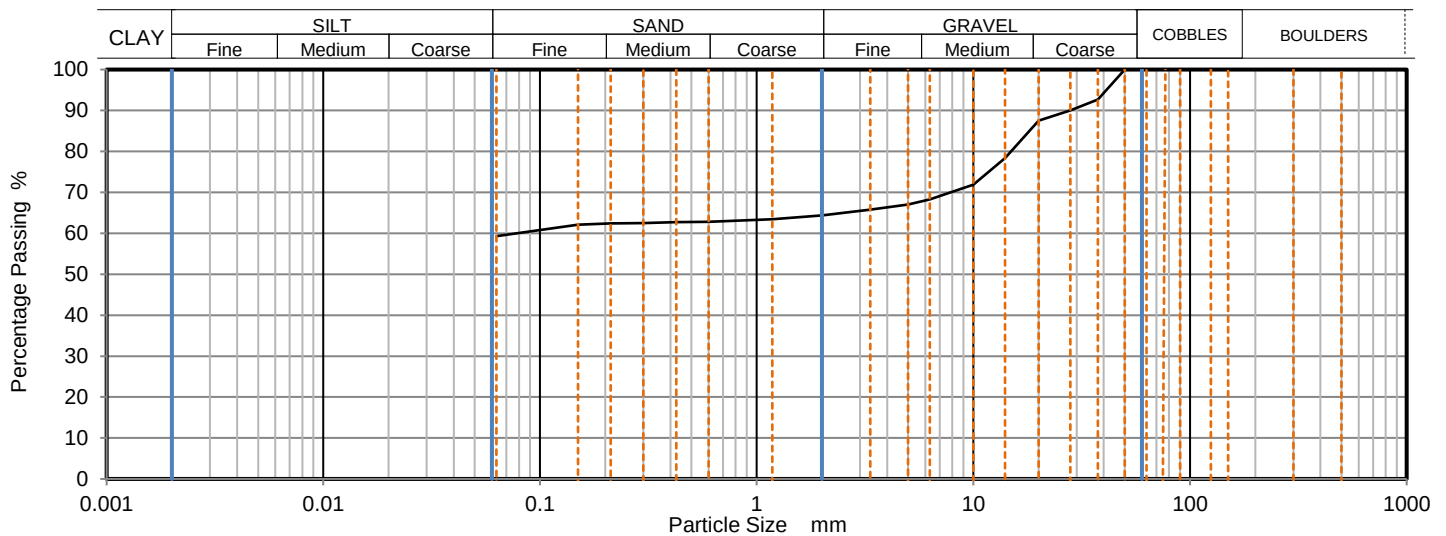
Laboratory Reference: 420404  
Hole No.: Parcel B MTP102  
Sample Reference: Not Given  
Sample Description: Yellowish brown gravelly slightly sandy CLAY  
Sample Preparation: Sample was quartered, oven dried at 107.8 °C and broken down by hand.

Depth Top [m]: 1.50  
Depth Base [m]: Not Given  
Sample Type: B

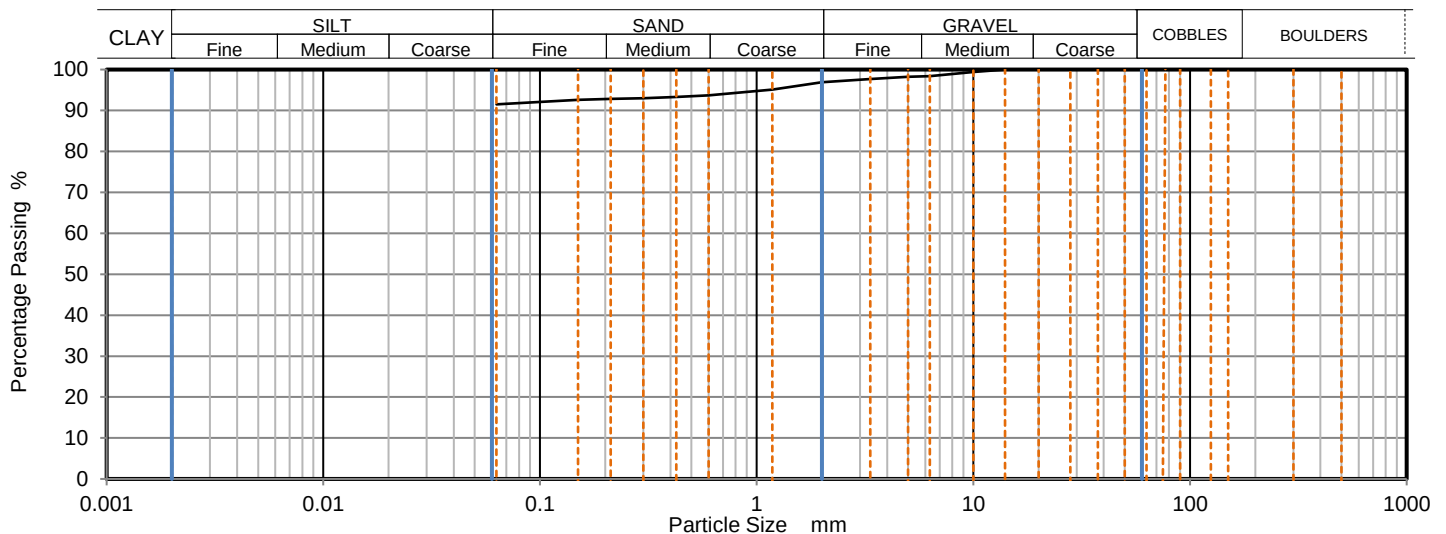
Laboratory Reference: 420406  
Hole No.: Parcel B MTP103  
Sample Reference: Not Given  
Sample Description: Yellowish brown slightly sandy slightly gravelly CLAY  
Sample Preparation: Sample was quartered, oven dried at 107.8 °C and broken down by hand.

Depth Top [m]: 1.50  
Depth Base [m]: Not Given  
Sample Type: B

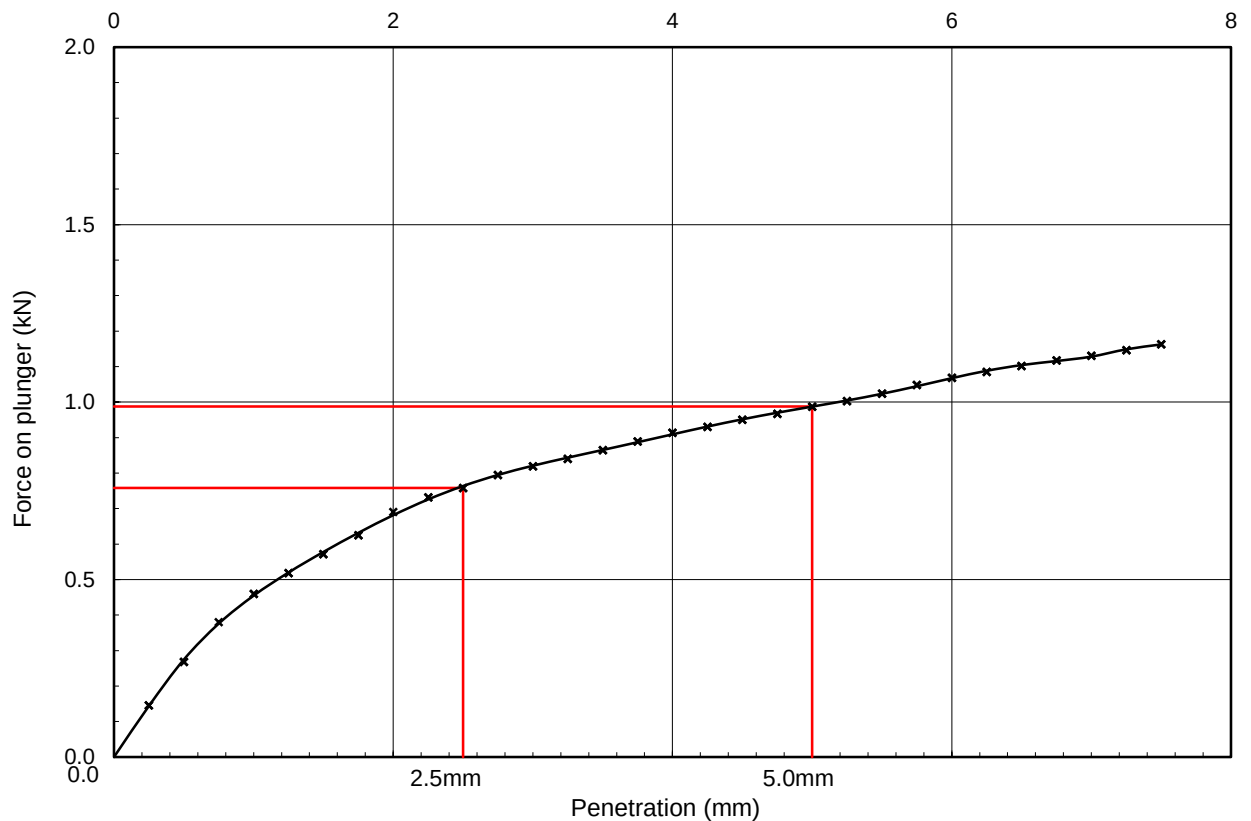
Surcharge: 0.0 kg  
Seating Load: 50 N  
Moisture Content: 24 %  
CBR Value: 5.7 %

The test load was applied using a hand operated screw jack.  
The surcharge mass applied to the surface of the test area on a 250mm diameter ring. The rate of loading was maintained at 1.0 mm per minute.

- 6.5.1 Five in situ CBR tests were undertaken as a part of this investigation (MCBR104-MCBR108) and recorded CBR percentages of between 3.9 and 11% a design CBR percentage of 4.0% would therefore be recommended.

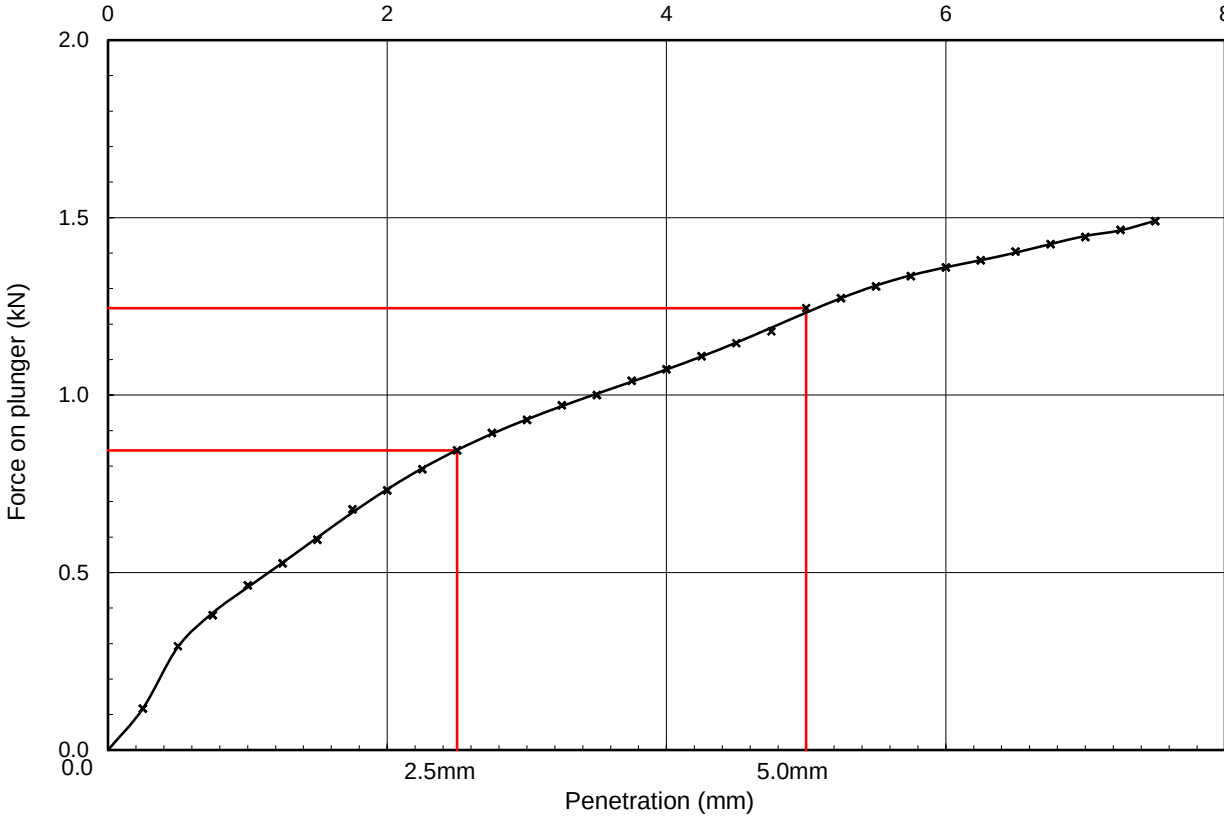
The test load was applied using a hand operated screw jack.  
The surcharge mass applied to the surface of the test area on a 250mm diameter ring. The rate of loading was maintained at 1.0 mm per minute.

Force on plunger (kN)

Penetration (mm)

| Originator | Checked & Approved | CALIFORNIA BEARING RATIO<br>BS1377 : Part 9 : 1990 Clause 4.3 | |

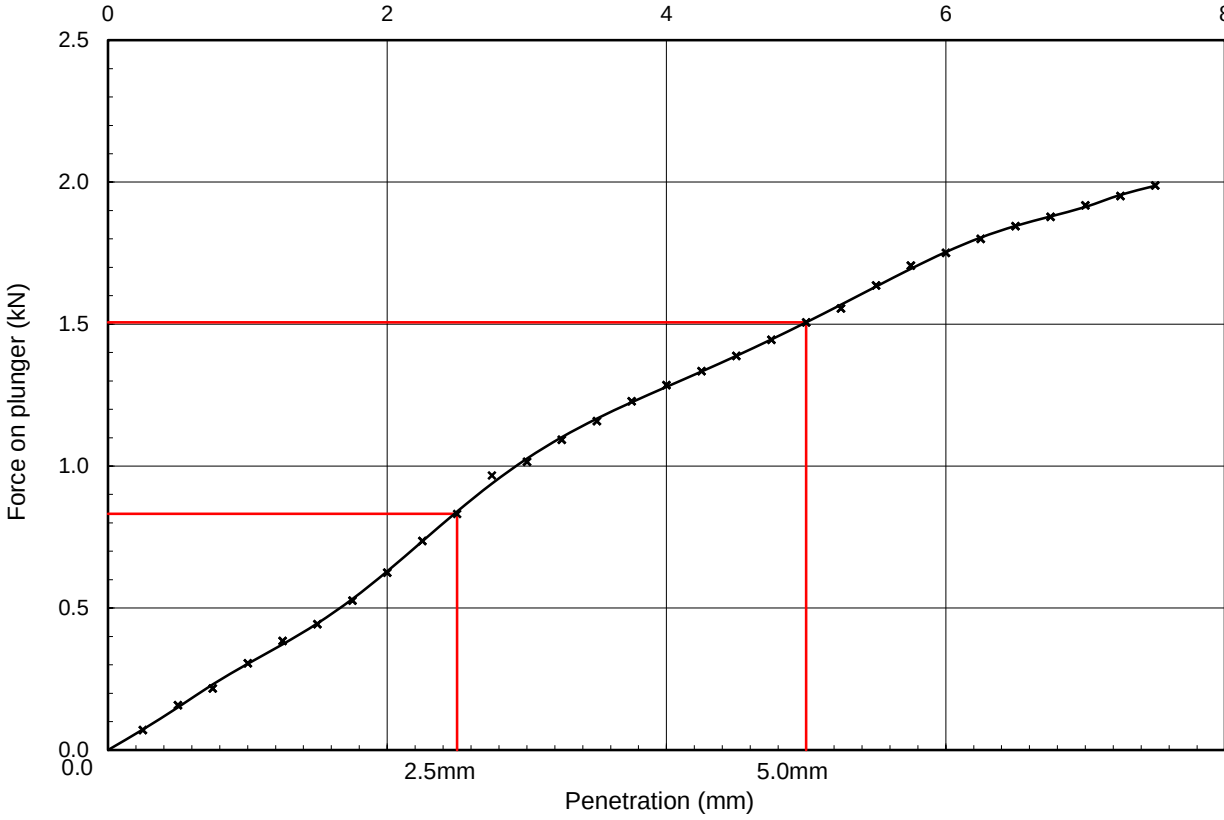
Force on plunger (kN)

Penetration (mm)

| Penetration (mm) | Force on plunger (kN) |

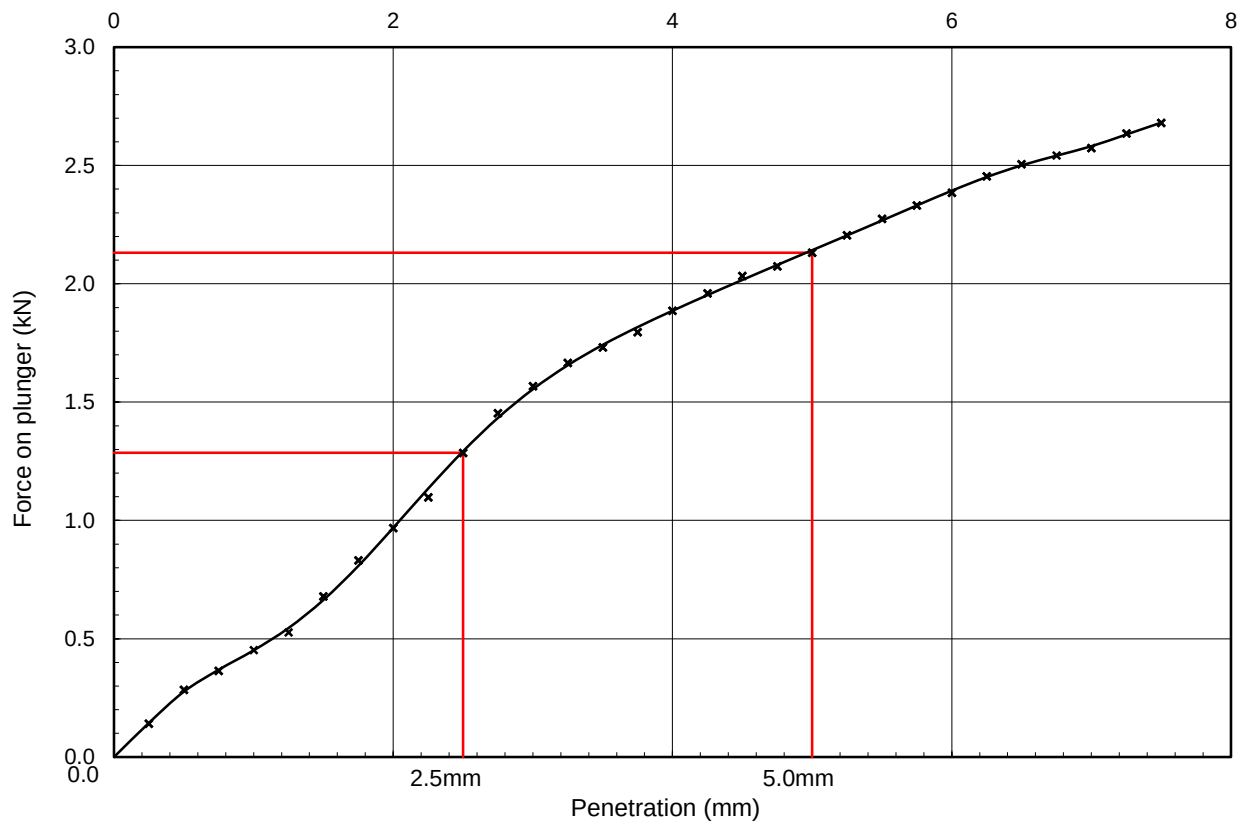
Surcharge: 0.0 kg  
Seating Load: 50 N  
Moisture Content: 20 %  
CBR Value: 11 %

The test load was applied using a hand operated screw jack.  
The surcharge mass applied to the surface of the test area on a 250mm diameter ring. The rate of loading was maintained at 1.0 mm per minute.

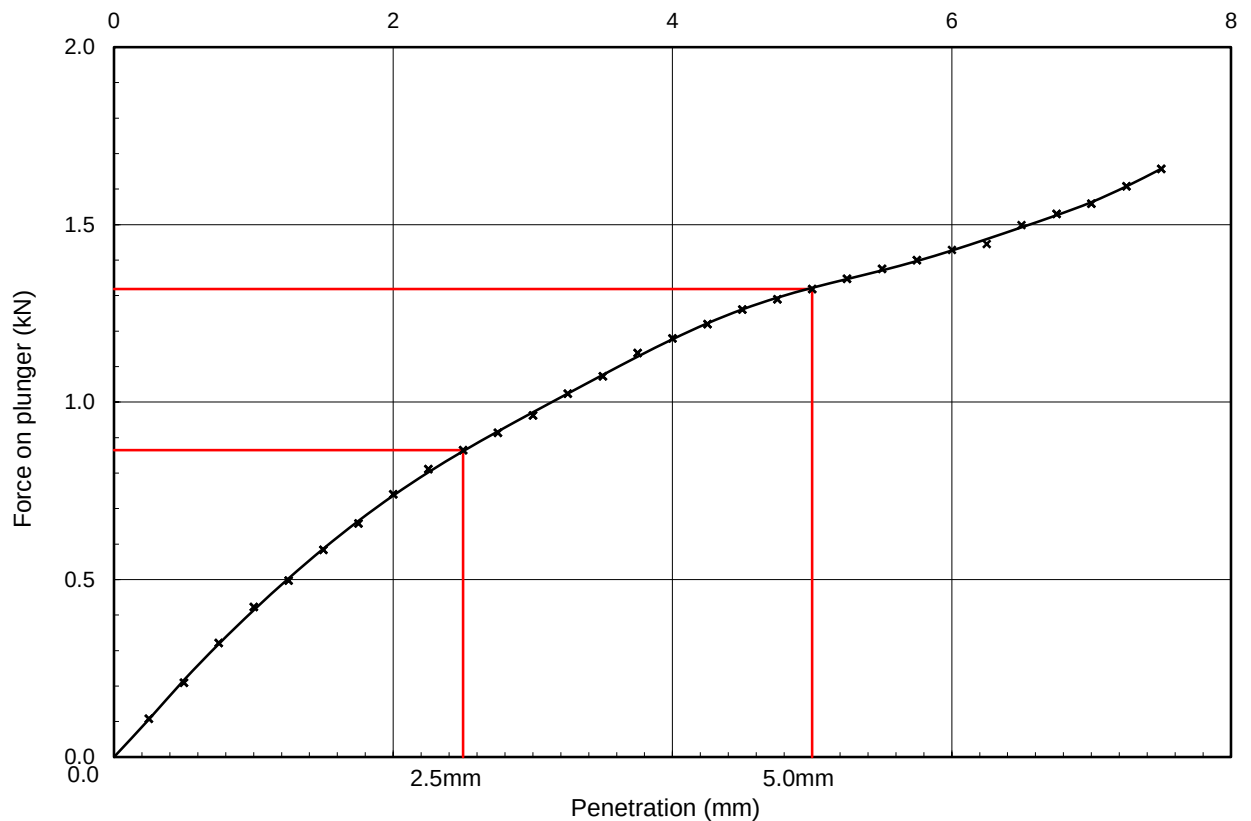
Surcharge: 0.0 kg  
Seating Load: 50 N  
Moisture Content: 19 %  
CBR Value: 6.6 %

The test load was applied using a hand operated screw jack.  
The surcharge mass applied to the surface of the test area on a 250mm diameter ring. The rate of loading was maintained at 1.0 mm per minute.

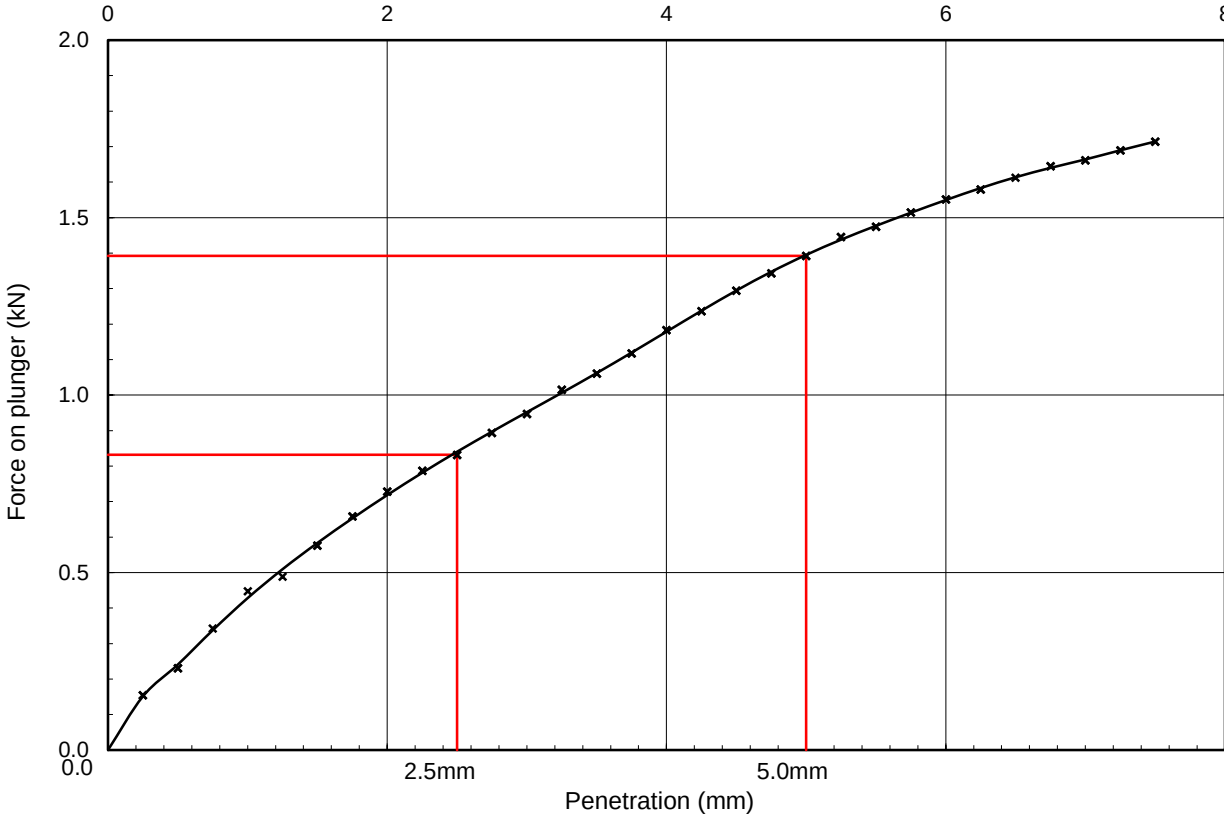
The test load was applied using a hand operated screw jack.  
The surcharge mass applied to the surface of the test area on a 250mm diameter ring. The rate of loading was maintained at 1.0 mm per minute.

Force on plunger (kN)

| Penetration (mm) | Force on plunger (kN) |

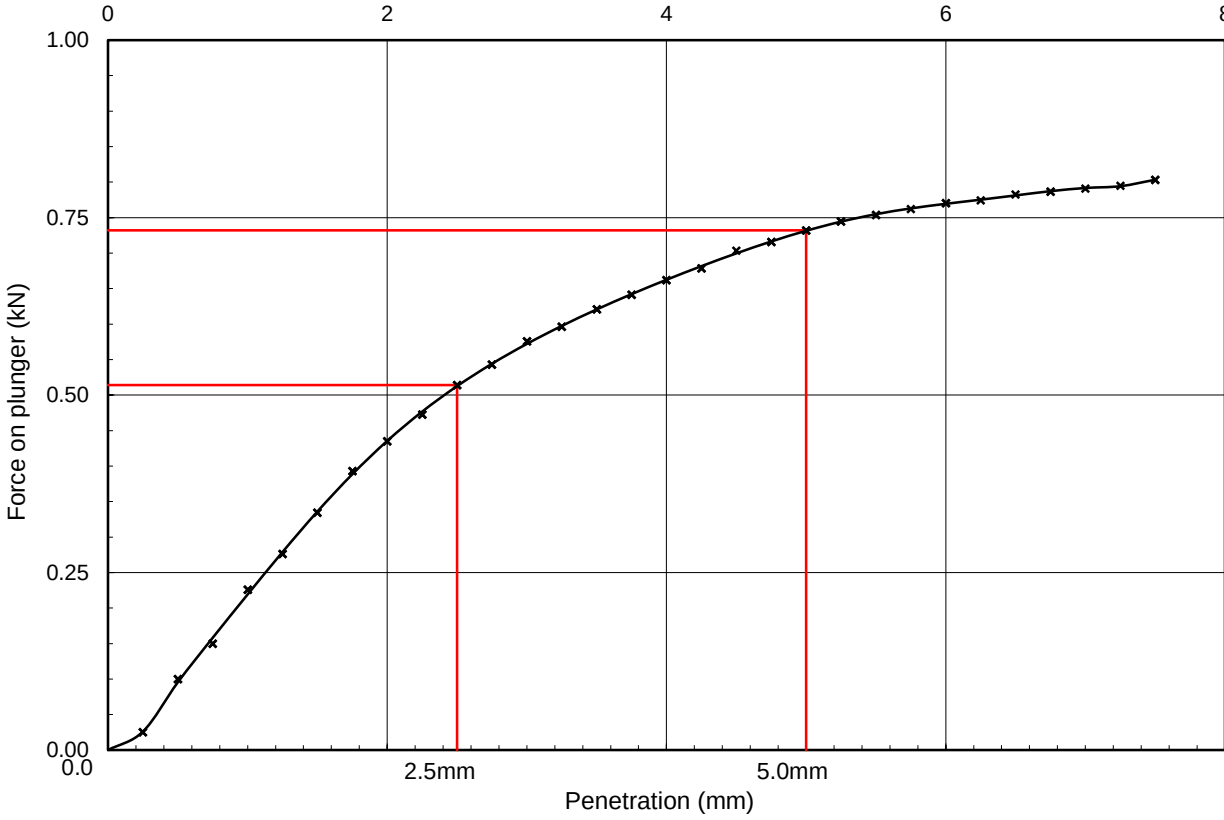
CBR Value: 3.9 %

The test load was applied using a hand operated screw jack.  
The surcharge mass applied to the surface of the test area on a 250mm diameter ring. The rate of loading was maintained at 1.0 mm per minute.
