### The Site

## Existing Plan

## Existing Access & Routes

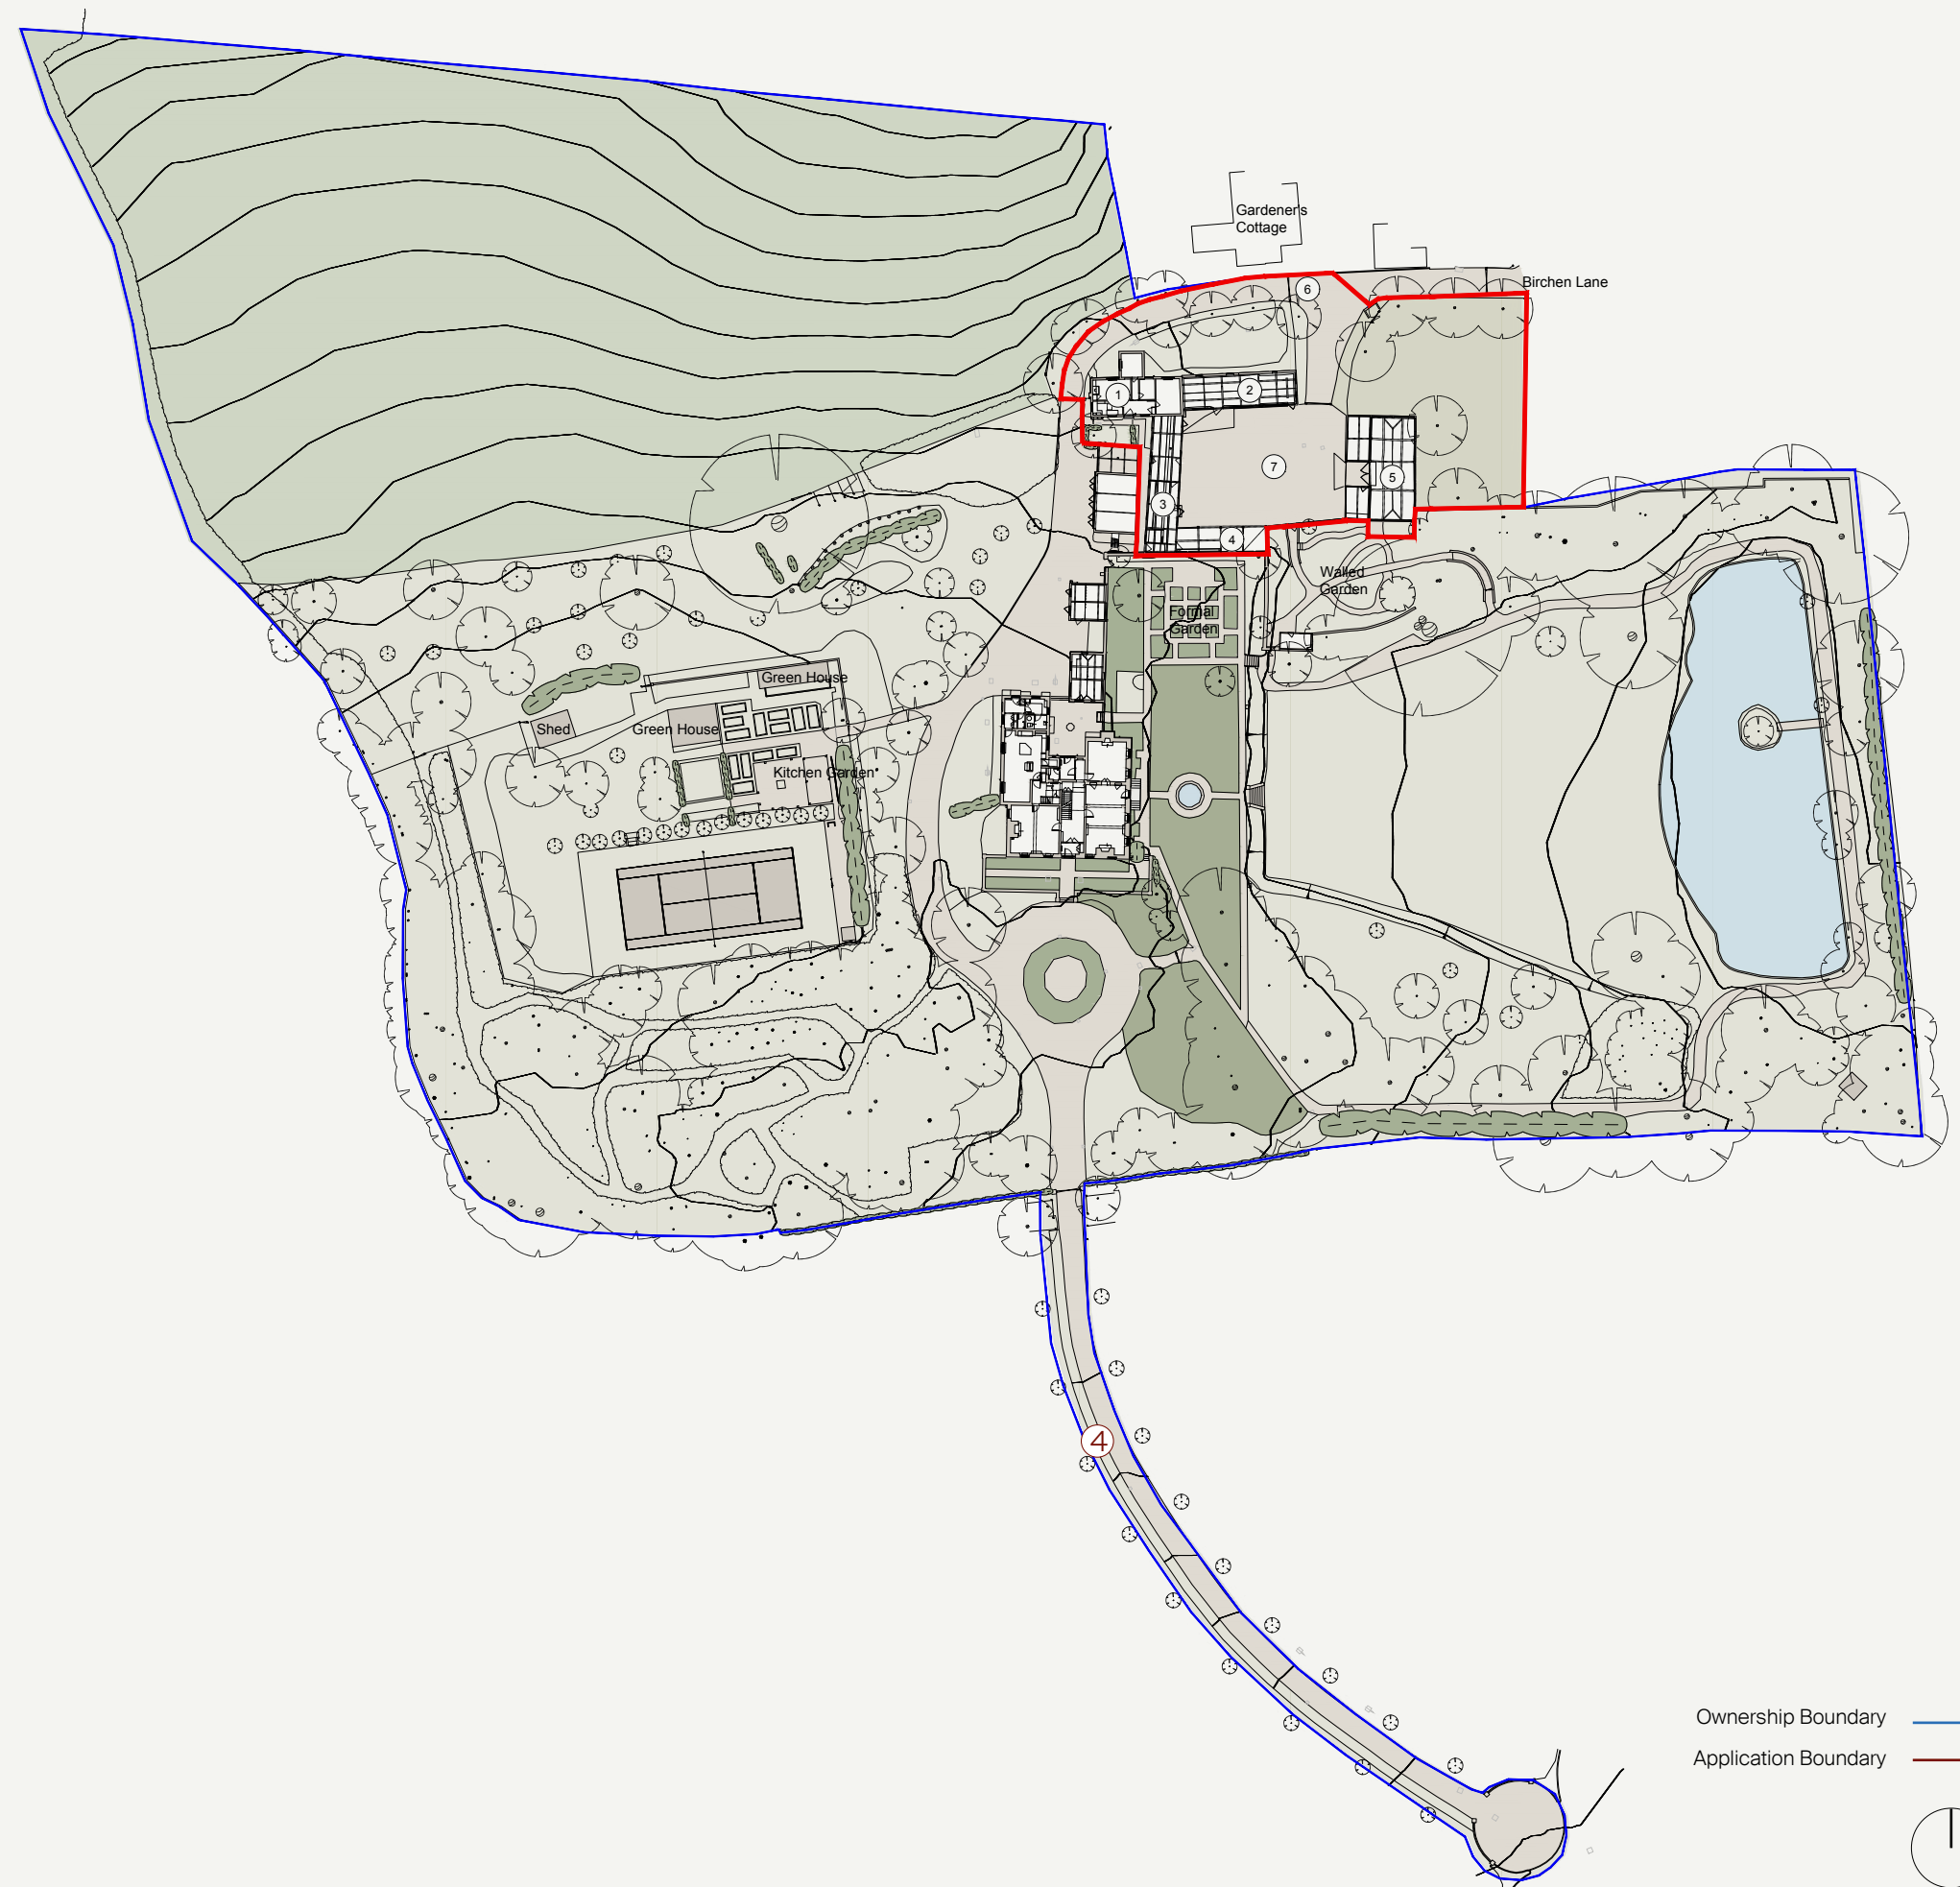
The adjacent plan reflects the existing site extents and proposed application boundary.

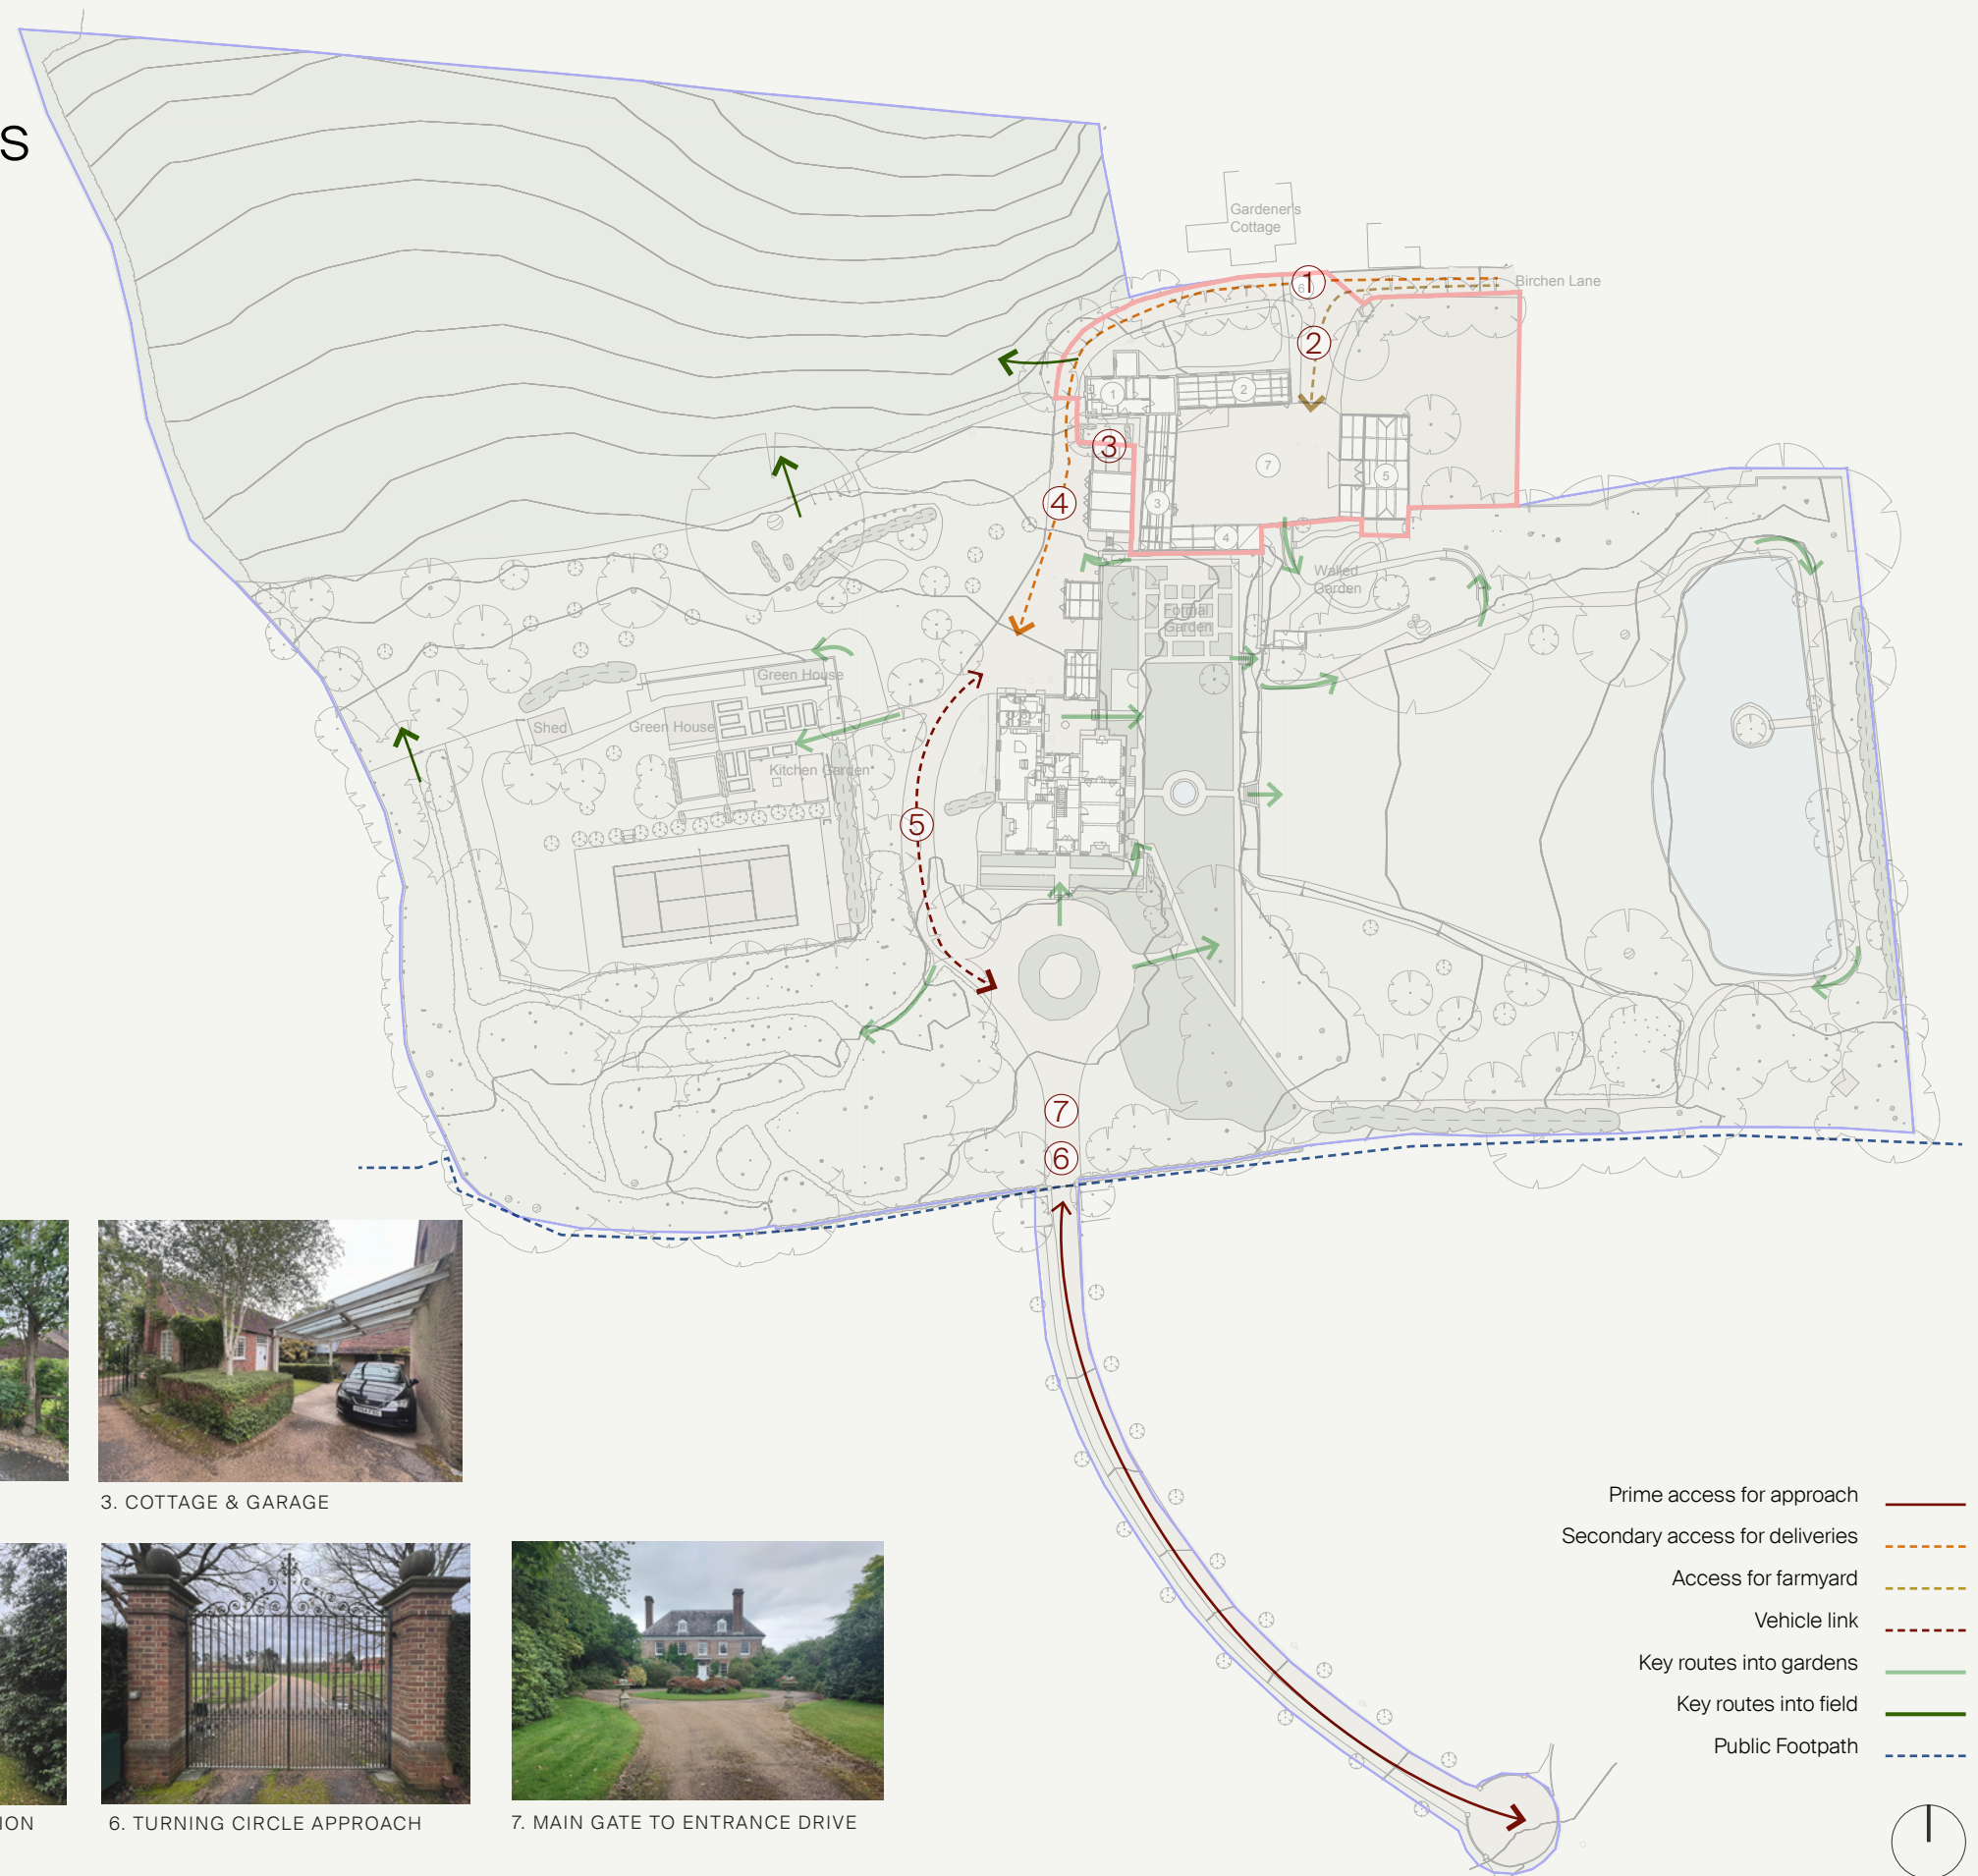
To the North, Birchen Lane provides secondary access to the House via a private driveway (1), with also an independent spur into the the farmyard (2). Typically, these are used for deliveries, servicing and informal access. The southern access from Gander Green forms the historic and formal access to the house, primarily used by the residents.

The proposals do not effect these existing access routes.

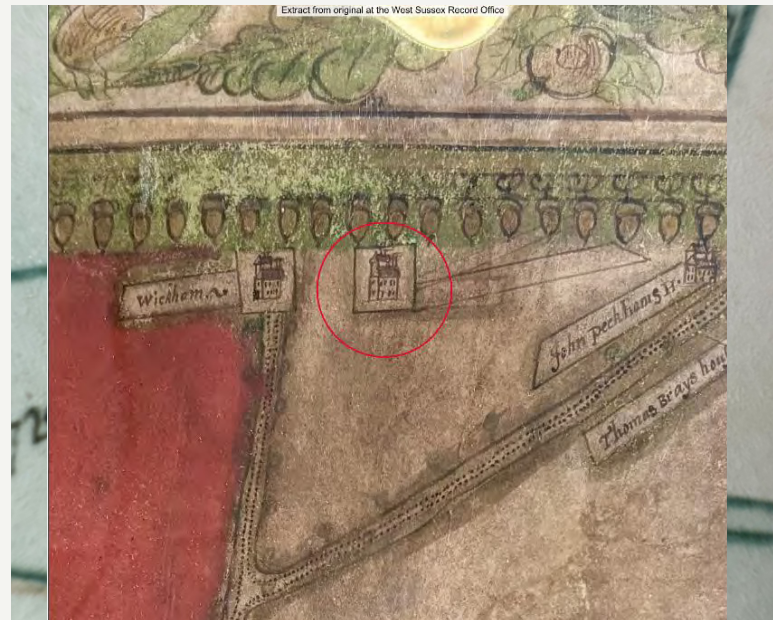
Historic Map 1638

A detail from the Map of Cuckfield, Lindfield & Wivelsfield  
Evidence of settlement however no evidence to suggest this is the current house.  
Construction is believed to occur in late C17th / early 18th Century.

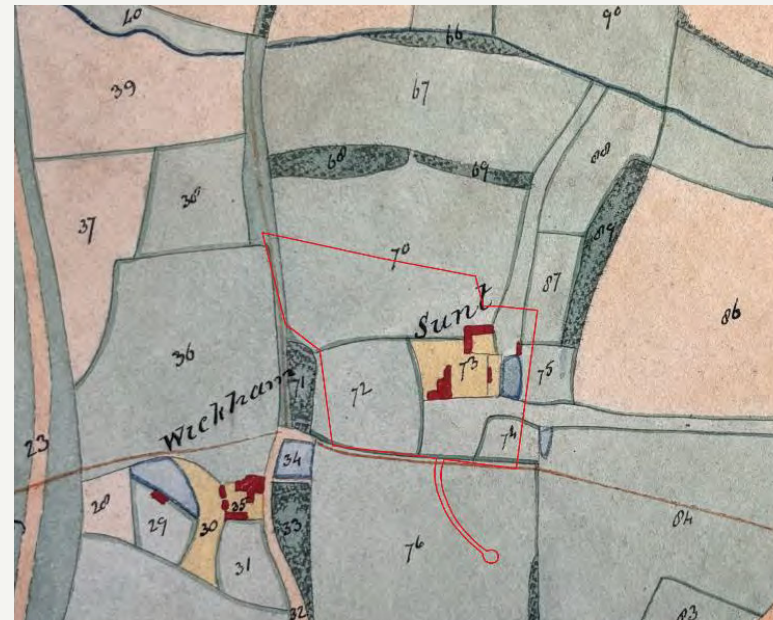
Historic Map ca. 1844

A detail from the Map of Lindfield Parish in the County of Sussex.  
Sunte House is shown in red and there seems to be no extension to the north-west yet.

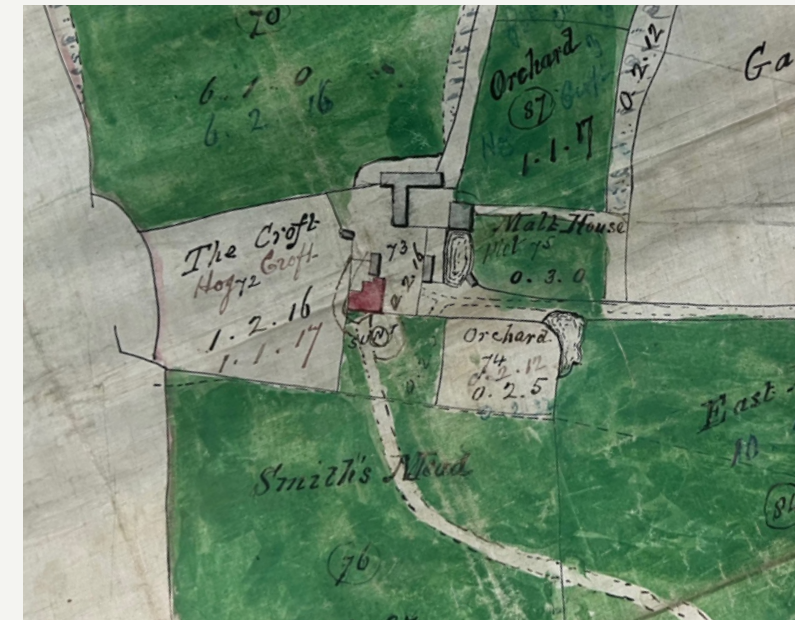
Historic Map ca. 1845

Lindfield Tithe Map: At this time a T-shaped building defined the western edge of the farmyard with a square building on the eastern side. The plot to the west was described as pasture and named "The Croft".

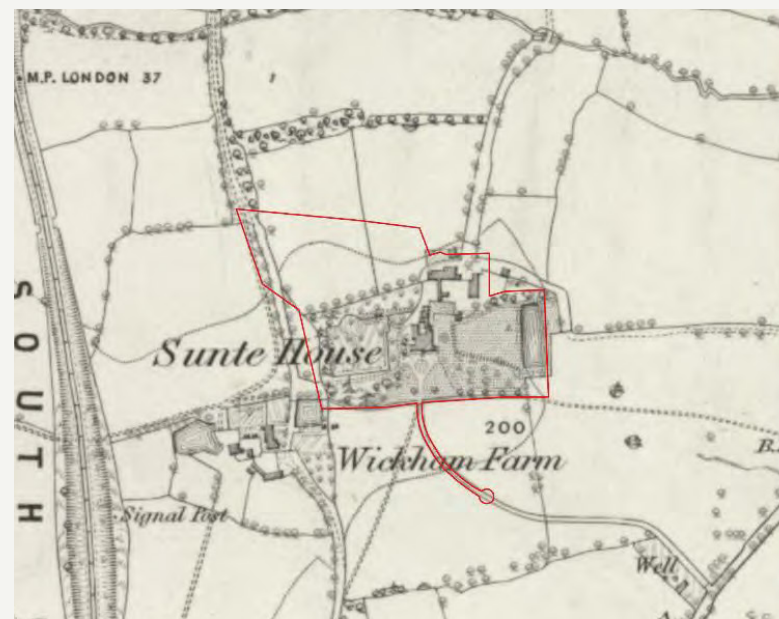
Historic Map 1879

OS Sussex Sheet XXVI: The North west extension to the Main House seems to be completed, along with the Byre and a reconfiguration / extension to the Barn.

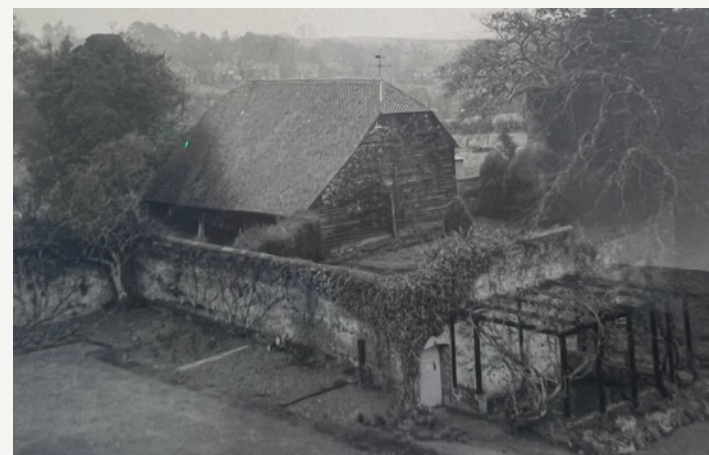
This area of the site has experienced a series of significant fabric additions and adjustments throughout its history, as reflected in the adjacent images. This includes, but is not limited to, adjustments made as part of the extant permission following 2005 permission (in the stables) and changes in the barn footprint & form. This is comparatively evident when seeing the historic photograph below and absence of opening in the catslide roof.

HISTORIC PHOTOGRAPH OF BARN  
(UNDATED)
