## **The Castle, Hickstead**

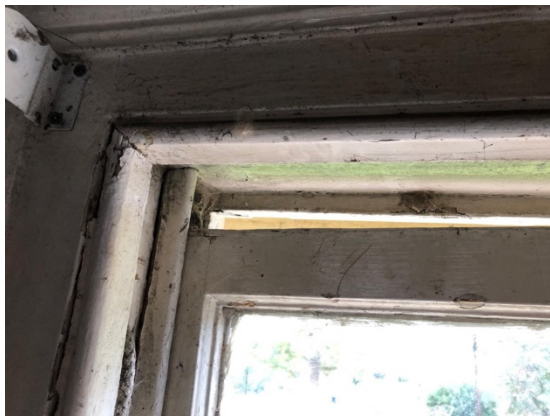
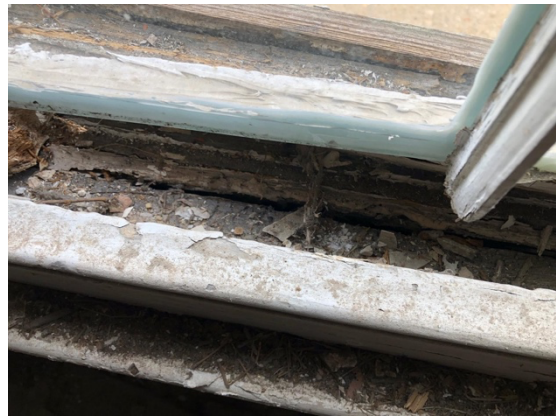
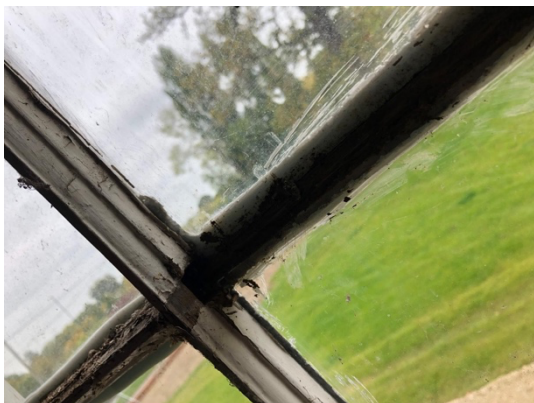
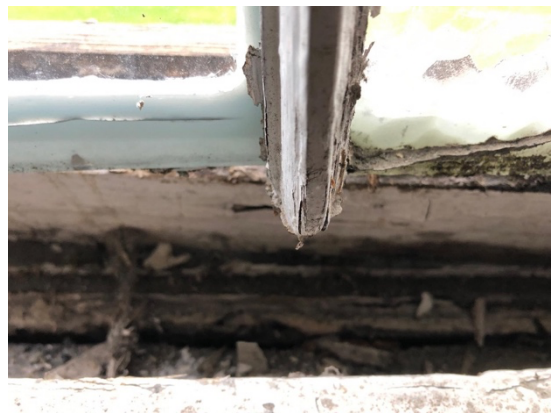
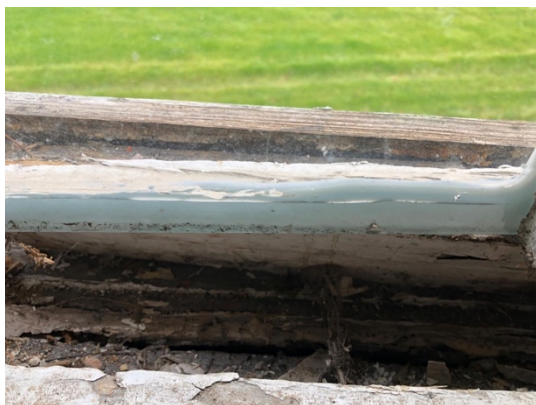
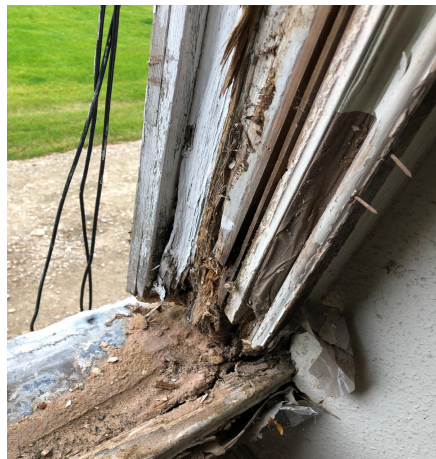
**Window FF8 -** *The top sash & box are over 2" out of square, the cill is completely rotten, bottom rail of bottom sash has completely come away. Bottom of glazing bar tenons have completely gone, internal glazing bars completely missing. Outside linings to main box are rotten at bottom and the outside has been faced up with 4" x 3/4" to make it look good. Rotten and broken away or missing pulley stiles at cill trenching.*
