# Historic Building Record

**Ashill Regen Ltd**

**West Hoathly Brickworks, Hamsey Road,  
Sharpthorne, East Grinstead**

**June 2025**

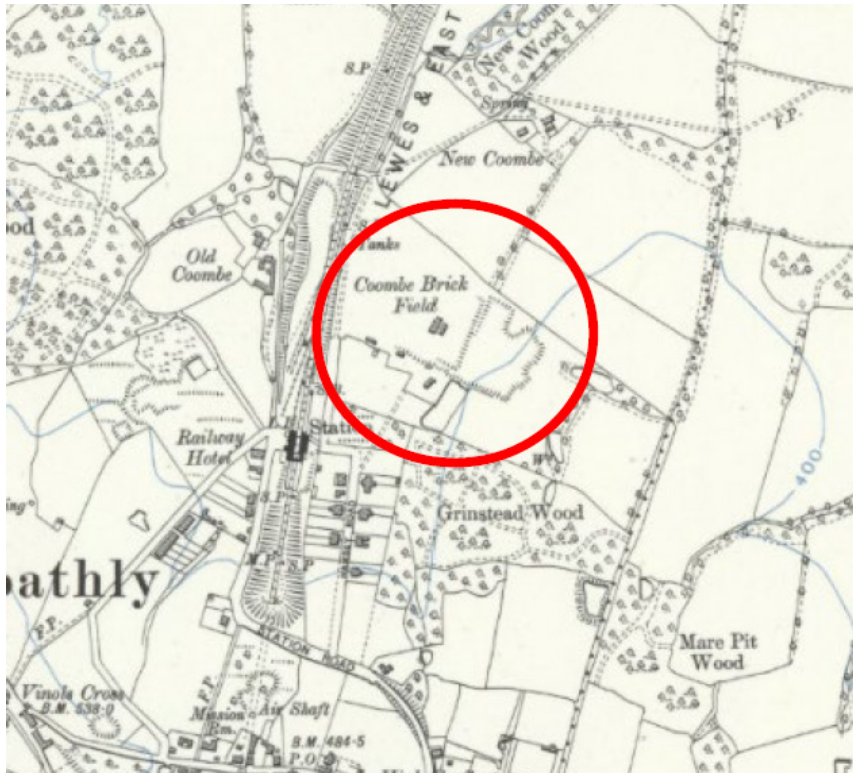
Figure 2.1. OS Map 1909 (Source – National Library of Scotland [NLS])

2.5 The Brickworks opened in 1880 and is illustrated on mapping from 1909 as “Combe Brick Field”. The ‘Old Workshop’ is visible on mapping from 1909 shown in Figure 2.1 and highlighted in blue in Figure 2.2 as likely to be one of the two structures.

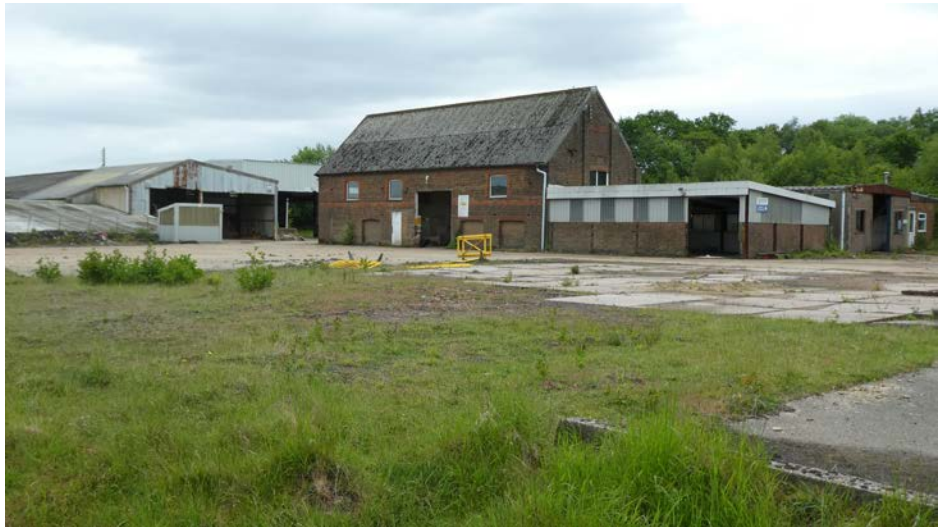
Photo Ref. 1

**Details** Viewing the historic building looking north-east from the centre of the site.

The building stands in open space, showing unobstructed views of its primary west-facing frontage.

Modern buildings are seen, attached to the southern elevation of the historic building, and also forming part of its setting to the north-east.

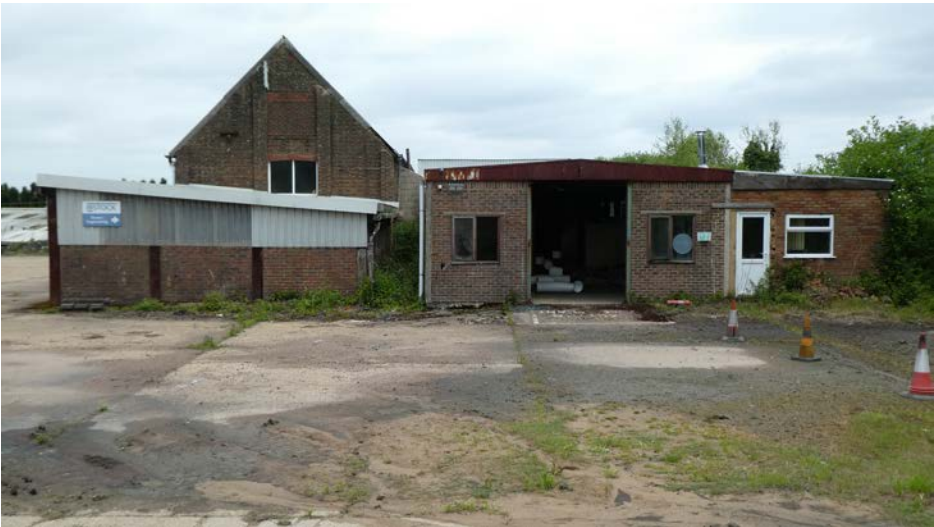
Photo Ref. 2

**Details** Viewing the historic building looking north.

The gable end of the historic building is visible, but the foreground and lower level is obscured by modern ancillary structures that developed as the brickworks grew overtime.

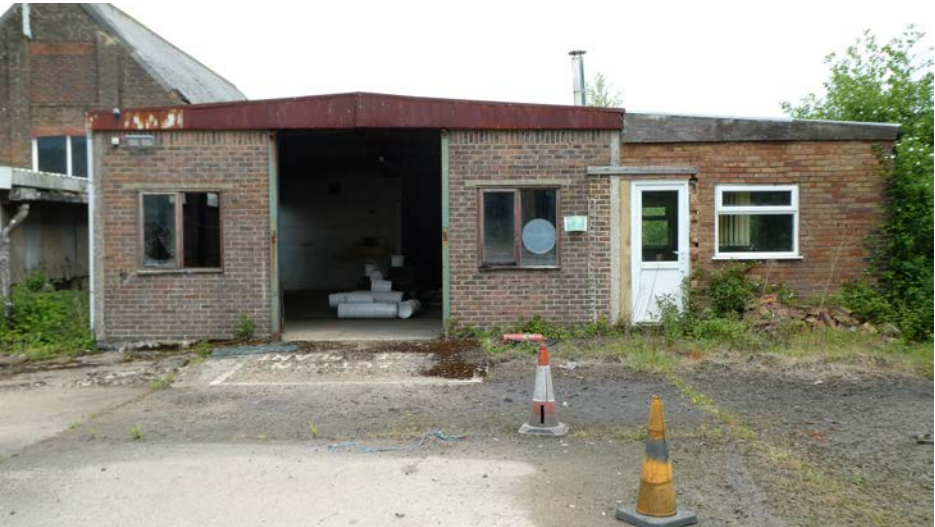
Photo Ref. 3

**Details** Viewing the modern ancillary buildings looking north.

The gable end of the historic building remains visible behind modern ancillary structures that developed as the brickworks grew overtime.

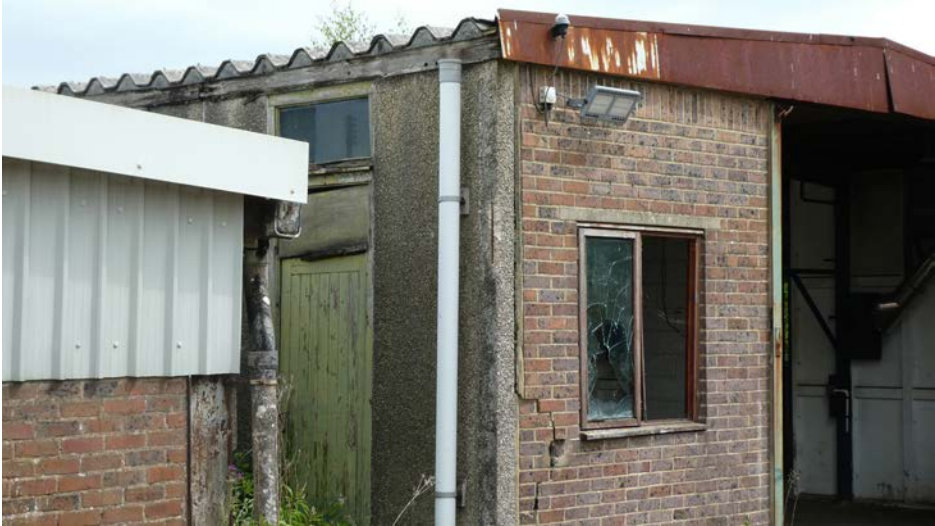
Photo Ref. 4

**Details** Viewing the modern ancillary buildings looking north-east.

The modern ancillary structures show a range of different building materials, including brick, concrete, metal sheeting, timber windows, and uPVC pipework.

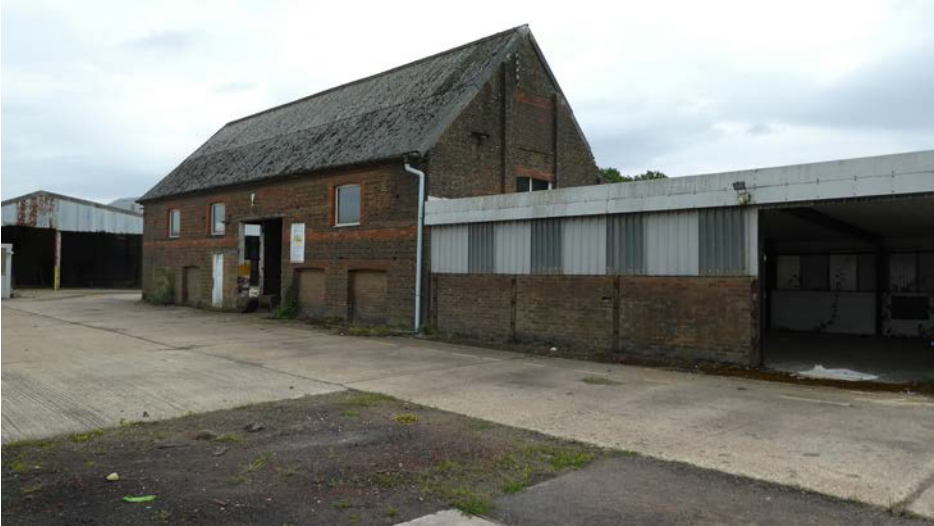
Photo Ref. 5

**Details** Viewing the historic buildings looking north-east, at closer range than photo ref.1.

At this closer range more detail can be seen in respect of features and material finishes.

The juxtaposition between the historic building and the modern ancillary additions are more pronounced.

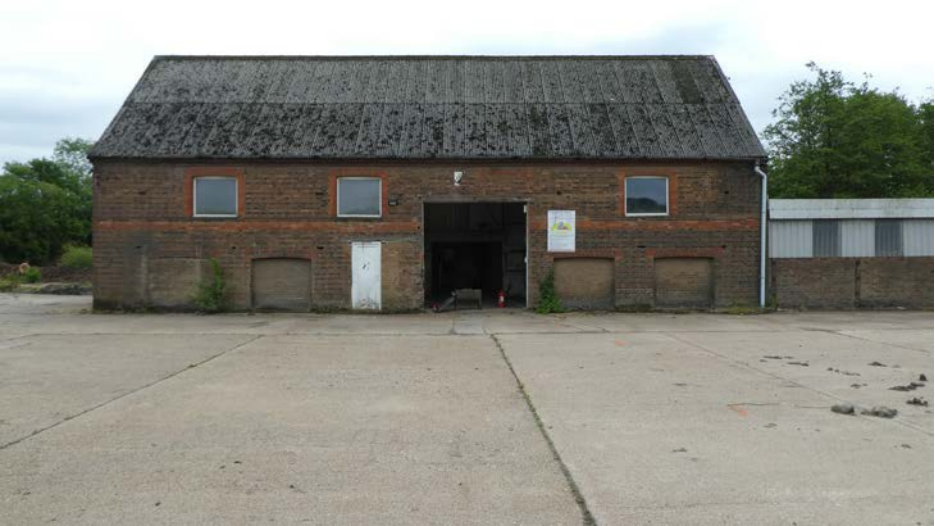
Photo Ref. 6

**Details** Viewing the historic buildings looking east, revealing its full primary elevation.

The various alterations to the building's fenestration can be seen, including the creation of a large opening that was most recently a roller-shutter access point.

Blocked up openings are seen close to the ground, whilst three openings with modern windows are seen above.

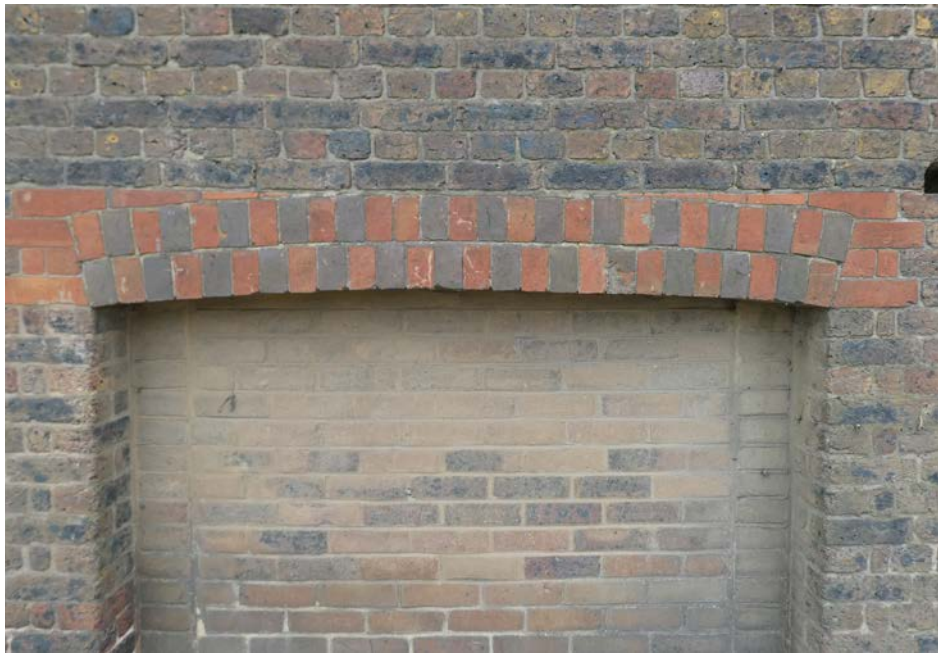
Photo Ref. 7a

**Details** Detail showing the use of different brick colours to create a characterful chequerboard window header.

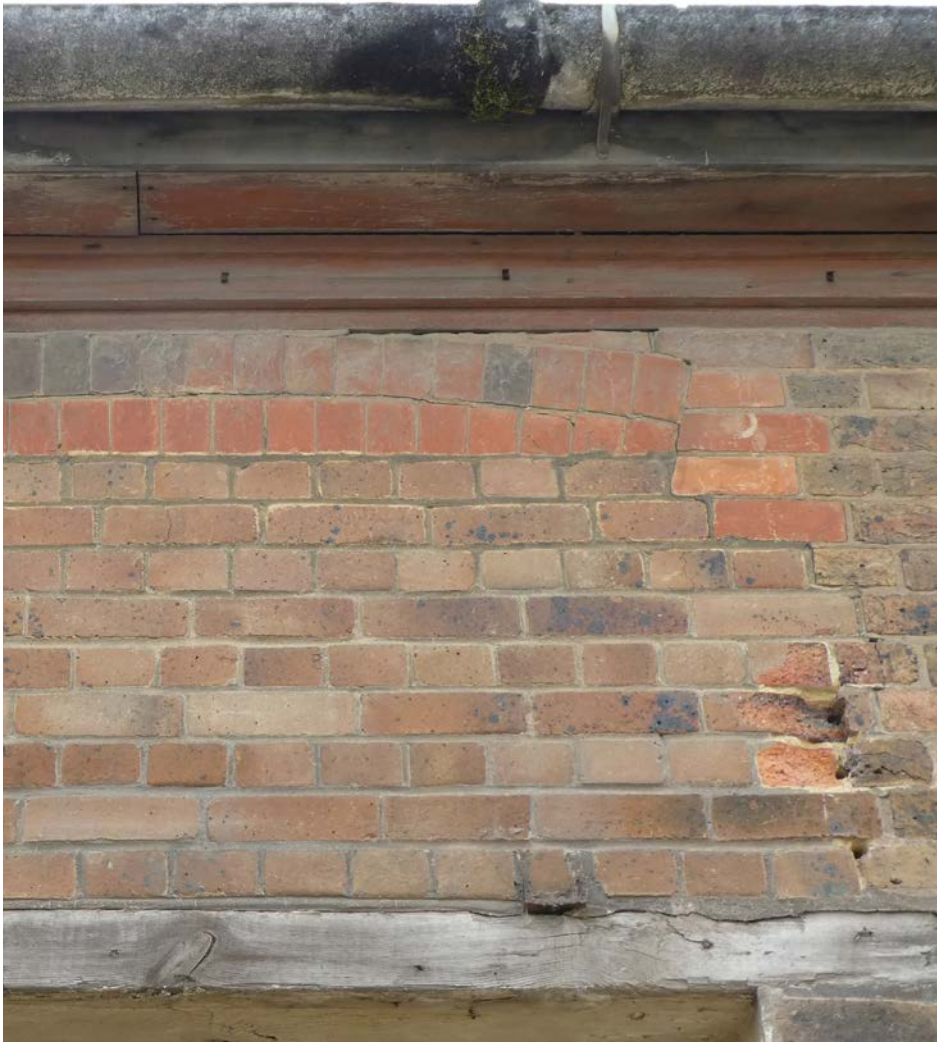
Photo Ref. 9

**Details** Detail showing a timber lintel, beneath a blocked up window opening where the header has been retained. Above this timber eaves are seen.

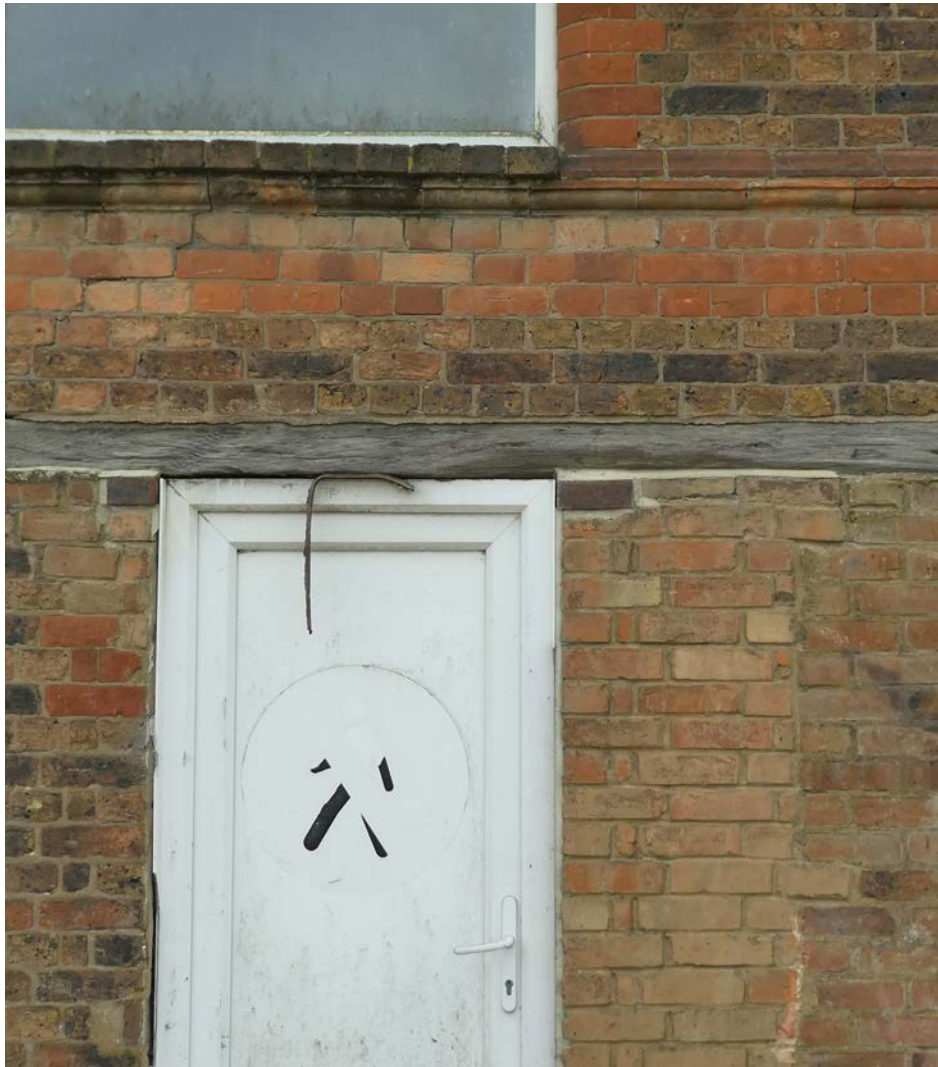
Photo Ref. 10

**Details** A close-up photo showing a modern uPVC door inserting into a blocked up opening. This opening includes a timber lintel.

Above this can be seen more of the red brick banding feature, beneath a modern window.

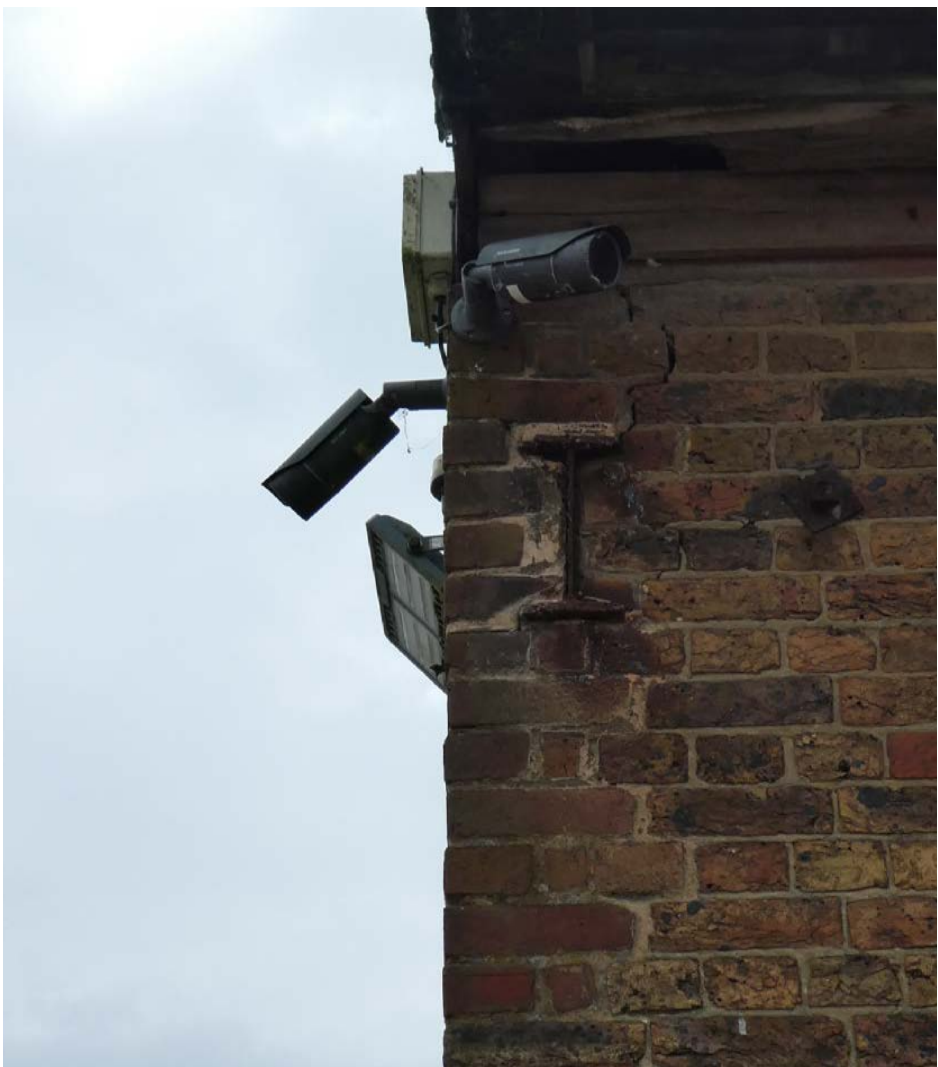
Photo Ref. 11

**Details** A detail showing the end of an iron girder projecting through the brickwork. The iron girder can be seen in photo ref. 9, supporting the large opening on the north facing elevation.

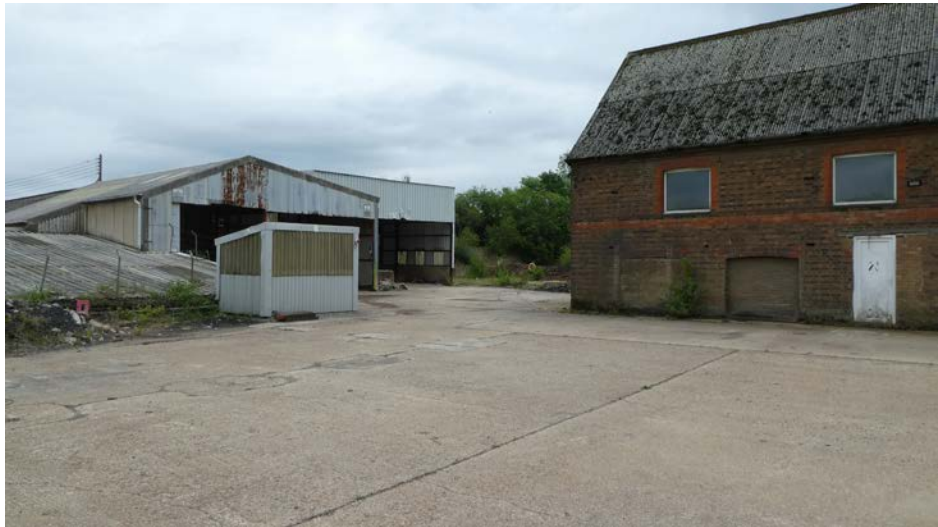
| Photo Ref. | 12 |

**Details** A view looking north-east, showing the relationship between the historic building and the wider site, including the modern ancillary buildings.

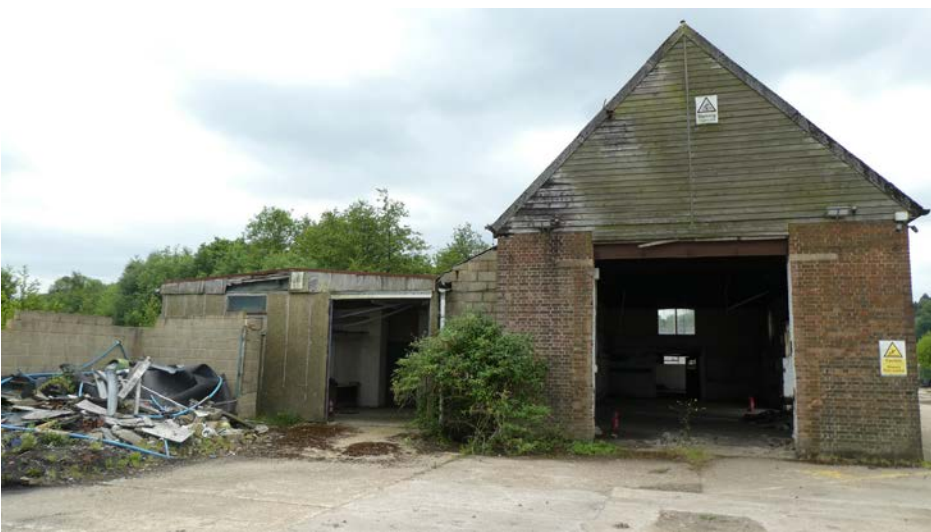
| Photo Ref. | 13 |

**Details** A view looking south west, showing the historic building alongside modern ancillary structures.

The gable end of the historic building is timber clad, with a large central open beneath, supported by an iron girder.

The lack of doors allows for glimpses into the main space of the historic building, including through to the window on the southern elevation.

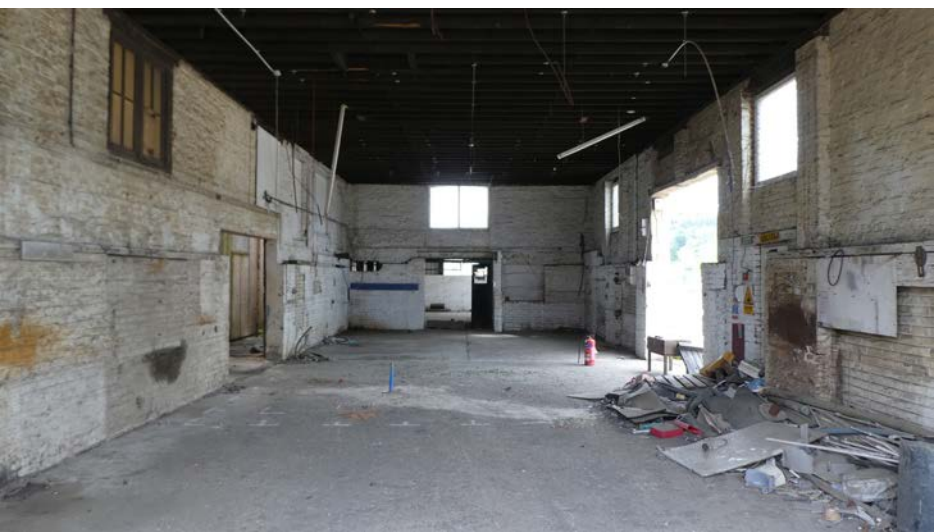
| Photo Ref. | 14a |

**Details** An interior view of the main space of the historic building, showing the volume of the space.

Walls are whitewashed brick, the floorslab is concrete, and the roof structure above is timber.

The rightside wall (as seen in the photo) features a large opening most recently used for a rollershutter, and two window openings at high level.

The leftside wall (as seen in the photo) features a small but modern opening, with an example of a four panel timber window above, likely to be original to the building.

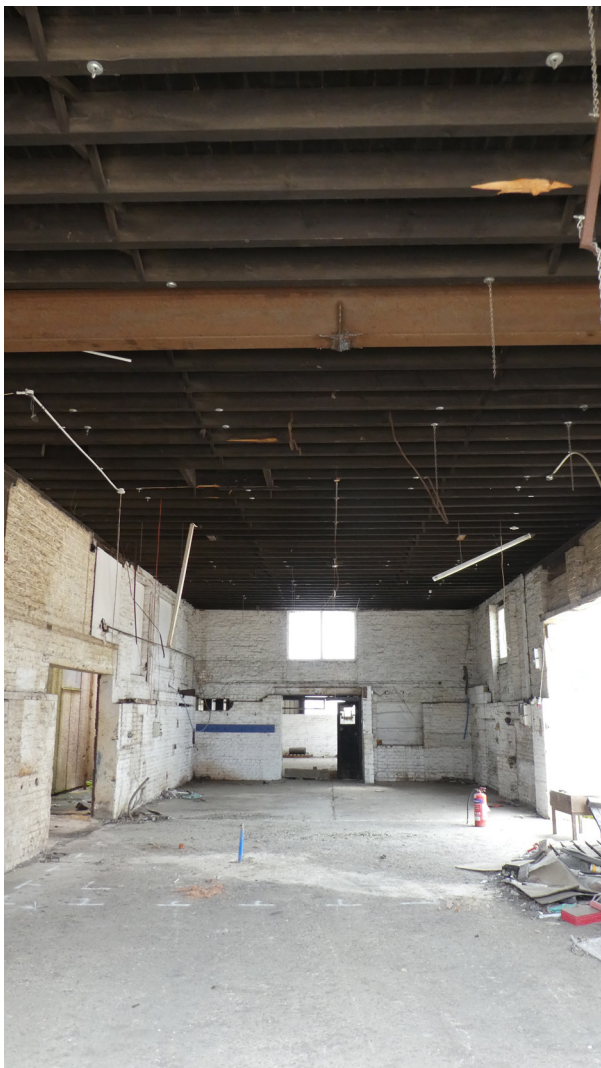
Photo Ref. 14b

**Details** A photo showing the underside of the timber roof structure.

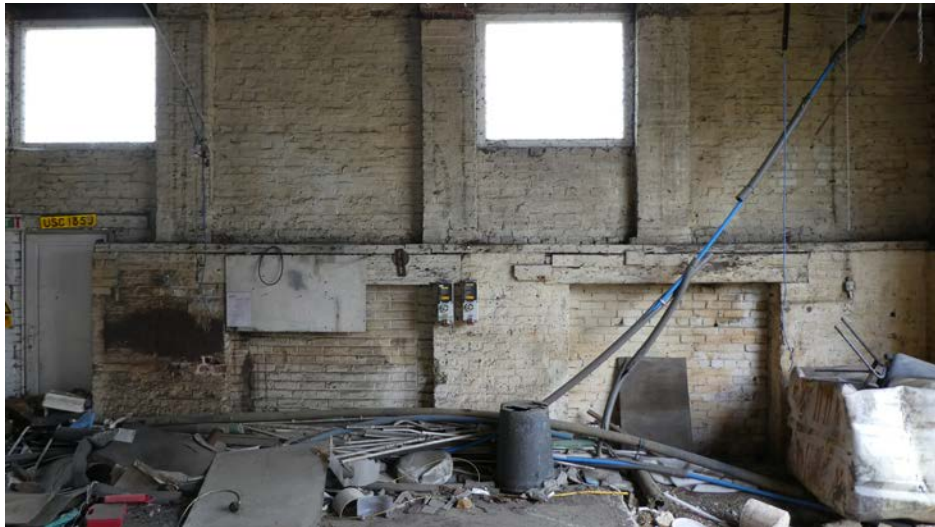
Photo Ref. 15a

**Details** A view of the interior west elevation, showing two open windows and two blocked up openings.

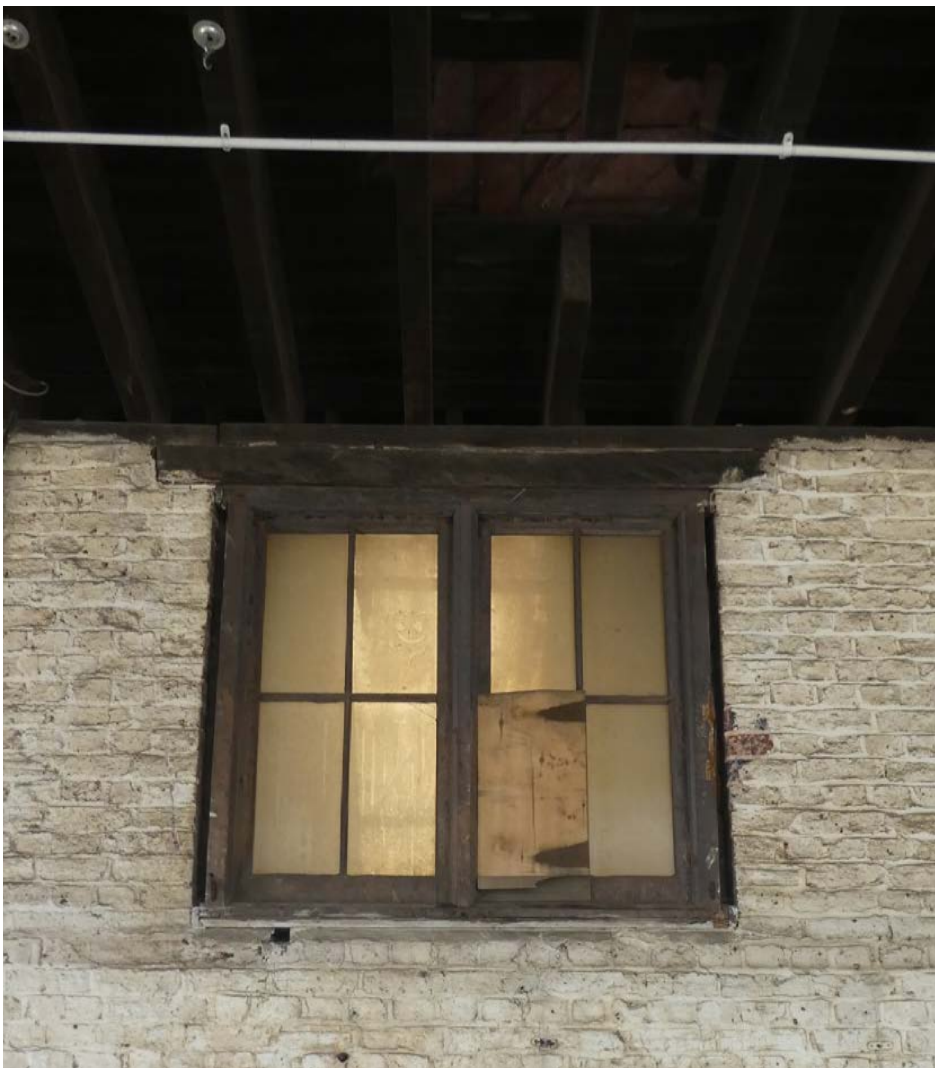
Photo Ref. 15b

**Details** A view of one of the four-pane timber windows, which are likely original to the building. These windows are now internal, with a modern lean-to-structure enclosing them from the other side of this view.

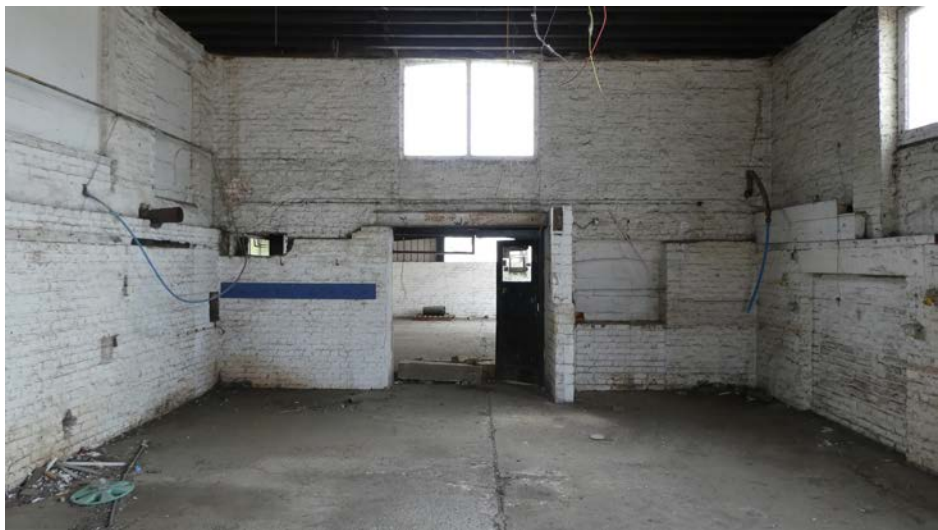
Photo Ref. 16

**Details** A view standing in the middle of the main volume of the historic space. The external window in the gable end on the southern elevation can be seen, above a doorway leading into one of the modern ancillary buildings.

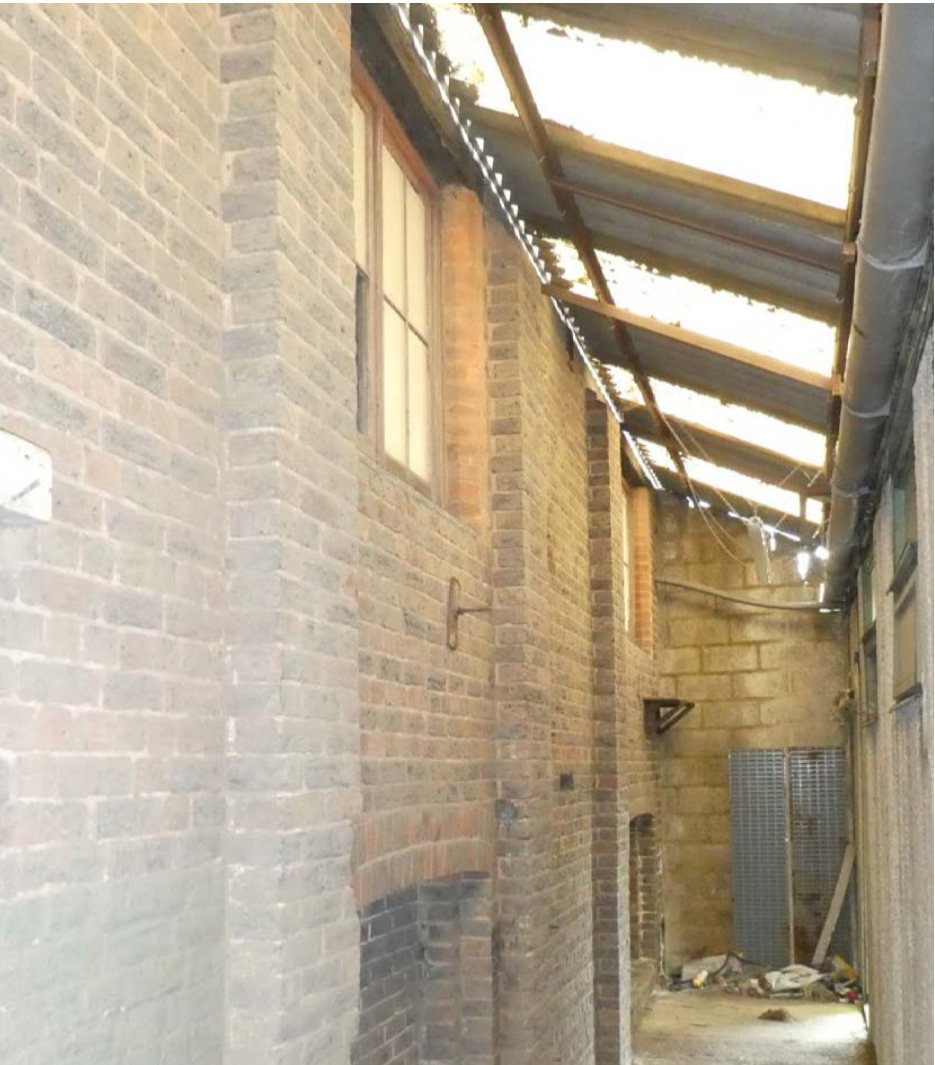
Photo Ref. 18

**Details** A view looking down the lean-to structure which now encloses what would have originally been the exterior elevation of the historic building. Two historic timber windows can be seen, above recessed bricked up openings. The ancillary structure is constructed from a mixture of blockwork and concrete panels, with an asbestos roof.

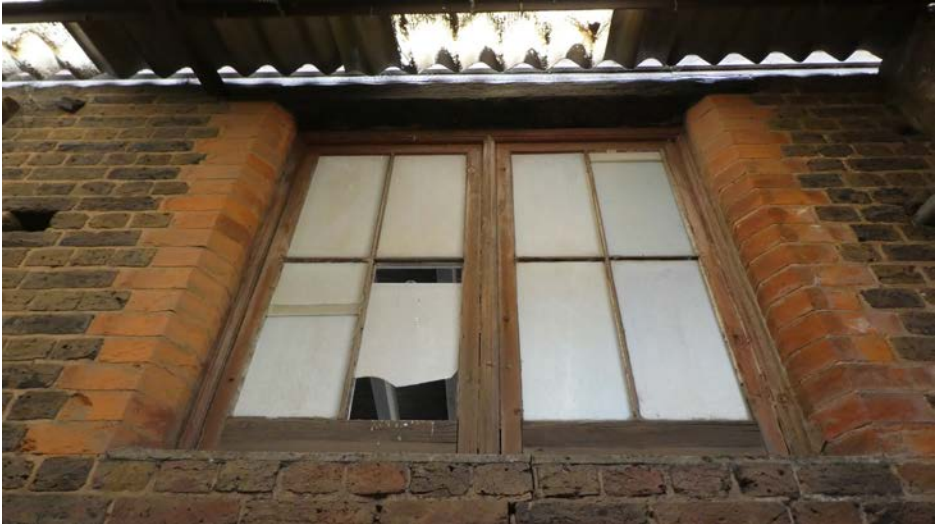
Photo Ref. 19

**Details** A more detailed view of one of the historic windows, as it would have appeared when this elevation was external. Like the west facing elevation, red brick is used for the window surround.

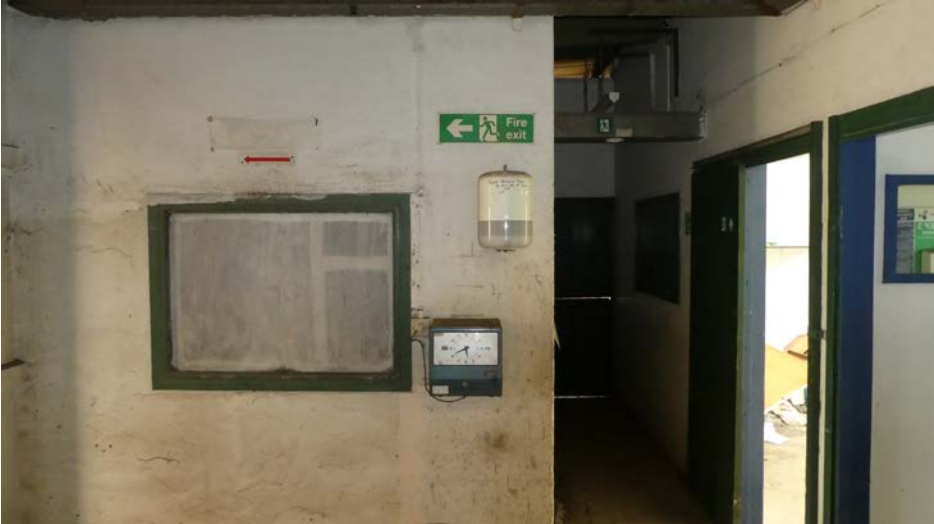
Photo Ref. 20a

**Details** An example of an interior in the modern ancillary structures, showing partitions and small rooms used for office/kitchen/toilets.

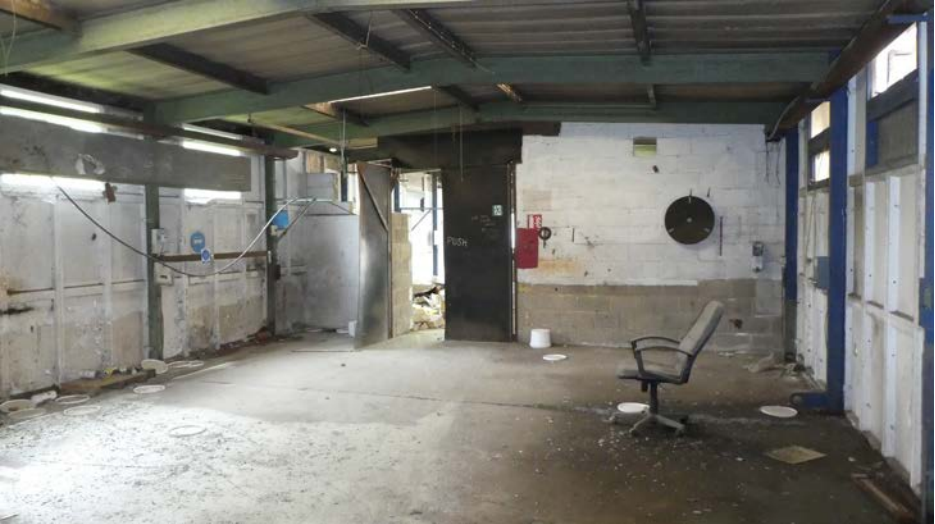
Photo Ref. 20b

**Details** A view of one of the modern ancillary spaces, showing simple construction materials and no features of note.

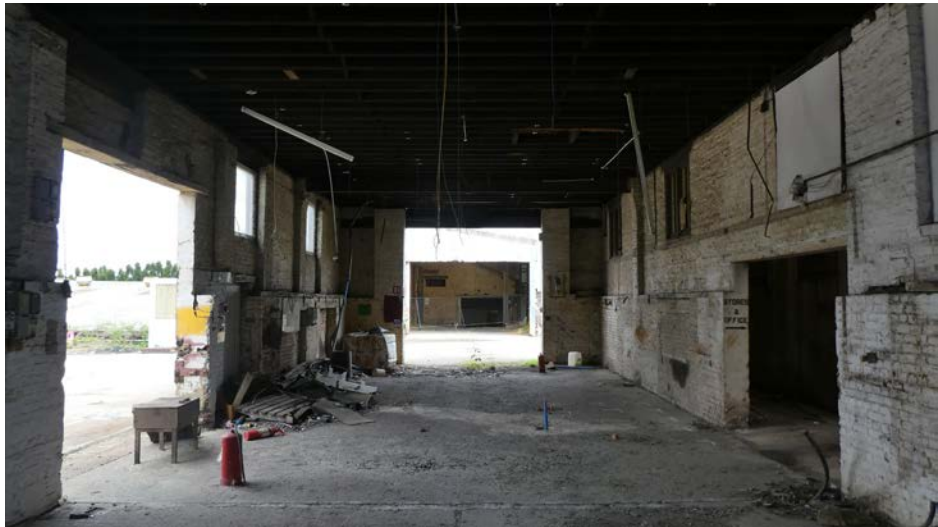
Photo Ref. 21

**Details** A view looking north-east from within the historic building. The large opening on the leftside is where the rollershutter entrance was located, whilst the rightside leads into the lean-to structure and the ancillary buildings.

The view north-east looks through to the wider site and the modern complex of structures.

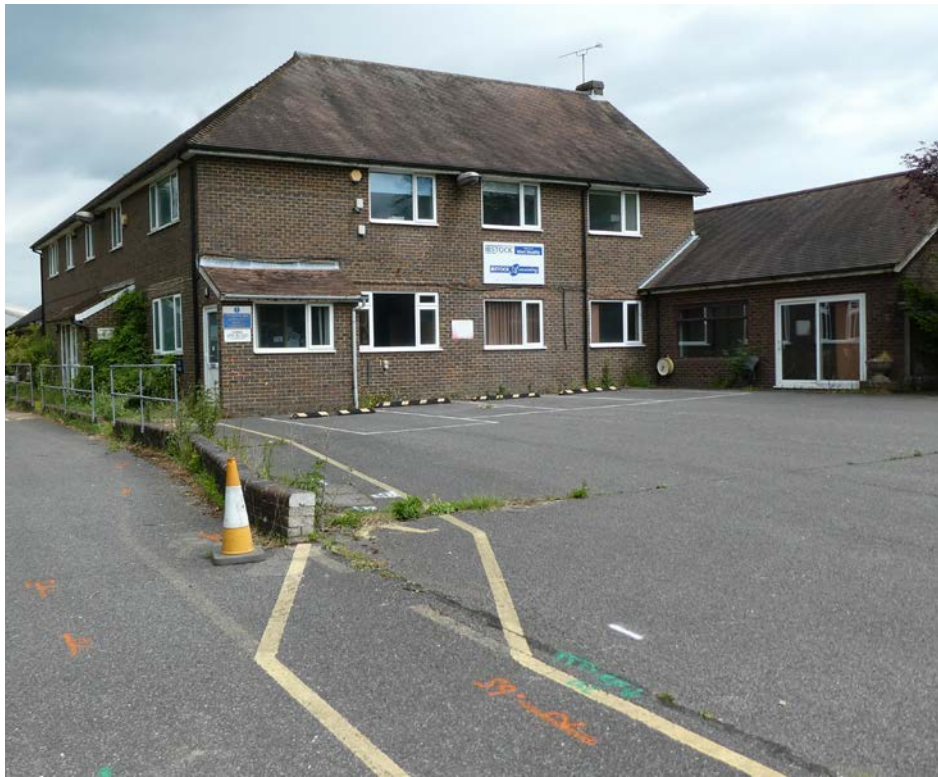
Photo Ref. 1

**Details** Looking north. A two storey domestic building, with single storey outrigger.

The main site office for the complex, and the first building seen on site after passing through the gates.

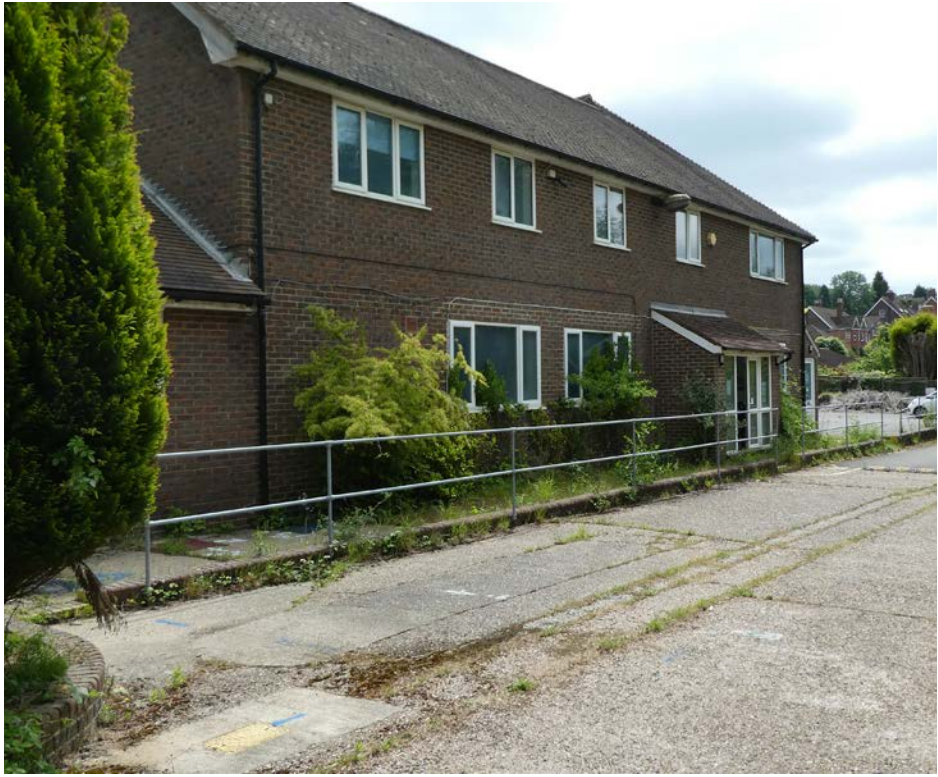
Photo Ref. 2

**Details** A view looking south, showing the main site office building.

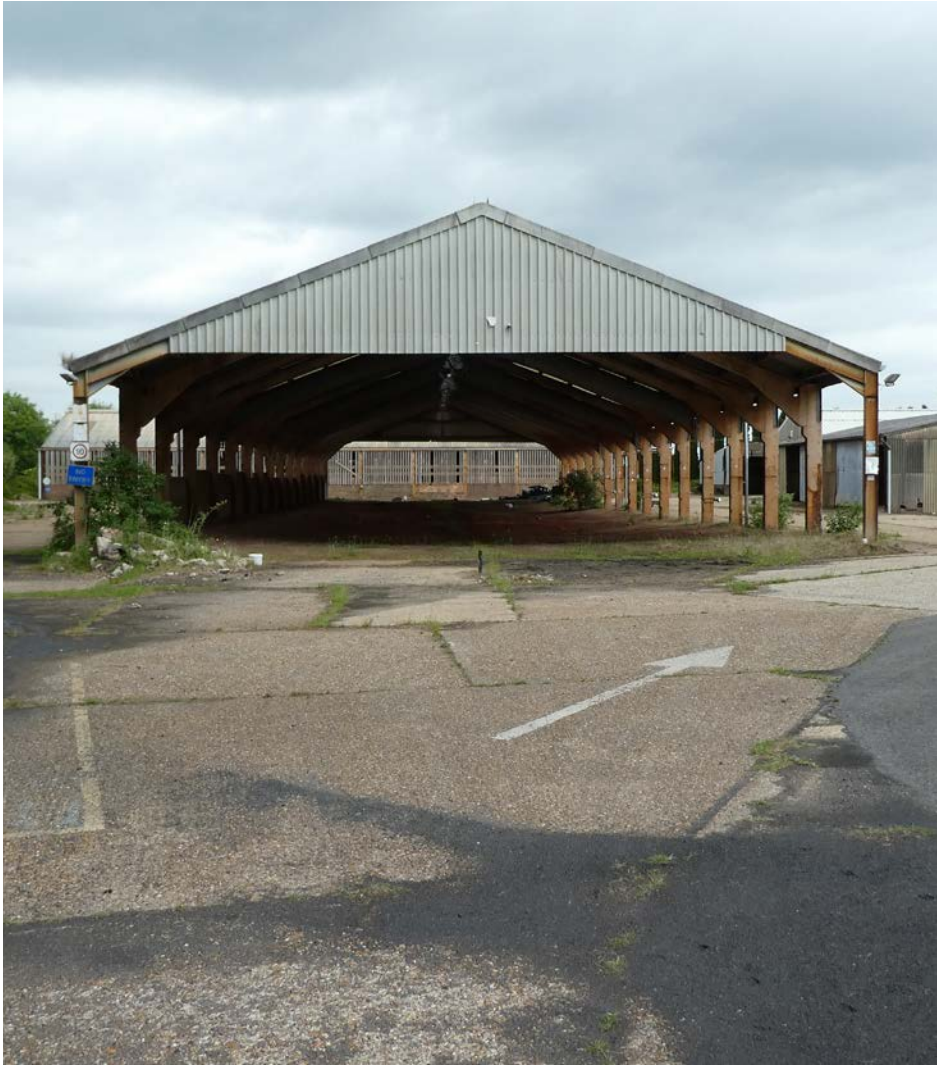
Photo Ref. 3

**Details** A view looking north, towards one of the open sided structures on site. The structure is double-height and timber-framed, with a metal sheet roof.

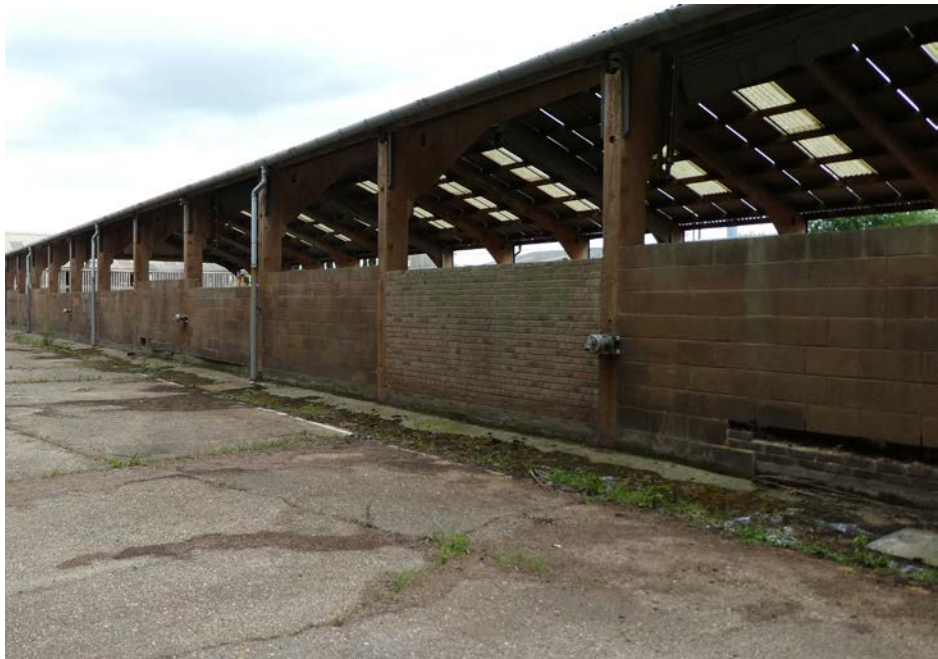
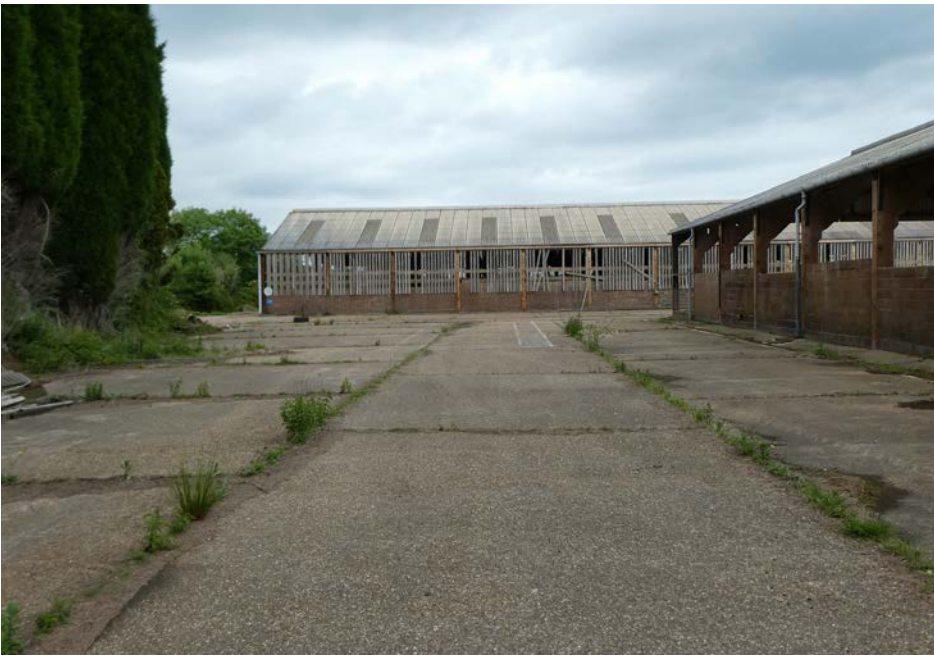
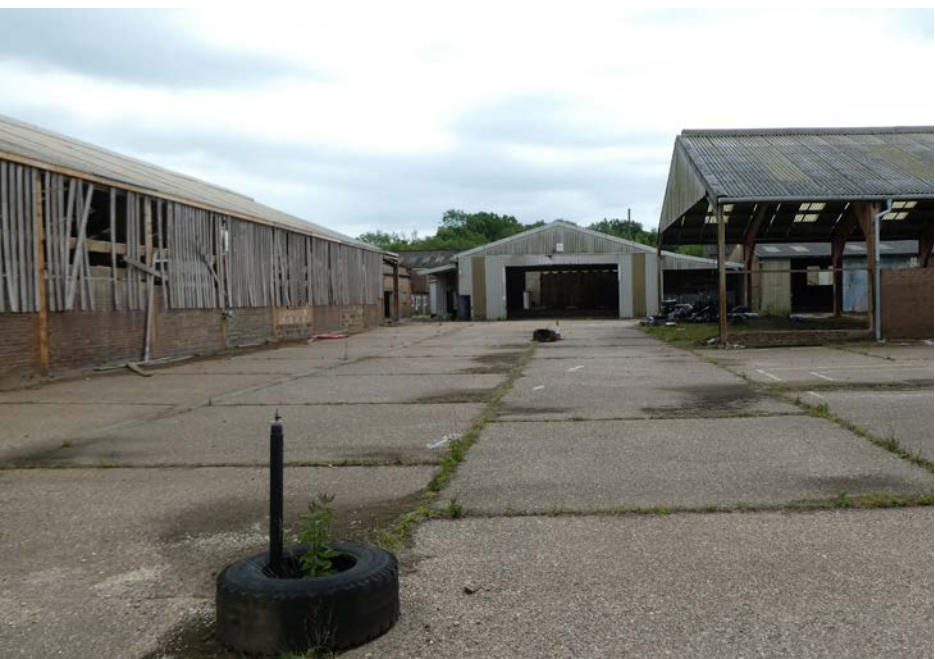
Photo Ref. 4

**Details** A view looking northeast along the side of the structure shown in ref. 3. Blockwork is used at lower level.

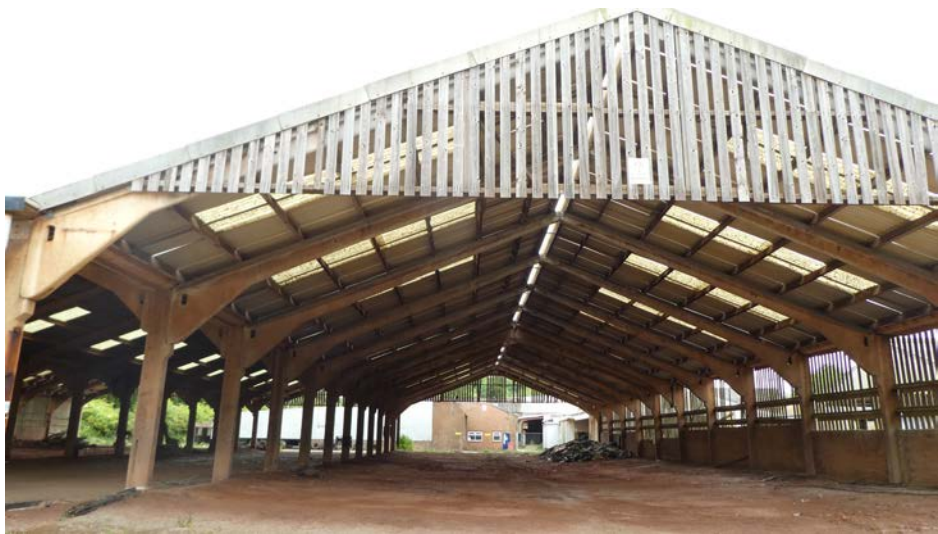
Photo Ref. 7

**Details** A view looking east, showing the interior of the another of the open sided modern structures. This one is concrete frames, with timber slatted screening on the side elevations.

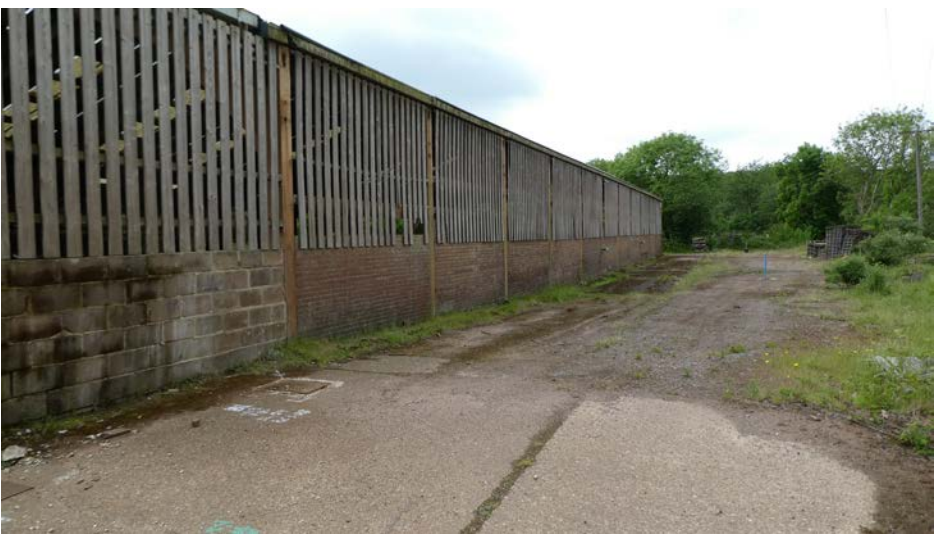
Photo Ref. 8

**Details** A view looking west along the large open sided structure shown in Ref. 7. This elevation is fully enclosed by timber slats.

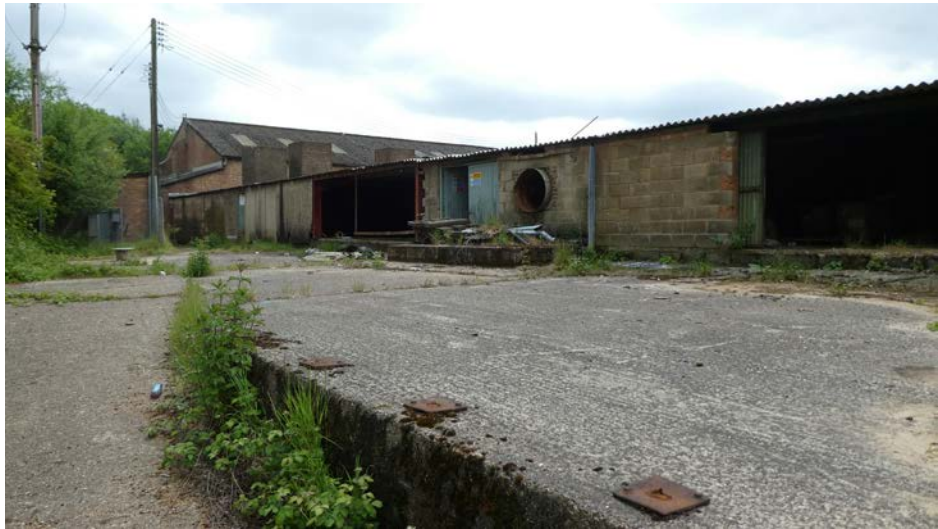
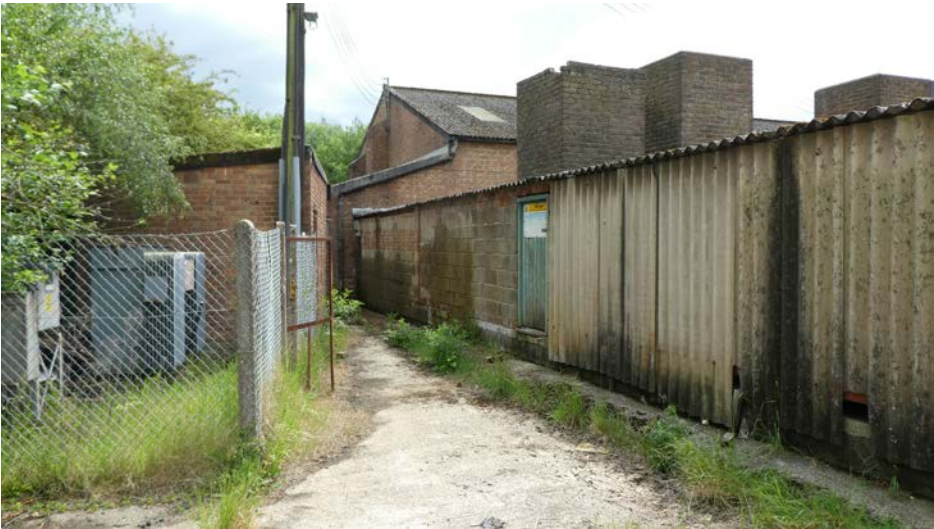
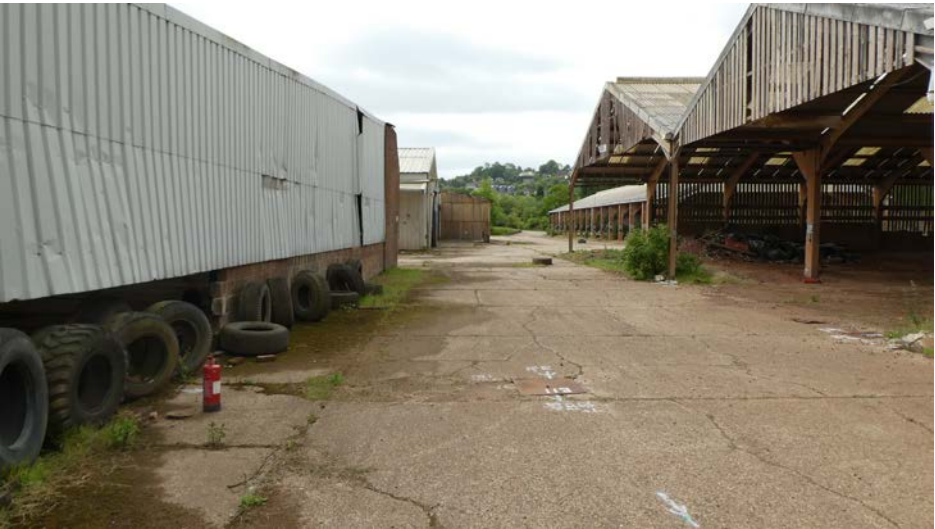
Photo Ref. 10

**Details** A view east along the building shown in Ref. 9.
