# Historic Building Record

**Ashill Regen Ltd**

**West Hoathly Brickworks, Hamsey Road,  
Sharpthorne, East Grinstead**

**June 2025**

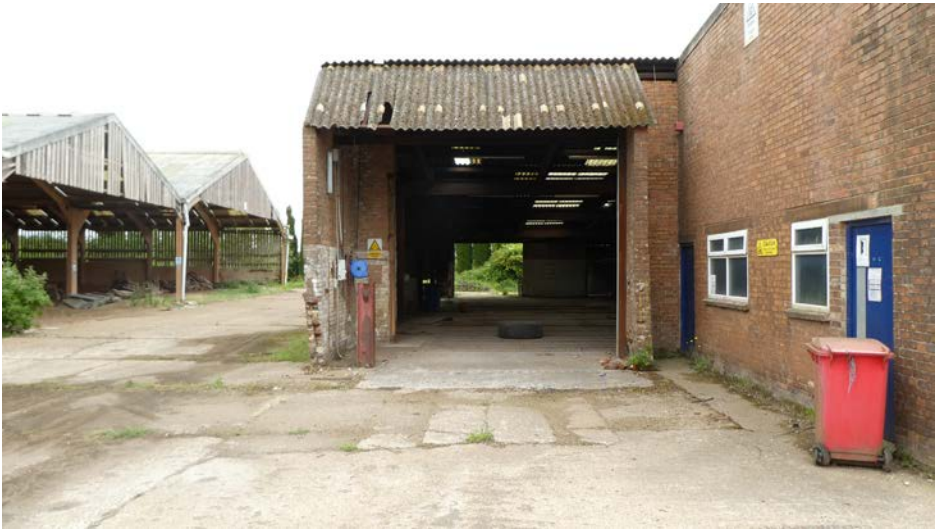
Photo Ref. 13

**Details** A view looking north, showing modern brick buildings with corrugated metal roofs.

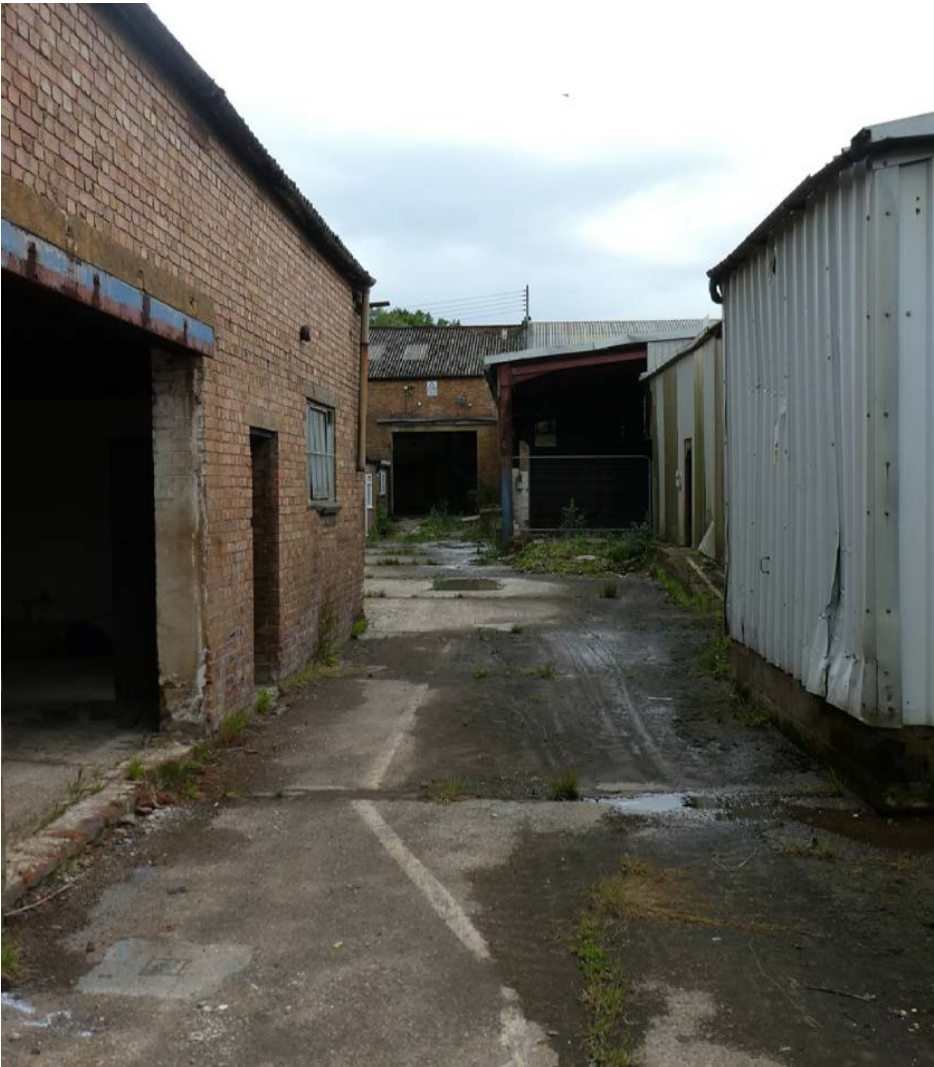
Photo Ref. 14

**Details** A view looking east into the centre of the modern complex of buildings on site. Buildings are constructed from a mix of brick and metal sheet panels.

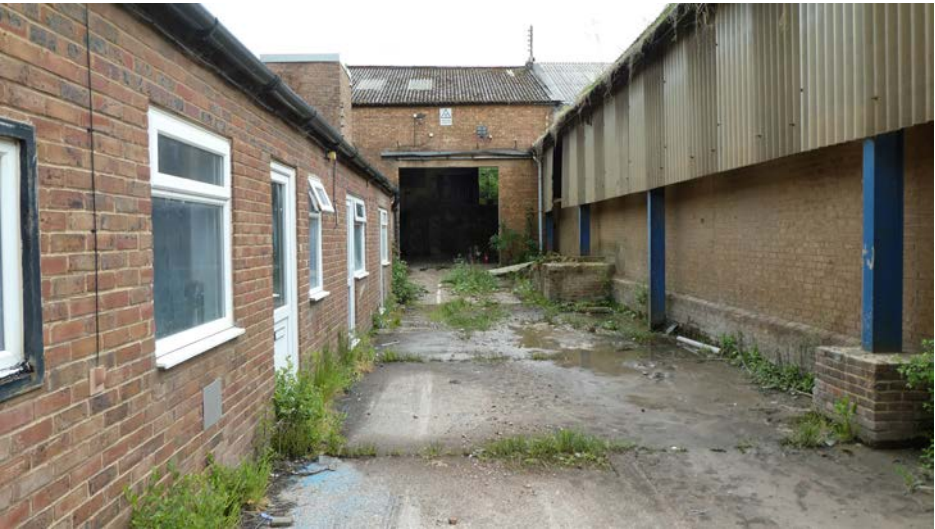
Photo Ref. 15

**Details** A similar view to Ref 14, but further into the site.

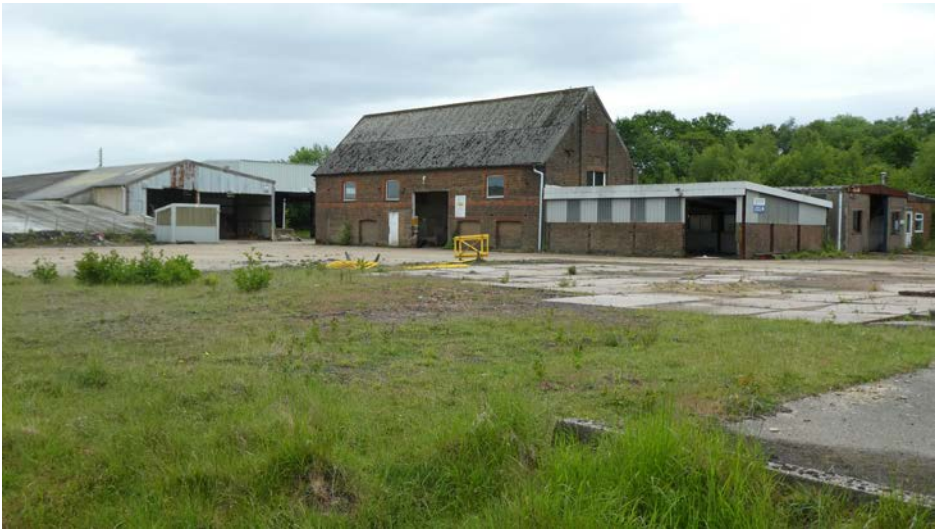
Photo Ref. 19

**Details** Viewing the historic building looking north-east from the centre of the site.

The building stands in open space, showing unobstructed views of its primary west-facing frontage.

Modern buildings are seen, attached to the southern elevation of the historic building, and also forming part of its setting to the north-east.

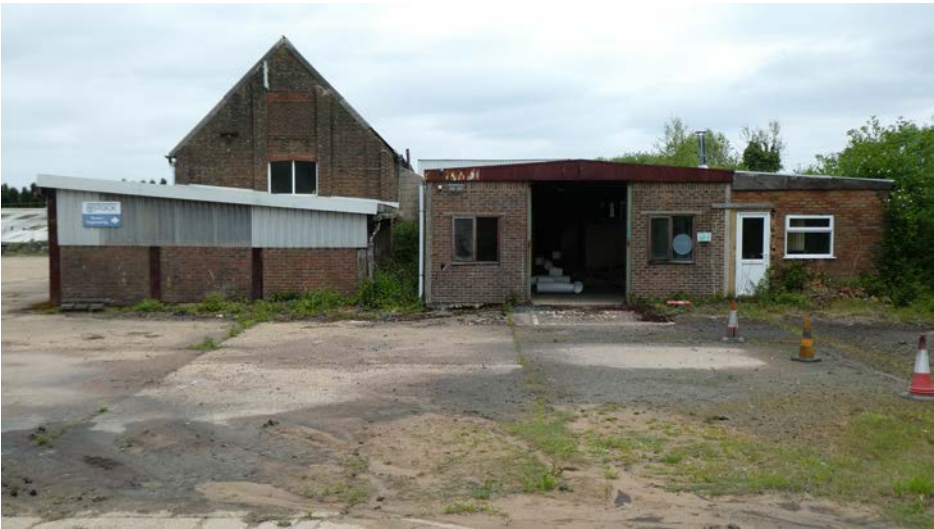
Photo Ref. 20

**Details** Viewing the historic building looking north.

The various alterations to the building's fenestration can be seen, including the creation of a large opening that was most recently a roller-shutter access point.

Blocked up openings are seen close to the ground, whilst three openings with modern windows are seen above.

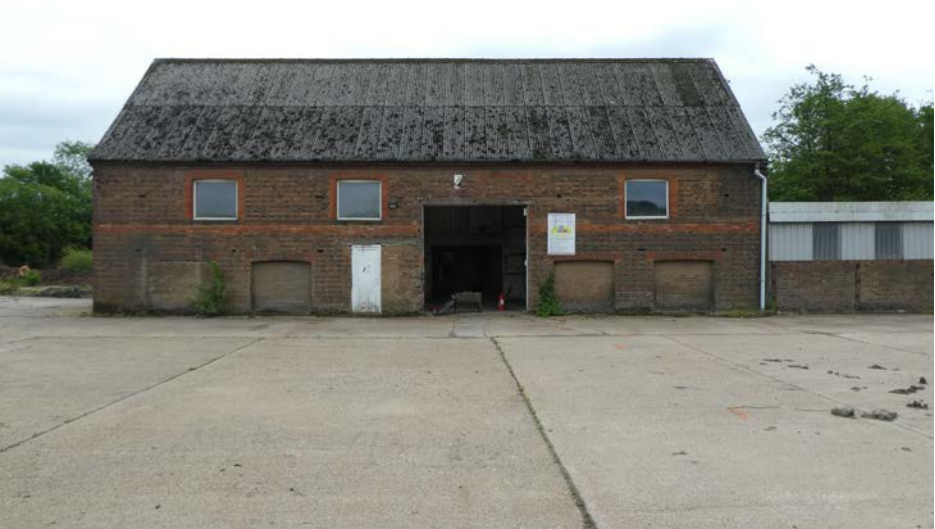
Photo Ref. 21

**Details** Viewing the historic buildings looking east, revealing its full primary elevation.

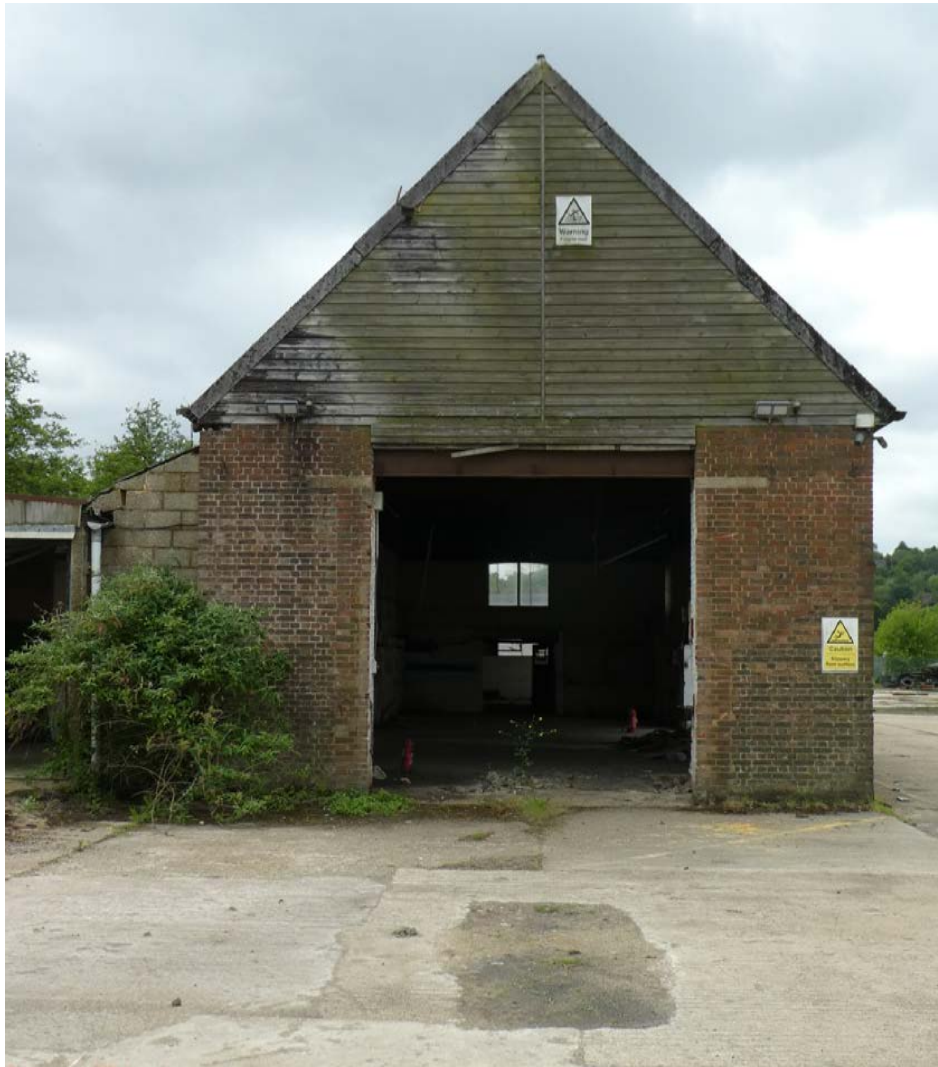
Photo Ref. 23

**Details** A view looking south west, showing the historic building alongside modern ancillary structures.

The gable end of the historic building is timber clad, with a large central open beneath, supported by an iron girder.

The lack of doors allows for glimpses into the main space of the historic building, including through to the window on the southern elevation.
