# THE MARTLETS SHOPPING CENTRE REDEVELOPMENT: PROPOSED HIGH1WAY WORKS

Road Safety Audit  
Stage 1

Report Title: Stage 1 Road Safety Audit

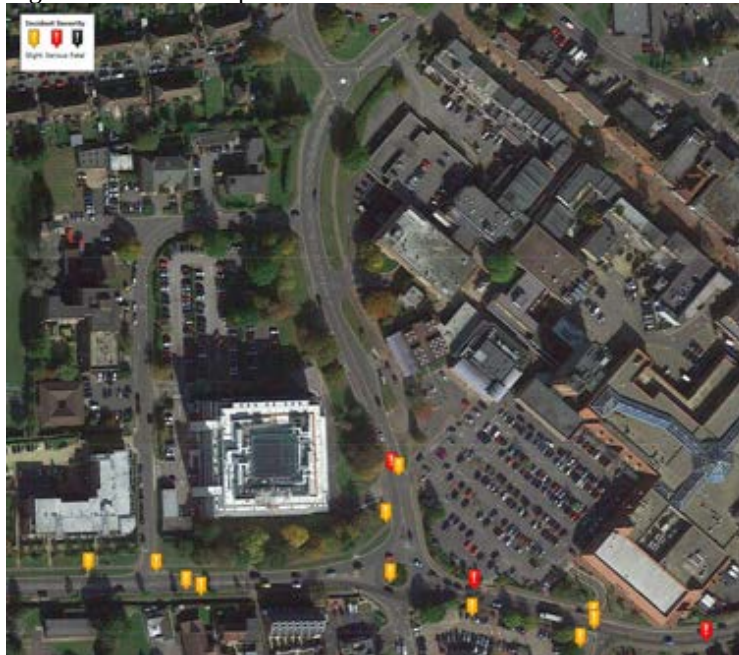
Figure 5.1 – Crashmap Extract

5.4.2 An extract of crashmap.com showing recorded collisions and their severity is provided at Figure 5.1 below.

5.4.3 As can be seen in Figure 5.1 above, no location within the study area had a distinct clustering of five or more collisions (i.e. one or more per year).
