THE OLD BAKERY, 65-65A HIGH STREET,  
LINDFIELD, WEST SUSSEX, RH16 2HN

## HISTORIC BUILDING ASSESSMENT & RECORD OF THE GEORGIAN ERA CEILING

Mid Sussex District Council Reference: DM/23/2298

Report No. 2023544  
February 2025

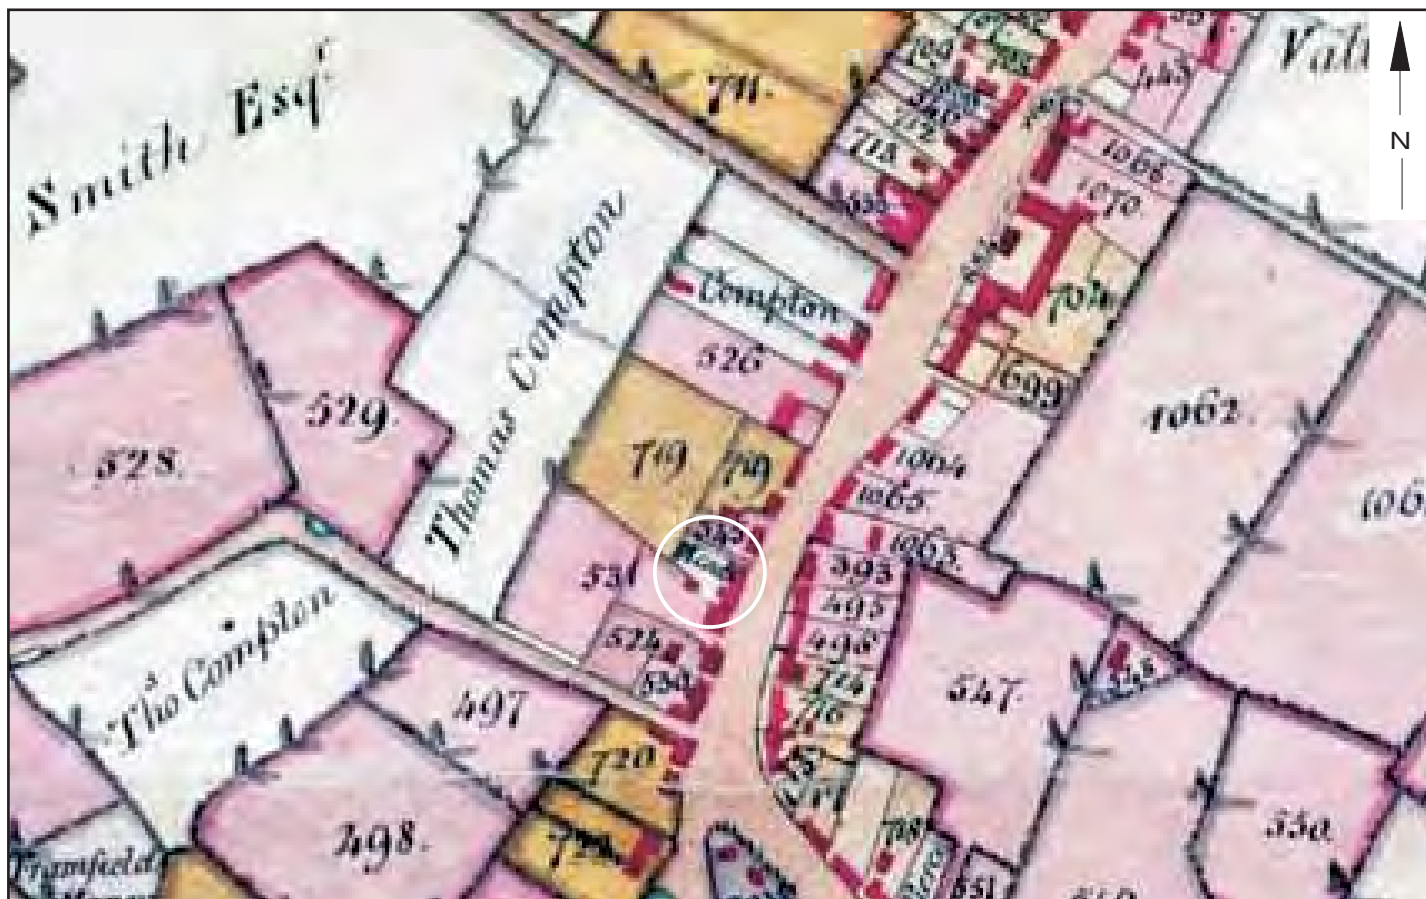
Figure 2

William Figg map, 1829 (ESRO ACC 2327-1-5-15)

The property under Richard Humphrey (c. early 20th C)

- 4.1.3 In 1829 the Lewes cartographer William Figg drew a detailed map of the manor (Figure 2), from which it is clear that virtually every house on Lindfield High Street, and much of the agricultural land behind them, formed tenements of the manor. One of the few exceptions was The Old Bakery, marked simply with the word *Meads*, representing the name of the current owner.<sup>5</sup>

5.5.2 A photograph of the building was reproduced in the Lindfield Life magazine, showing the property with render concealing the timber-frame at the northeastern end of the building, the fenestration on the street-front and the shop front including the lattice-screen to the cellar (Figure 2).

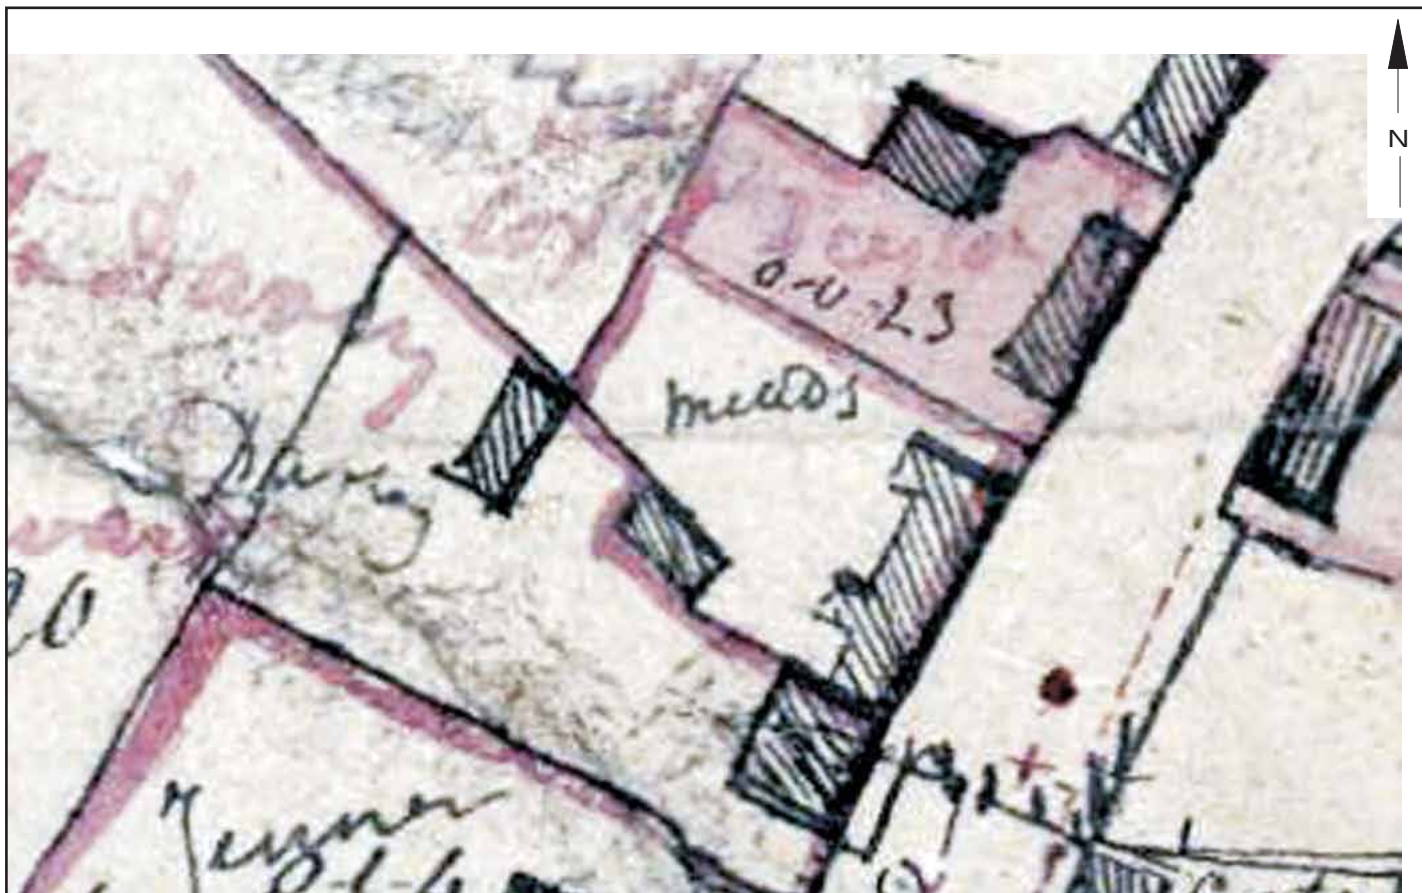
William Figg's draft for his map of the manor of South Malling Lindfield, 1824 (ESRO ACC 3412-3-259)

Tithe Map of Lindfield, 1845

- 4.2.2 The 1824 map shows a long, relatively narrow building with a cross-wing at the north end of the house, a projecting rear range (or possibly the rear part of a second cross-wing) towards the southern end and a substantial outbuilding on the southern boundary of a small curtilage.
- 4.2.3 The features identified on the early map were depicted unchanged on the tithe map of 1845 (Figure 3) and on Ordnance Survey maps of 1874, 1896, 1909, 1937 and 1956 despite subdivision of the building into two separate properties between 1937 and 1956). The two early maps show a well in the yard (Figures 4 – 6).

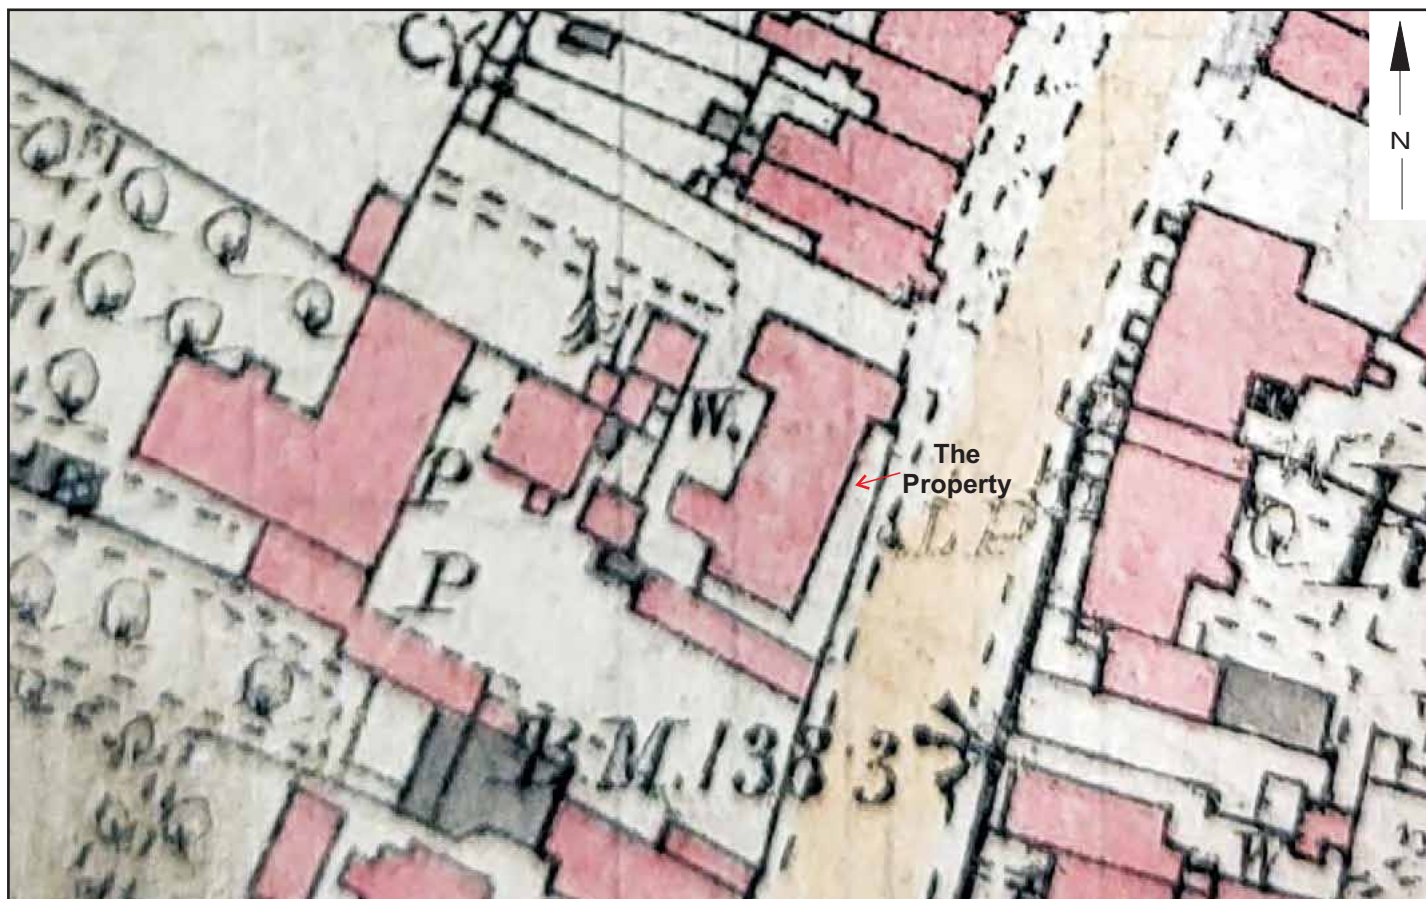
First Edition County Series (1:2500) Ordnance Survey Map 1876

First Revision County Series (1:2500) Ordnance Survey Map 1896

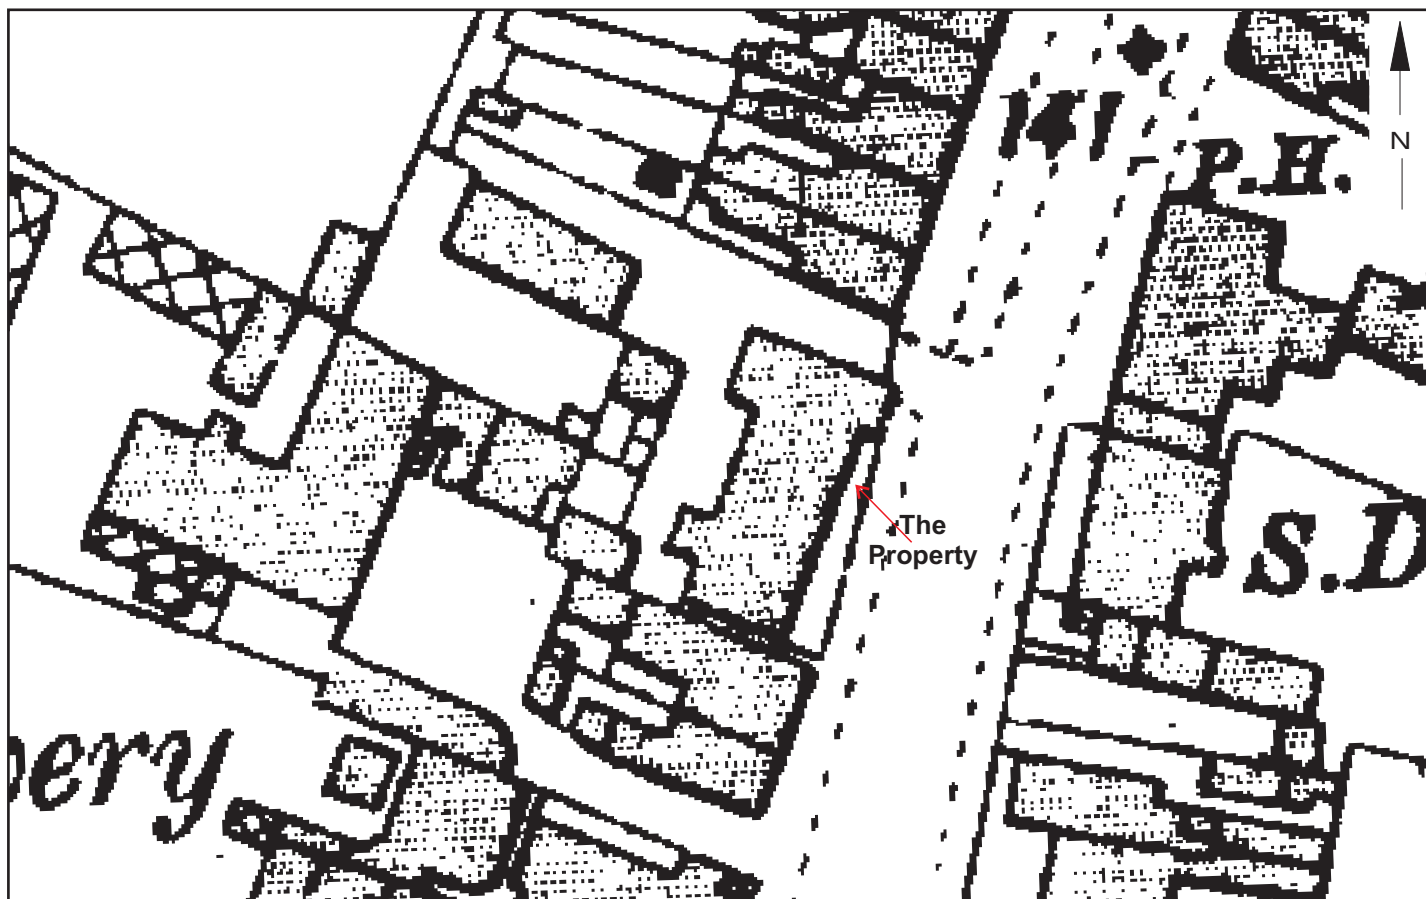
2nd Revision County Series (1:2500) Ordnance Survey Map 1909

3rd Revision County Series (1:2500) Ordnance Survey Map 1931

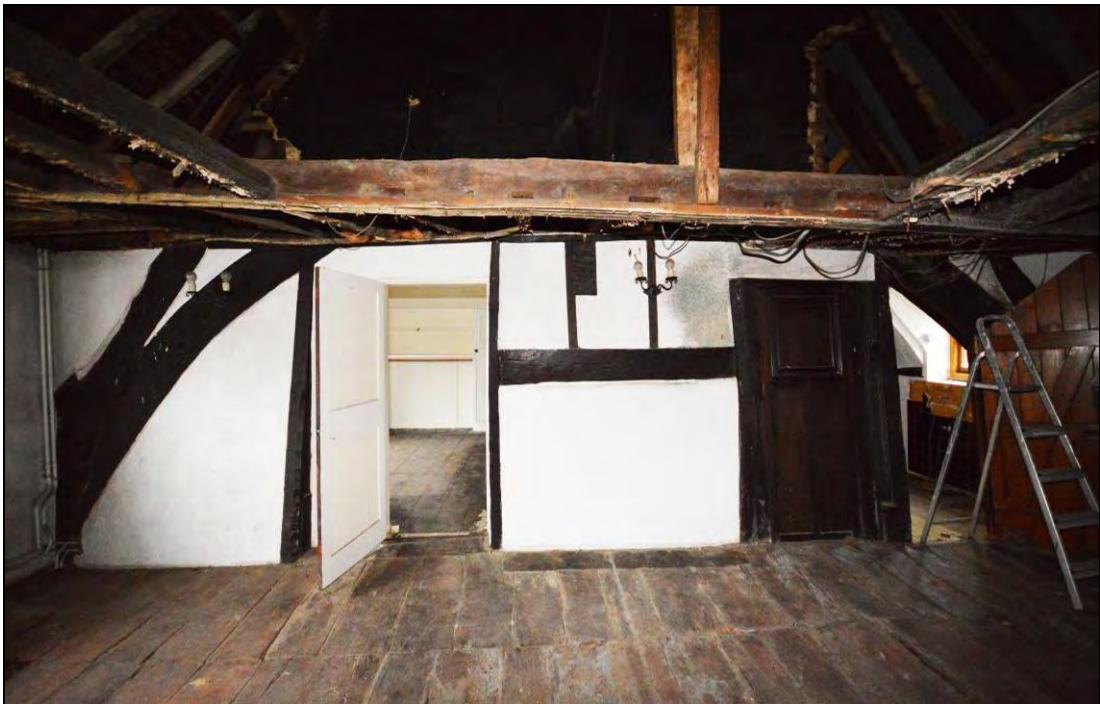
Plate 3: The base-cruck truss (T1) between bays 1 and 2 of the main range (the hall)

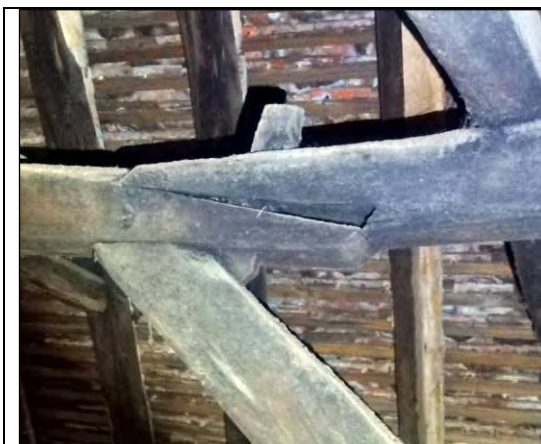
Plate 4: Detail of the splayed scarf joint and its prominent key

- 5.1.10 The splayed scarf is an early type of joint in use during the 13<sup>th</sup> and 14<sup>th</sup> centuries and is of particular interest here in the inclusion of a key. A similar versions of the scarf joint had been recorded in the barn at Fairstead Hall in Essex albeit with four face-pegs, the barn is considered as being of fourteenth century origin at the latest, possibly c. 1330 (Hewett. C.A., 1969, *The Development of Carpentry, 1200 – 1700: An Essex Study*).

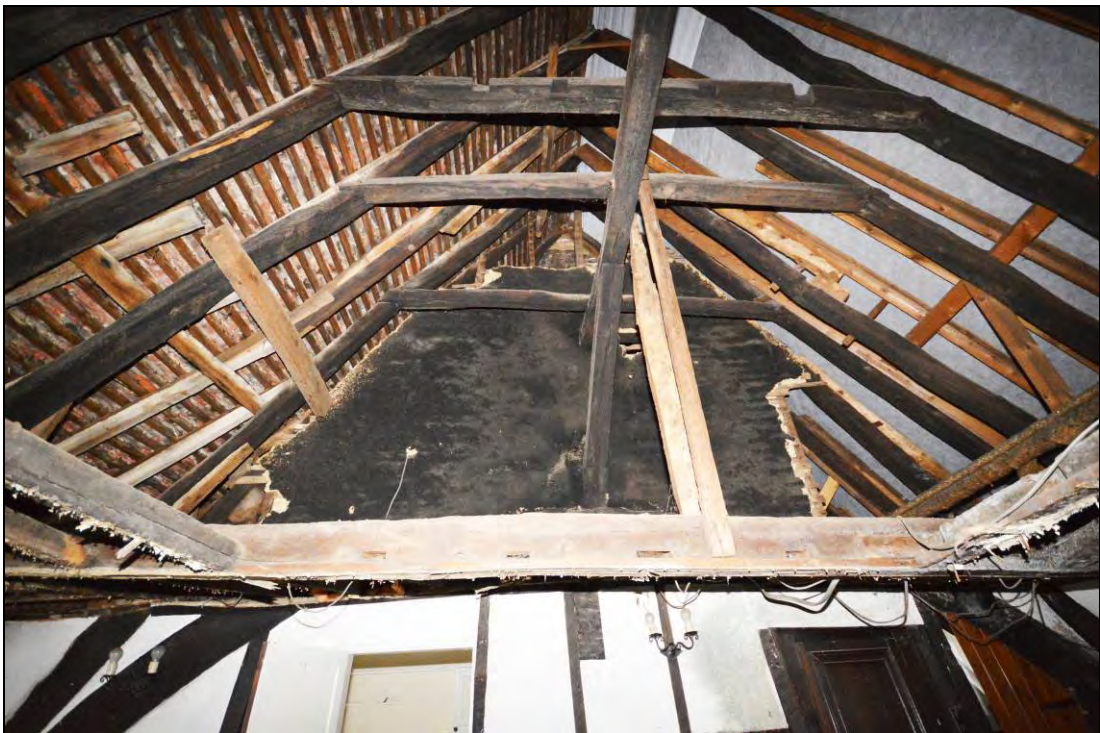
Plate 5: The roof over the hall looking towards the base-cruck truss and the soot-blackened partition inserted in phase 2

- 5.1.13 All of the roof members within the hall are soot-blackened, commensurate with the single storey open form of the building as first built. It is important to note that there is tentative evidence to suggest that the roof terminal at the north end of the building had been a hipped one prior to the creation of the cross-wing: this is discussed in detail below (*Form and Function*; Plate 15).

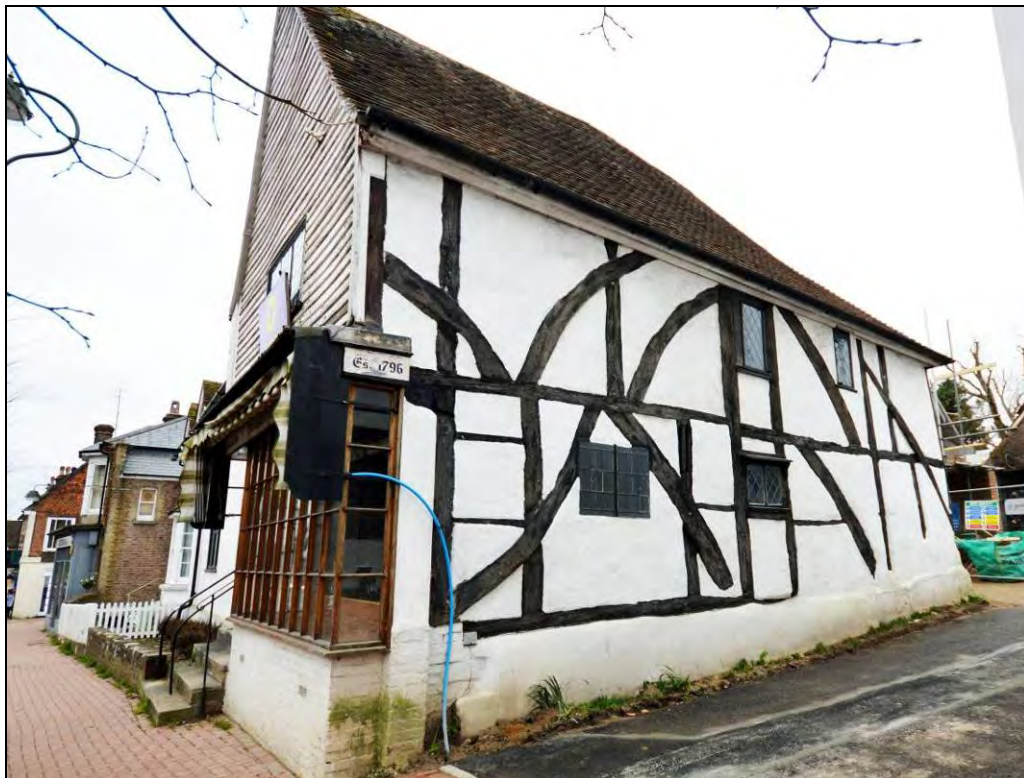
Plate 6: The cross-wing showing the jetty and the wall framing, the jetty under-built to create a shop front

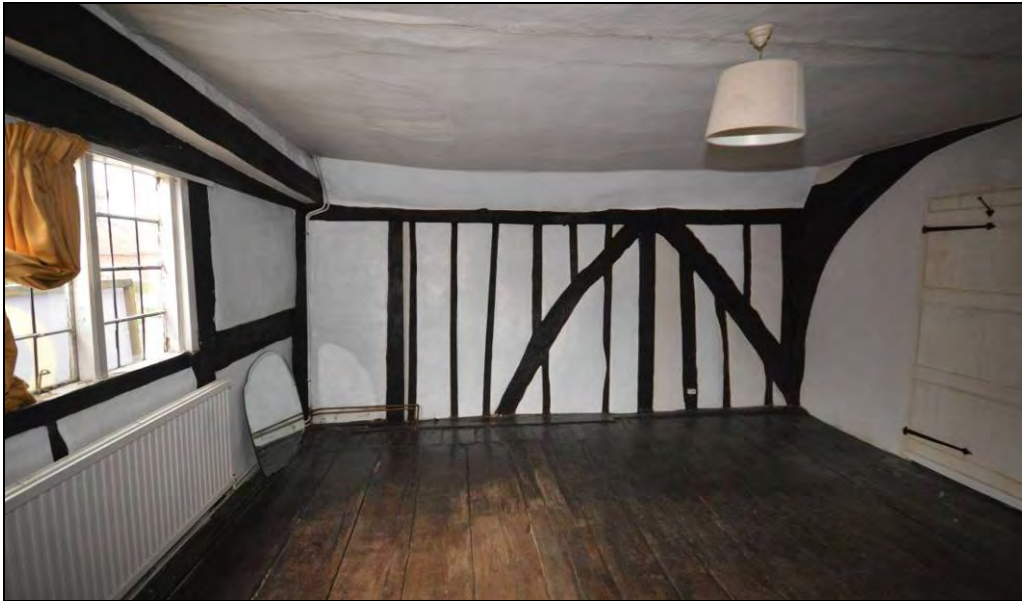
Plate 7: The southwest wall of the cross-wing at first floor level, and an oblique of the street-front elevation and its Georgian window

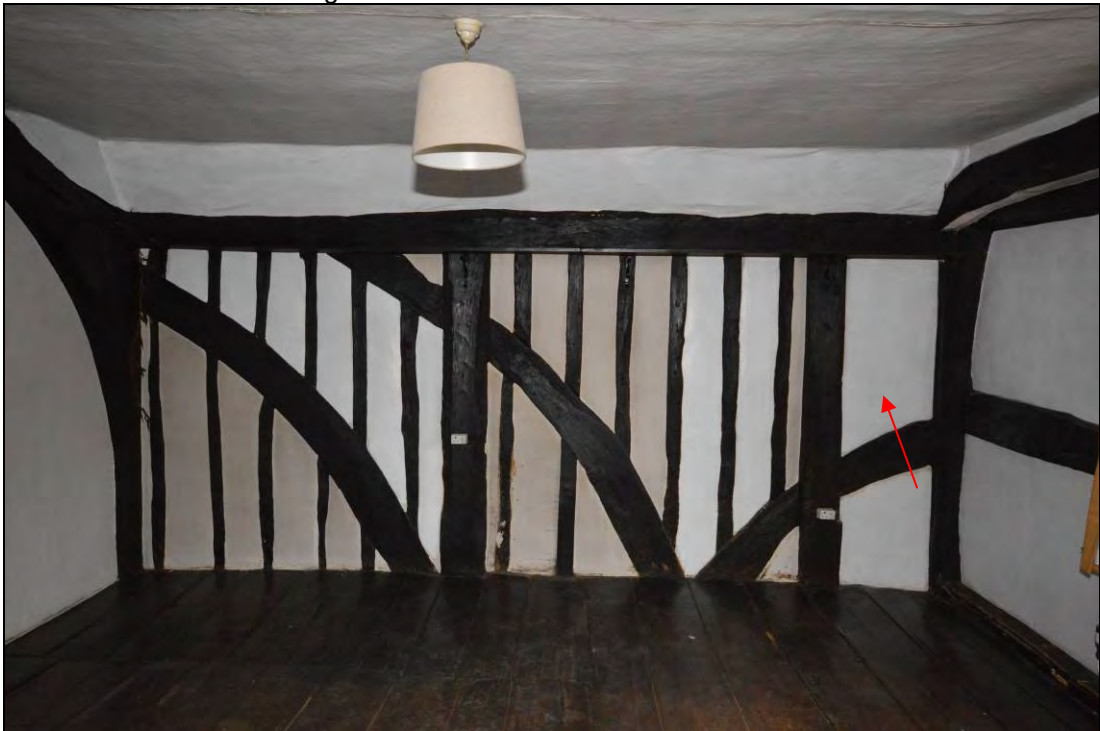
Plate 8: The northeast wall of bay 3 at first floor level on the interior, the low foot-brace to the southeast accommodates a former shuttered opening above it (red arrow, see also Figure 8)

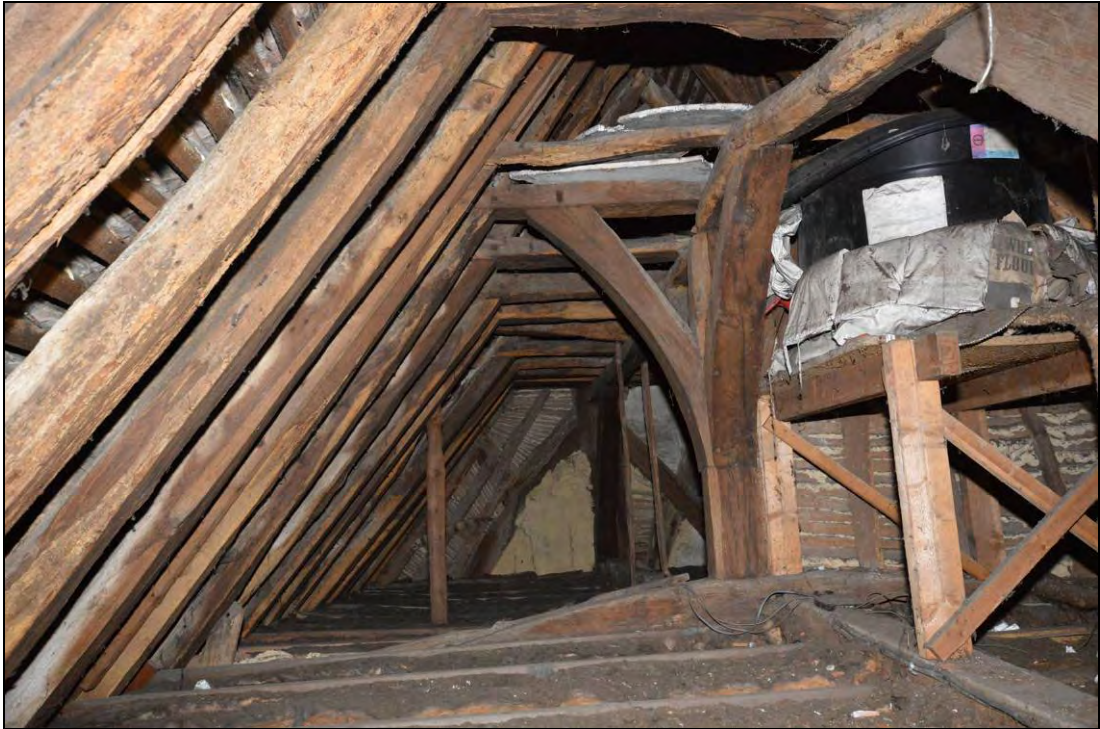
Plate 9: The interior of the cross-wing roof looking to the southeast gable, its substantial crown-post and flanking cross-bracing with the four-way braced truss over the two-bay hall at the centre

- 5.1.41 All three crown-post configurations differ, that over the open truss as described above has four-way head-bracing (Figure 8; Plate 9) and its northwestern counterpart is foot-braced to the tie-beam with one head-brace rising from the southeast side of the post to the collar purlin.

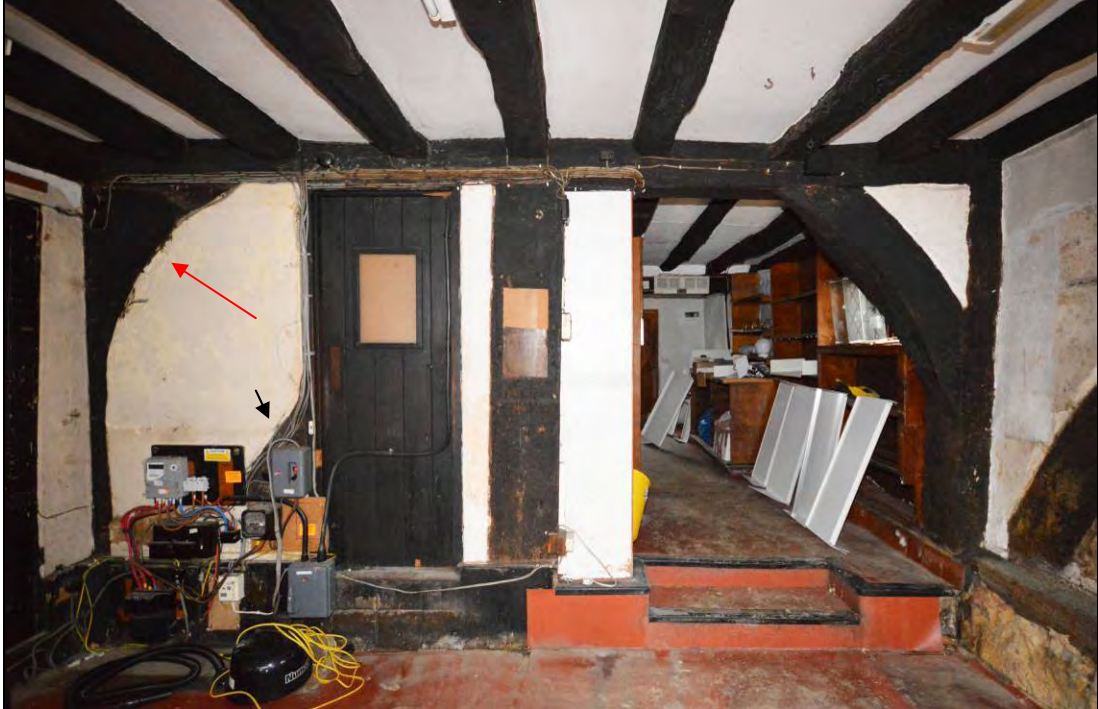
Plate 10: The T4 truss on the ground floor showing the central stud, braces, and durn-type bracket (red arrow), the surviving base of the foot-brace just visible behind the meter (black arrow)

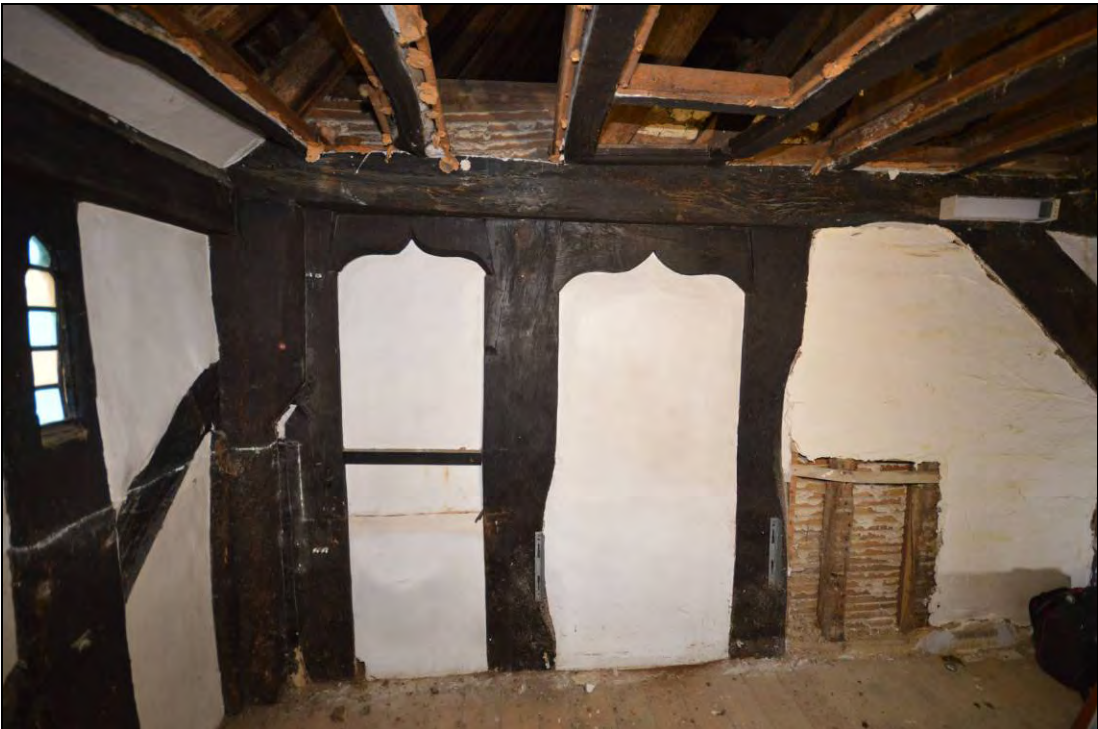
Plate 11: The two adjacent doorways at first floor level in the T5 truss viewed from within the northwest end bay (bay 5; Figure 8)

- 5.1.25 The doorways are undoubtedly an early feature, however, close inspection has revealed that they studs are inserted, that their bases are nailed onto a sole-plate supported over the joists forming the first floor. The structural details and the fact that the timbers are the only extant part of the building that includes Arabic type carpenter's marks, favour an early insertion into the building rather than original features.

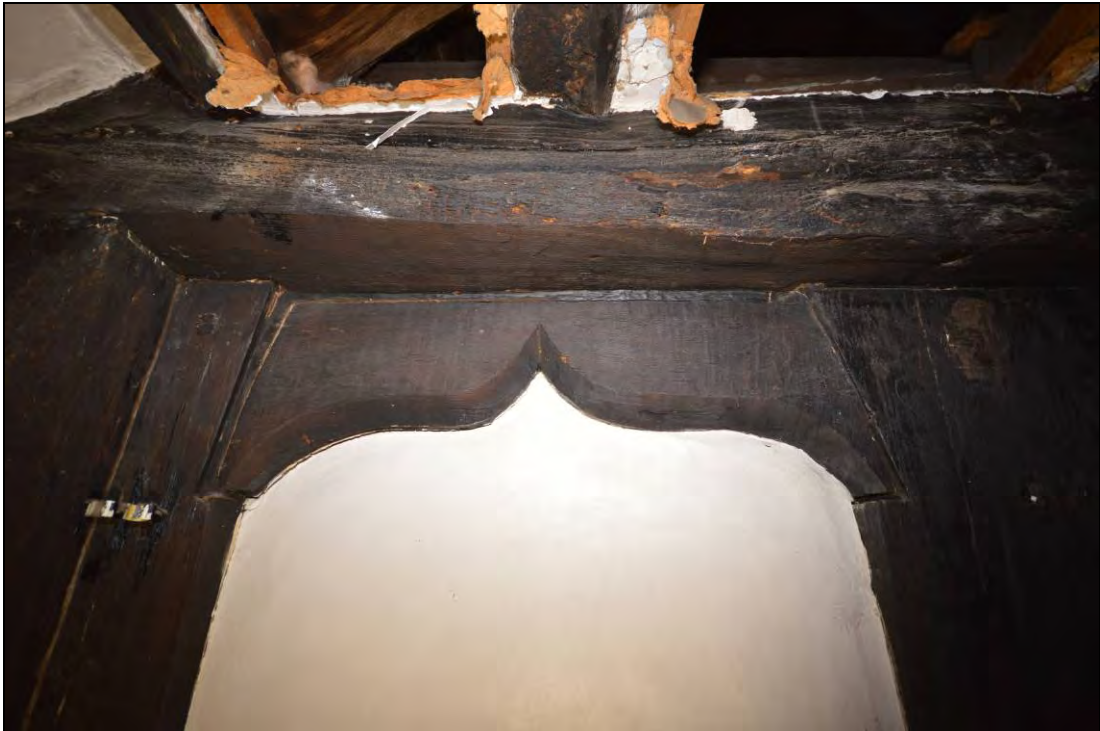
Plate 12: Detail of the chamfered leading edges of the ogee door-heads and the squinted abutments to their jambs (northwest side)

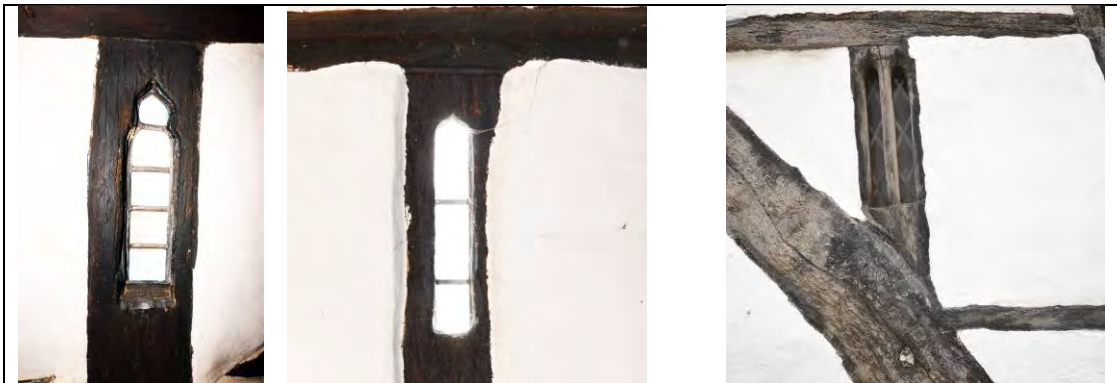
Plate 13: Single lancet in bay 3, first floor, single lancet in bay 5 ground floor and double lancet in bay 3 ground floor

- there is a third lancet window within a stud in the northeast wall of bay 5 of the cross-wing at ground floor level: this lancet does not appear to match the others particularly well and may represent a later introduction to the group (Plate 13).

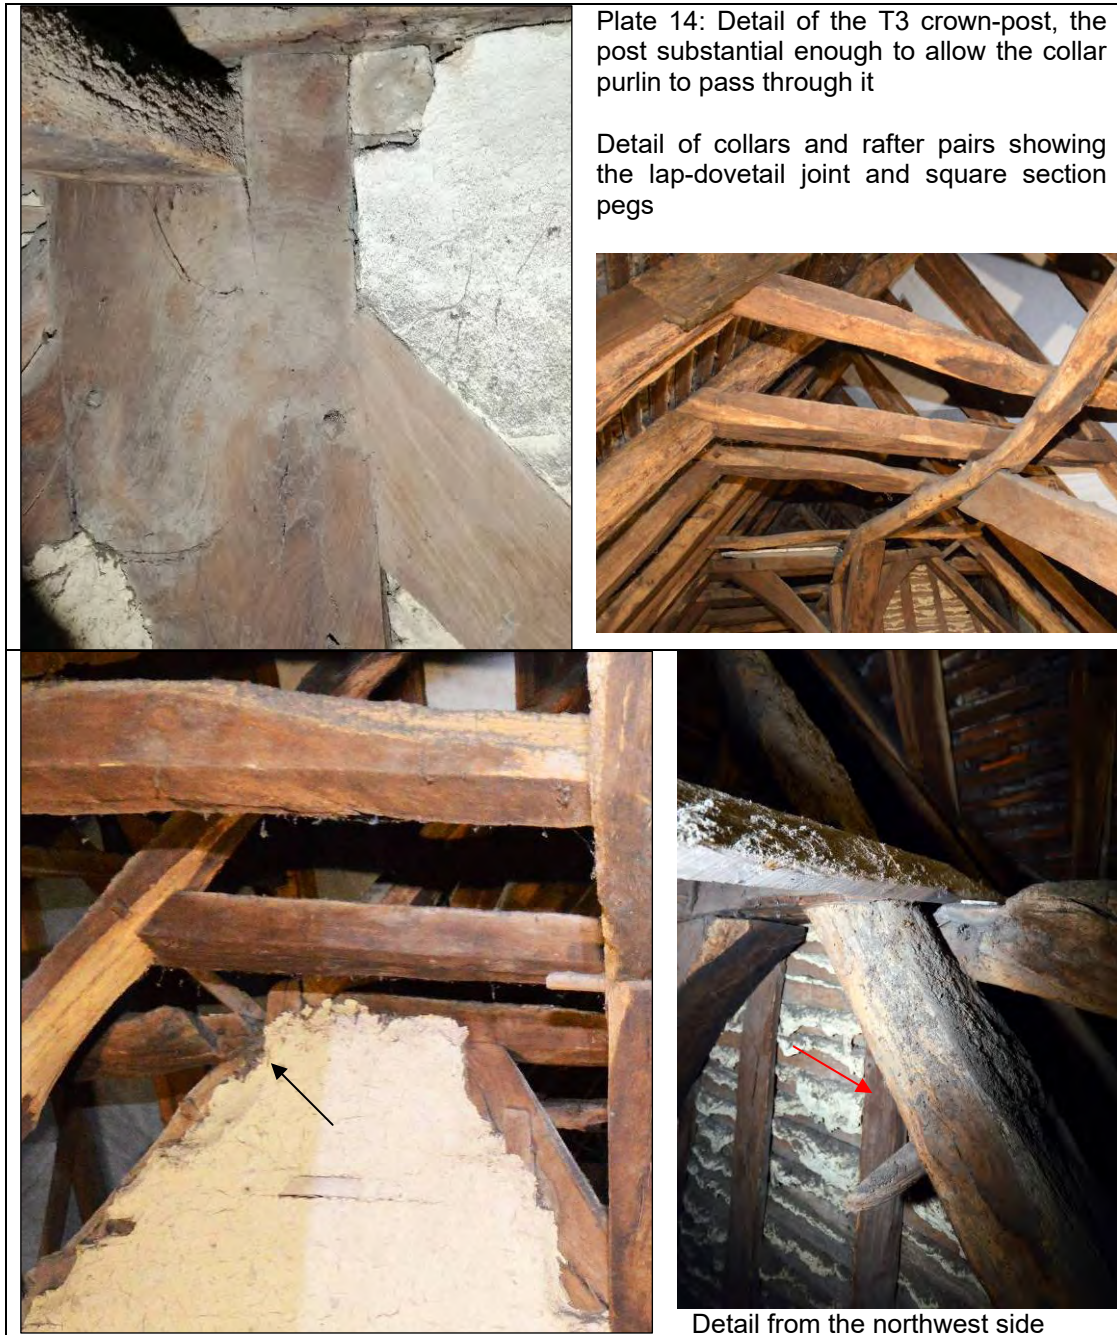
Plate 15: The tenon with its central peg-hole situated at the end of the collar purlin at its junction with the former open truss (T4) of the cross-wing (black arrow). The detail shows the same junction from the northwest side of the truss, in addition to a robust peg that had been driven through the rafter below the junction of the two roof structures (red arrow)

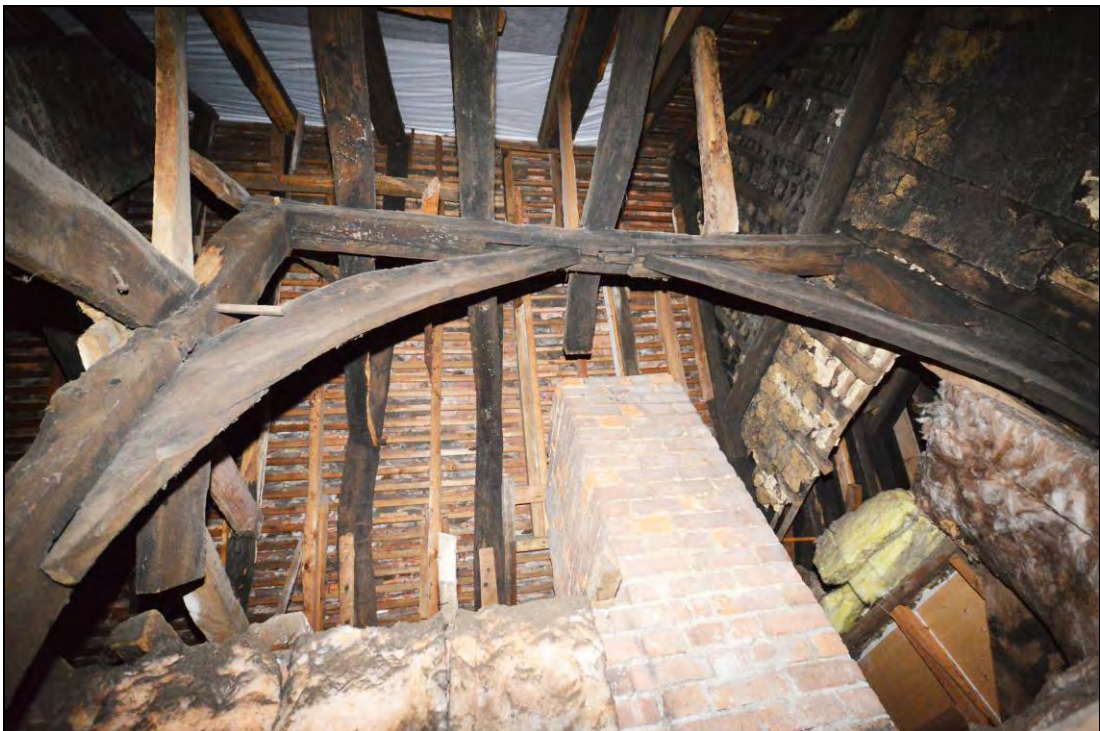
Plate 16: The roof over bay 6, the southwest end of the hall rebuilt during phase 2 to create an attached kitchen

- 5.2.13 A scarf joint is extant between the two head-braces on the collar purlin over bay 6: this is an edge-halved scarf with bridled abutments and two edge-pegs (face-pegs not seen; Plate 16).

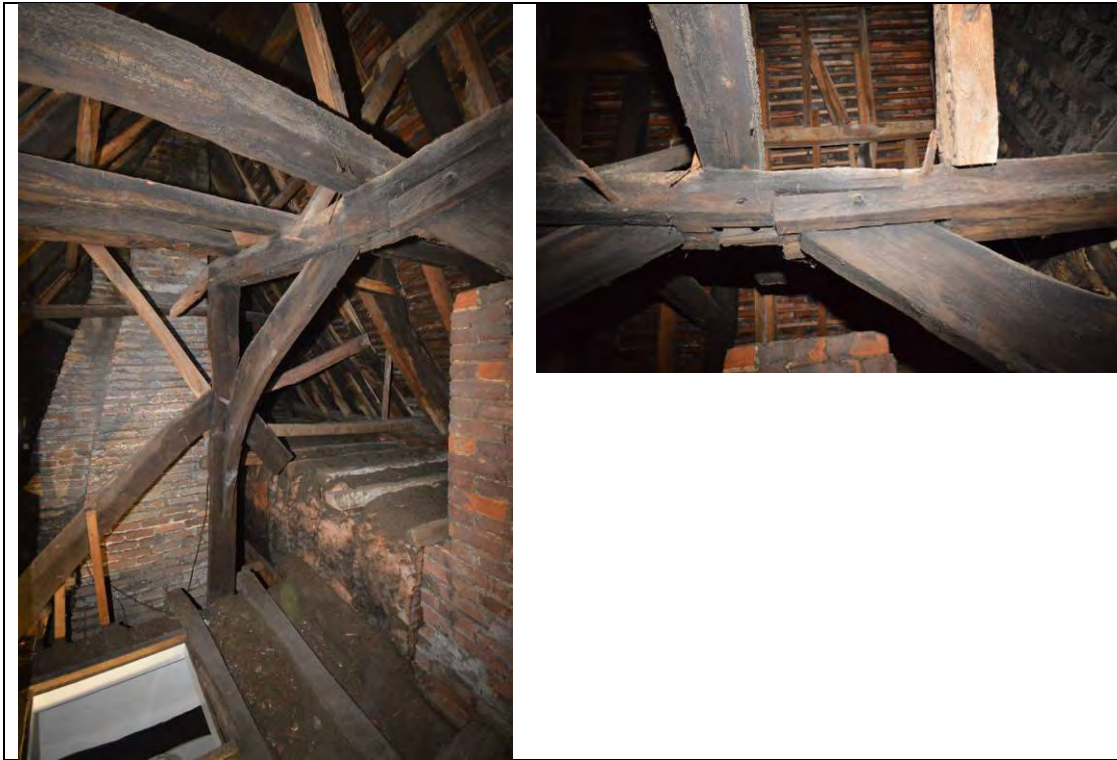
Plate 17: The T7 crown-post and detail of the scarf to the collar purlin between it and T8

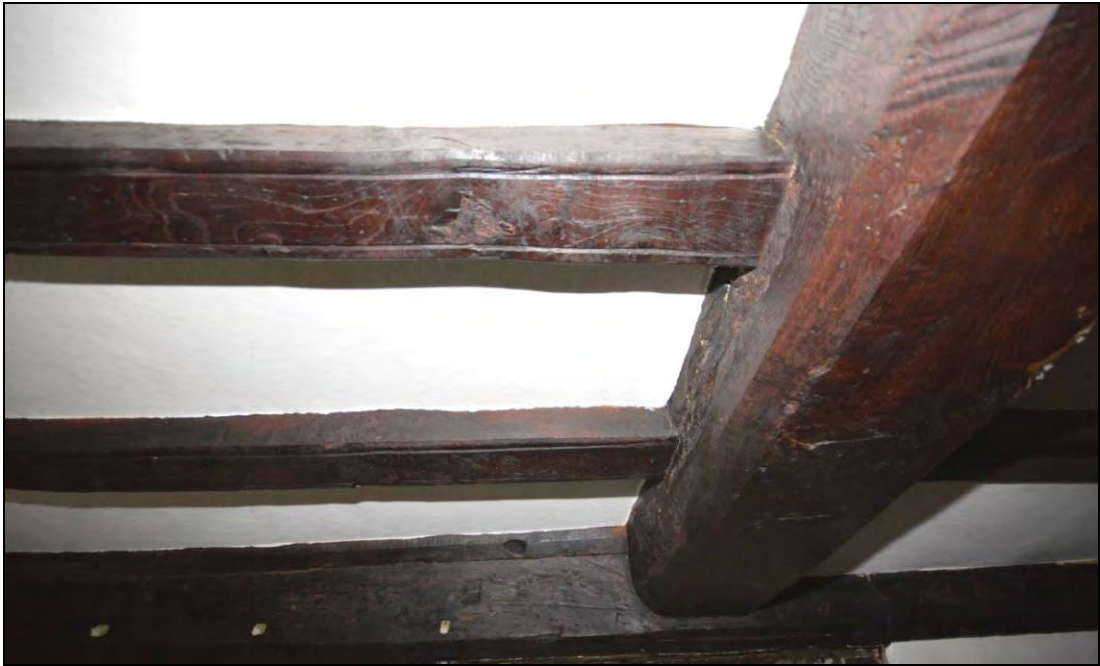
Plate 19: Detail of the inserted floor added to bay 1 of the hall to create a chamber above, note the moulded detail to the robust joists.

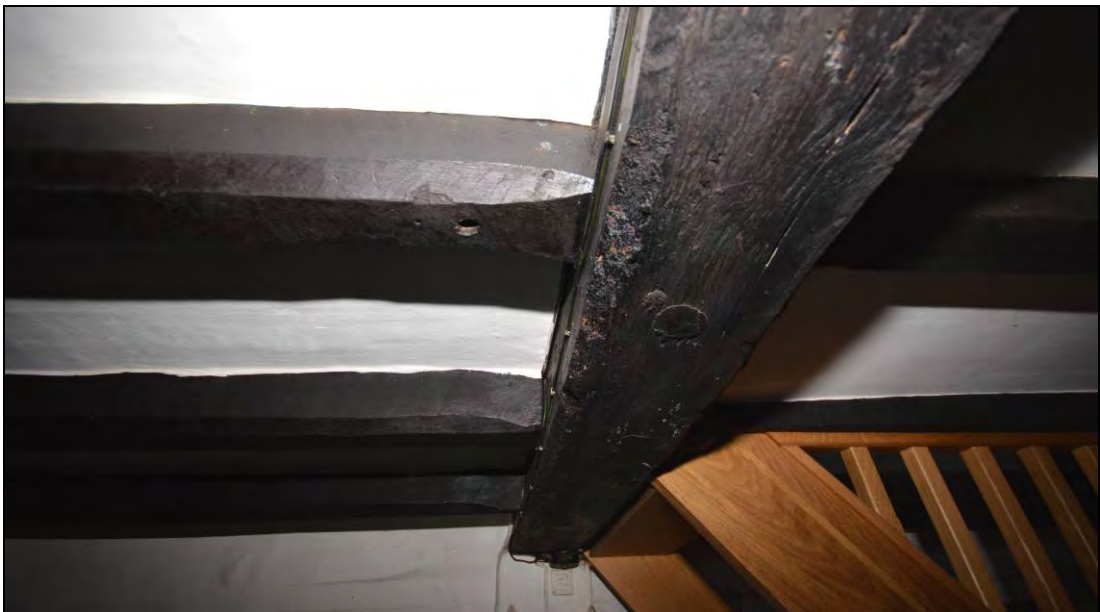
Plate 20: Detail of the surviving joists of the first floor structure in bay 6

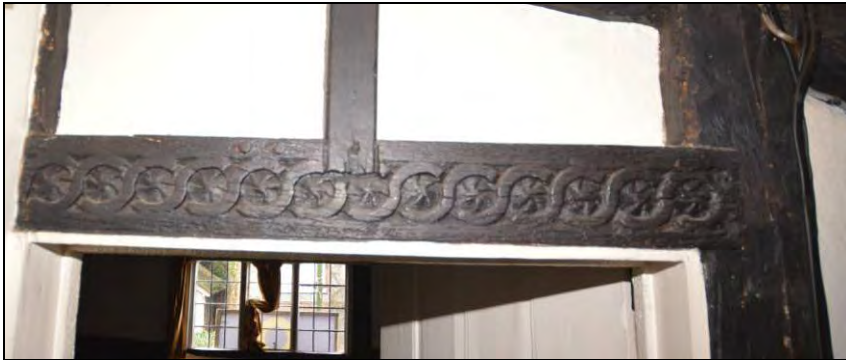
- 5.3.15 The northwest side of the doorway has a decorative timber head-plate nailed to the principal post of the truss (Plate 21). The head-plate includes carved strapwork. The door details and the strapwork are commensurate with a 17<sup>th</sup> century origin.

Plate 21: Decorative strap-work over the doorway in the T5 truss

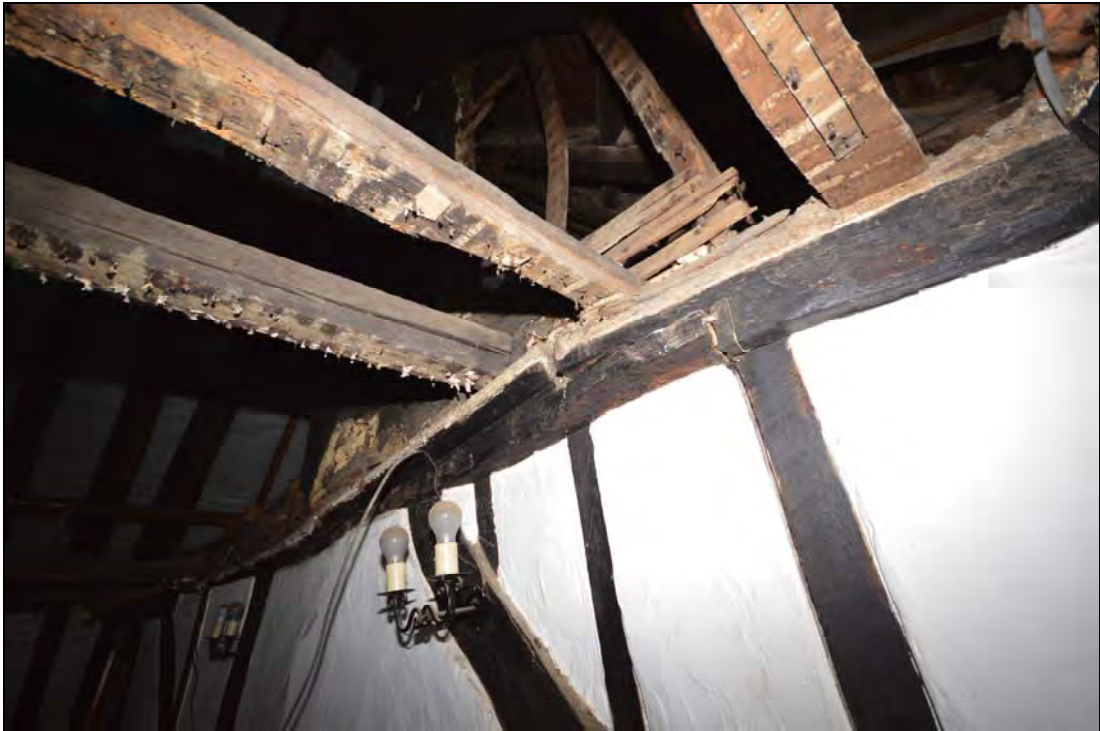
Plate 25: Detail of the bearer attached to the wall plate/tie-beam of the T2 truss/southwest wall plate between the main range and cross-wing

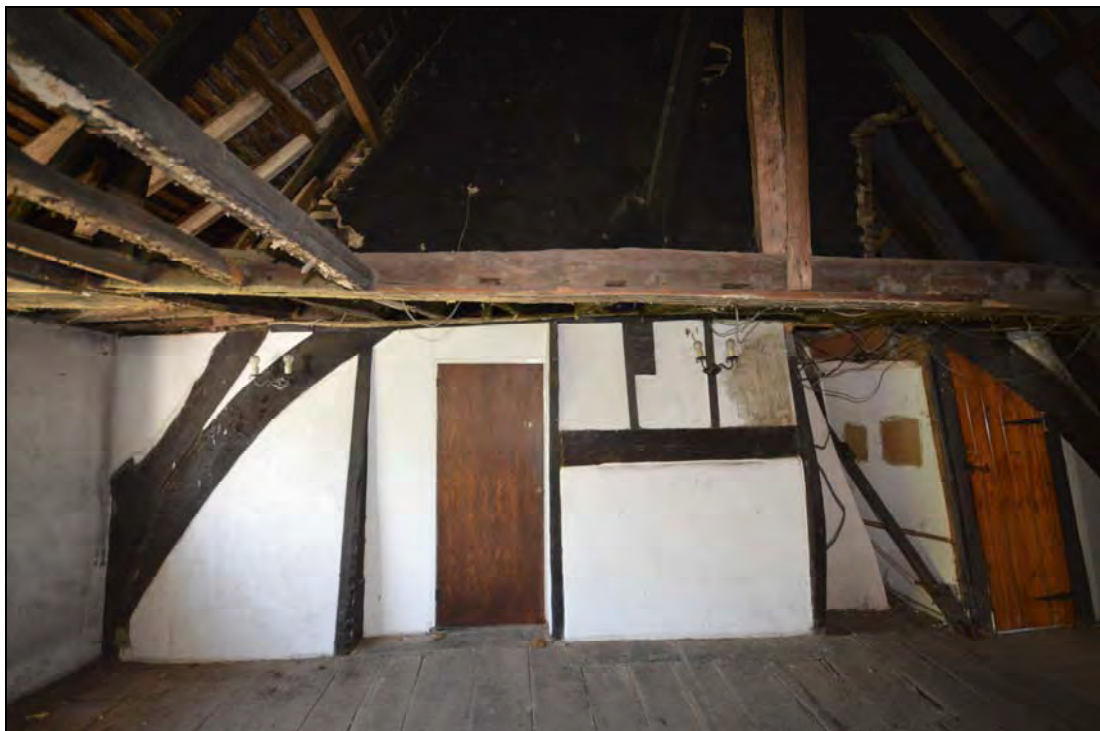
Plate 26: Detail of the girder spanning the width of bay 2 from the inserted flying plate to the southeast to one of the rafters in the northwest roof slope; also shows two of the suspending members used to support the girder

timber studs or suspending members, nailed to the girder and to the collar purlin of the crown post roof above (Plate 26).

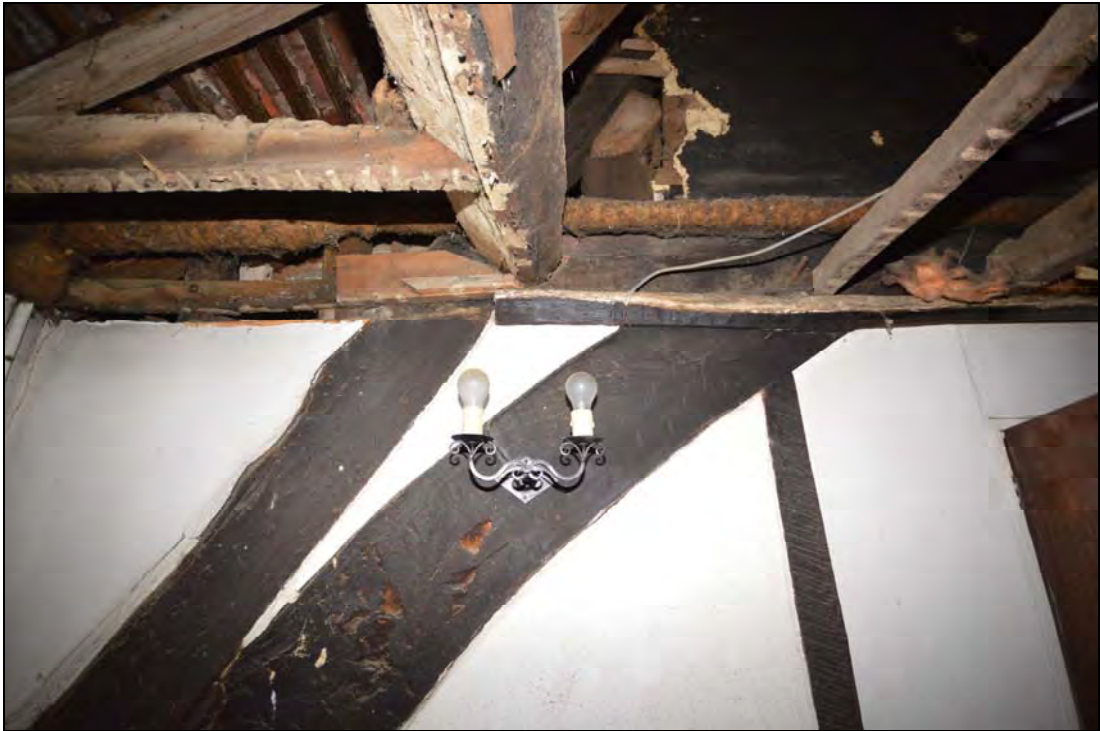
Plate 27: The junction of the inserted flying plate at the southeast side of bay 2 with the 14<sup>th</sup> century base cruck truss

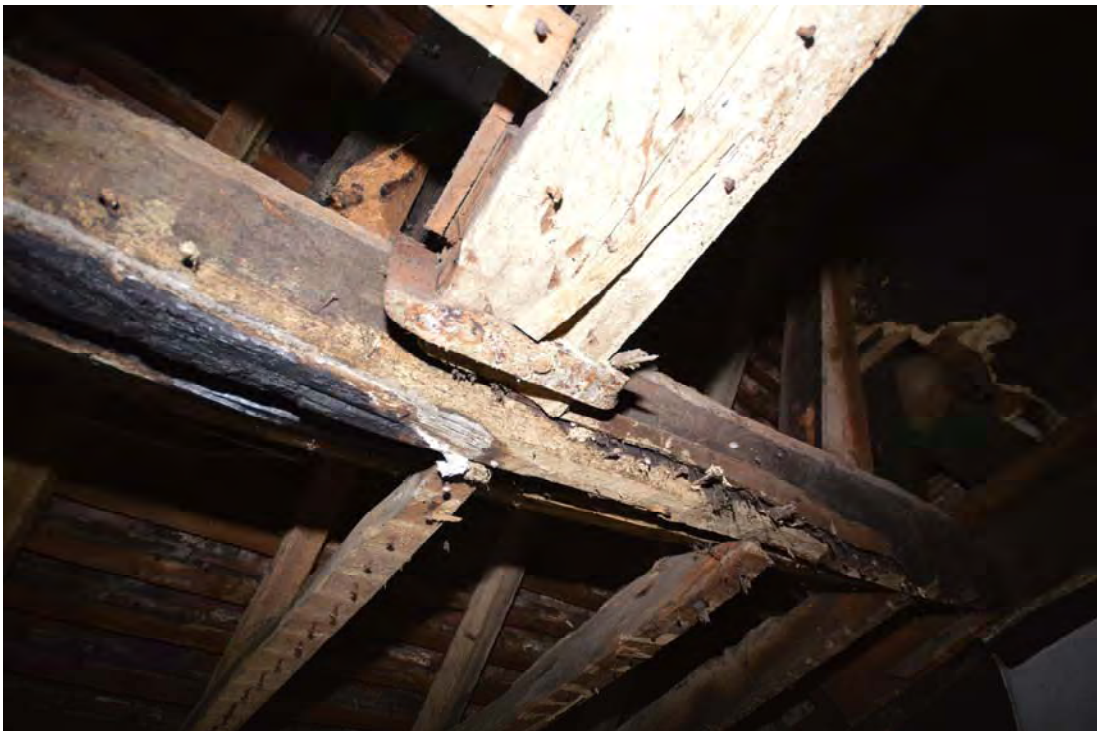
Plate 28: The stirrup strap at the junction of the flying plate and the girder
